SUBJECT : Mercury Vapor Exposure and Engineering Controls  
Evaluation Inside the Mill/Refinery Building  
Cactus Gold Mine, Kern County, CA

SUBJECT : Mercury Health Hazard Surveys & Evaluations  
Cactus Gold Mines Company Mill  
Kern County, CA  
(MSHA I. D. No. 04-04787)  
May 2-4, 1989 & July 18, 1989

Mercury Health Hazard Survey and Evaluation

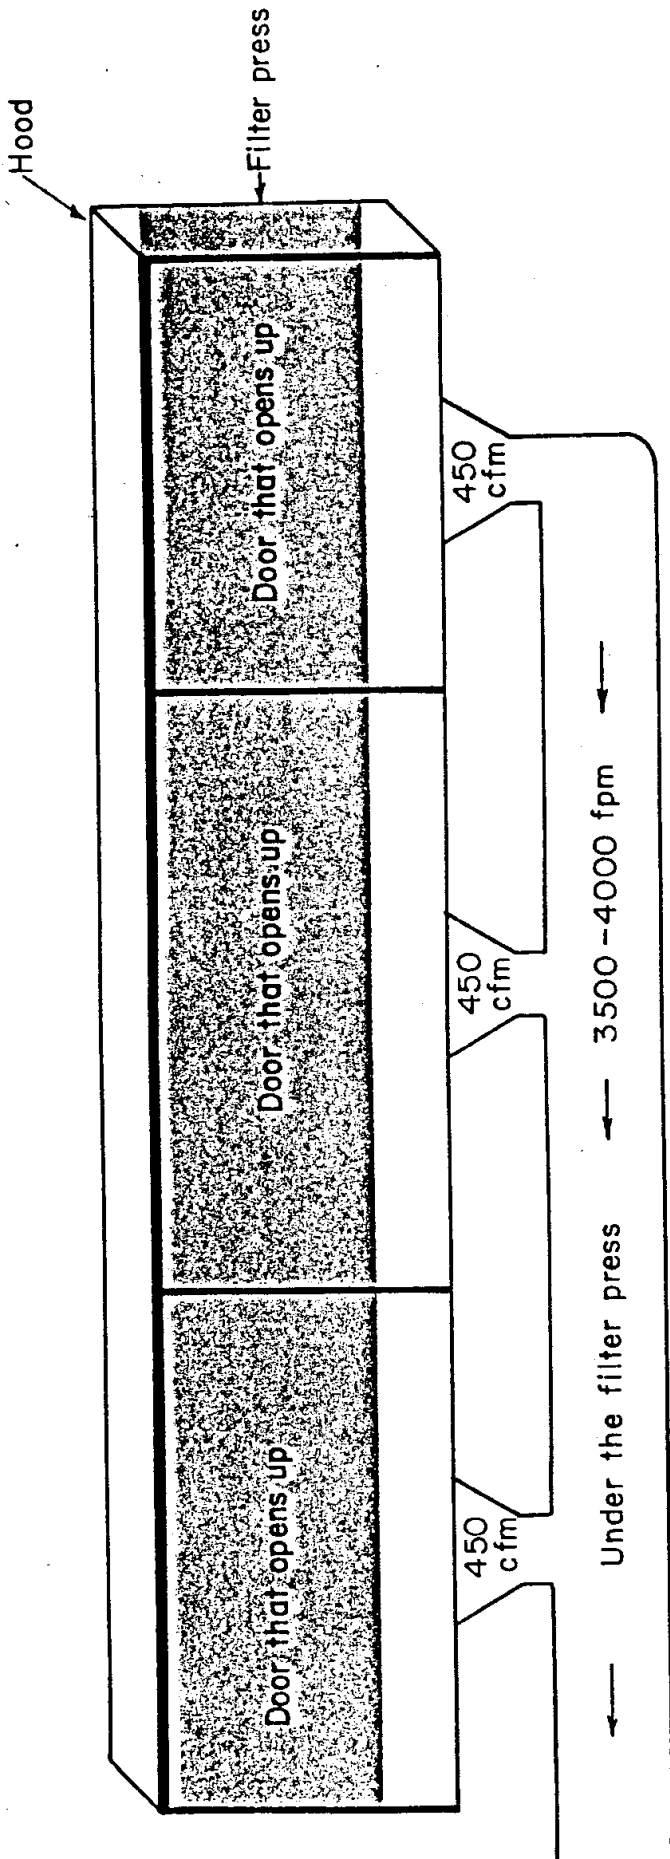
Exhaust hood for filter presses

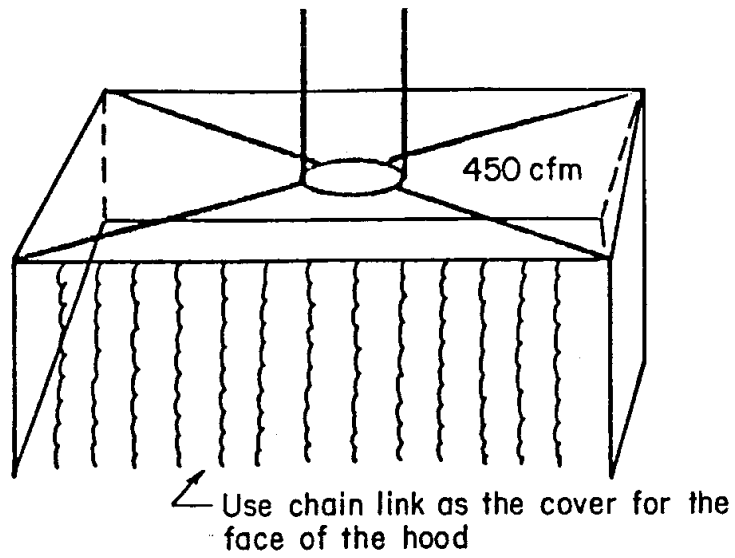
Canopy hood for cones during cooling process

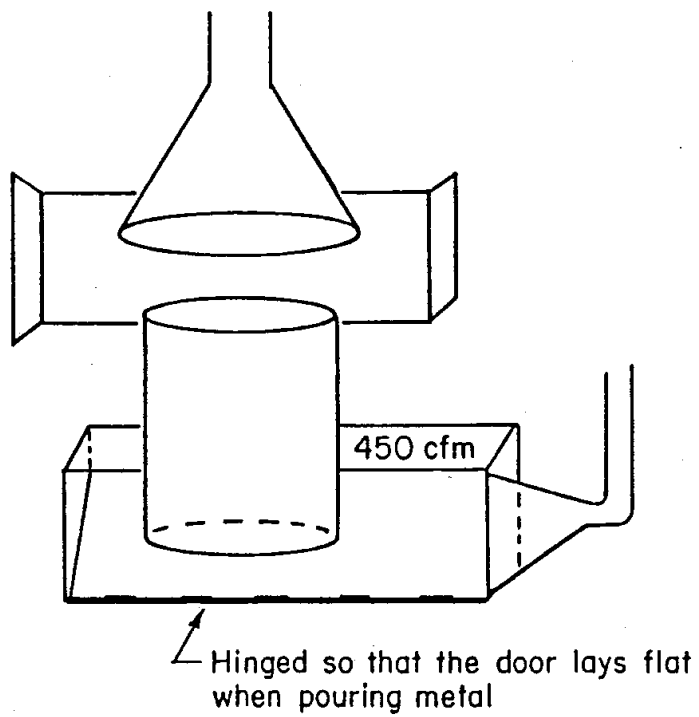
Canopy and downdraft hoods for furnace

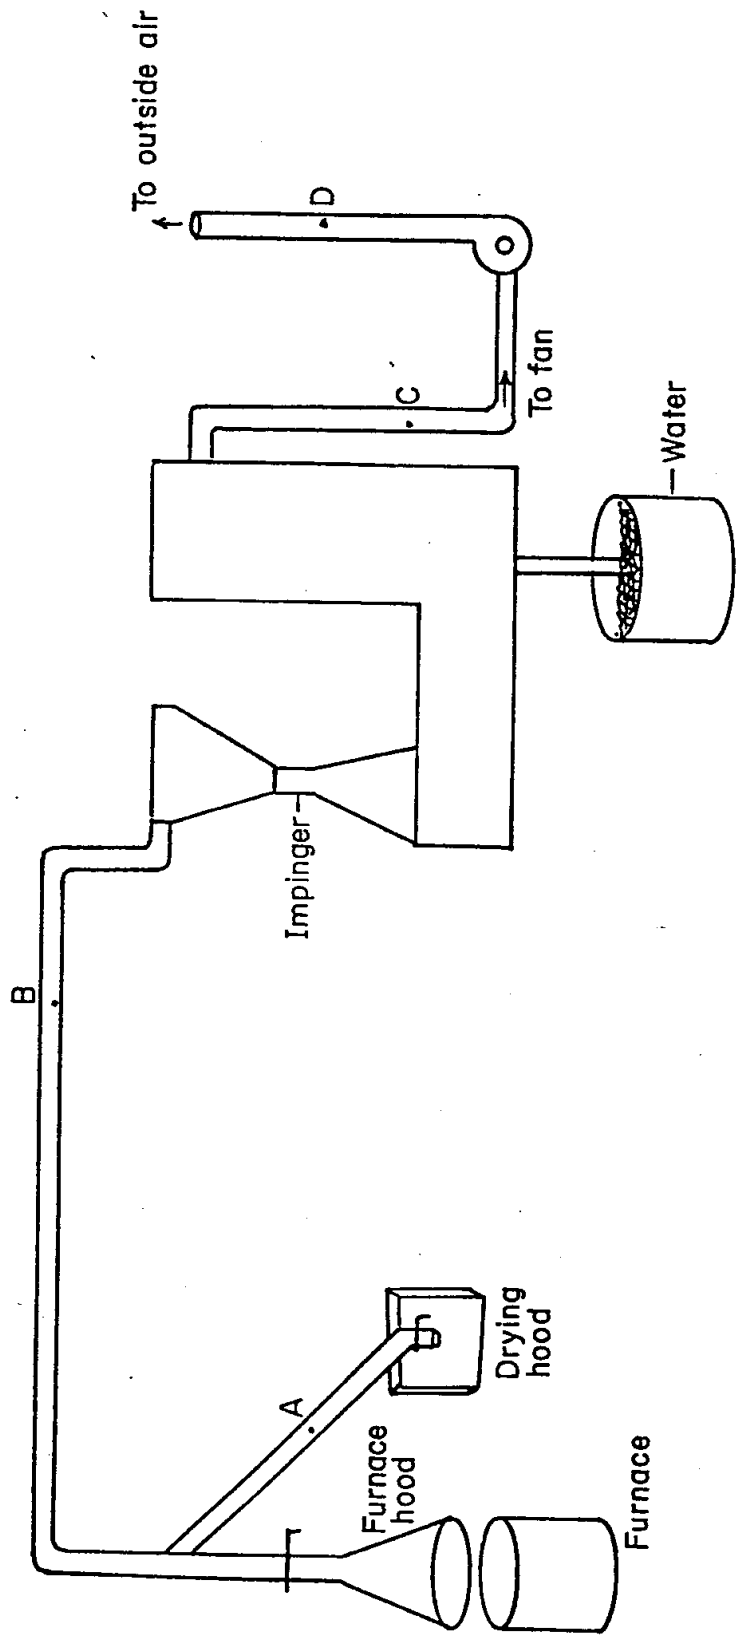
Exhaust Ventilation Measurements  
Refinery

1. The scrubber is not designed to control mercury emissions. Some mercury is being trapped by the scrubber while the rest is sucked through the fan and blown out the exhaust stack. This is evident when large amount of mercury were found on the roof of the mill building. Since April 14, 1989, the company has installed an activated carbon filtering unit to collect mercury. This unit is designed to remove low levels of mercury vapor from the exhaust air stream before the air reaches the exhaust stack.
2. The exhaust ventilation system does not service all the mercury emission sources inside the refinery. Locations such as the slag pour-off plate and the "precip" weighing station which were sources of mercury vapor are not covered.
3. The canopy hood over the furnace captures only the mercury vapor that is carried toward it by the thermal currents generated by the burning process.

Location	Velocity (fpm)	Quantity (cfm)
Branch "A" - Dryer hood	1183	466 *
Branch "B" - Main line to scrubber	2851	2238 *
Scrubber exhaust "C"	5849	2304 *
Fan exhaust "D"	3266	2564 *
