Fatality Investigation Report

OR 2011-16-1

Millwright fatality involving a hydraulic accumulator

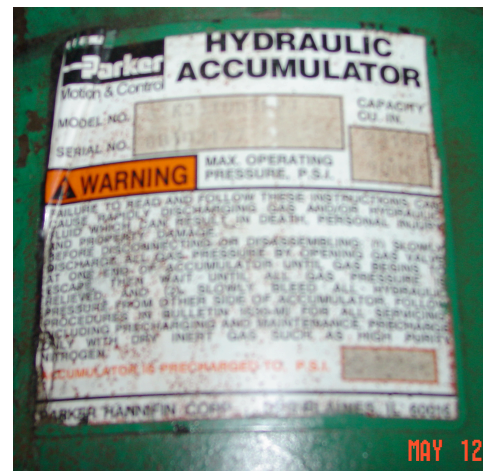
Warning label on the side of the hydraulic accumulator warns that contents are under pressure and should be released by opening and removing the gas valve prior to disassembly.

- There were two warning labels on the accumulator stating the nitrogen gas had to be released prior to performing repairs. This is also mentioned in the service bulletin that was in the shop. A pressure gauge was available in the shop that if used, would have

- Changing the warning label location so it is readily visible when attempting to remove the cap may prevent fatalities of this type. The label explicitly stated the potentially fatal nature of the hazard “Failure to read and follow these instructions can cause rapidly discharging gas and/or hydraulic fluid which can result in death, property damage or injury.” However, it’s unknown if the label located on the side of the accumulator was visible to the victim once the accumulator had been laid on the work bench. Relocating the label to the ends, or requiring the worker to break a seal that included this warning, might increase the chance that the warning would be viewed and followed.

Recommendation #5: Manufacturers or employers should consider altering the placement of warning labels, or applying additional labels or seals, on the cap area of accumulators to ensure they remain visible while removing the caps.

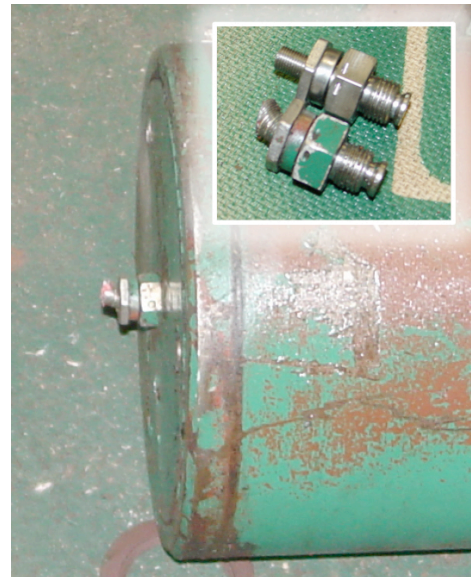
As per the rebuilding kit instruction manual, once the gas has been released using the manufacturer recommended charging and gauging assembly, the gas valve must be removed. After removal of the gas valve, the accumulator can then be strapped down in order to release hydraulic pressure and remove the hydraulic end cap on the opposite end. The gas pressure release valve (shown at upper right) is the only externally visible part of the accumulator in addition to the hydraulic valve end cap (lower photo in red circle), and it functions similarly to a bike tire or "schrader" valve. It is used to add nitrogen and to bleed off gas pressure. Evidence suggested that the damage to the valve as shown in the photo at right occurred when the accumulator flew off the table during the incident.

However, Oregon OSHA investigated the functionality of the damaged gas pressure release valve. Some orange/red material was wedged in the valve, so it was investigated whether the valve port was plugged with debris. No evidence was found to show a plugged valve port. The valve also includes an engineering control feature, which

ABOVE: Gas pressure release valve in incident, believed to be damaged when accumulator flew off the table. Shown removed next to a new valve.

is a small hole bored through the side of the valve body that will relieve accumulator pressure as the valve is removed, should pressure still exist from port blockage or failure to release. However, evidence was clear that the valve had not been removed before the fatal attempt was made to disassemble the accumulator.

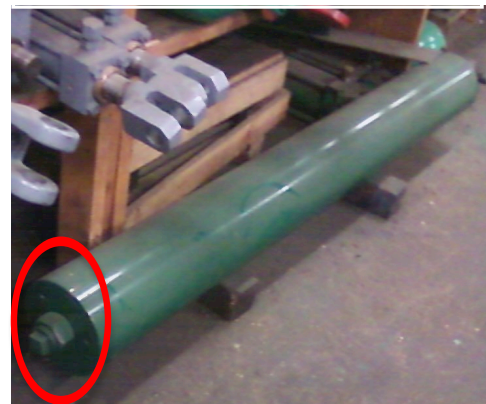
BELOW: Hydraulic accumulator (same model as in incident) with hydraulic pressure end cap shown in the red oval.

Based on the witness interviews, the accumulator had been strapped to a metal workbench. It is unknown if the side-located warning label was visible to the victim after the accumulator had been strapped to the bench. A steel plate adapter with a large nut welded to the center had been bolted onto the end cap (in red circle in

photo on prior page) so a socket “breaker bar” wrench could be attached to help turn the cap. A “cheater bar” had been attached to the breaker bar for even more leverage and one millwright was assigned to apply pressure to the cheater bar. A pipe wrench had also been placed over the socket. The deceased hooked the pipe wrench to a small electric hoist that was also applying pressure to the cap and a second assistant millwright was helping to hold the pipe wrench. With time and considerable effort the cap was slowly unscrewed and was almost completely off when the pressurized nitrogen gas caused the cap to “explode” off the end of the accumulator. Actual gas pressure was unknown, but presumed to be up to 750 psi, which is the normal operating pressure specified by the manufacturer. The deceased was standing directly in front of the cap when it released and was struck in the pelvic area by the cap and other tools, and his right femoral artery was lacerated. The other two millwrights sustained non-life threatening injuries from being struck by other flying tools.

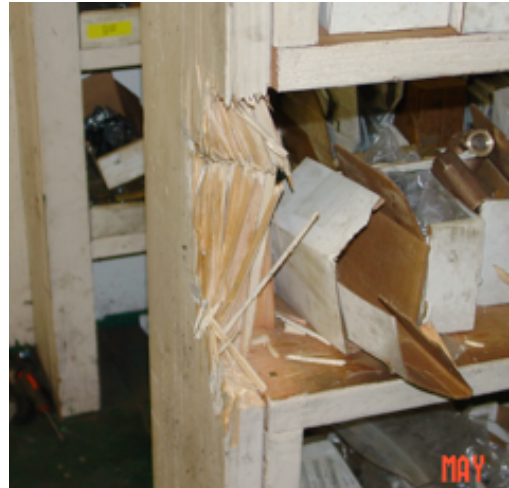
Shelf damaged by flying tools demonstrates violent nature of the event.
