MIFACE Investigation Report: #13MI091

Subject: Painter Died When Elevated Scissor Lift Tipped to Side When Tire Entered Pavement Depression

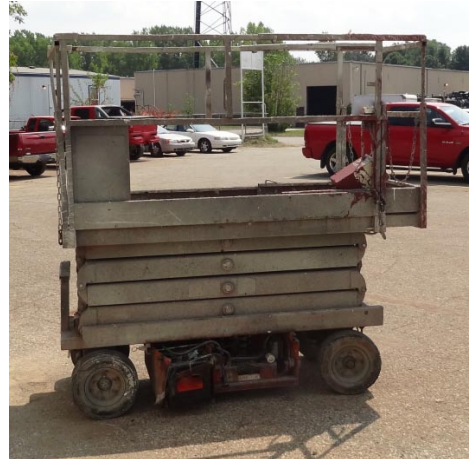
The company owned and maintained scissor style self propelled work platform (scissor lift) involved in the incident was a Skyjack 3220. The lift had been used during spray painting operations and the control box and other informational labels on the machine were covered with paint overspray making them illegible (Figure 2). The safety director indicated that platform controls operated the scissor lift as designed and there were no operational issues with the lift. It is unknown if the lift had tilt sensing equipment installed by the manufacturer.

Figure 2. Scissor lift involved in the incident

The lift had been used during spray painting operations and the lift and control box were covered with paint overspray making the informational labels illegible and the indicator lights indiscernible. These conditions may not have had a direct impact on the incident; however, the general condition of the machine indicated a lack of appreciation for maintaining equipment in safe working condition. Employers should ensure that equipment receive regular preventative maintenance and service according to the manufacturer’s recommendations to ensure it is in good working condition.

- Employers should maintain equipment in accordance with the manufacturer’s recommendations.

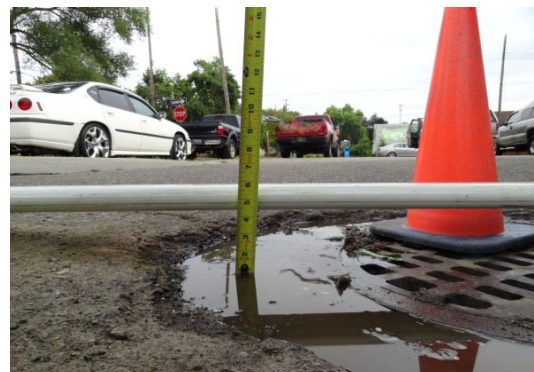
The pavement around the wastewater storm drain involved in the incident had deteriorated and the grate recessed into the asphalt approximately 4 ½ inches (Figure 4). The pavement sloped toward the drain to provide parking area drainage.

Figure 4. Storm drain cover/pavement condition at incident
