## **Massachusetts FACE • Occupational Fatality Report**

### **Immigrant Roofer Electrocuted When an Aluminum Ladder Platform Hoist Contacted Overhead Power Line - Massachusetts**

**Investigation: # 10-MA-019-01**

**Release Date: July 18, 2011**

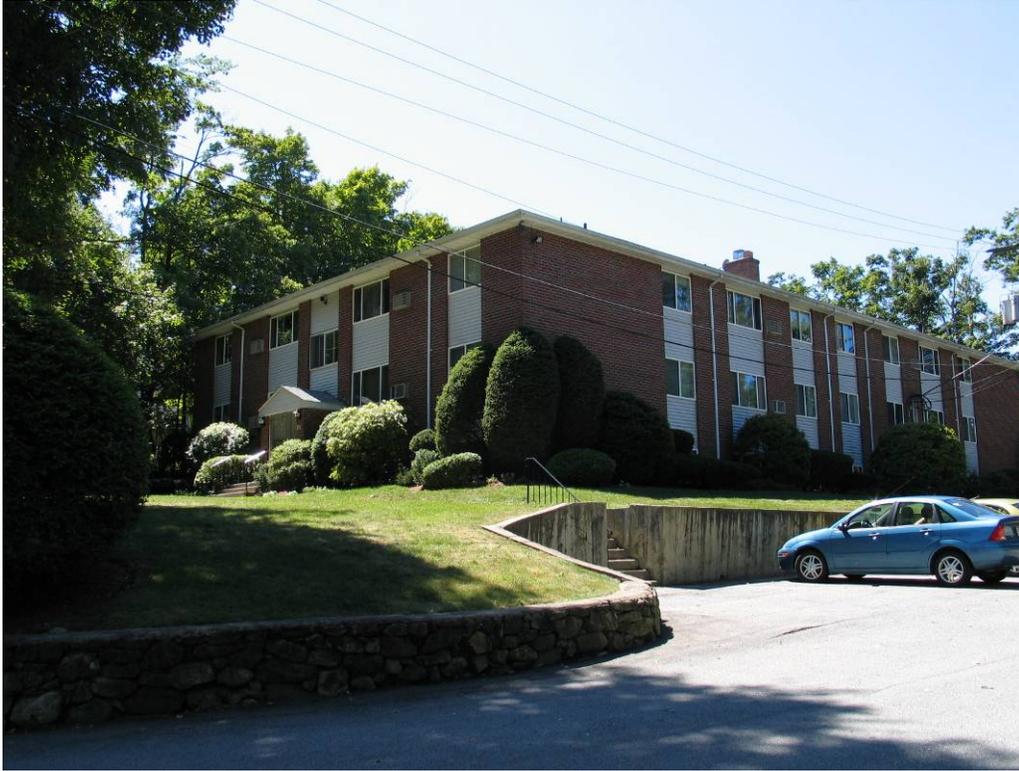
**Figure 1 – Building where the work was being performed**

The job being performed at the time of the incident involved replacing the roofing shingles of a condominium building and masonry work on the building's center chimney. It was estimated that the job would take two weeks to complete. The condominium complex consists of a single building in a suburban residential area. The building houses 24 condominiums and is two and one half stories high with a 4 in 1 pitch hip style roof that was approximately 23 feet high at the roof's edge (Figure 1). The front of the building faces east and is parallel to the roadway.

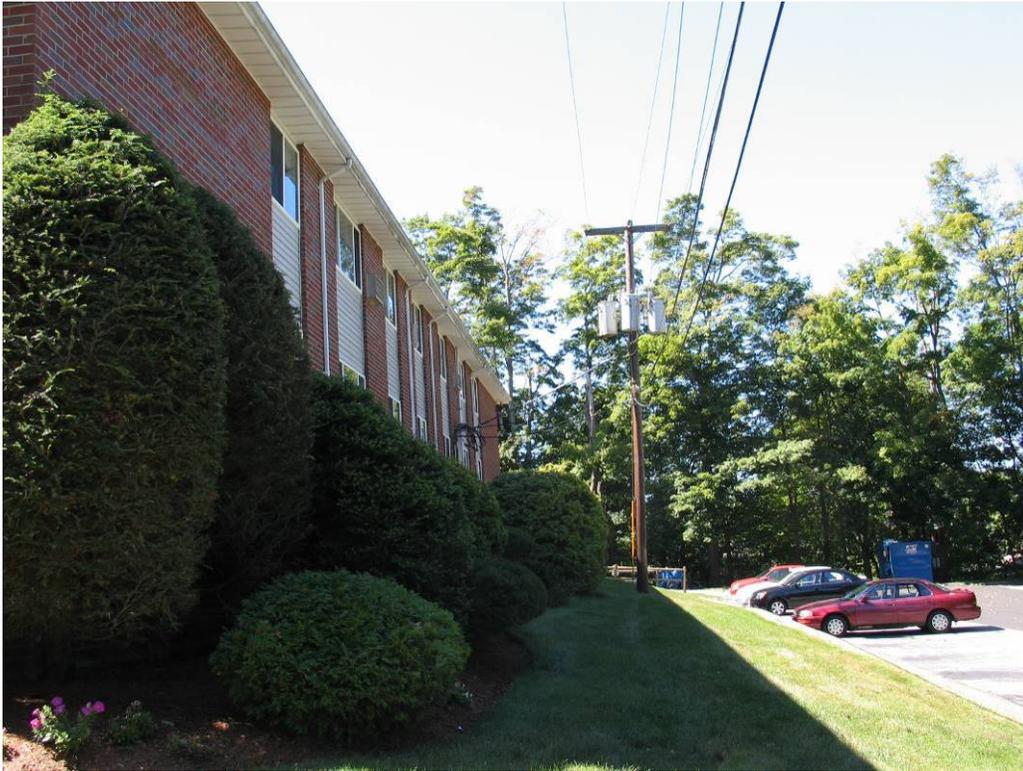
**Figure 2 – Incident location**

The northern side of the building has mature bushes against the building, then a grassy area, a cement retaining wall, and a parking lot for the condominium unit owners. The grassy area between the building and the cement retaining wall slopes away from the building. There are two utility poles on the northern side of the building. One of the poles is located in front of the building, between the building and the street, and the second utility pole is located at the building's center point and approximately 16 feet away from the building in the grassy area between the building and retaining wall. The utility poles carry the building's electrical, telephone, and cable wiring from the street. The main electrical wire attached to the utility pole was an 8,000 volt line (Figure 2).

Once onsite the day of the incident, the workers offloaded materials, supplies, and equipment from the company truck. Then the company owner left the work site at a little before 9:00 a.m. to pick up some additional supplies. After the company owner left the work site, the victim and two co-workers started to set up an aluminum ladder platform hoist on the northern side of the building on the grassy area between the building and the utility pole and overhead power lines (Figure 2).

Prior to the incident, the ladder was lying on the ground parallel to the building, between the building’s northern side and the utility pole on the grassy slope. The victim and the two co-workers then started the task of up-righting the ladder. The victim grabbed the end of the ladder that was to be raised and the two co-workers footed the other end of the ladder. The victim then started to walk the ladder up to the vertical position. When the ladder reached a fairly vertical position, the two co-workers started to slide, potentially on the damp grass, and lost their balance. The ladder fell in a northerly direction and came in contact with the 8,000 volt energized overhead power line.

In this case, with energized overhead power lines in close proximity to the building, the control measures should have included, but not have been limited to:

- Using only non-conductive tools/equipment, including ladders (Recommendations #1).
- Contacting the local electric company to either shield the power lines or, if necessary, turn off the power if work will require employees to get closer than 10 feet to energized power lines (for high voltage levels over 50 kv, distances greater than 10 feet are required).<sup>4,5</sup>
- Reviewing the hazards and the control measures with all employees onsite. These hazards and control measures should also be explained to any employee arriving onsite for the first time throughout the project.

The employer should ensure that all control measures remain in place until the job is complete. In addition, in this case, observing the overhead power lines could have led to not allowing the ladder platform hoist to be set up on the same side of the building as the power lines.

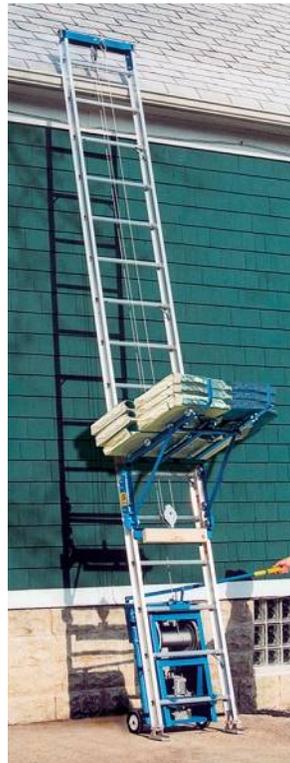
**Figure 3 – Ladder platform hoist similar to the one involved in the incident**

An aluminum ladder platform hoist is a piece of equipment that is used to bring materials, such as bundles of roof shingles or tools, to a work location that is at a higher level, including roofs. The use of ladder platform hoists will help ensure that workers are not carrying materials, supplies or tools up and down extension ladders. This allows workers to climb ladders safely by being able to keep three point contact with the ladder at all times. Ladder platform hoists are typically made up of a heavy duty straight aluminum ladder, motor, cables, pulleys, and a platform or carriage that the items to be lifted are set on or in. The ladder platform hoist involved in this incident was designed with a five horsepower gasoline engine and a 32-foot long ladder. The 32-foot ladder was made of two 16-foot straight ladders bolted together with a metal plate. The ladder did have a warning sticker from the manufacturer that stated “warning, watch for wires (with an arrow point up), aluminum conducts electricity”.

**Recommendation #4: Manufacturers of ladder platform hoists should design the ladder section of the platform hoists to be non-conductive.**

**Discussion:** To ensure that workers are not shocked or electrocuted when up-righting or maneuvering ladders, manufacturers of ladder hoists should design the ladders to be non-conductive. Non-conductive ladders will help protect workers and others from electric shock and electrocution if the ladder was to inadvertently come in contact with an electrical conductor, such as an overhead power line. In this incident, the ladder section of the hoist was two 16 foot long straight aluminum ladders bolted together. If the ladder used on top was made of non-conductive material or had a non-conductive coating, then the electrocution hazard would be minimized.
