## FATALITY ASSESSMENT AND CONTROL EVALUATION

### **Flatbed Truck Starts on Its Own, Crushing Auto Body Shop Worker Case Report 14NY013**

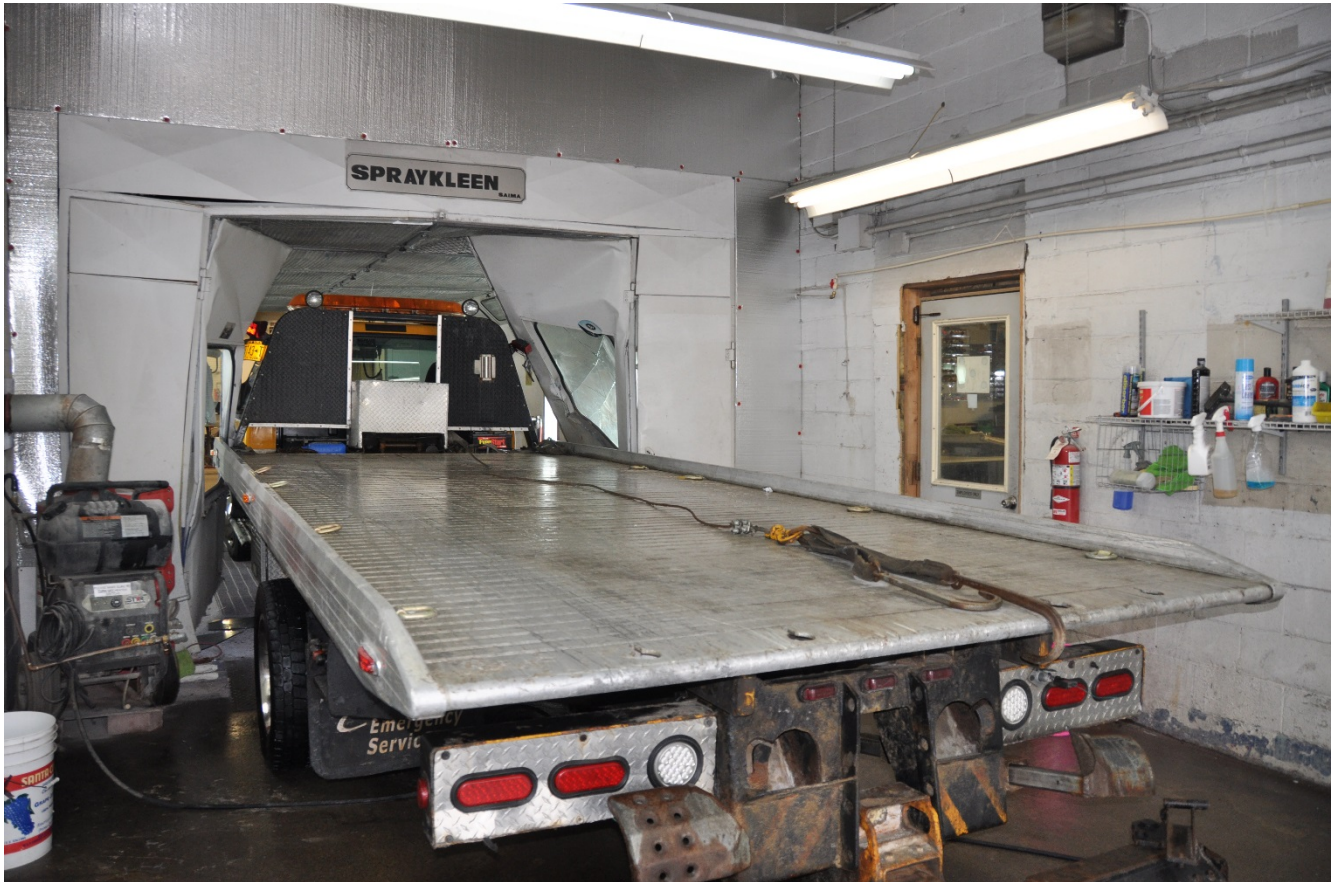
*Photo 1. The Ford 550 Super Duty truck suddenly rolled forward 16 feet and crashed into the paint booth when the victim was cleaning the truck in the wash bay (photo courtesy of OSHA).*

At approximately 11:00 am, a shop technician came into the wash bay through the garage door and saw the truck was rolling forward. The technician yelled to alert others. The truck rolled 16 feet into the paint booth and stopped, smashing the paint booth door and pushing it open backwards into the paint booth. The victim was pinned and crushed between the paint booth door and the passenger side of the truck. There were six other employees on site that day. One worker called 911. The other workers pulled the paint booth door away from the victim and freed him. The emergency medical technicians (EMTs) arrived within minutes. The victim was transported to a hospital where he died from crushing injuries.

**Recommendation #1:** *Employers should ensure that workers always set parking brakes and chock the wheels when working on or around a vehicle.*

**Discussion:** The flatbed truck spontaneously started and moved forward due to an improperly installed starter. To prevent injury, workers should always set the parking brakes and chock the wheels before working on or around a vehicle. Employees should include this requirement in the company safety standard procedure and provide worker training and supervision to ensure compliance.

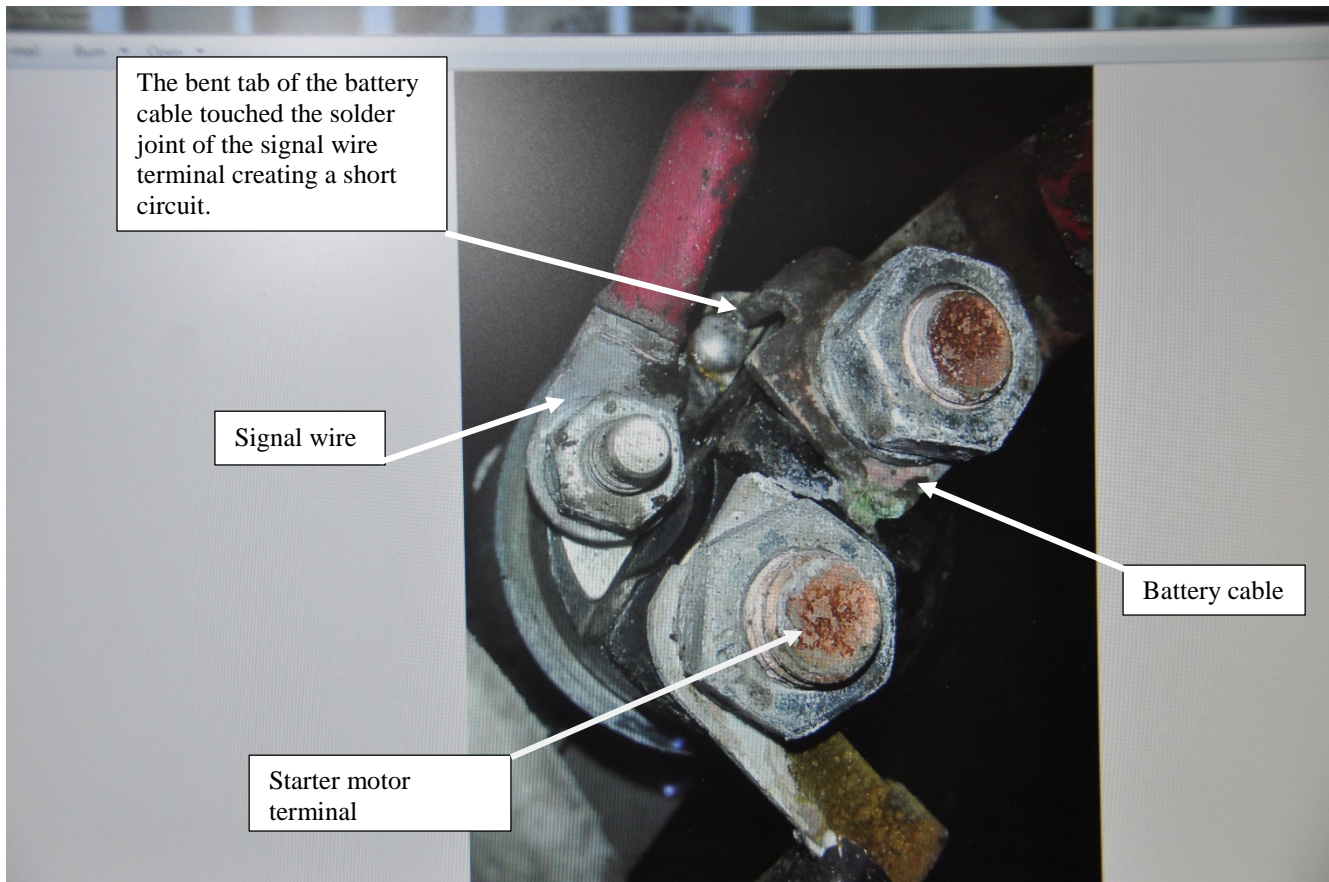
Photo 4 shows how the cables were connected to the solenoid of the flatbed truck that was involved in the incident. There was a tab that was bent at a 90 degree angle on the truck's battery cable (Photo 4). In order to prevent a short circuit, the tab should be securely placed into the slot on the battery terminal (see "battery cable terminal slot" in Photo 3). As it is shown in photo 4, the battery cable tab was not placed in the battery cable terminal slot. Instead, it was 90 degrees counterclockwise from its designed position. The bent tab was in close proximity to a raised solder point of the signal wire terminal. The battery cable was not tightened and it could be wiggled by hand. The Ford certified mechanic noticed that the starter motor was hot which indicated that the starter motor was getting power from the battery even when the truck was not running. He concluded that the likely cause of the spontaneous starting of the truck was the short circuit on the solenoid.

*Photo 4. Three terminals (battery cable terminal, signal wire terminal, and starter motor power wire terminal) on the Ford 550 Super Duty truck solenoid and the cables connected to them. The tab of the battery cable contacted the solder joint of the signal wire creating a short circuit (photo courtesy of OSHA).*

The starter unit was located under the passenger side door. While the victim was cleaning the passenger side with the pressure washer, the bent tab on the battery cable likely contacted the soldered point on the signal wire terminal. The short circuit sent the battery power to energize the starter motor that caused the truck, which was in First gear, to lurch forward and crush the victim.

**Recommendation #2:** *Employers should ensure that employees take extra precautions to insure that starters are installed properly according to the manufacturer's specifications.*

**Discussion:** In this case, the tab of the battery cable was not secured in the slot on the solenoid battery terminal to prevent it from contacting the signal wire. When installing a starter, extra precautions should be taken to ensure that the battery cable is properly installed to prevent a short circuit. Employers should ensure that all parts are installed strictly following the manufacturer's requirement.
