## Analysis of Bench Crest Performance at the Yellowstone Mine: A Case Study

J. Whyatt<sup>1</sup>, M. MacLaughlin<sup>2</sup> and S. Miller<sup>3</sup>

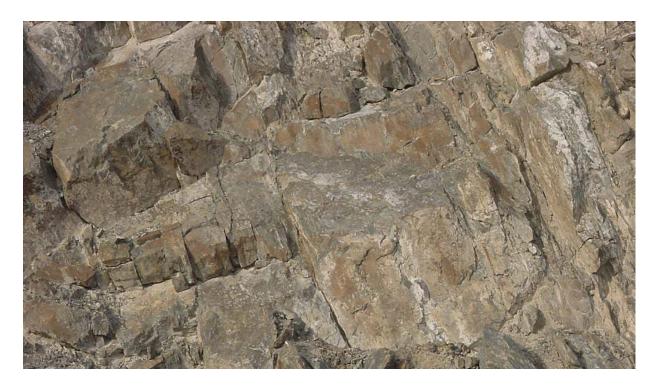
The study focused on a 90 m (300 ft) section of a single bench within the north wall of the south pit in hydrothermally-altered dolomite of Precambrian age. This rock is overlain by Tertiary age Huckleberry ridge tuff. Severe fracturing of the dolomite appears to form at least four major sets (figure 1). Fractures are likely related, at least in part, to movement along a major fault that runs through the pit, striking N-NW with near vertical dip. This fault lies adjacent to the west end of the study scan line. The rock mass was classified as "Fair" for the RMR and "Very Poor" for the "O" system (Appendix A).

Figure 1: Fractured rock on a bench face.

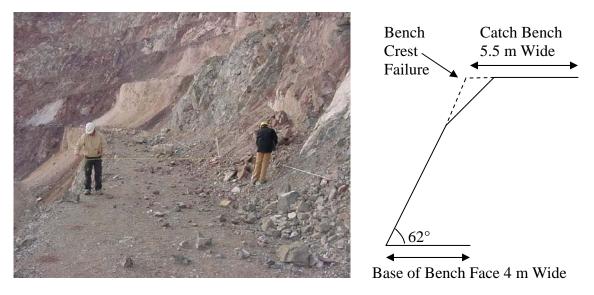
Figure 2: Students measuring the bench width and idealized cross section.

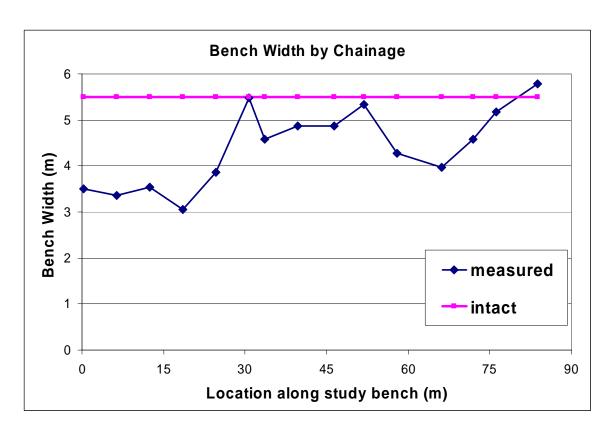
The overall slope angle of the north wall was measured by Brunton compass at roughly  $40^{\circ}$ . Benches are 7.6 m (25 ft) high with an estimated intact bench width of 5.5 m (18 ft) and bench face dip of  $62^{\circ}$ . However, the students found that the bench crest was intact at only a handful of locations along the study bench section (figure 2). Widths measured along the study bench are plotted in figure 3. Narrower sections of bench were caused primarily by wedge failures of various sizes along the bench crest (figure 4). Wedges were formed by, and have slid upon, pre-existing fracture planes.

Figure 3: A plot of measured bench widths by distance along the mapped section of the study bench.

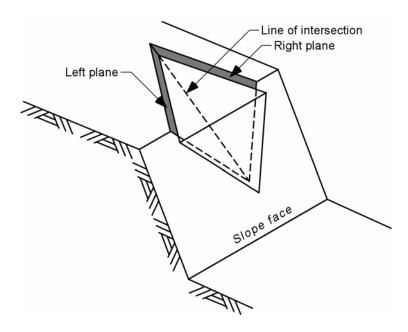
Figure 4: Idealized wedge geometry showing left and right fracture planes.

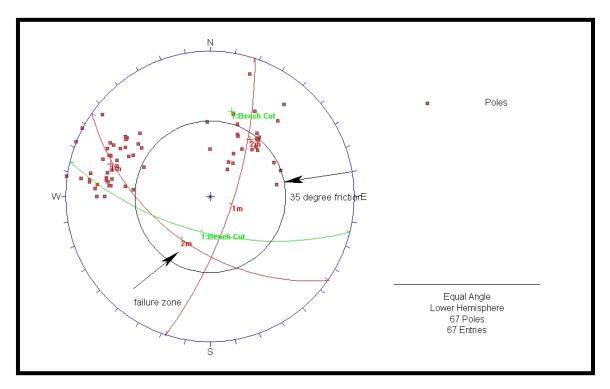
Figure 5: Stereonet plot of joint poles, joint set average orientations and pit slope.

A first cut analysis of wedge stability was developed as shown in figure 5. Bench slope, average fracture-set orientations and the wedge formed by "average" fractures were plotted to show that the wedge formed by set "average" fractures daylights in the bench face. The plunge of the fracture set intersection beneath this wedge was found to be steeper than a 35° friction angle circle, a typical joint friction angle. Thus, failure of such a wedge is likely. Plane failure on the joint set is also possible but its apparent dip in the bench cross section is flatter than the plunge of the wedge fracture plane intersection. Thus, wedge failure will be preferred where both are possible. This tendency is evident in the predominance of wedge failures observed in the field.

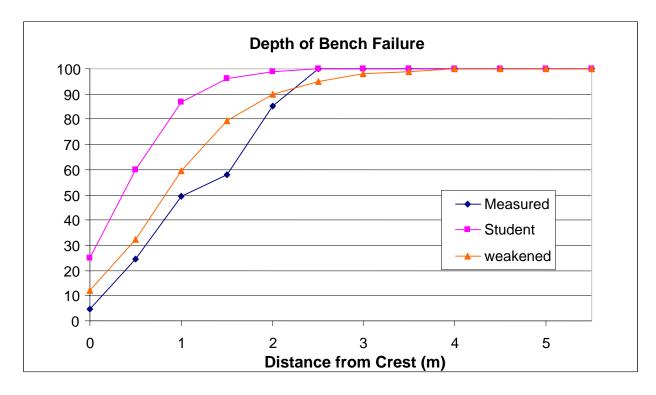
Initial Bwedge analyses run by the students failed to match results observed in the field and crashed the program for particular ranges of parameters. Identification of these problems led to discovery and elimination of a number of flaws in Bwedge. The analysis was then repeated, using the student-developed set of input parameters. Results for these input values overestimated retention of the bench crest, but correctly matched retention of portions of the bench further from the crest (figure 6). This result is surprisingly good, especially considering that it does not consider extensive disruption of the outer portion of the bench by blasting noted by Mike Cerino.

Figure 6. Estimated probability of stability at various depths into the bench crest based on (1) measurements, (2) a model using the student set of fracture parameters and (3) a set of weakened parameters.

An attempt was made to explore the effects of blasting on the bench model by weakening fracture strength. The friction angle was decreased from in situ to saw-cut values and the stabilizing influence of fracture waviness removed. Bwedge runs using these weaker values more closely fit observations for the outer bench, but also underestimate retention deeper into the bench – which is also more sheltered from blasting. This result suggests that the student set of parameters may well describe the fracturing in situ, prior to the influence of blasting. To the extent that this proves to be the case, the overall slope angle could be steepened, while preserving both bench face angle and effective bench width, through more careful blasting. If all blasting effects were removed, and a 90% probability of maintaining a minimum bench width was desired, benches could be narrowed by a full meter. The overall slope angle could be steepened by about 5°, to roughly 45°.

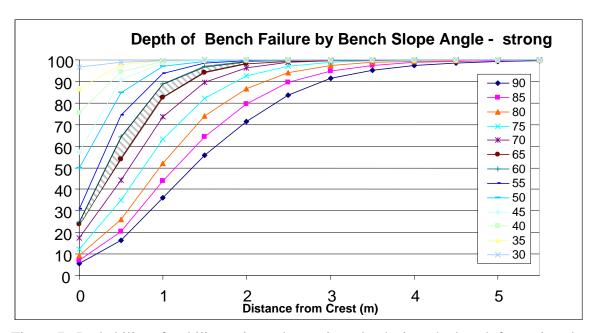
Figure 7. Probability of stability estimated at various depths into the bench for various bench face angles. Curves for steepened slopes are, in sequence, below and to the right of the shaded interval which indicates the actual bench face angle. Curves were computed with Bwedge using the "strong" set of fracture properties.

For example, we can examine the current design for strong properties (figure 7) and a threshold probability of 90%. Recall that this chart is most relevant when failure extends into rock that is not weakened by blasting. For instance, when careful blasting practices are used or steepening of the bench face pushes failure deeper into the bench. With the current design, the sacrificial width is a little more than a meter. If the bench face were steepened to a vertical dip, the unreliable portion of bench width would increase to more than 3 m. The bench width would have to be increased by a similar amount to maintain the necessary catch bench width.

Given a desired surviving bench width, figures 7 and 8 can be used to estimate the additional bench width that should be developed to allow for local crest failures. That is, the design should consist of a "sacrificial" width that will likely fail, at least locally, and a deeper "protected" width that should have a high probability of survival as a functioning catch bench. Obviously, steepening the bench face increases the sacrificial width while cutting this angle back reduces it. However, it is clear from these figures that it is not possible to completely eliminate crest failure, only manage how much must be dealt with.

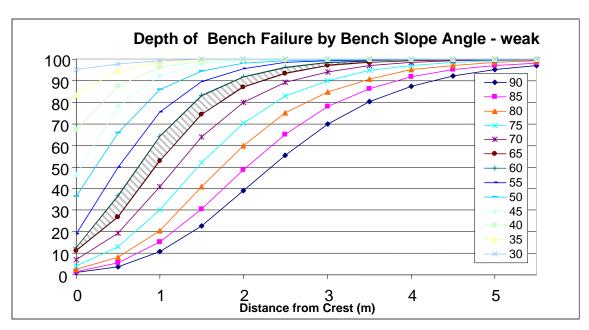
Figure 8. Plot of figure 7 recalculated for "weak" set of fracture properties.

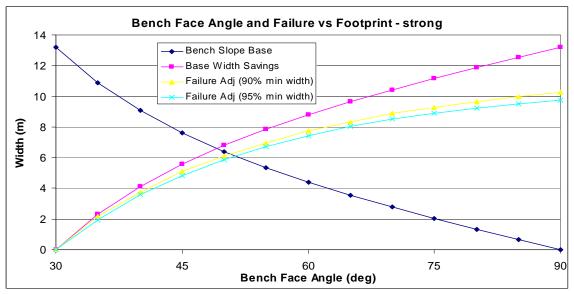
Bench footprints can be calculated for a variety of face angles (and other parameters) and the results used to obtain an optimal overall slope angle. This tradeoff is illustrated for this case in figures 9 and 10. The absence of an inflection point in these curves shows that a vertical bench face is optimal, at least for the wedge bench crest failure mechanism.

Figure 9: Bench slope footprint plotted as a function of bench face angle. The savings in footprint width are plotted for steepening of the bench face from an initial angle of 30°. These savings are then adjusted for a sacrificial segment of bench width containing crest failures with 90% and 95% probabilities. Sacrificial segment width was calculated with Bwedge using the "strong" set of fracture properties.

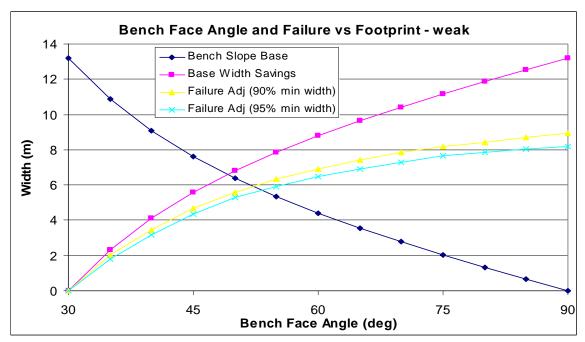
Figure 10: Plot of figure 9 recalculated for the "weak" set of fracture properties.

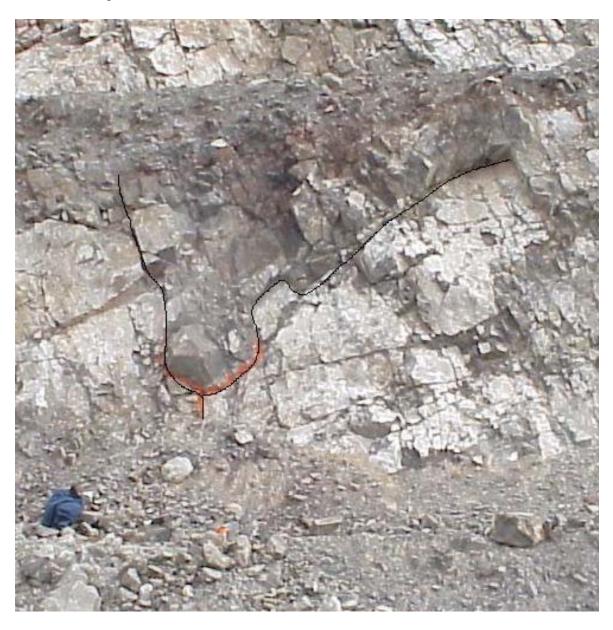
#### Wedge 1:

- Joint striking 132°, dips 53°, 6.1m (20 ft) long, cemented caliche infill up to 13 mm (½ inch) thick broken in places and intact in others, waviness 26 cm (14 inches) amplitude over a 3 m (10 ft) wavelength.
- Foliation fracture striking 15°, dips 72°, 3.7 m (12 ft) long, infill broken, planar.
- Apex of partially failed wedge daylights 4.3 m (14 ft) from crest (photo below). (Note: 4.3 m (14 ft) depth of apex is longer than the foliation fracture, because of rubble on top of the wedge. The actual fracture length was likely longer than 3.7 m (12 ft) before blasting.)

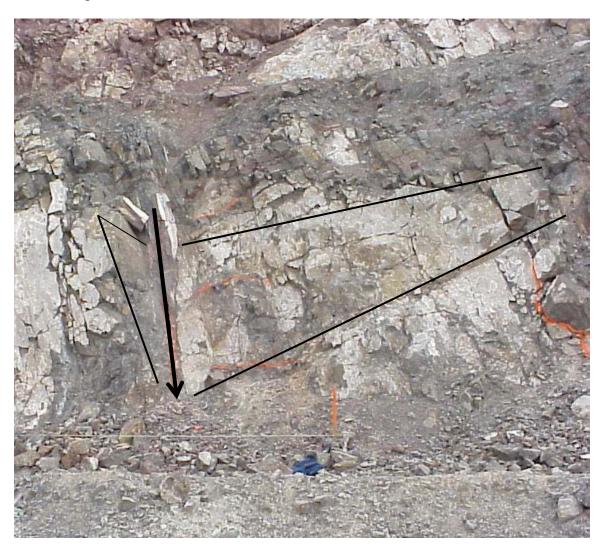
#### Wedge 2:

- Joint striking 113°, dips 51°, 6.1 m (20 ft) long, cemented caliche infill with steps, waviness 2 cm (3⁄4 inch) amplitude over a 15 cm (6 inch) wavelength.
- Foliation fracture striking 20°, dips 70°, 6.1 m (20 ft) long, open fracture with caliche infill.
- Failed wedge apex daylights 6.1 m (20 ft) from crest (photo below). Arrow traces apex of steeply dipping wedge and lines illustrate sliding planes. Bench crest is near the top of the picture.
