# Noise and vibration reduction of a vibrating screen

D.S. Yantek, P. Jurovcik and E.R. Bauer

Mechanical Engineer, general engineer and mining engineer, respectively,  
NIOSH, Pittsburgh, Pennsylvania

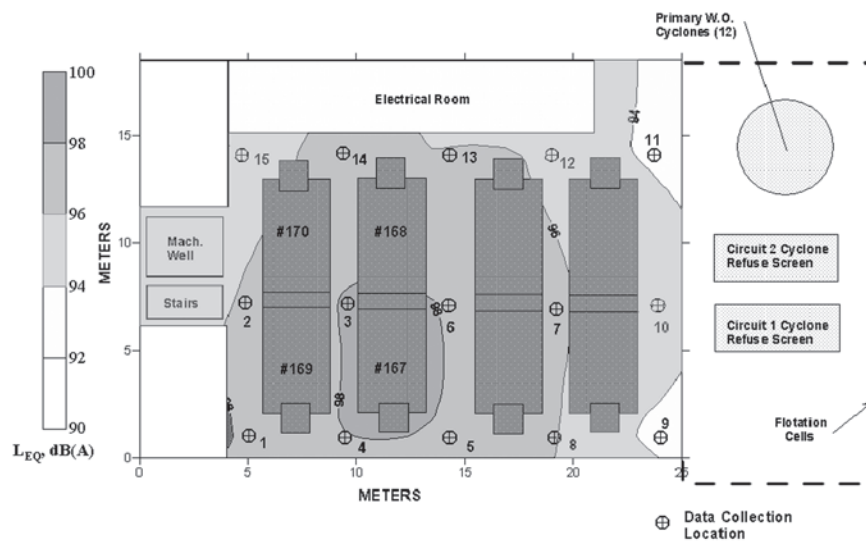
**Figure 1** — Contour plot of the A-weighted sound levels around a group of eight clean coal screens.

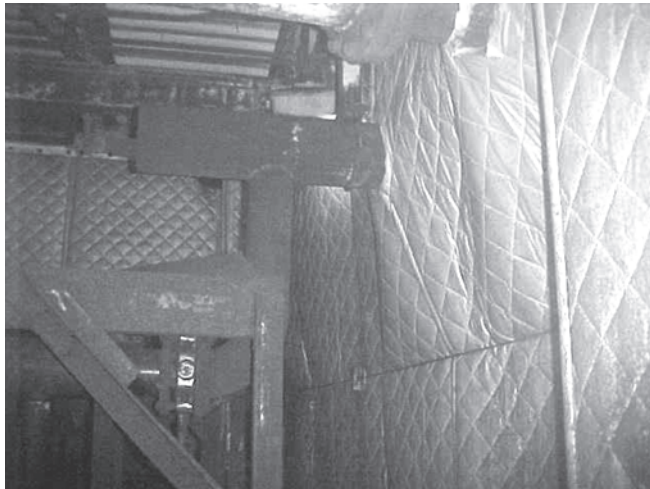
**Figure 3** — Barrier-absorber curtain between Screens 169 and 167 showing tight seal around piping.

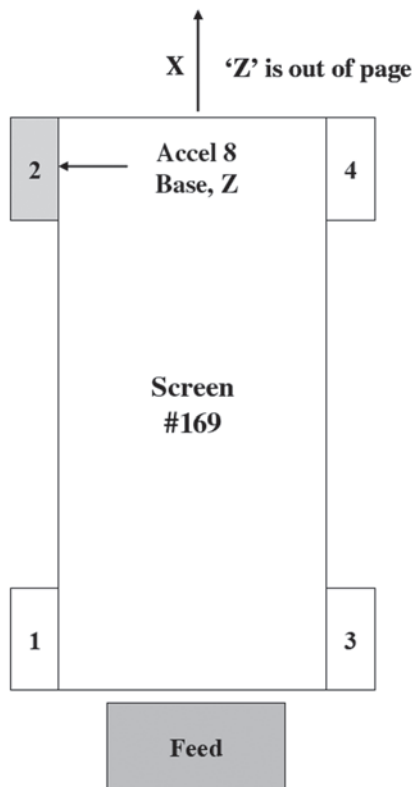
To examine the vibration associated with noise radiation, the time waveform of the accelerometer signal on the building side of the mounting location highlighted in Fig. 10 was compared for the steel coil springs and rubber isolators.

**Figure 10** — Location used to compare the acceleration time history with steel coil springs and rubber isolators.

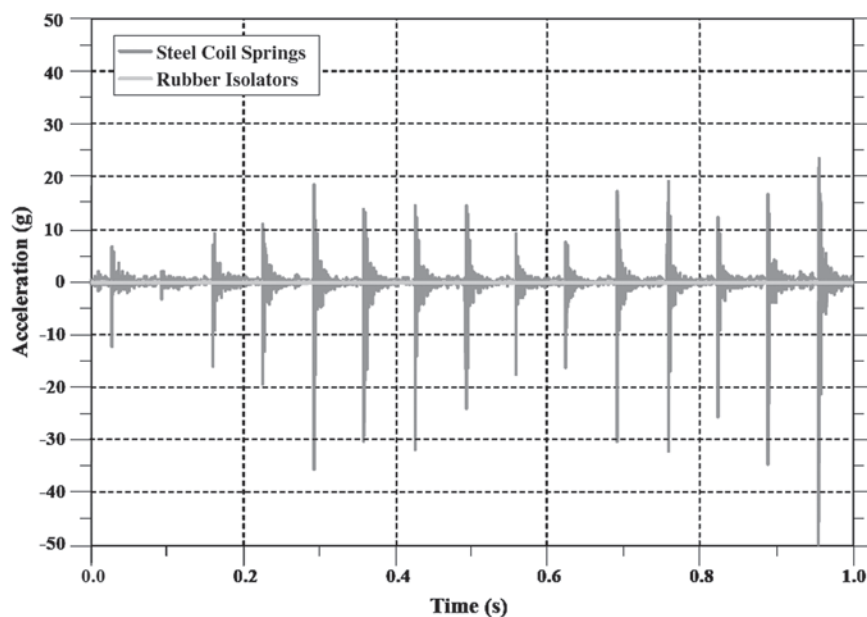
Figure 11 shows the time waveform with the steel coil springs and with the rubber isolators. The figure shows that 15 impacts per second occurred with the steel coil springs. This impact rate corresponds with the rotation frequency of the vibration mechanisms. The impacts cause peak-to-peak high-frequency vibrations on the order of 75 g at this location. Similar results were observed at the other mounting locations.

The impacts could be due to contact between an inner and outer coil spring, a coil spring and its positioning disk, a friction check and the screen, or the screen and a fixed object such as a chute, pipe, or support structure. These impacts cause the screen and its support structure to vibrate and radiate noise. Therefore, these impacts must be eliminated to reduce screen noise in the most efficient manner.

**Figure 11** — Acceleration in Z-direction at Mount 2 with steel coil springs and rubber isolators.

On the reinstallation of the steel coil springs, vibration measurements were taken at the spring mounting locations to determine the cause of the steel-on-steel impacts observed in the original data (refer to Fig. 11). The steel-on-steel impacts were not observed at this time. It is possible that the original test data were influenced by an installation problem with the springs, which would increase the sound level around the screen. It is also possible that during the year that had passed, any high spots on the gears in the rebuilt mechanisms had worn away resulting in smoother tooth engagement. In addition, with the rubber isolators, more vibration was transmitted to the building, which could have increased the drive noise. Proper installation of the steel coil springs may have eliminated the steel-on-steel impacts and reduced the vibration transmitted to the building, thus decreasing the noise radiated by the screen and the building.

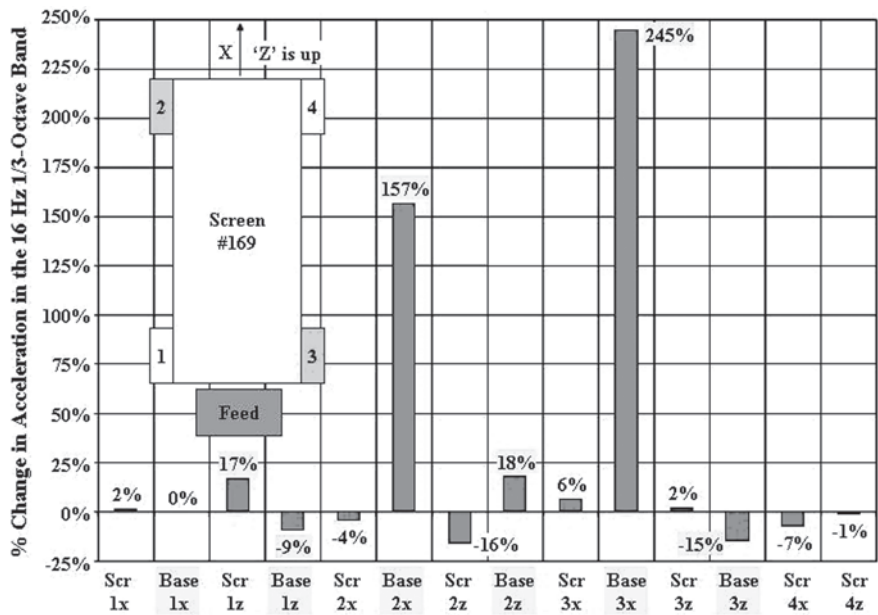
Figure 12 shows the percentage change in the accelerations in the 16 Hz 1/3-octave band for the fore/aft (x) and vertical (z) directions on both the building (base) and screen side of each mount. The figure shows that the building vibration at the left mount on the discharge end and the right mount on the feed end of the screen increased substantially. Subjectively, an increase in the building vibration could be felt in the corner of the building where the acquisition equipment was located. The low-frequency vibration with the rubber isolators was significantly higher than with the steel coil springs, even though the high-frequency vibrations were lower with the rubber isolators.

The increase in building vibration is probably due to a difference between the system spring rates with the rubber isolators and the steel coil springs. With the steel coil springs, two sets of inner and outer springs are used at each mount at the discharge end whereas one inner and outer spring and a third spring are used at each mount on the feed end. However, with this arrangement, the product of the feed end spring rate with the distance from the feed end mounting location to the screen center of gravity is equal to the product of the discharge end screen rate with the distance from the discharge end mounting location to the screen center of gravity. In this case, the translational and rotational motions of the screen are decoupled so the screen motion is primarily translational in the direction of the force applied by the eccentric mechanisms.

Figure 12 — Percentage change in the acceleration in the 16 Hz 1/3-octave band due to replacing steel coil springs with rubber isolators.

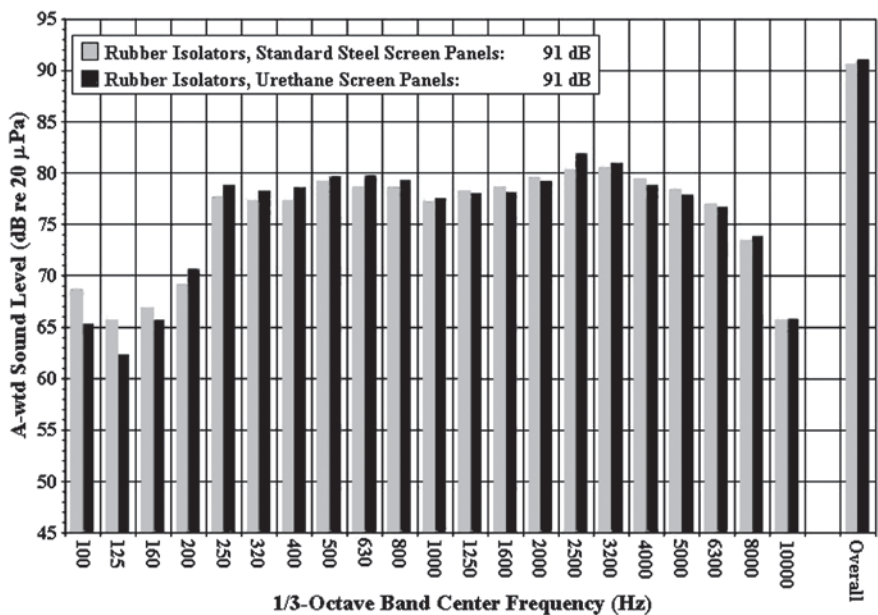
ing coal. Figure 13 shows the background-noise-corrected A-weighted 1/3-octave band sound levels with the standard and urethane screen panels. A slight increase in sound level was observed. However, the increase was only a few tenths of a decibel, which is within measurement error. The figure indicates that the urethane screen panels did not reduce the sound level around the test screen in this case. These results

Figure 13 — A-weighted 1/3-octave band sound levels while processing coal with standard steel screen panels or urethane screen panels and rubber isolators coal.

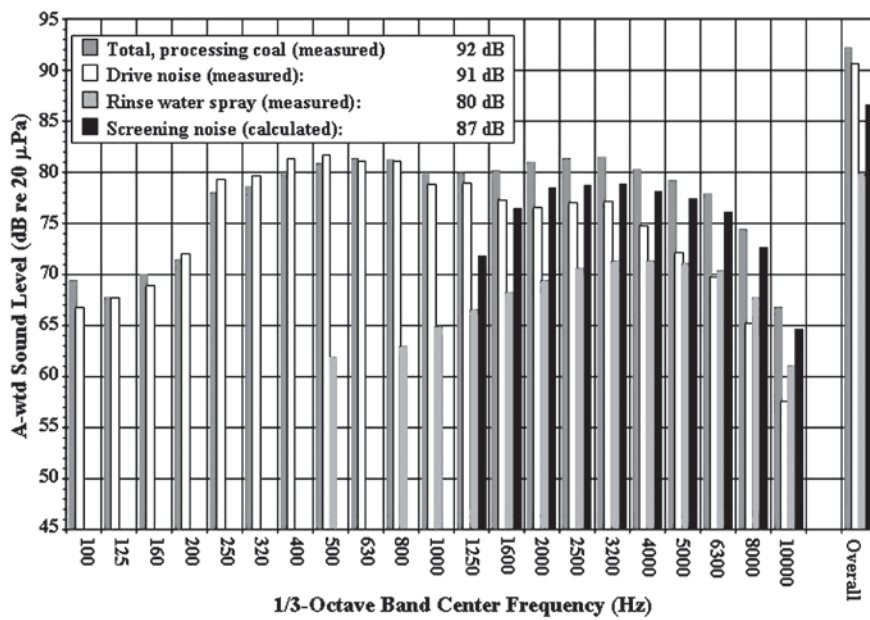
The A-weighted 1/3-octave band sound levels for the total screen noise, drive noise, rinse-water spray noise and screening noise are shown in Fig. 15. The figure shows that drive noise is dominant in the 100 through 1,600 Hz 1/3-octave bands, whereas screening noise is dominant above the 1,600 Hz 1/3-octave band. Therefore, the most effective approach to reduce the sound level around the screen would be to first address the drive noise in the 100 through 1,600 Hz 1/3-octave bands. Once the sound level due to drive noise is reduced to 87 dB(A), drive noise and screening noise would be equal contributors to the sound level around the screen during full operation. At this time, a decision would have to be made regarding which of these two noise sources would be most easily addressed to further reduce sound levels, if necessary.

Figure 15 — A-weighted 1/3-octave band sound levels for the total screen noise, drive noise, rinse water spray noise, and screening noise.

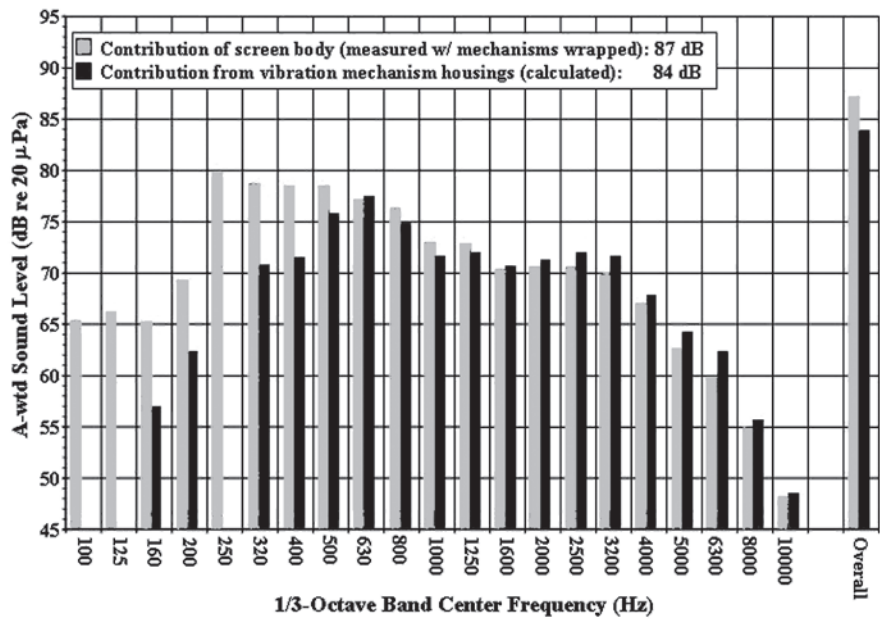
Figure 16 shows the A-weighted 1/3-octave band sound levels due to screen body and mechanism housing vibration. The sound levels due to screen body and mechanism housing vibration were found to be 87 and 84 dB(A), respectively. Because a 3-dB difference in levels indicates a doubling of energy, screen side vibration can be said to have twice the significance of mechanism housing vibration in terms of drive noise. The spectra indicate that the noise radiated by the screen body is dominant in the 100 through 500 Hz 1/3-octave bands. The screen sides account for 83% of the sound energy for this band. In the 630 through 1,600 Hz 1/3-octave bands, the figure shows that the screen

sides and mechanism housings generate similar sound levels with each contributing approximately 50% to the drive noise in this frequency range. In the 2 through 10 kHz 1/3-octave bands, the sound levels due to mechanism housing vibration are higher than those associated with screen side vibration. Mechanism housing vibration accounts for 58% of the drive noise sound level in this frequency range.

Figure 16 — A-weighted 1/3-octave band sound levels for noise radiated by screen body and mechanism housings.

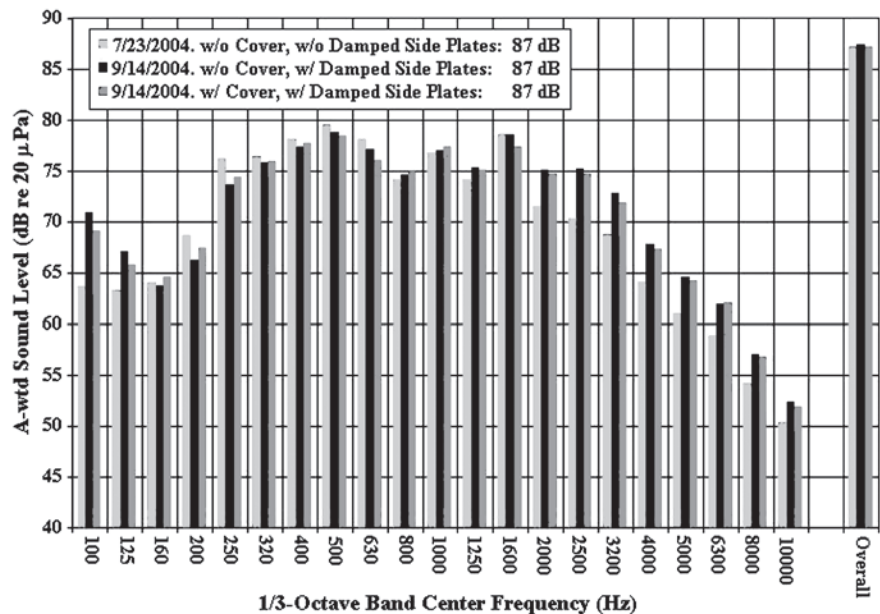
Figure 22 shows the A-weighted 1/3-octave band sound levels for baseline conditions and with the engineering noise controls installed. As the figure shows, neither the damped side plates alone nor the damped side plates and mechanism covers reduced the overall A-weighted sound level. It was expected that the sound level would be reduced by 3 dB or more. The figure shows that the sound levels in the 200 through 630 Hz 1/3-octave bands were reduced by 1 to 2 dB with the damped side plates. With the damped sides and mechanism covers, the reductions in this band were again 1 to 2 dB. In the 800 through 10 kHz 1/3-octave bands, the sound levels measured with the engineering controls installed increased from 83 to 84 dB(A). Because it is unlikely that installing these noise controls would increase the sound levels

**Figure 22** — A-weighted 1/3-octave band sound levels for vibration only operation for mechanism cover and damped side plate tests.

in these bands, something must have changed with the vibrating screen during the period between baseline testing in July 2004 and the testing with the noise controls in September 2004.

Further investigation of the screen revealed a possible cause for the increase in sound levels. One of the inner springs on the discharge end of the screen was broken when the damped side plates were installed. As a result, only three springs were installed on the right side of the discharge end when the damped side plates were installed. With three springs at this location, it is likely that the screen would undergo a pitching/rolling motion that could create steel-on-steel contact between the support springs or with the screen and the base. Either case would increase noise radiation.

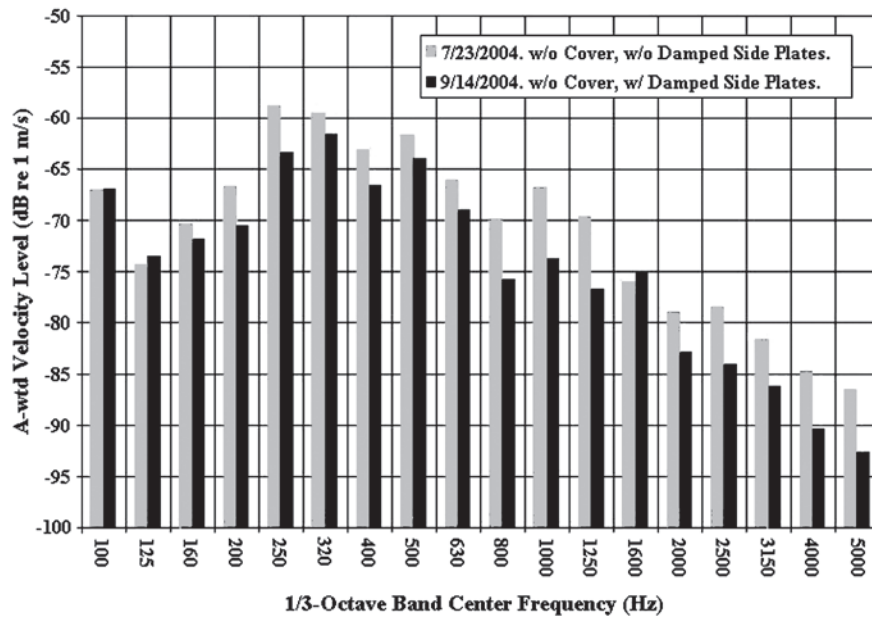
**Figure 23** — A-weighted average velocity level on left side of the screen without and with damped sides.

the screen, respectively. Figure 23 shows reductions in the A-weighted velocity levels on the left screen side ranging from 2 to 7 dB in the 200 through 5 kHz 1/3-octave bands with the damped sides. For the right screen side, Figure 24 indicates reductions of 1 to 6 dB in the 200 Hz through 5 kHz 1/3-octave bands. In the 200 through 630 Hz 1/3-octave bands, the A-weighted vibration levels were reduced by 3 dB on the left side and 4 dB on the right side. The A-weighted vibration levels in the 800 Hz through 5 kHz 1/3-octave bands were reduced by 6 dB on the left side and 3 dB on the right side. With these substantial reductions, the A-weighted sound levels should have been reduced by 3 dB or more. More research should be performed to evaluate the effects of mechanism covers and the damped sides on the radiated sound levels.
