# **Semi-Truck Team Driver Pinned and Killed while Adjusting Tandems**

**Incident Number: 14KY064**

**Kentucky Fatality Assessment and Control Evaluation (FACE) Program**  
**Incident Number: 14KY064**  
**Release Date: September 2, 2015**  
**Subject: Semi Truck Team Driver Pinned and Killed while Adjusting Tandems**

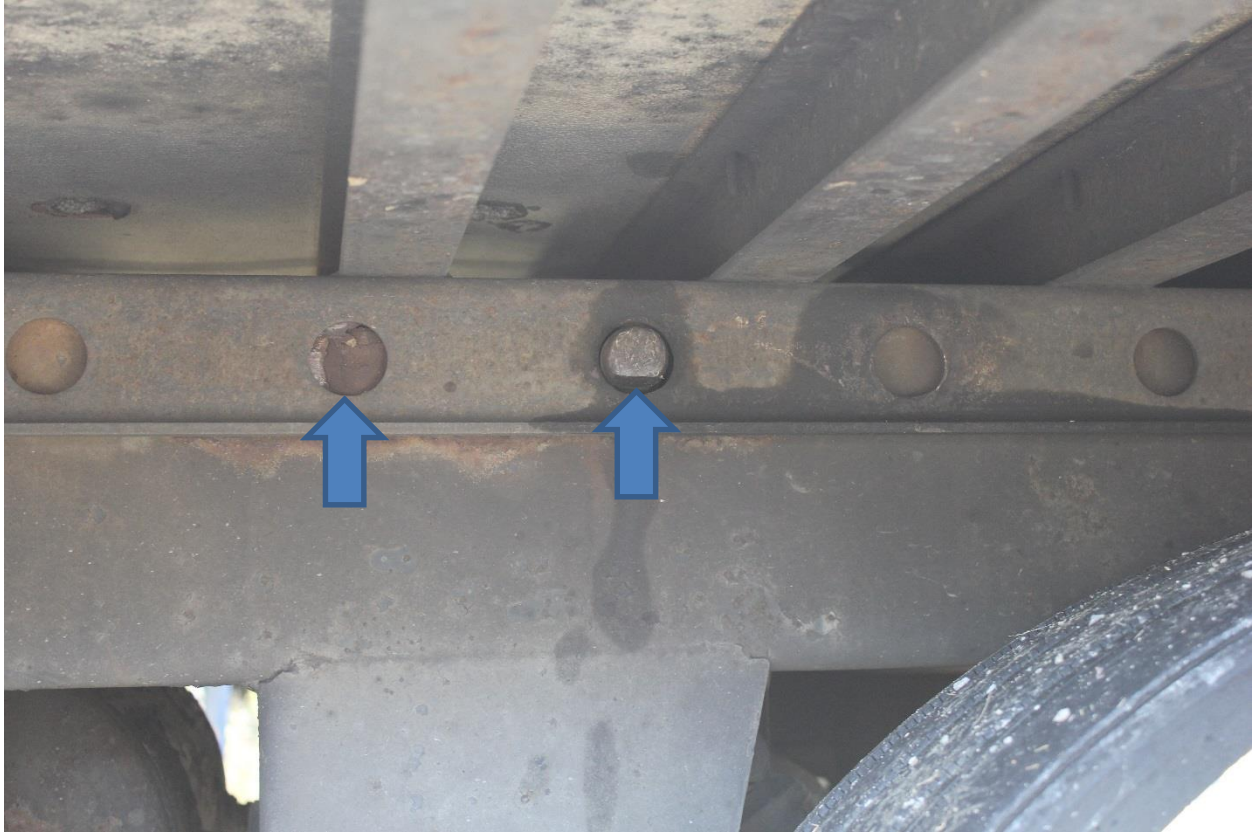
driver sprayed WD-40 onto the pins then struck them with a hammer in an attempt to loosen the rust that caused the pins to stick. When the pins were loose, he actuated a manual release lever near the front of the tandem and instructed the semi-truck driver to rock the truck back and forth to release the tandems (see photos #1 & #3).

Photo #1 Pins to adjust tandems

**Recommendation No. 1: Employers should consider providing extension rods to manually adjust tandems that will allow workers to remain clear of moving or shifting tandems.**<sup>1</sup>

Extension rods can pull the release latch and prevent drivers from having to position themselves between the tires and tandems. The extension rod also helps protect drivers' shoulders from rotator cuff injuries.

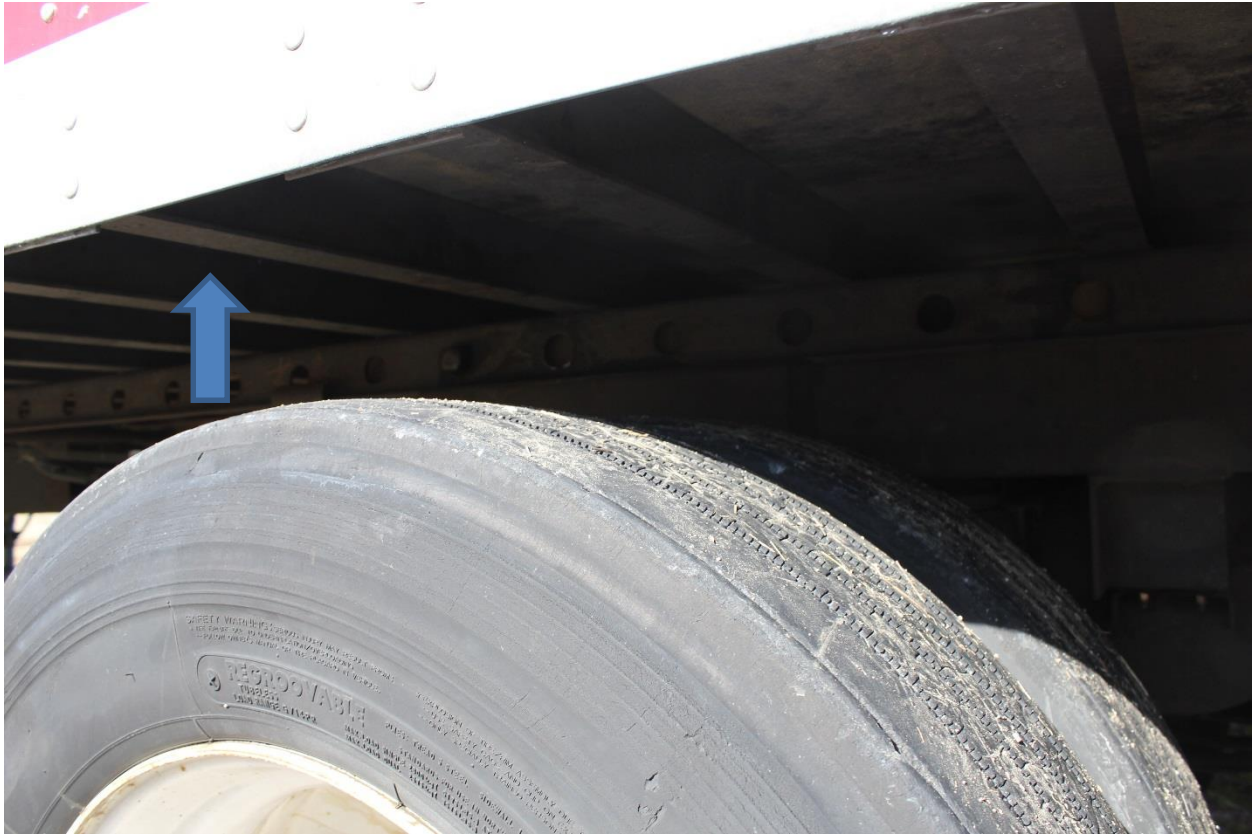
On October 30, 2014, at approximately 7:00 am, a semi-truck driver and fellow team driver parked in a chain restaurant parking lot to make their delivery, unloaded their product, and were adjusting the tandems on the trailer. The team driver placed himself near the tandems while the semi-truck driver climbed into the truck cab to rock the truck so that the tandems would slide into place. The team driver was found with his head pinned between the tire and the bottom of the trailer.

Photo #2 Area where victim was pinned

**Recommendation No. 2: Tandem adjustments should be performed by the semi-truck driver.**

Employers should consider the implementation of a best practice where only the semi-truck driver adjusts the tandems. This prevents miscommunication between two drivers and eliminates placing one of the drivers in a hazardous situation.
