Operator Dies after Excavator Tips Over the Side of a Bridge into River

Investigation: # 08WA00101
Release Date: August 7, 2014
SHARP Report: # 52-31-2014

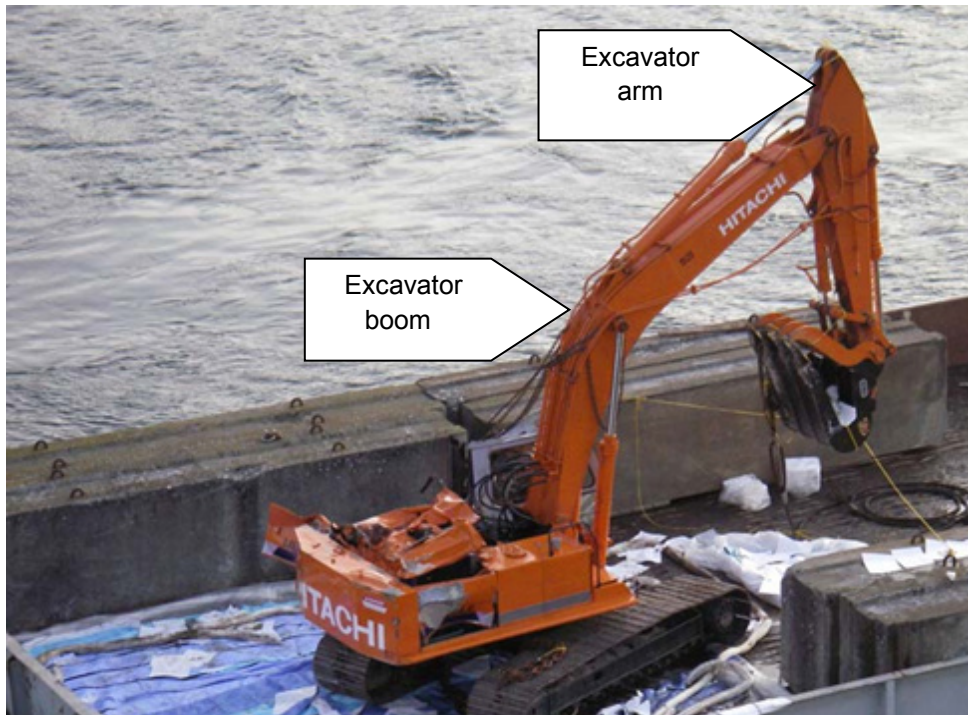
Photo 3: Hitachi Excavator UH083LC on recovery barge after incident

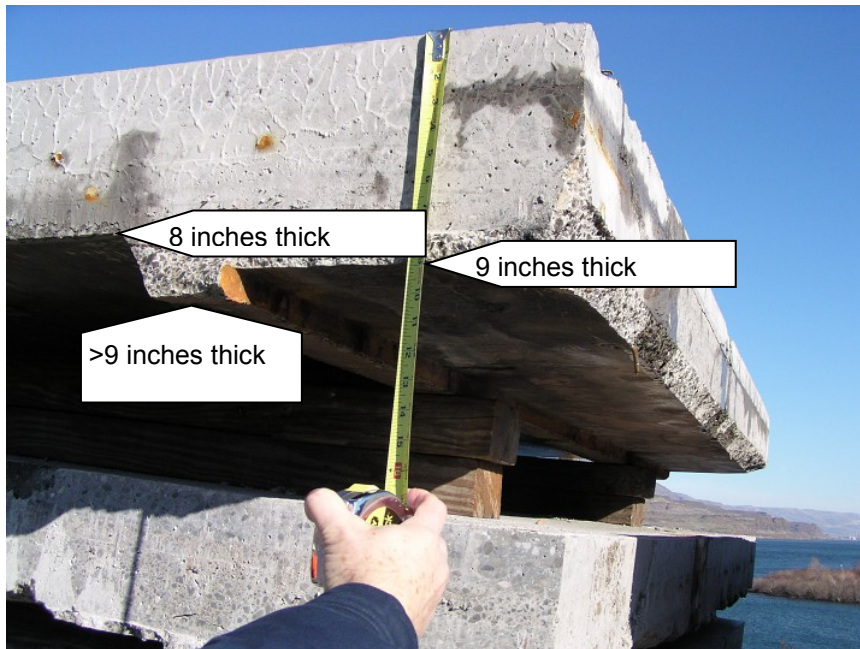
The concrete slab involved in the incident measured 120 inches long by 86 inches wide and an average of 8 inches thick, and weighed 6,600 pounds. This equates to a density of 138 pounds per cubic foot. The corner to corner length was 13 feet 3 inches. The combined weight of the concrete slab and the Slab Crab bucket attachment was approximately 9,600 pounds, more than 3,000 pounds over the tipping point at 10 feet height while extended 25 feet over the side. According to estimates from the initial DOSH inspection, the concrete slab involved in the incident was approximately 2,000 pounds heavier than estimated.

Photo 5: Concrete slab involved in incident showing that thickness exceeded 8 inches

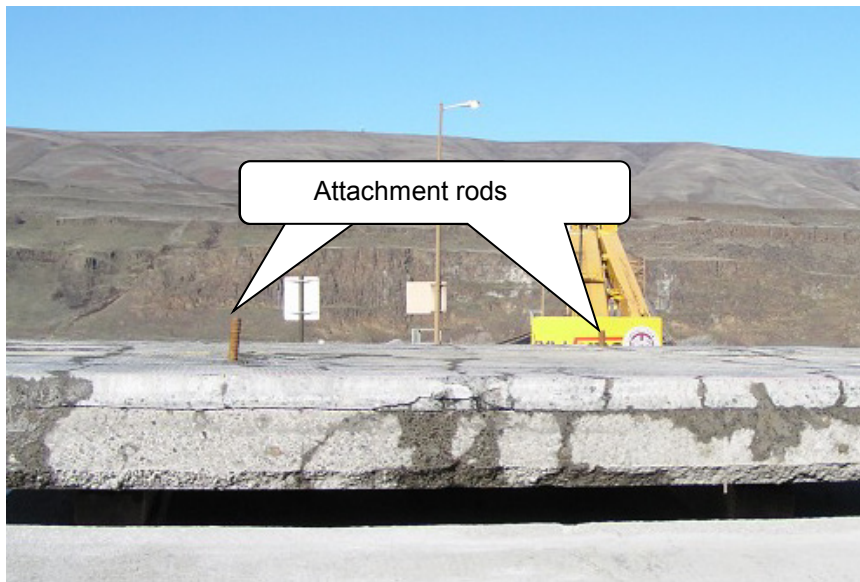
Photo 6: Concrete slab with arrows pointing at threaded rods used for hoisting by chain sling

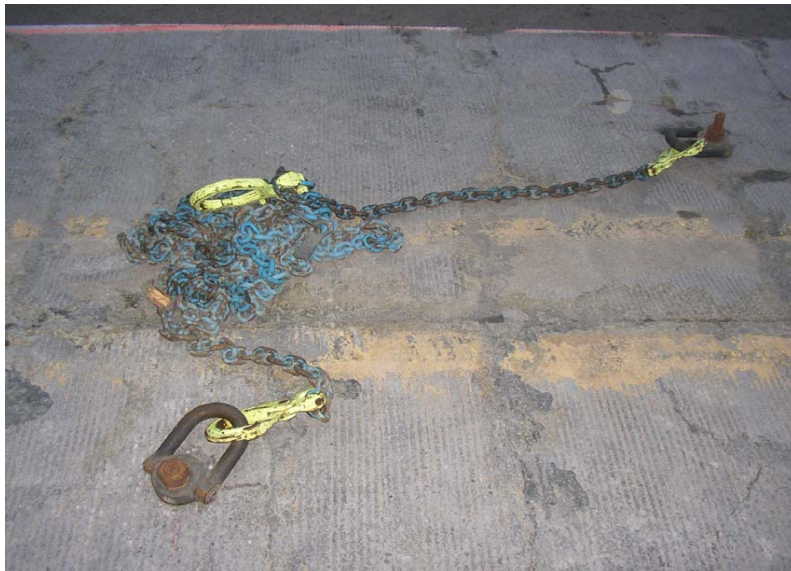
The second method for removing the bridge deck was used when bridge structural members, transverse diaphragms, prevented direct use of the Slab Crab. Transverse diaphragms are used, depending on their location, to resist lateral wind loads or transfer the loads from the deck down to the bearings.^[1] For this method, holes were drilled in opposite corners of the cut concrete slabs. Threaded rods, plates, nuts and swivel pad eyes were inserted into the corner holes and utilized as rigging connection points. A two-leg bridal chain sling attached the rigging connection points to the Slab Crab. The excavator would then raise the Slab Crab to apply tension on the chain rigging and break through the remaining uncut concrete. Each leg of the bridal chain consisted of a grade 100 chain that was 20.5 inches long; the working load limit was 12,300 pounds in a two leg 60 degree configuration.

Photo 7: Chain rigging format and chain sling used to lift concrete slabs with transverse diaphragms

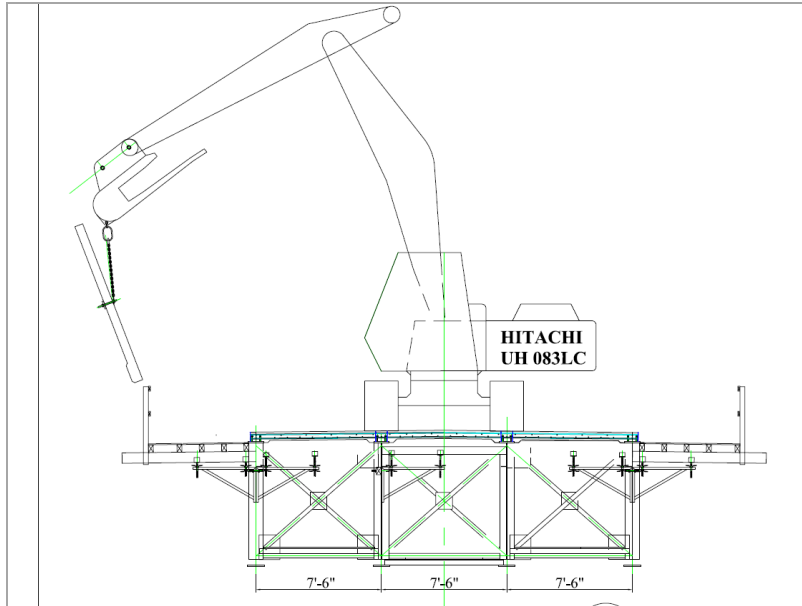
The project engineer observed that as the operator rotated the excavator, it appeared the suspended slab would contact the guardrail. In order to raise the slab and clear the guardrail, the operator armed-out, or extended the arm.. This suspended the slab beyond the designated safety zone, the temporary wooden walking deck and guardrail, established by the employer. The project engineer estimated that the arm and boom were at or near full extension, approximately 25 feet. The slab successfully passed over the guardrail, but with the arm near full extension to the side, the excavator became unstable and began to tip.

Diagram 1: The position of concrete slab before excavator started to become unstable

As the operator was lifting the concrete slab and swinging it to the left, he attempted to adjust for the slab hanging more vertically than was planned by arming out the load. He inadvertently extended the slab past the excavator's designated safety radius and it became unstable. To regain stability, the operator armed in the slab after it had already passed below the edge of the bridge deck due to excavator tipping. Instead of stabilizing the excavator, arming-in caused the excavator to slide sideways. According to the DOSH inspector, the operator used a common corrective measure for excavators by arming in the load. On the ground or a solid supporting surface, arming in the load would allow the operator to lower the load, thus reducing the force applied to the excavator. A solid surface on which to lower the load and relieve the force exerted on the excavator may have prevented it from tipping over the bridge.

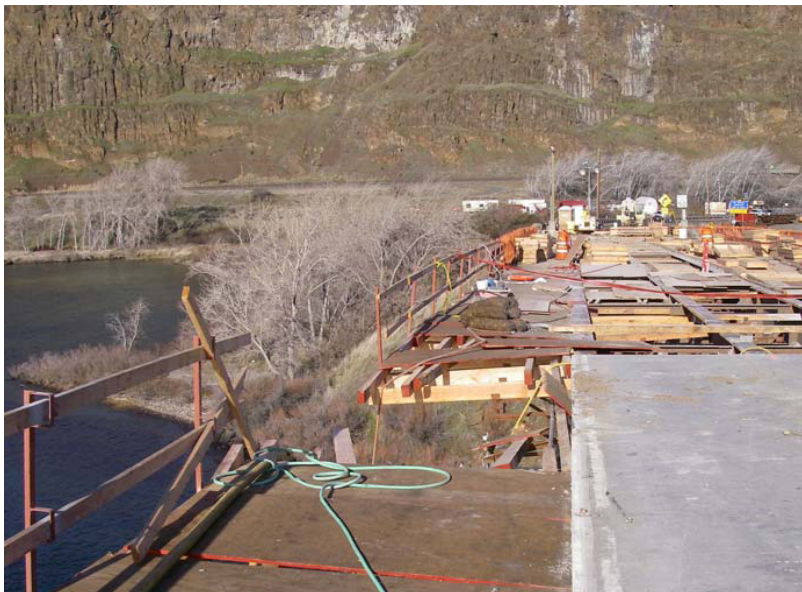
Witnesses stated that the excavator initially slid sideways on its tracks towards the side of the bridge. Witnesses also observed that the excavator moved relatively slowly at first, but once it was past the tipping point, it quickly went over the side of the bridge. The operator was attempting to get out of the cab as the excavator went over the side of the bridge, falling 60 feet into water that was 20 feet deep (photo 10). The WSDOT inspector was approximately 15 feet away when the excavator tipped over the bridge.

Photo 10: Site where excavator tipped over showing damage to guardrail, temporary walkway, and marks caused by excavator sliding

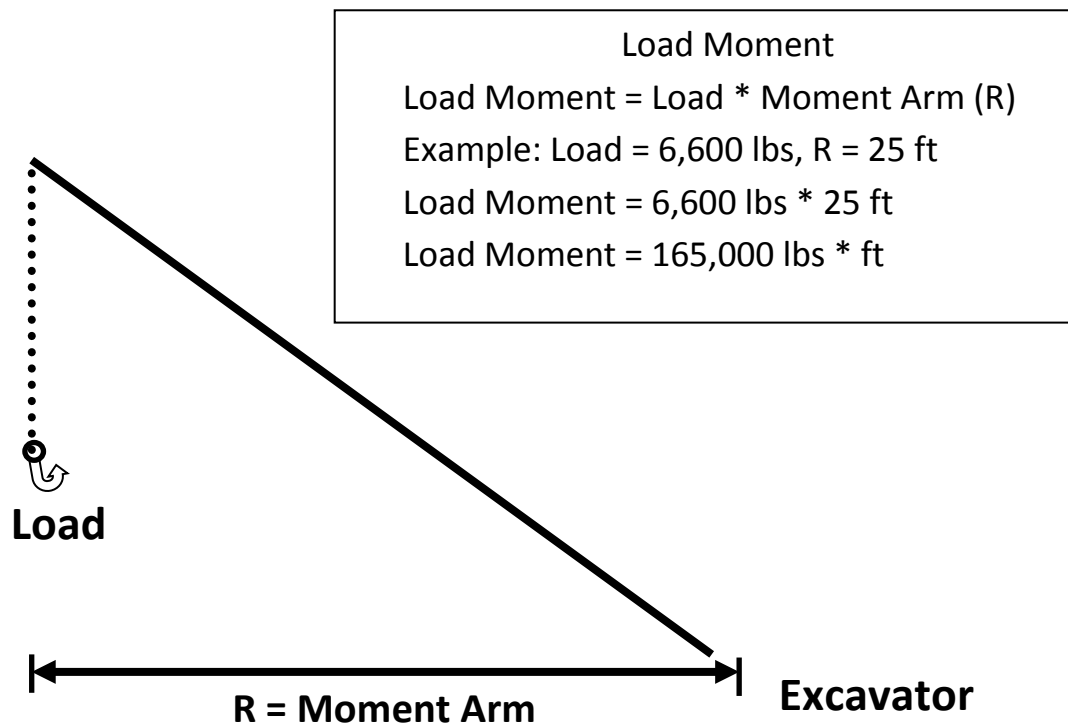
moment arm was the horizontal distance from the load center of gravity and the center rotation of the excavator (approximately 25 feet).^[11]

When the operator of the excavator armed out the concrete slab extending it to approximately 25 feet he increased the force being applied to the excavator by 20% and surpassed the safe lifting capacity of the excavator.

Diagram 2: Excavator boom with suspended load characterizing load moment

Safe load indicator systems with acoustic and visual warning devices are intended to inform machine operators when the lift is approaching an overload condition. Load moment limiters will physically lock the machinery if conditions become unsafe.^[12] Some newer models of excavators and other earthmoving machines are equipped with these devices, but they may also be retrofitted to older machines.
