# Orchard Laborer Dies when Crushed Between a Motor Grader and Semi-Truck in Washington State

Investigation: # 09WA04701  
Release Date: February 11, 2013  
SHARP Report: #: 52-27-2013

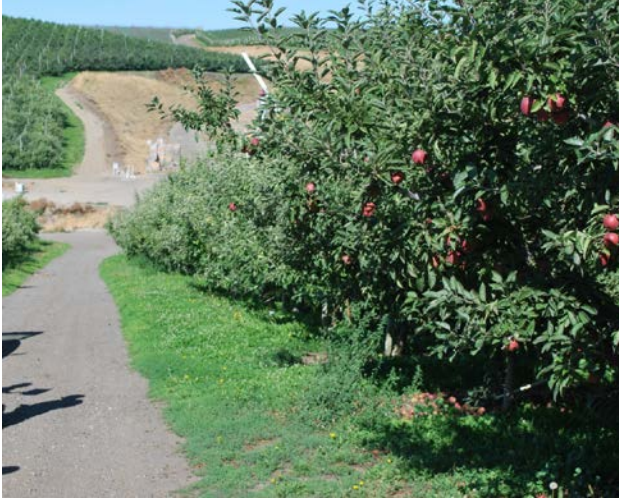
**Orchard Road with 6-7% grade.**

The semi-truck and flatbed trailer was at the orchard to pick up full apple bins. The semi-truck was traveling to a designated level area used for loading apple bins when it lost traction due to the 6-7% grade road and got stuck.

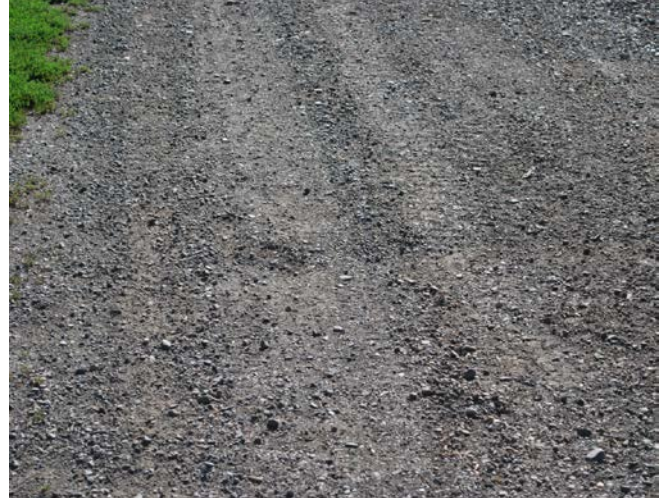
**Close-up of gravel covering the orchard road.**

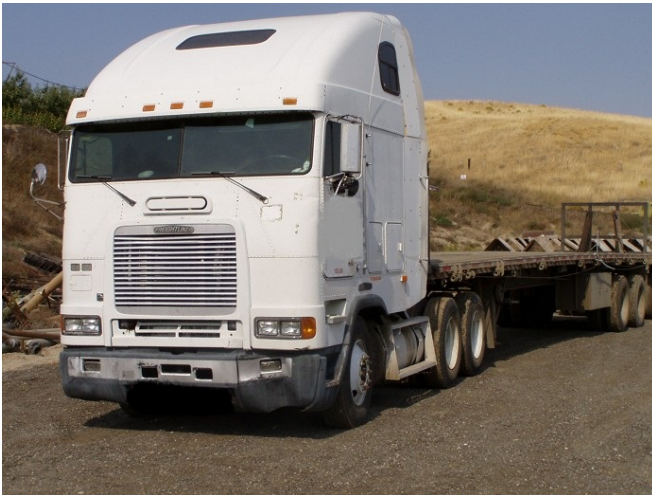
**Semi-truck with flatbed trailer involved in incident.**

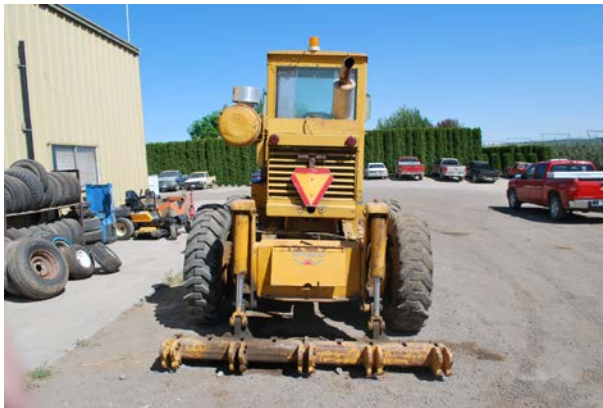
View of motor grader from rear.

According to the National Safety Council all motor graders, bulldozers, and scrapers should be equipped with an audible reverse alarm that operates automatically when the machinery is in reverse motion.<sup>3</sup> The incident motor grader was not equipped with a reverse alarm. If it had a reverse alarm, the worker and semi-truck driver might have been less likely to remain in the crush hazard area. If heavy mobile machinery was manufactured without a reverse alarm it is recommended that employers either remove that piece of machinery from service, or have it retrofitted with a reverse alarm.

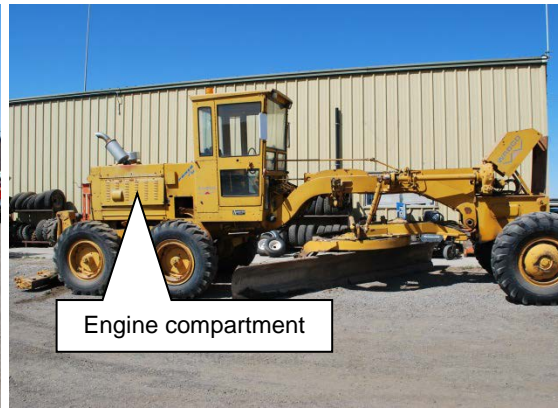
Side view of motor grader.

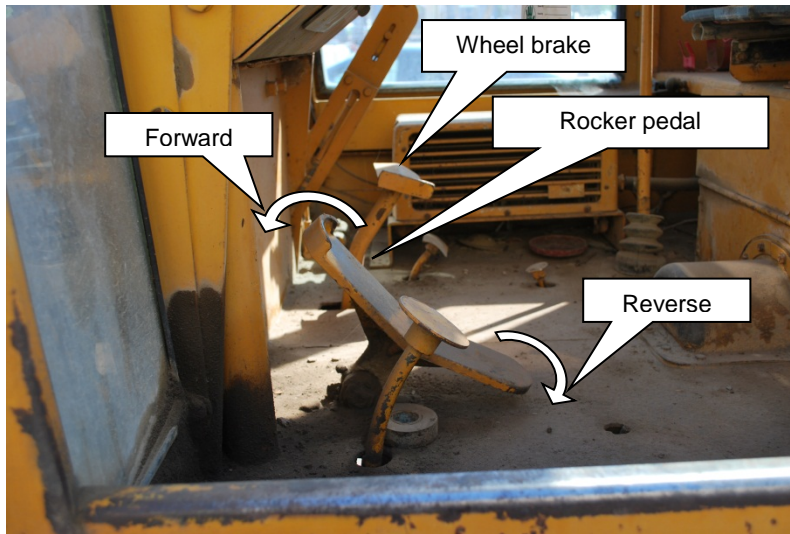
Rocker pedal and wheel brake.

According to manufacturer's manual, each of the four tandem wheels on the motor grader is equipped with a hydraulic actuated, shoe-type brake. The brakes activate when the operator pushes down on the wheel brake located to the right of the rocker pedal. The operator of the grader at the time of the incident said that the brakes failed and he was unable to stop it as it was backing up. The operator said that the brakes often needed to be pumped before they would work completely after the grader had not been used for at least a week.

After the incident the DOSH inspector tested the traveling and emergency brakes of the motor grader on the orchard road where the incident occurred. The inspector did not find any brake fluid leaks, and both the traveling brakes and the emergency brakes prevented movement of the grader on the sloped road.

Two eye witness reports claimed that the motor grader came to a complete brief stop about 7 feet away from the semi-truck before suddenly reversing into the semi-truck. This indicates that the brakes may have been functioning properly at the time of the incident.

The operator reported that the motor grader had not been used in a couple months. Before using the motor grader, he did a quick walk around inspection but it did not include any functional testing of the hydraulic brakes and other safety systems. The operator also reported it was common for the motor grader to need the brake pedal pumped to work when it had not been used recently. If the brakes had been functionally tested, the operator could have identified and addressed any problems with the brakes before reversing the motor grader down a sloped road.

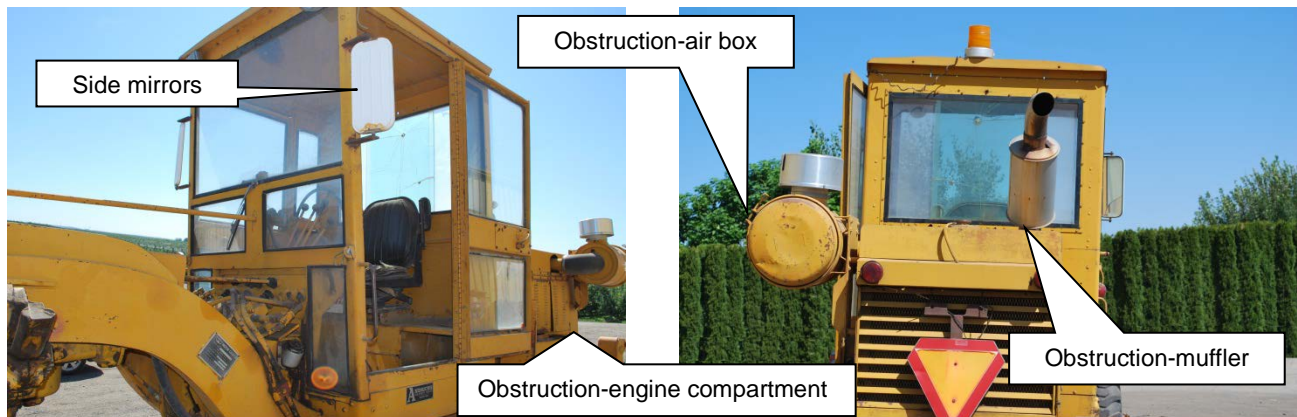
**Side mirrors and back window (along with view obstructions) the motor grader operator would have used while reversing downhill.**

Based on the inspection of the motor grader cab done by the WA FACE program and the managing partner, it is likely that the operator of the motor grader would have to stand in the cab and look over his shoulder out the back window beyond the rear of the engine compartment in order to see the worker and semi-truck driver while reversing the motor grader down the sloped road.

This motor grader was equipped with side mirrors. However, it still had blind spots for the operator. The height and length of the engine compartment created blind spots behind the machine that obscured the operator's view of the area where the worker and the driver were attempting to connect the chain. Diagrams 2 and 3, in appendix A, show examples of a motor grader operator's blind spots from the ground level and five feet above the ground (These blind spots were determined using a 27 ton CAT16G motor grader).<sup>4</sup> For more diagrams characterizing machinery visibility for motor graders and other commonly used heavy machinery see NIOSH's Construction Machinery Visibility webpage at: [www.cdc.gov/niosh/topics/highwayworkzones/BAD/imagelookup.html](http://www.cdc.gov/niosh/topics/highwayworkzones/BAD/imagelookup.html)

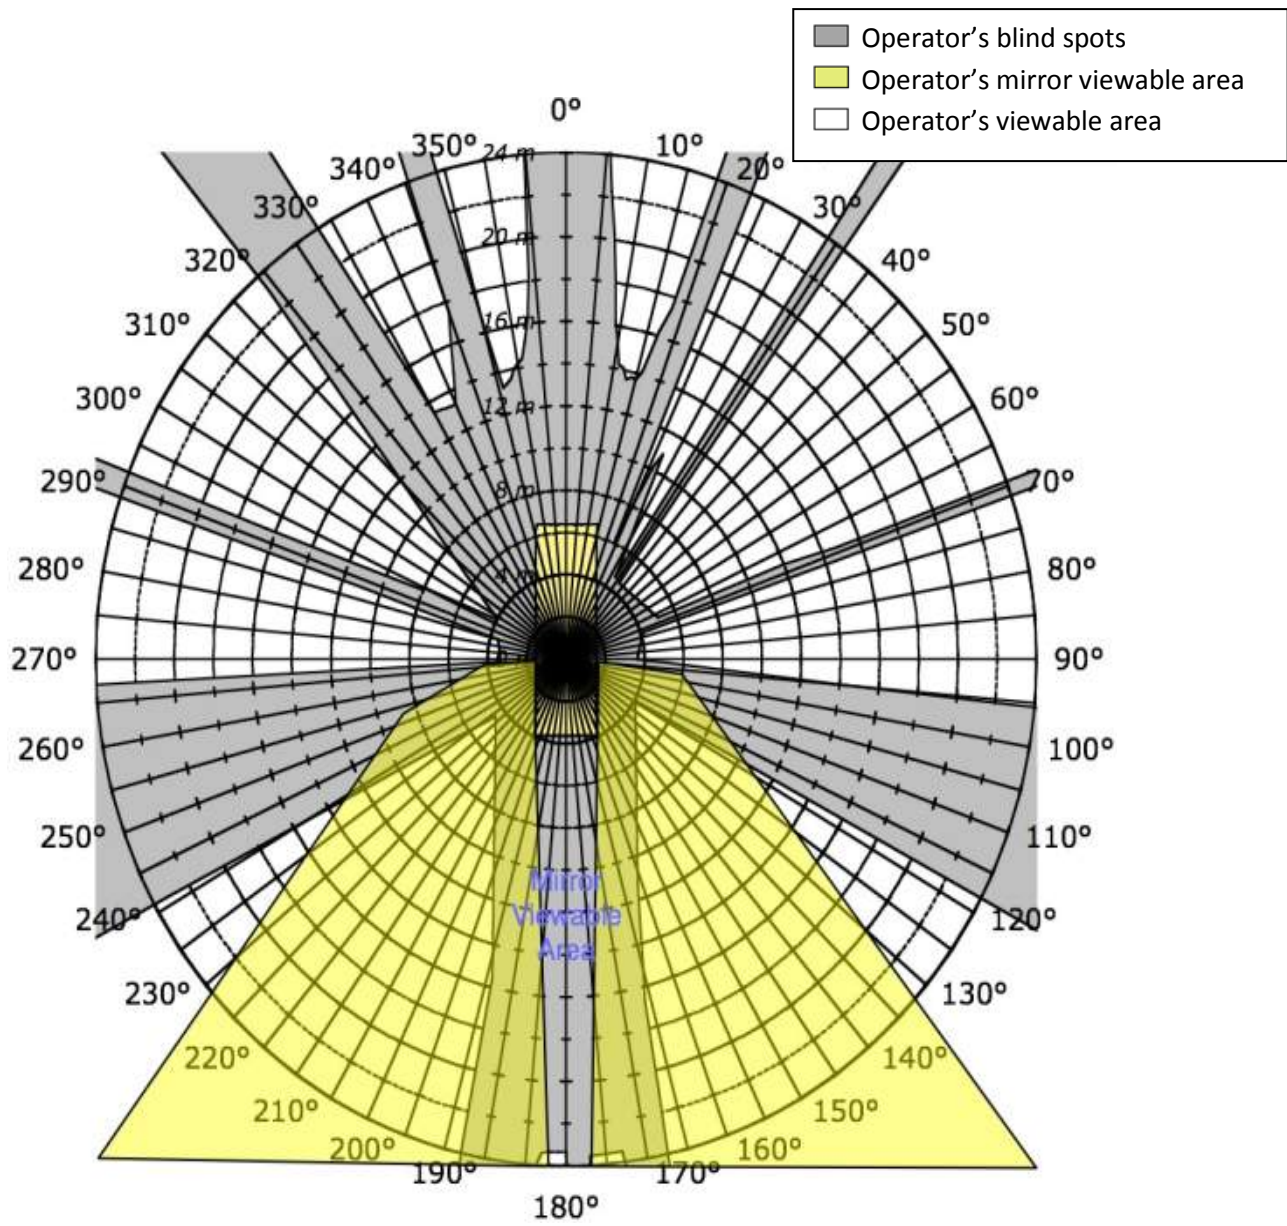
**Diagram 2: Blind spots at ground level for a 27 ton CAT16G Motor Grader**

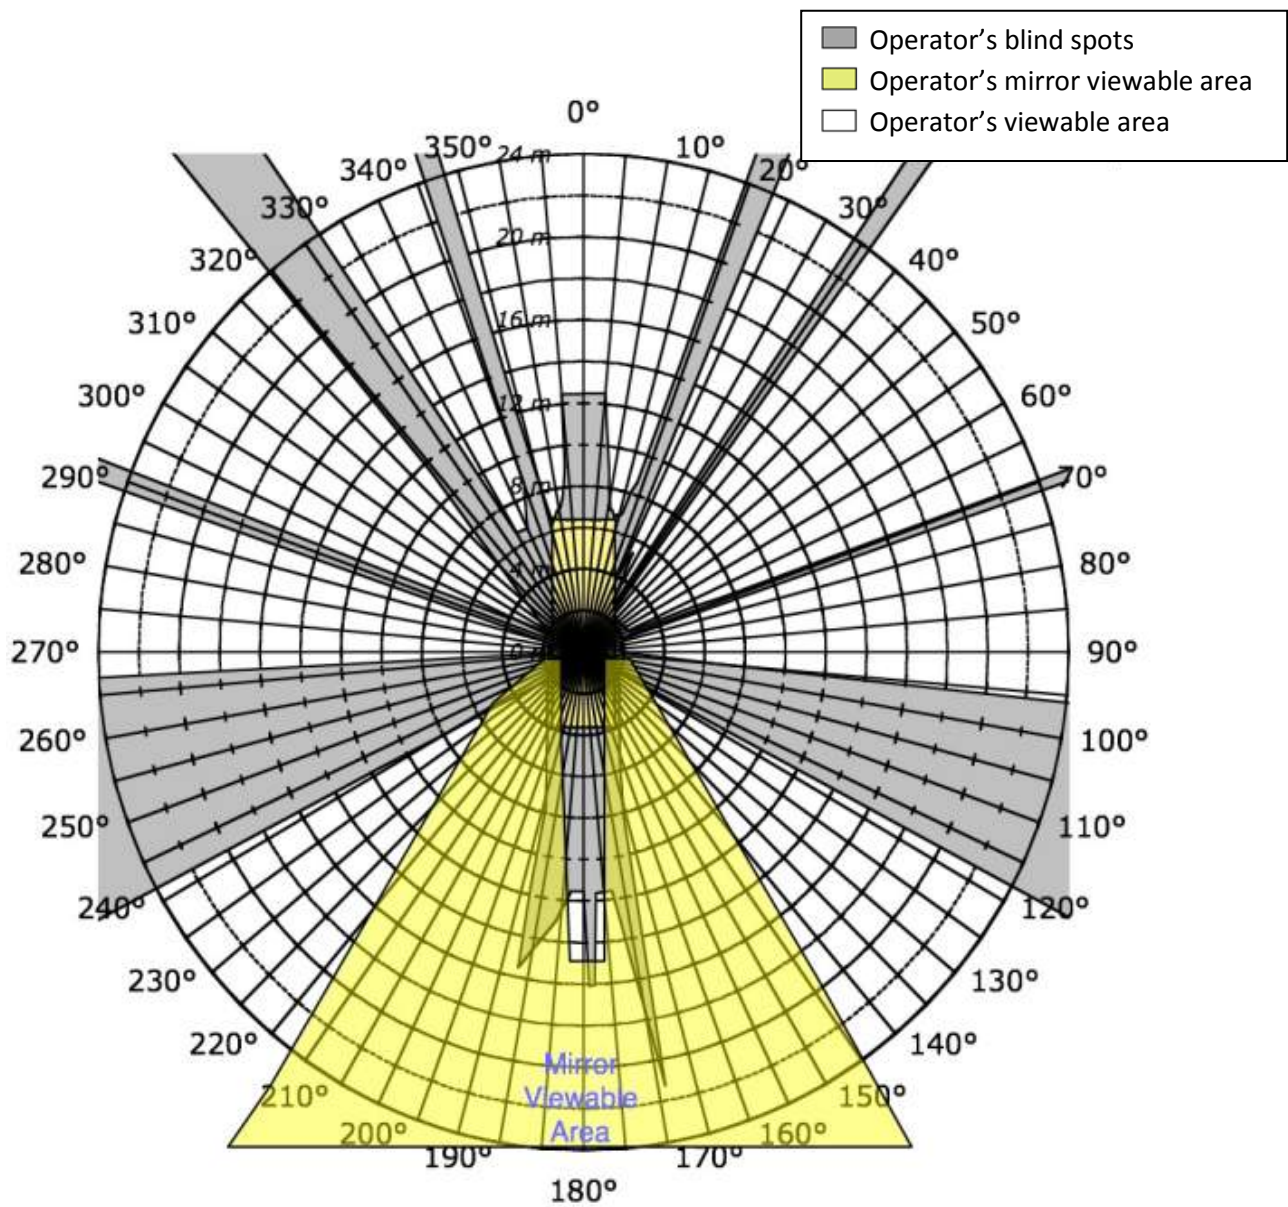
**Diagram 3: Blind Spots at five feet above ground level for a 27 ton CAT16G Motor Grader**
