REPORT#: 2022OR01

REPORT DATE: May 28th, 2023

Wildland Firefighter struck and fatally injured by hazard tree—Oregon

Oregon Fatality Assessment and Control Evaluation Program

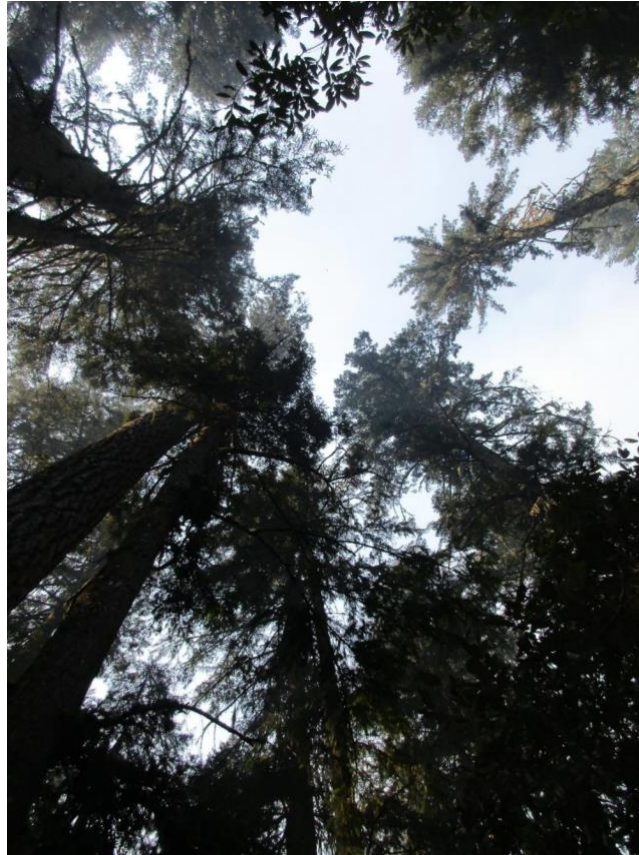
in this location were approximately 150 feet tall. **Image 3** is a photo taken from the incident site looking up at the forest canopy.

Image 3. View from beneath the forest canopy at the incident site (Oregon Department of Forestry and Bureau of Land Management Serious Accident Investigation Report, 2023).
