**REPORT#:** 24KY022

**REPORT DATE:** July 31, 2024

## Manufacturing Laborer Falls from Elevated Pallet, Succumbs to Injuries

# KENTUCKY

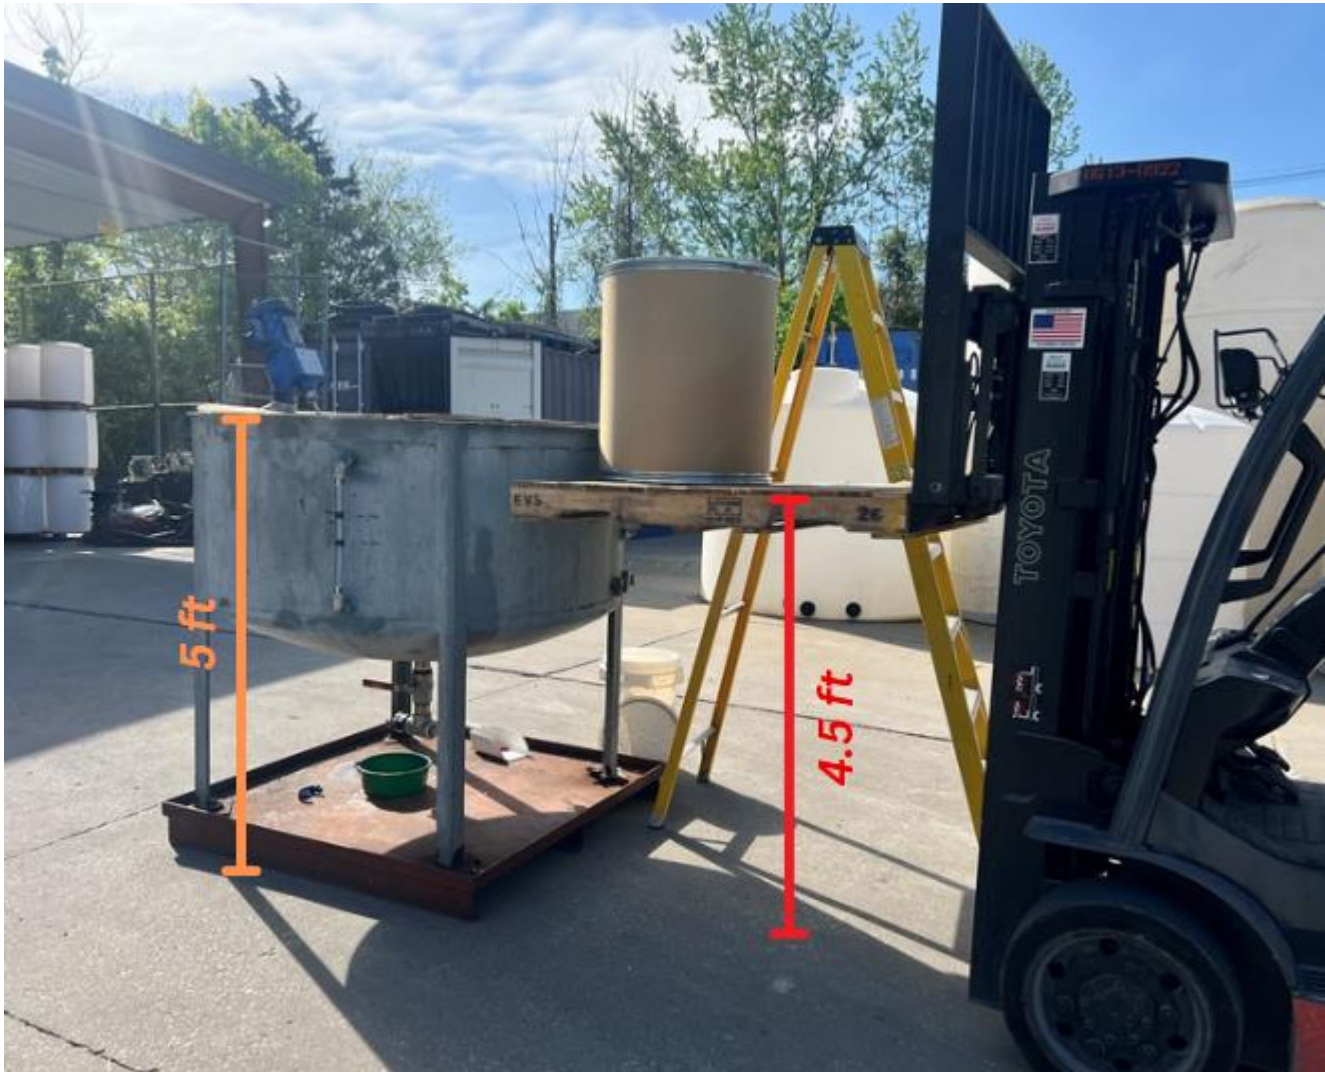
The commercial grade mixer sits approximately 5 feet from the concrete surface below. To access the mixer, the procedure in place at the time of the incident required employees to place the 132-pound drum onto a wooden pallet. Once on the pallet, the drum and pallet are lifted via forklift to the edge of the mixer. An 8-foot step ladder is then placed beside the elevated pallet, and employees climb the ladder to access the drum. From the ladder, the drum could be tilted forward to empty its contents into the mixer (photos 2 & 3). Although the process described above was the approved procedure the involved company had in place at the time the incident occurred, it required employees to improperly utilize [ladders](#).

However, it was discovered post-incident that employees were frequently standing on top of the pallet while emptying the drum, rather than utilizing the ladder. At approximately 7:54 a.m., while attempting to mix the contents of the drum into the mixer while standing on the pallet, the employee fell 4.5 feet from the pallet, striking the concrete surface below. Site security cameras did not catch the fall and the incident was not directly witnessed by other employees. However, an employee did catch the impact of the victim striking the surface below in his peripheral vision. The employee ran to the aid of the victim, who was initially responsive but going in and out of consciousness. A call to local emergency services was placed at 7:56 a.m.; an ambulance arrived 9 minutes later at 8:05 a.m. Emergency personnel transported the victim to a major Kentucky university medical center, where he succumbed to the injuries sustained in the incident the next day, on Tuesday, April 9, 2024, at 9:45 p.m.

Photo 2. Photo of commercial grade mixer, 132-pound product drum, ladder, forklift, and pallet, which were utilized when the incident occurred. Scene was reconstructed for investigation purposes. **Orange line** represents height of commercial grade mixer from the surface below. **Red line** represents height of the elevated platform the victim was standing on to the surface below. Photo property of Kentucky FACE.

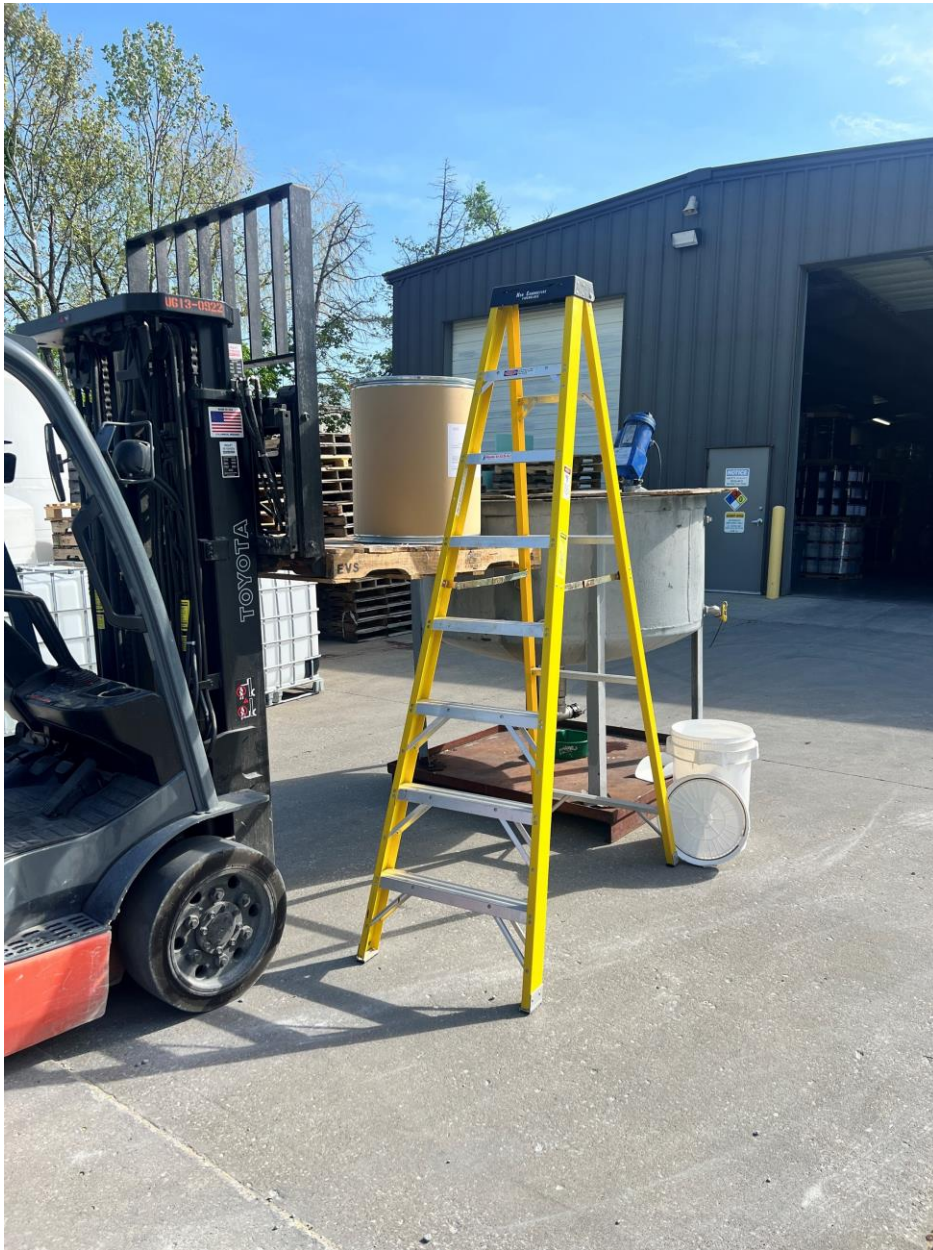
Photo 3. Photo showing additional angle. Photo property of Kentucky FACE.

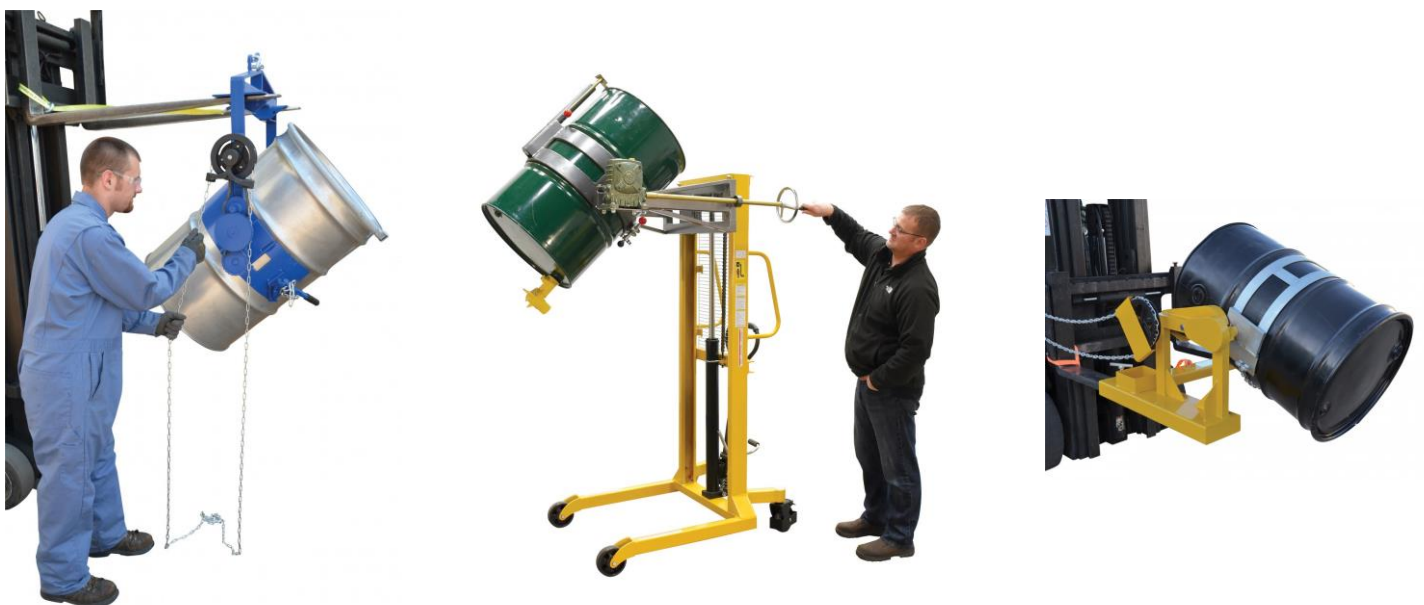
Photo 4. Photos showing various drum handling device options. Images obtained via Google search.

**Recommendation #1: Consider utilizing a drum handling device in lieu of working at heights.**

Discussion: According to the National Safety Council, falls to a lower level were the third leading fatal workplace event in 2022, resulting in 700 deaths.<sup>2</sup> In the case of this incident, it was discovered post-incident that employees were frequently standing on top of an elevated wooden pallet, approximately 4.5 feet from the surface below, to empty the contents of the drum into the mixer. The most effective way to address risk is to eliminate them when possible. Employers performing similar tasks should consider purchasing and requiring employees to utilize a drum handling device (photo 4), which would allow the same task to be completed while eliminating the need to work from an elevated surface and thus the risk of a fall. A variety of drum handling devices are available; employers should assess the functionality of each and select the device that best fits their needs.

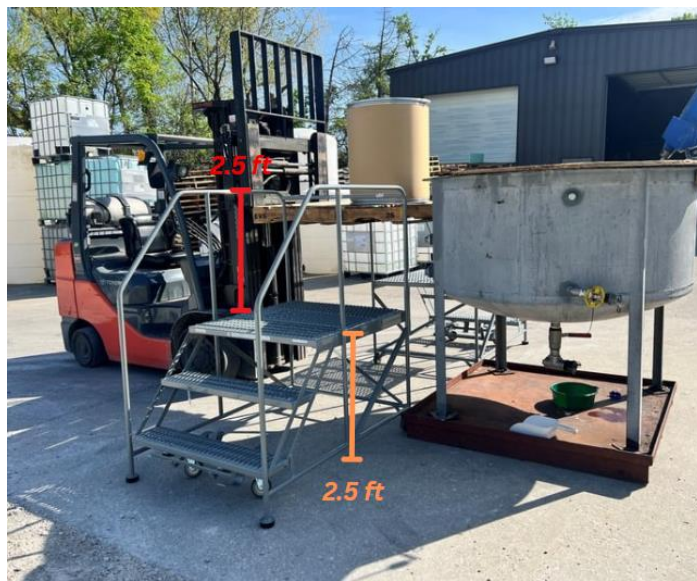
While the process reduces the risk associated with the task, it should be noted that if disregarded by employees, the elevated pallet is still accessible for employees to stand on.

Photo 5. Photo showing new ladders and process implemented by involved company. Photo property of Kentucky FACE.

***Recommendation #2: Consider modifying job procedures to prioritize the utilization of two employees when possible.***

Discussion: The involved company made alterations to its procedure shortly after the incident occurred to lower the risk associated with performing the mixing job task. The new procedure, demonstrated to FACE investigators during a site assessment, prioritizes utilizing two employees to complete the task, rather than one. As explained to investigators, standing on the pallet is prohibited. In lieu of utilizing a standard step ladder, the involved company purchased two platform ladders (photo 5) that are equipped with a guard rail system that offers fall protection to employees. The platform ladder on which employees stand measures 2.5 feet from the ground, and the guard rail extends 2.5 feet from the standing platform. Once the 132-pound drum is loaded onto the pallet, a forklift elevates the pallet to the mixer's edge. Once in place, the two platform ladders are placed on both the left and right side of the pallet (photo 5). Two employees, one on each ladder, work in unison to tilt the drum, emptying its contents into the mixer.

- The new ladder reduces the height at which the employees perform work from 4.5 feet to 2.5 feet,
- The new ladder offers fall protection via an integrated guardrail system, and
- The new procedure prioritizes the utilization of two employees, making the task less strenuous.

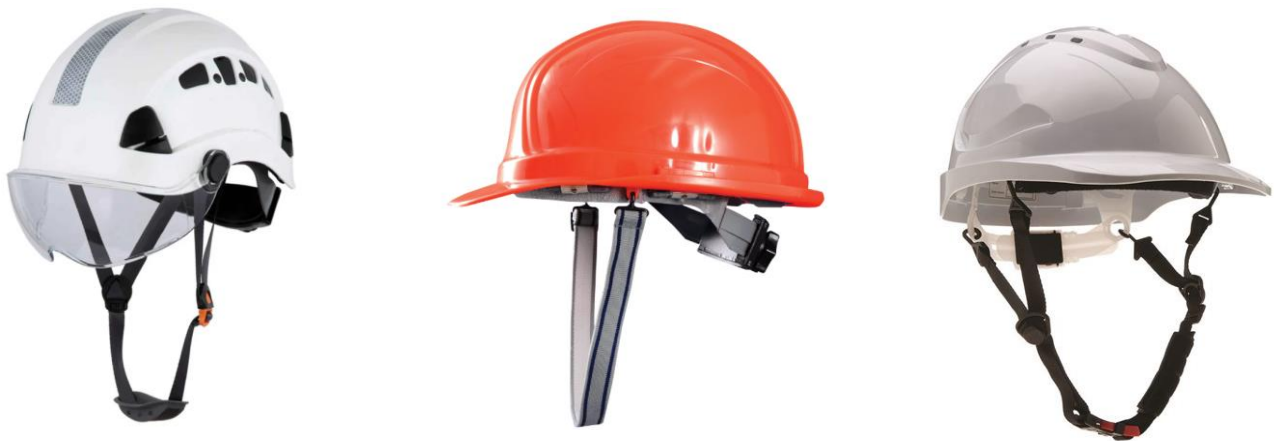
Photo 6. Hard hat options with chin straps. Photos obtained from Google image search.

***Recommendation #4: Consider requiring hard hats equipped with chin straps when working at heights.***

Utilizing hard hats, specifically hard hats equipped with chin straps (photo 6), could be an effective way to reduce the likelihood of a head injury when working at heights. OSHA states that proper head protection is crucial in work environments with falling objects, the potential for struck-by injuries, overhead electrical hazards, and risks from slips, trips, and falls. Scientific understanding of head injuries and head protection technology continues to advance. Modern head protection, whether it's a safety helmet or a hard hat, varies in styles and levels of protection, allowing employers and workers to choose head protection appropriate for the job. OSHA's head protection standards state that there can be compliance through the 2009, 2003, and 1997 editions of the American National Standard for Industrial Head Protection (ANSI Z89.1), published by the International Safety Equipment Association (ISEA). The range of products available today allows employers and employees to select the right type of head protection for the job.<sup>5</sup> For tasks or jobs that involve working from heights, OSHA suggests considering head protection with chin straps to prevent the head protection from falling off.<sup>4</sup>

To reduce risks associated with working at heights, Kentucky FACE investigators suggest that employers consider requiring hard hats equipped with chin straps.
