REPORT#: 24KY037

REPORT DATE: August 5, 2024

Truck Driver Killed After Semi-Trailer Wheel and Tire Cross Median, Strike Windshield

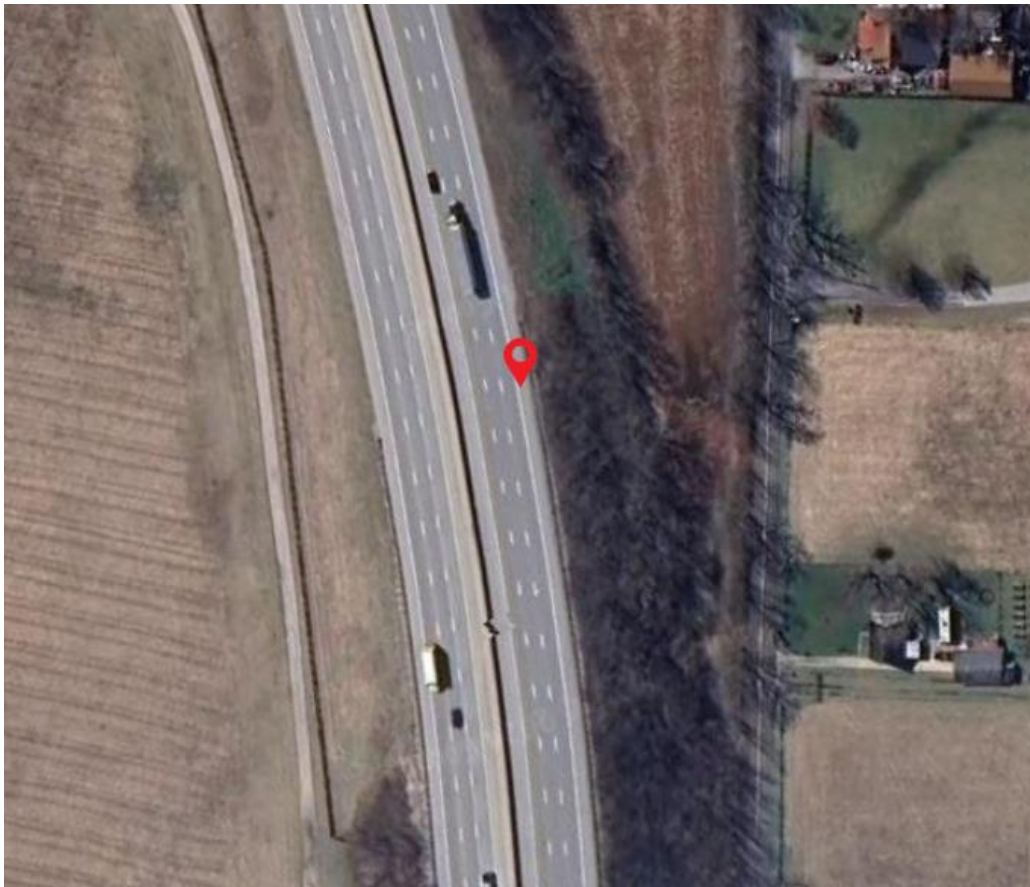
The incident initially began in the southbound lanes of a major six-lane interstate highway with a posted speed limit of 70 miles per hour (photo 1). Northbound and southbound travel lanes are separated by a concrete barrier; a standard W-beam guardrail is positioned on the right shoulder of the southbound lanes. The point of first contact occurred in the far-right lane as the commercial semi-truck and trailer traveled south. After initial contact, the truck veered right, where it struck the guardrail and came to final rest on the shoulder of the interstate (photo 2).

Photo 1. Overhead Google Earth image of Kentucky interstate where the incident occurred. Red location maker indicates approximate location of final rest.

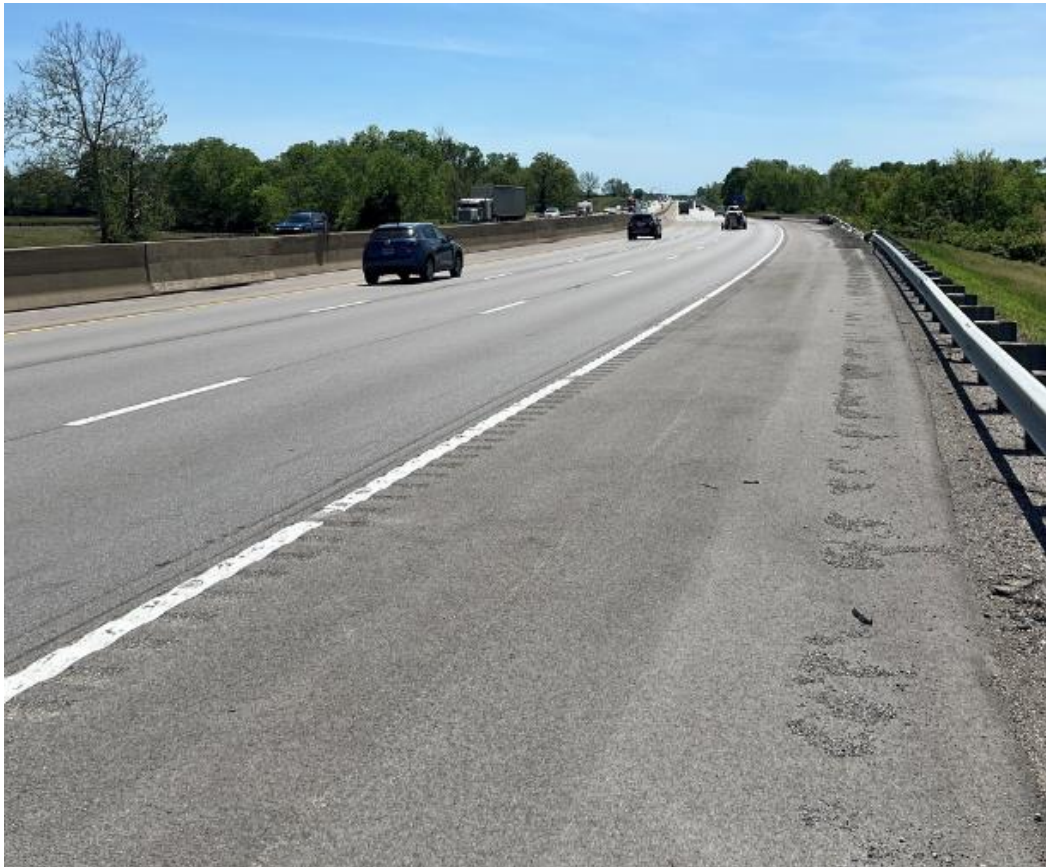
Photo 2. Photo showing the section of interstate where the incident occurred.
Photo property of Kentucky FACE.

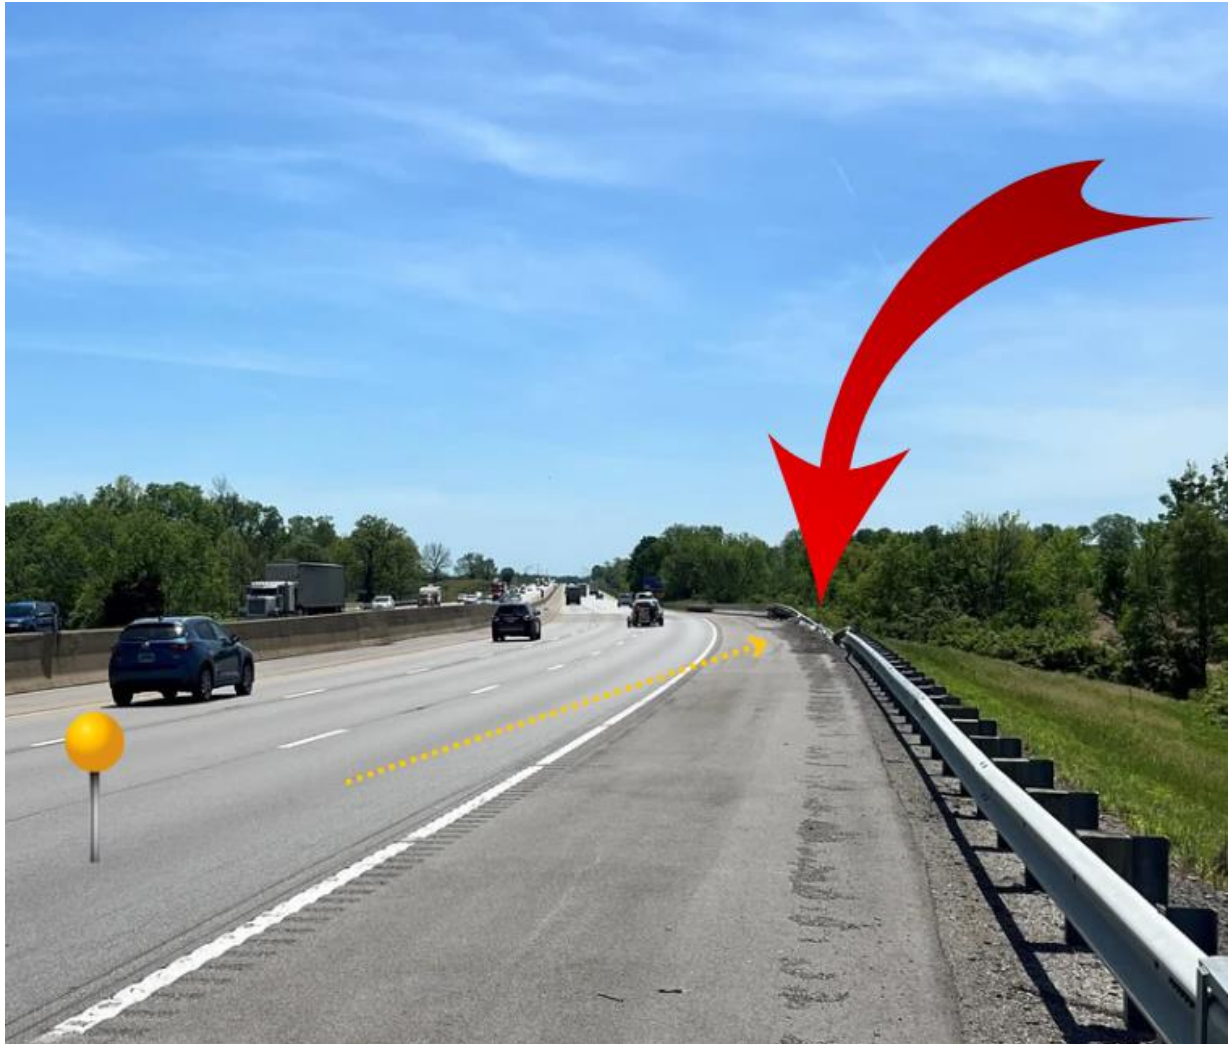
On Monday April 22, 2024, a 55-year-old male commercial truck driver (victim) arrived at work at approximately 9:30 p.m. to gather his supplies and conduct a pre-trip inspection on his semi-truck. Post-inspection, the driver departed the company's out-of-state headquarters en route to pick up his trailer. The trailer was located at a dairy farm approximately 20 miles north of the company's headquarters. Upon arrival, the driver (victim) connected his semi-truck to his tank trailer, which was loaded with 5,800 gallons of raw milk and weighed approximately 49,500 lbs. At 11:00 p.m., the driver (victim), departed for a Kentucky-based milk processing plant located 246 miles away. This trip was a regular dedicated route for the driver, who typically worked five days a week. Approximately three hours later, at 2:00 a.m., while the victim was driving southbound on a major, six-lane Kentucky interstate highway, a semi-trailer wheel and tire that had become detached from a semi-truck and trailer traveling northbound crossed the median and struck the front of the victim's truck. After striking the front of the truck, the wheel and tire combo struck the windshield and continued into the cab of the truck, striking the driver. According to investigators, it is suspected that the driver was killed instantly, as no evidence of attempted braking was located on the highway. Post-impact, the truck veered right, striking the guardrail located on the right shoulder of the highway, which resulted in extensive damage to the passenger's side of the truck. The semi-truck and trailer came to a final rest upright, on the shoulder of the highway, against the guardrail (photo 5 and diagram 1).

Photo 5. Photo showing victim's lane of travel (yellow location marker), direction of travel after initial strike (yellow dotted arrow), and final rest/damage to guardrail (red arrow). Photo property of Kentucky FACE.

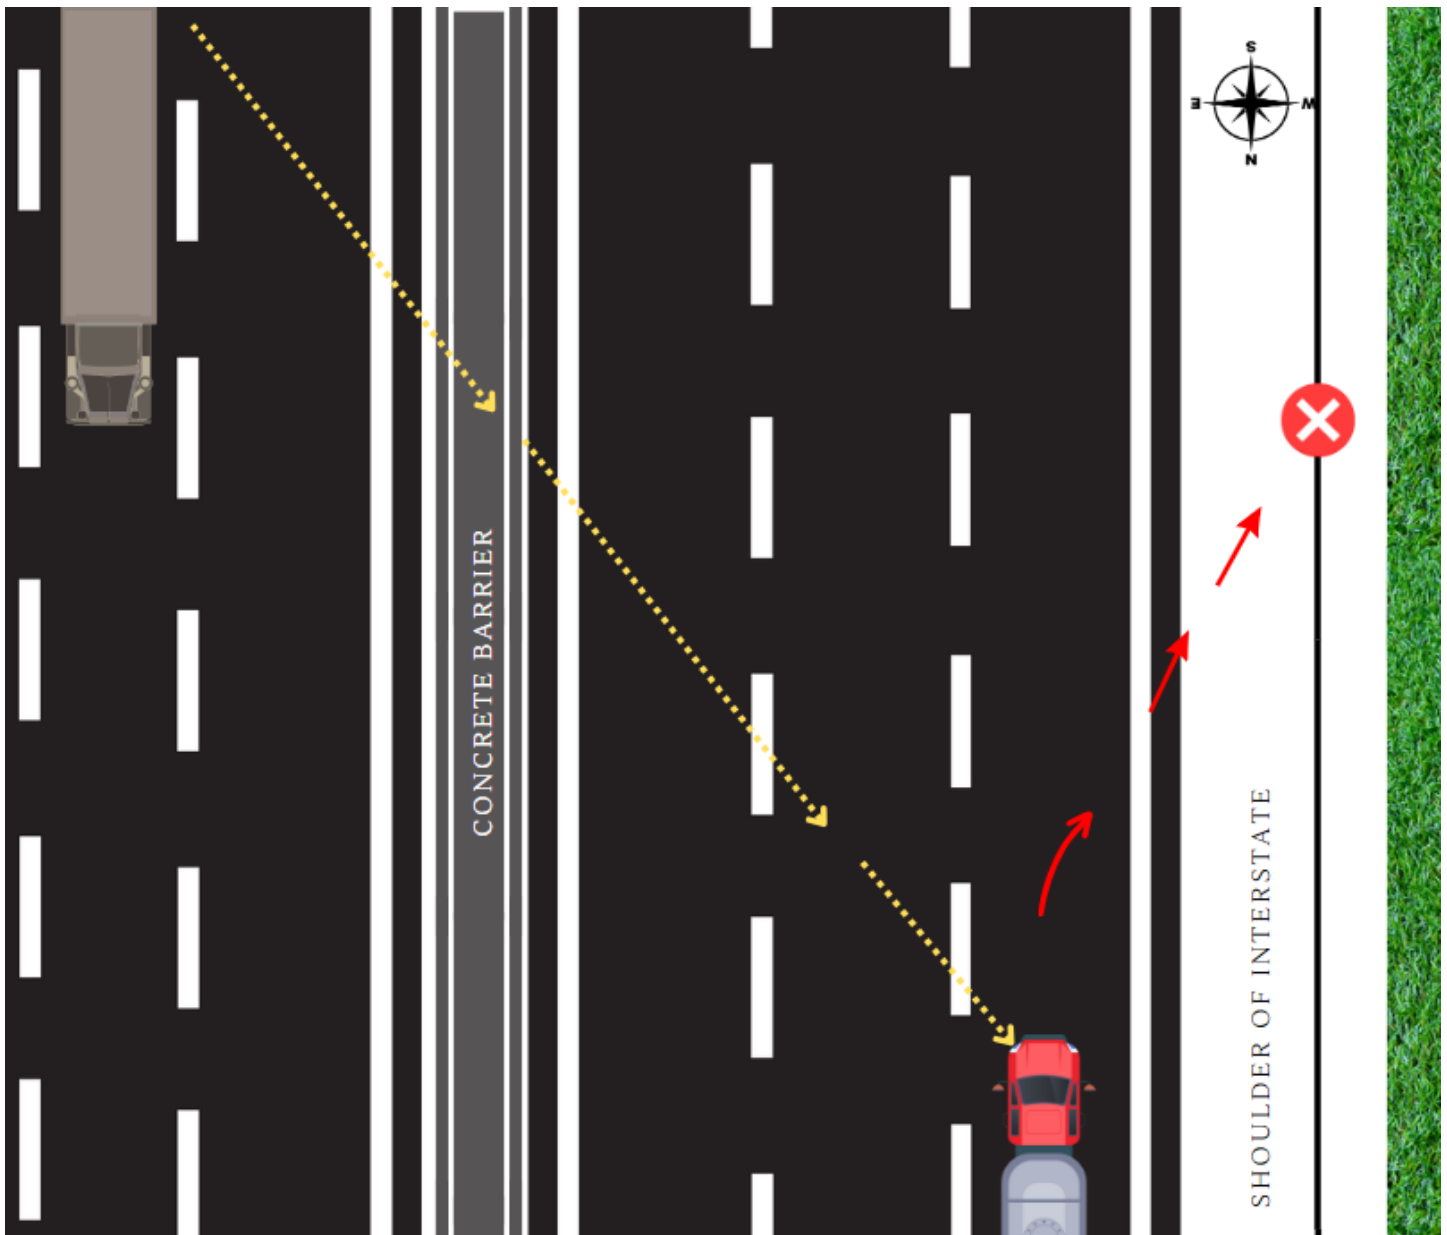
Diagram 1. Diagram showing victim's direction and lane of travel (red semi-truck) and other involved vehicle's direction of travel (brown semi-truck). The yellow dotted line represents the approximate path the wheel and tire combo traveled across the concrete barrier to strike the victim's vehicle. The red arrows represent the approximate path the victim's vehicle traveled after being struck. The red X represents final rest against the guardrail on the shoulder of the interstate. Diagram property of Kentucky FACE. *Note: Diagram is not to scale.*

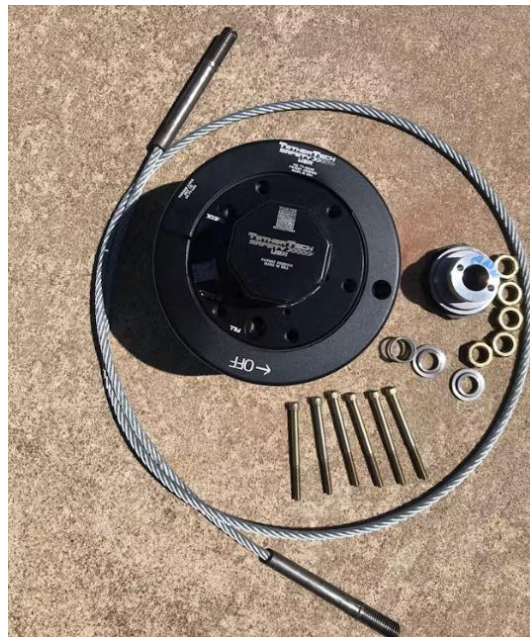
Photo 7. Photo showing the Tether Tech System. Photos obtained from www.fleetowner.com.

Recommendation #1: Consider installing wheel separation prevention devices.

[Tether Tech Safety](#), an Oklahoma-based company, has created a product that aims to eliminate wheel separation due to bearing and/or wheel fastener failure. The hub system utilizes a steel cable that runs through the axle tube and tethers the wheel to the endcaps, eliminating the possibility of wheel separation when hub and/or wheel fasteners fail.⁵

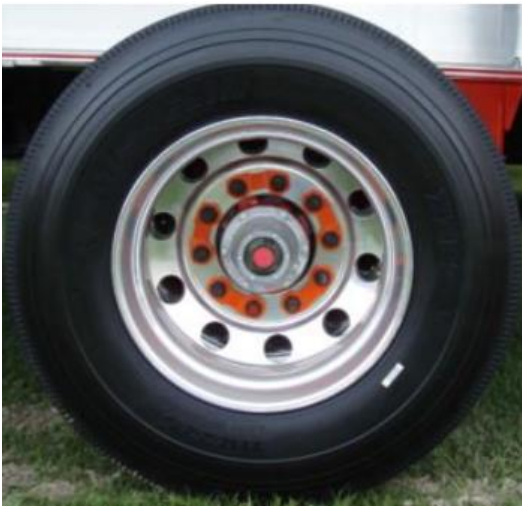
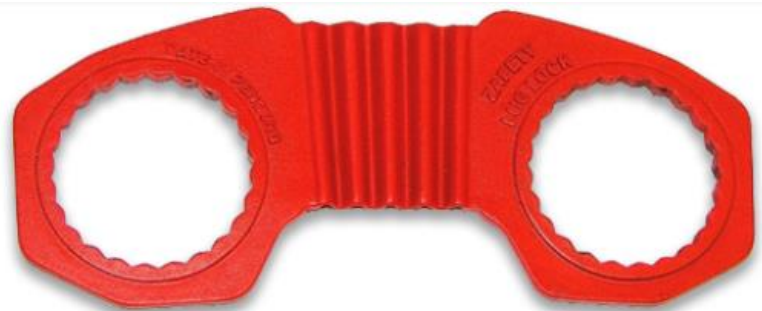
Photo 6. Photos showing [Zafety Lug Lock](#) device. Photos obtained from Zafetyluglock.com

[Zafety Lug Lock](#), a product designed and developed by Tafcan Consulting Ltd., aims to prevent wheel fasteners from backing off. The device is installed over two adjacent lug nuts and creates enough resistance between the two lug nuts to minimize their ability to rotate and fall off, thus preventing wheel fastener-related incidents.⁶

Kentucky FACE does not endorse any specific products, but investigators suggest that commercial carriers consider using wheel separation prevention devices to reduce the likelihood of wheel separation incidents.
