REPORT#: 2015-02 **REPORT DATE:** May 28, 2019

Two Tower Climbers Fatally Injured When a Cellular Tower Collapsed While Performing Tower Upgrades – West Virginia.

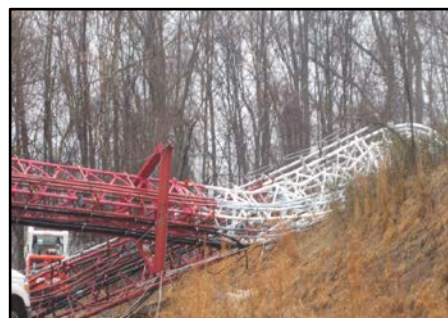
On February 1, 2014, at approximately 11:37 am, two tower climbers were fatally injured when a 340-foot, Rohn 80 series cellular tower collapsed during upgrading/construction activities. Four employees were working on the tower removing diagonal tower supports and no temporary supports were installed. As a result, the tower collapsed and two employees were killed and two others were injured.... [READ THE FULL REPORT> \(p.3\)](#)

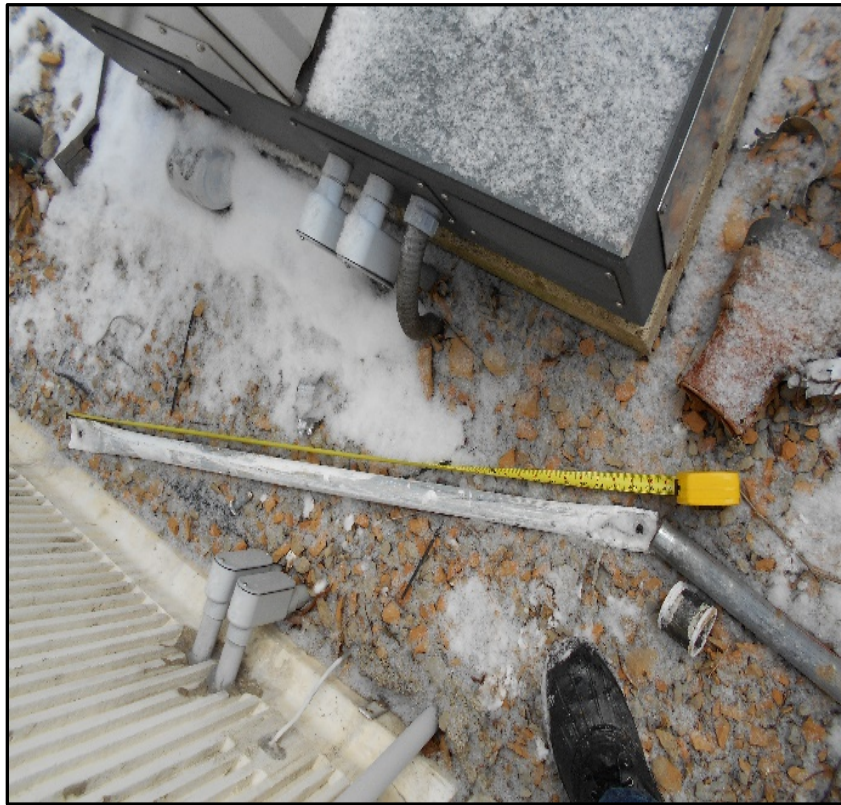
On February 1, 2014, a Rohn, series 80, cellular tower collapsed while four tower climbers were working on the tower. Three tower climbers were removing diagonal support bracing (3 foot 10 inches) (Photo 1) from the 60–80-foot section while a fourth worker was at the 20–40-foot section examining the legs and test-fitting a section of the leg stiffener to the tower leg to make sure the materials they had were appropriately sized. Another worker was on the ground, cutting sections of the bracing to length to replace the diagonal bracing that was removed. In addition, the foreman was located on the ground, communicating by radio and shouts to the employees on the tower.

Photo 1. One of five diagonal support braces (3 foot 10 inches) that were removed from Tower 1.

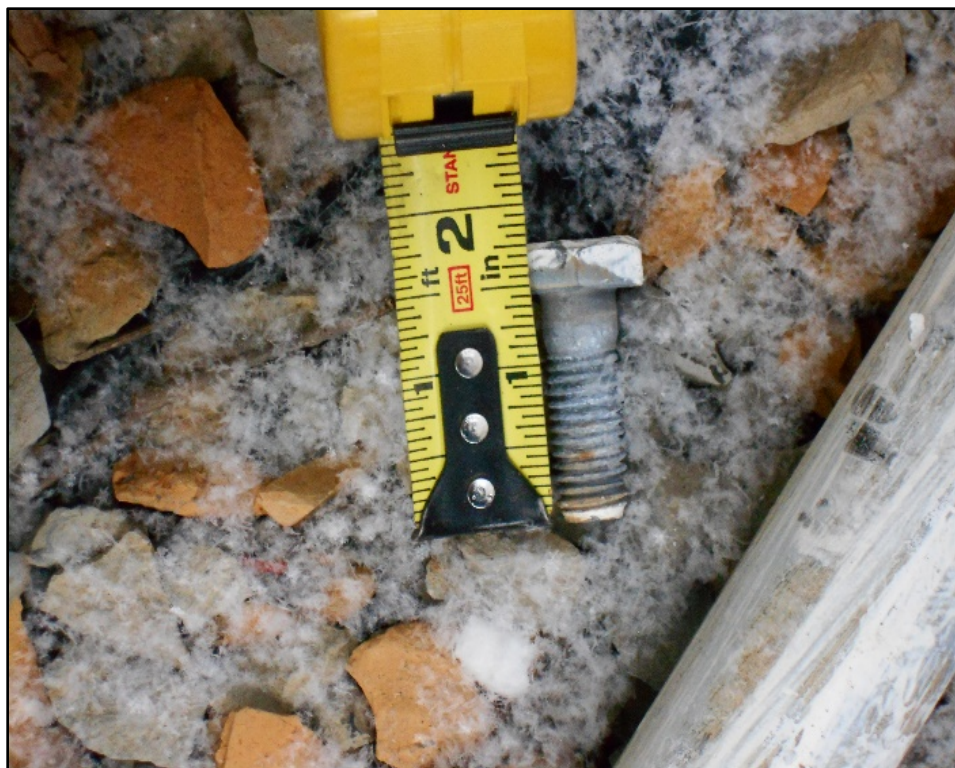
The three employees on the 60–80-foot section of the tower removed eight bolts (Photo 2) and five diagonal angle support braces: two angles from the A-B face, two angles from the C-B face, and one angle from the A-C face. The removal of the eight bolts also disconnected one end of the other diagonal bracing section on the tower. At each welded lug of the tower leg, one bolt connected two diagonal support braces. One diagonal had two holes for connection, one at each end. Removing one bolt would disable two diagonal support braces, although they would still be connected to the tower at the other ends (Figure 1). Because of this, 6 diagonal angle braces were weakened in addition to the 5 that were completely removed from the structure. The diagonals were removed without installing any temporary supports to offset the structural weakening of the tower.

Photo 2. One of the eight bolts removed from Tower 1.
(Photo courtesy of WV OSHA)

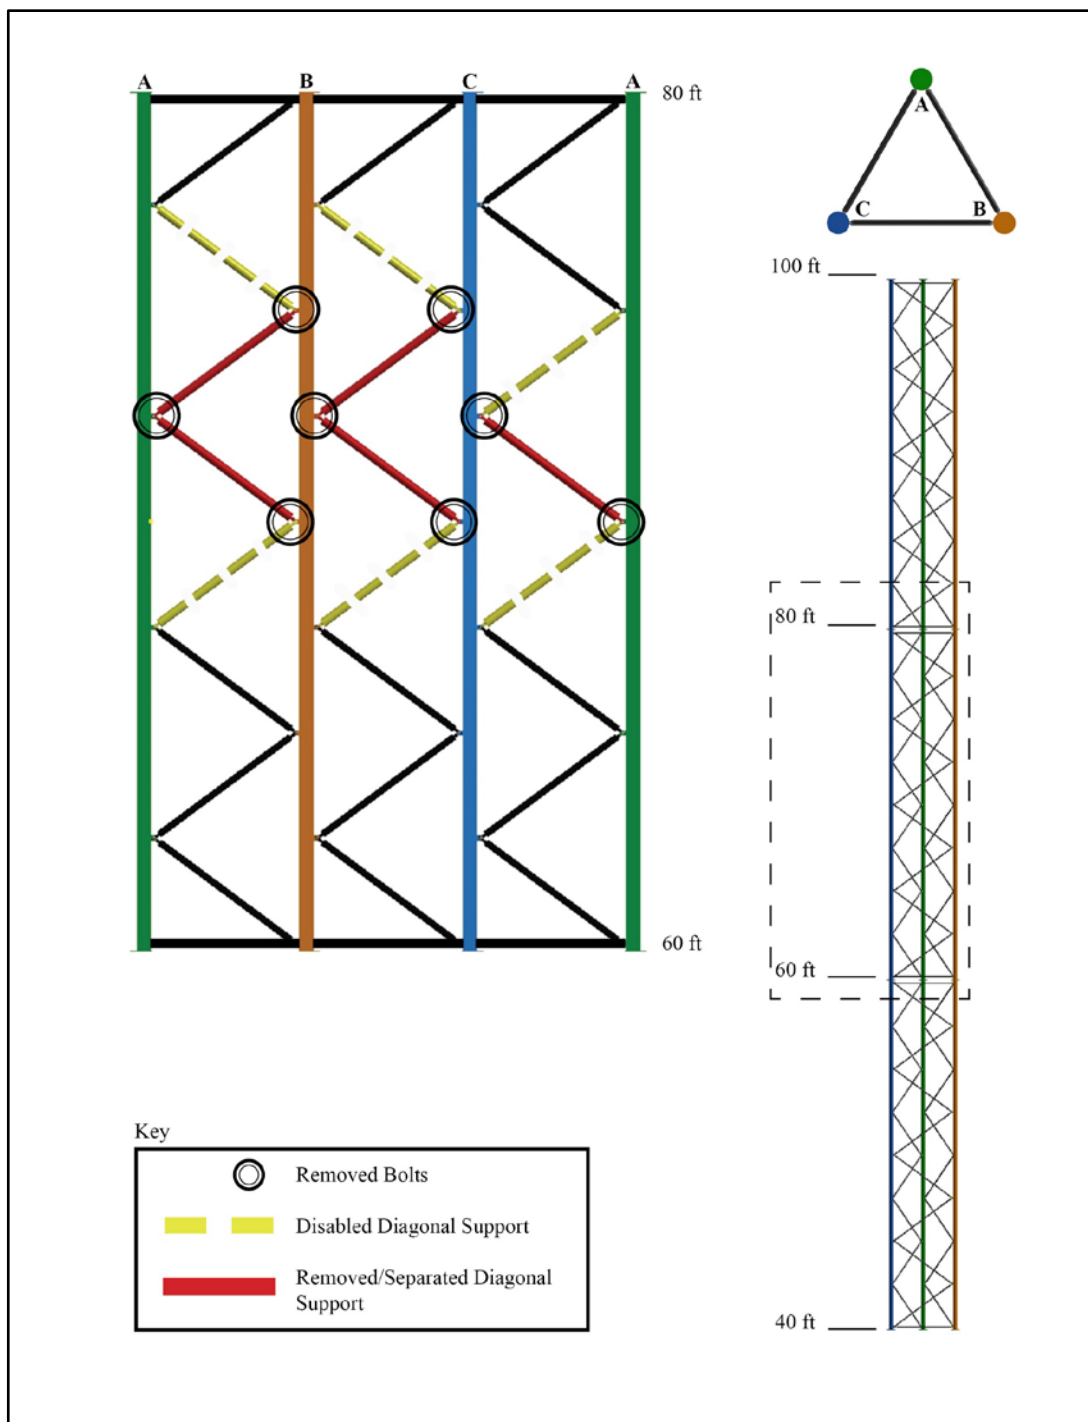
Figure 1. Section of Tower 1 shown with removed bolts and diagonal support braces.

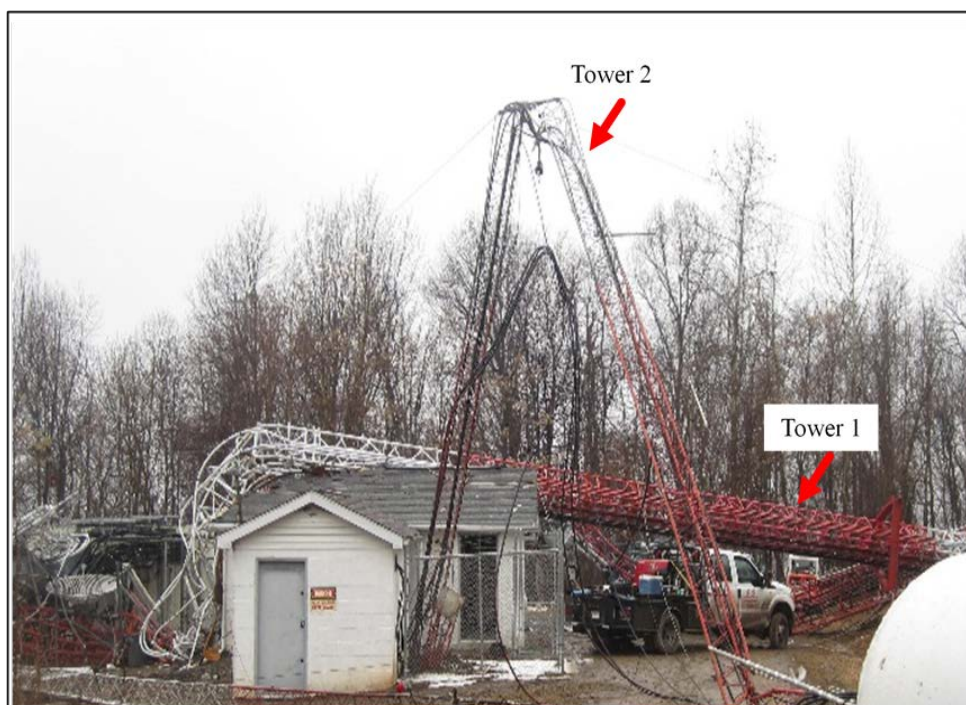
At approximately 11:37 am, the Tower 1 collapsed. As Tower 1 fell, it contacted guy wires to Tower 2, causing it to become unstable. Tower 1 fell to the ground, with a section of the tower landing on the top of the small building on the site (Photo 3). The 4 workers on the tower were thrown to the ground, resulting in crushing and impalement traumatic injuries to each of the workers. Two employees died either instantly or within a few seconds from injuries sustained from the tower collapse. The other two employees were sent to the hospital and subsequently recovered. In addition, a fire fighter was fatally injured while trying to rescue one of the injured tower climbers when the weakened Tower 2 collapsed [NIOSH 2014].

Photo 3. Incident scene of the two towers
(Photo courtesy of WV OSHA)
