Volunteer Fire Chief Dies in Motor Vehicle Incident While Responding to a Fire Alarm – Maryland

Fatality Assessment and Control Evaluation Investigation Report # F2009-12

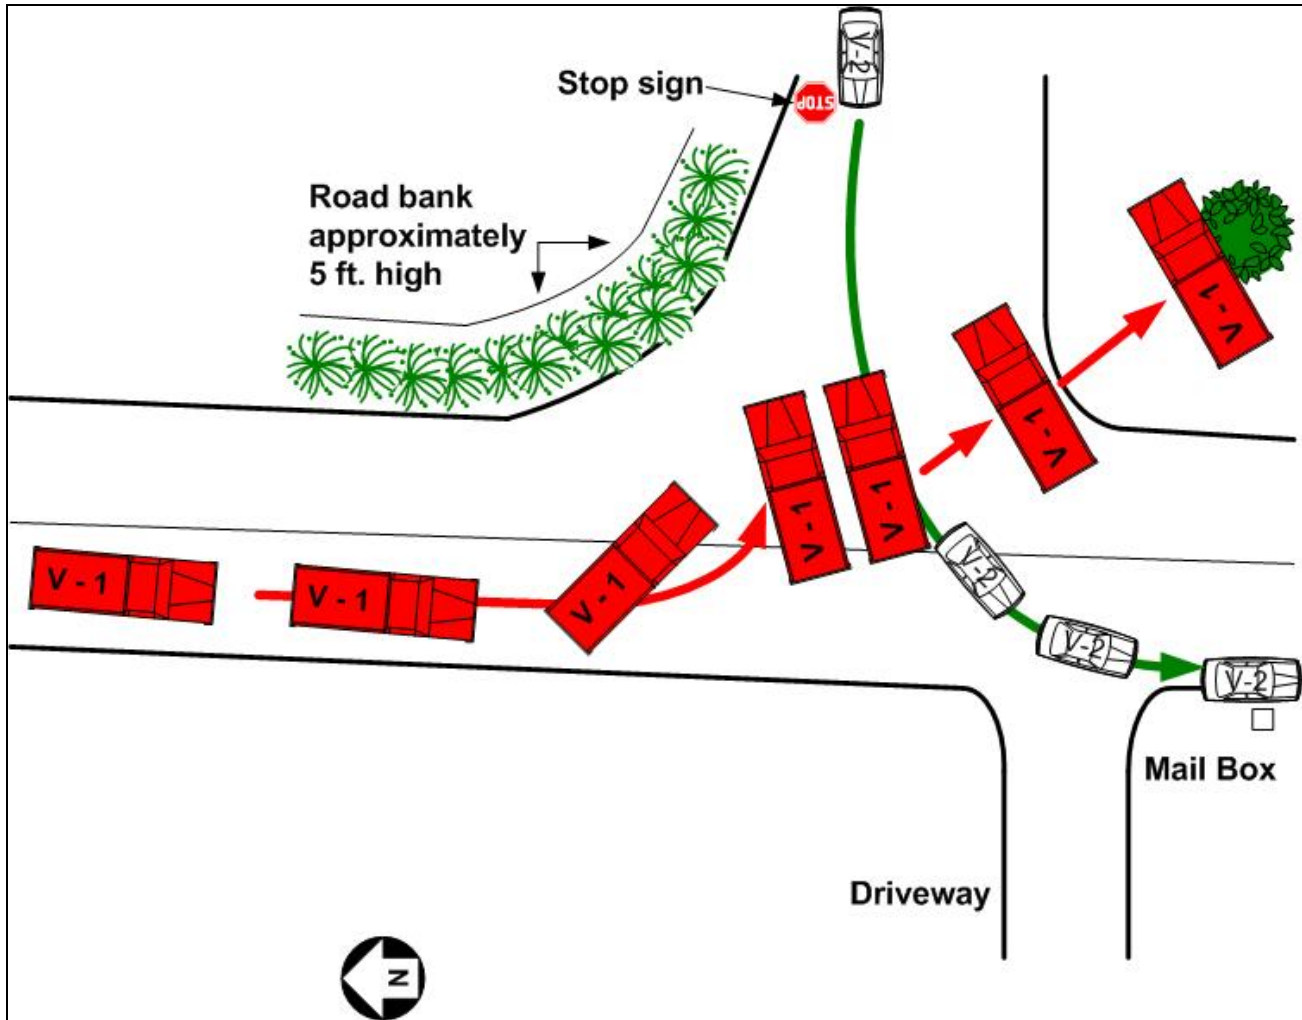
Diagram 1.

Overview of the incident scene. Victim's vehicle = V1, Compact vehicle = V2. V1 traveling south. V2 pulled out of the intersection and across the path of V1. V1 steered to the left causing the vehicle to turn approximately 90° and slide sideways across the roadway, eventually striking a tree.

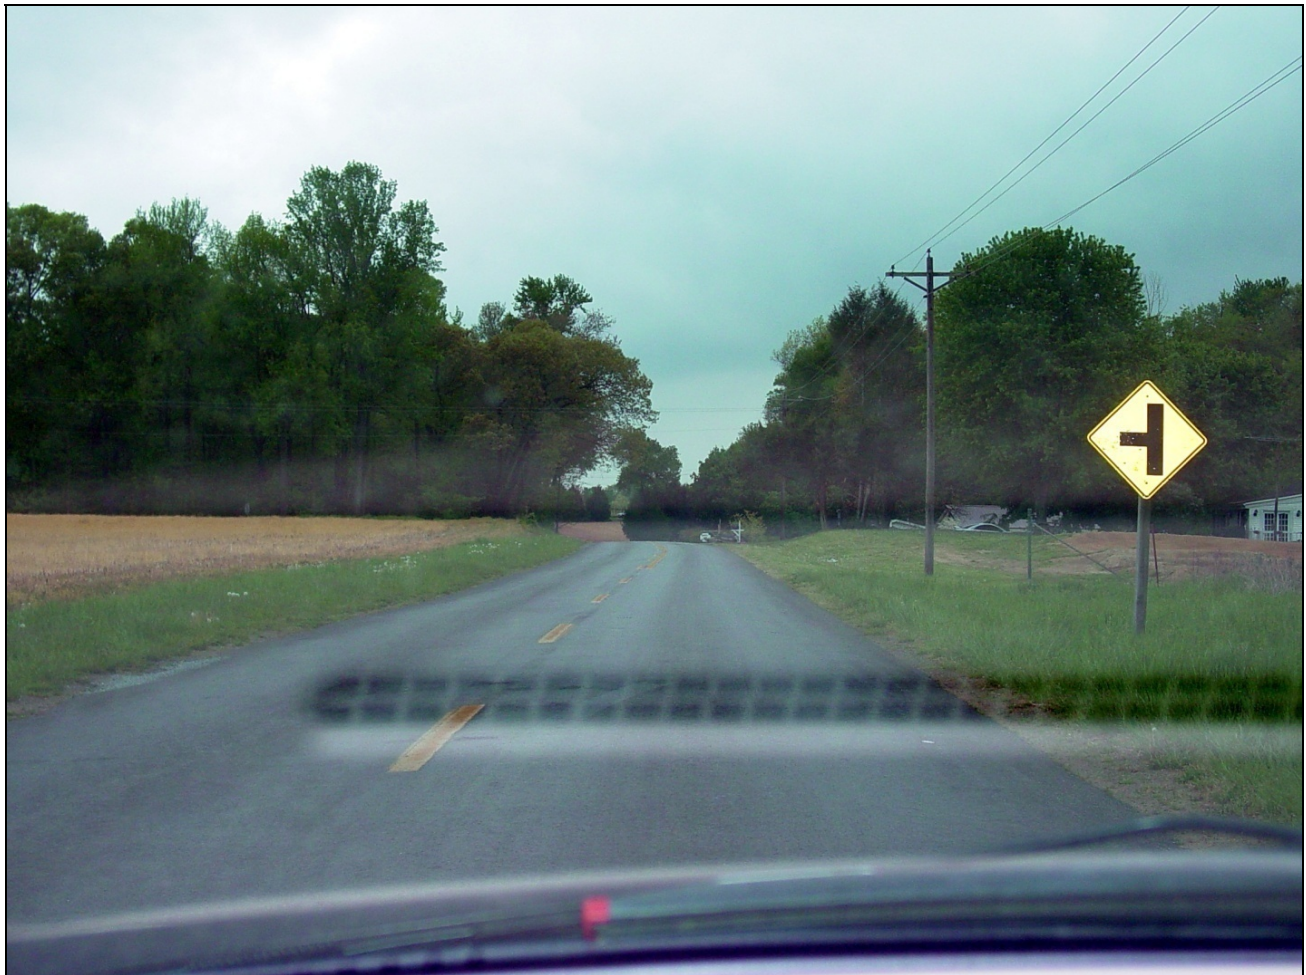
Photo 1.
Victim's vehicle traveled south on this county road.
Photo - NIOSH

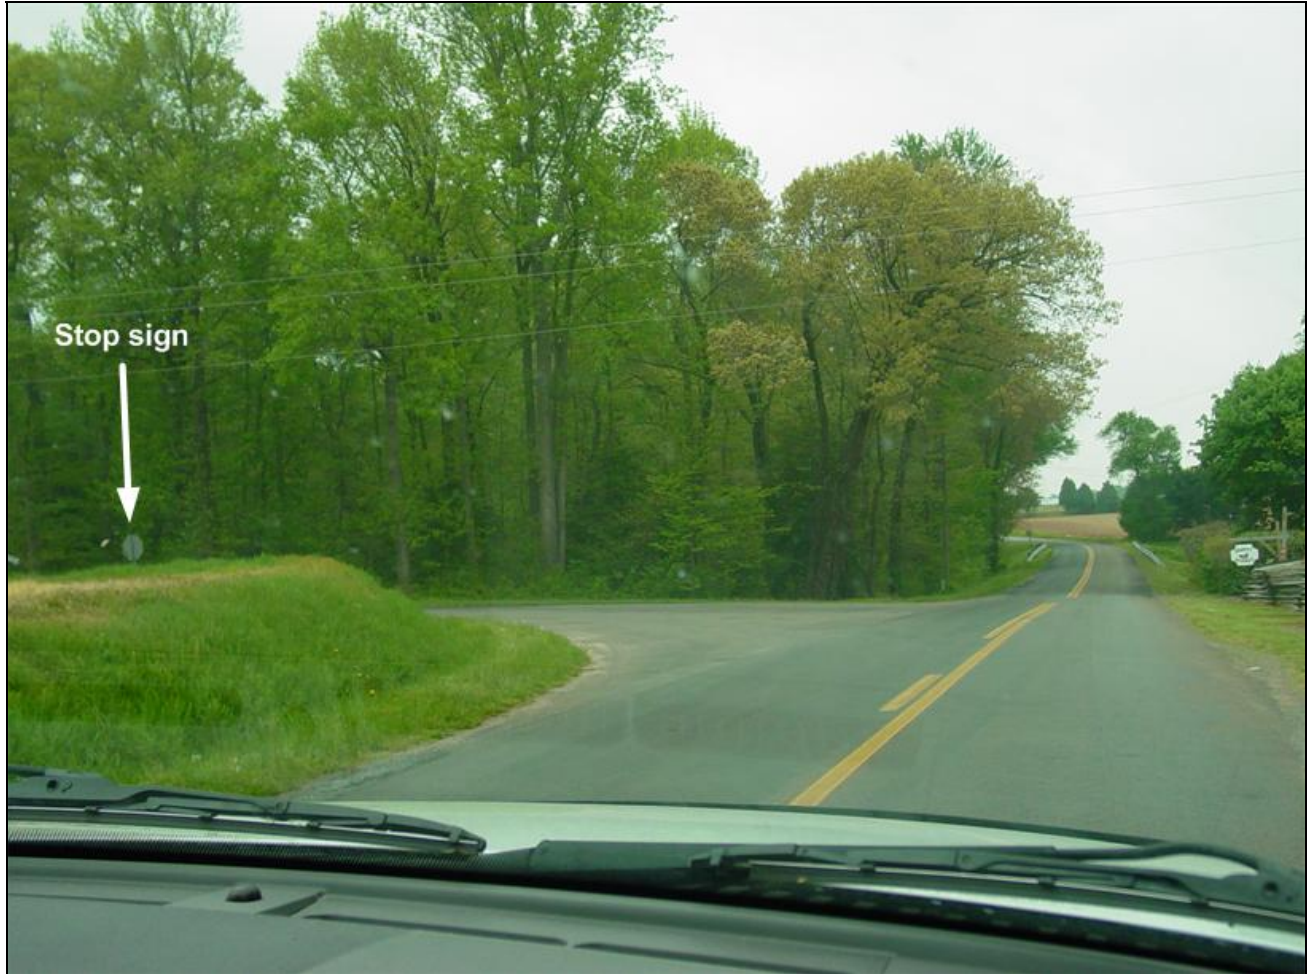
Photo 2 .
Victim's vehicle approached intersecting roadway on the left.
Photo - NIOSH

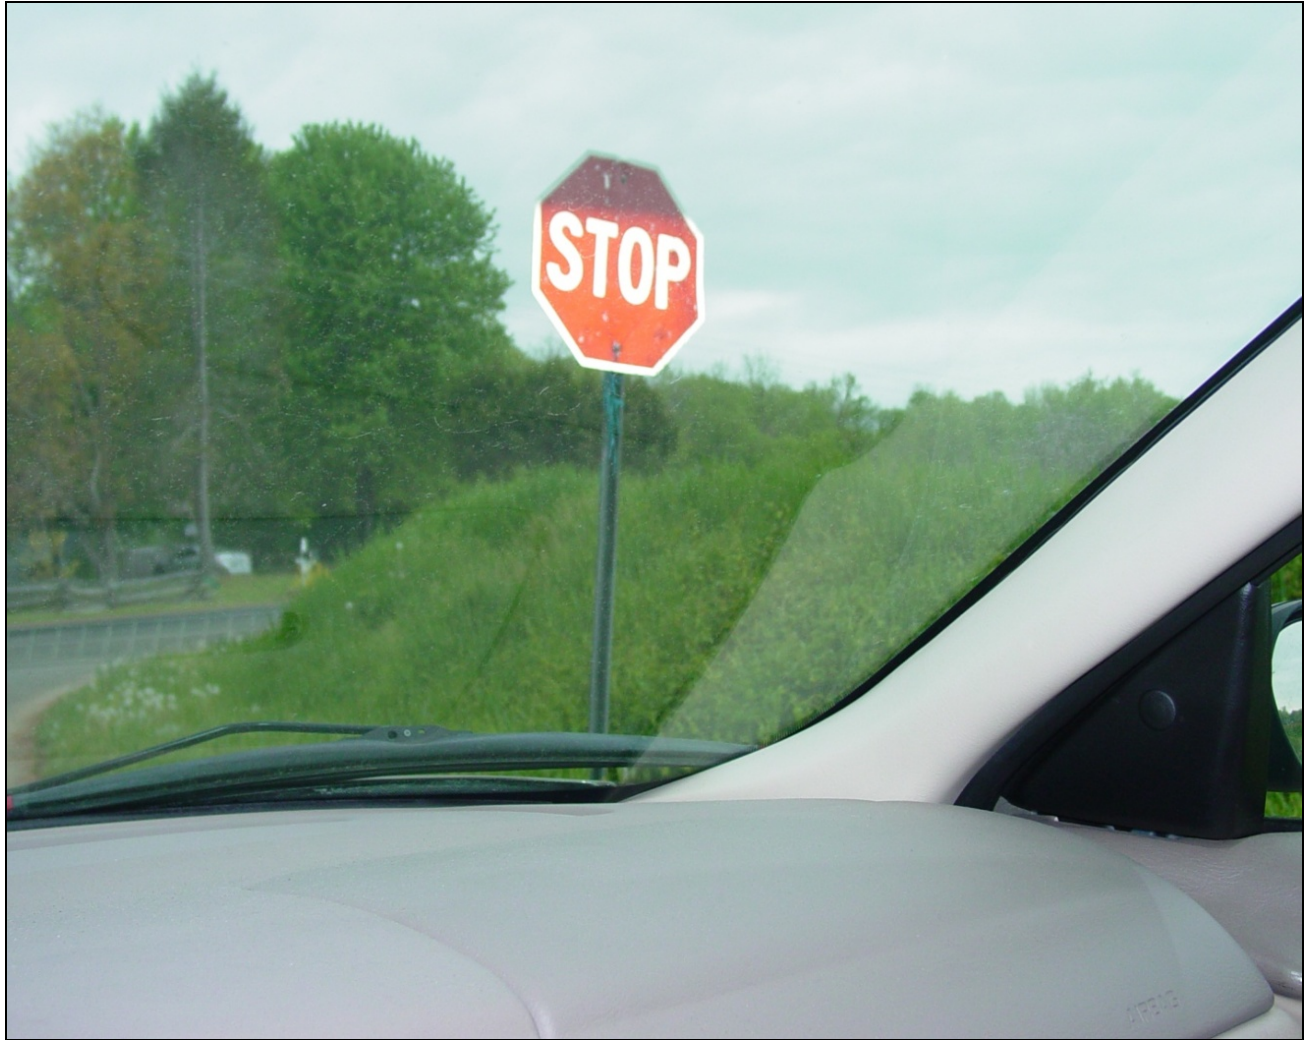
Photo 3.

photo 2). At about the same time, a compact vehicle was traveling west on the intersecting road, and approached the stop sign. Although the compact vehicle stopped at the stop sign, the view to the right (North) was somewhat obstructed by a 5-foot high embankment on the right hand side of the vehicle (see photo 3). The driver of the compact vehicle drove into the intersection across the path of the victim's vehicle, turned South and stopped on the South-bound side of the road (see photo 3 and diagram 1).

Discussion: Line-of-sight for motorists is one of the most important safety issues at an intersection. The ability of drivers to be able to see approaching traffic to determine if it is safe to enter the intersection is critical. Areas along the approach to an intersection and across the corners should be clear of obstructions that might block the driver's view of approaching traffic. In this incident, line-of-sight at the intersection was obstructed by a 5-foot high embankment, and although there is no evidence this directly caused the collision, the obstructed view likely prevented the drivers from seeing each other thereby causing a delay in their reaction time.

Compact vehicle stopped at this stop sign, prior to pulling out in front of chief's vehicle approaching from the right. Note the embankment approximately 5-foot high on right side of vehicle which restricted field of view to the right.

Recommendation #4: Governing municipalities (state, regional, and local) should ensure that adequate line-of-sight is maintained at roadway intersections, with an emphasis on routes routinely traveled by responding emergency vehicles/apparatus.

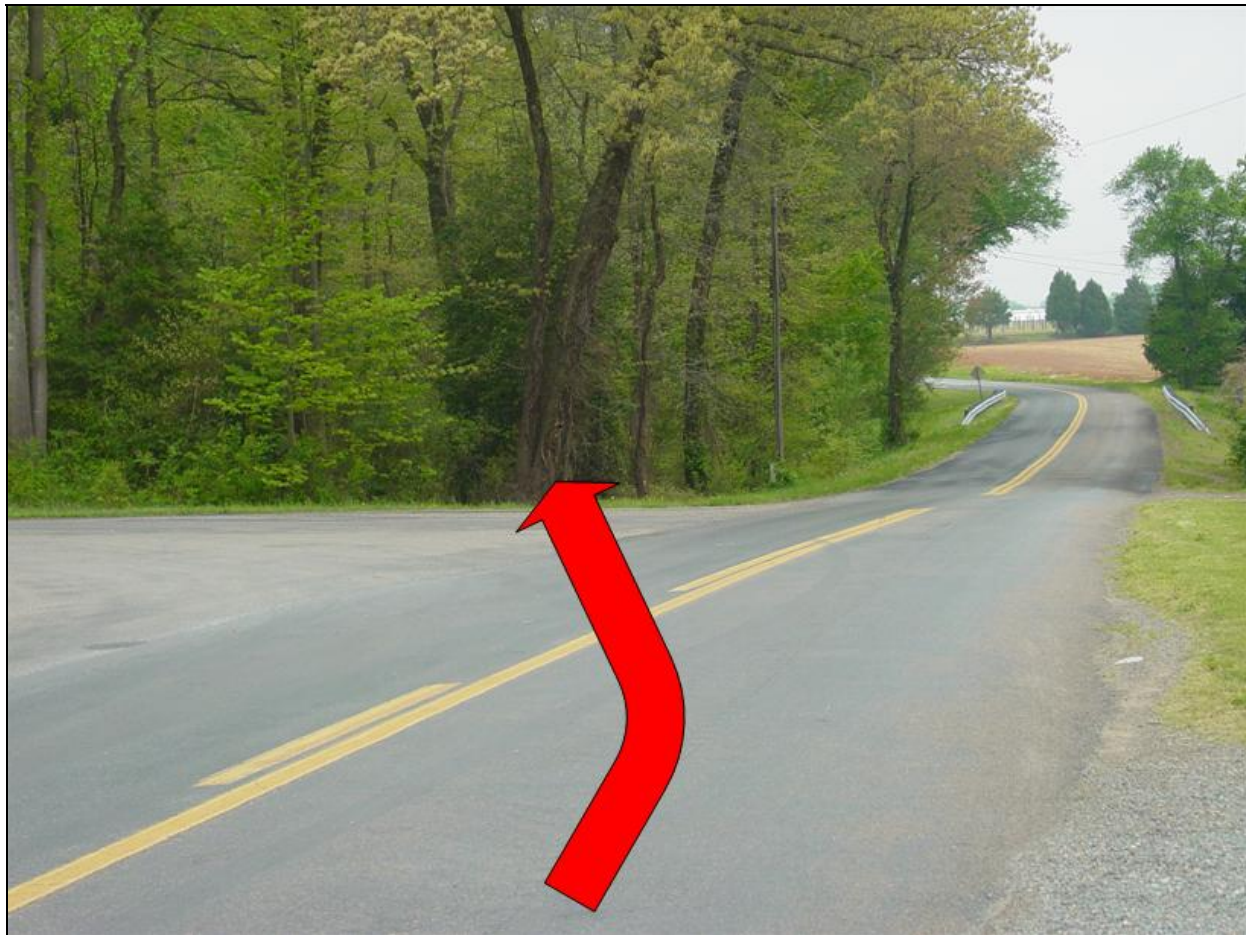
Photo 4.

In an attempt to avoid hitting the compact vehicle, the victim maneuvered to the left of the compact vehicle. When the victim maneuvered left, his vehicle turned sideways at about a 90° angle, and skidded down the center of the roadway. The vehicle skidded about 150 feet then left the asphalt roadway and continued to skid sideways through a grassy field (see photo 4). The vehicle skidded another 50 feet on the grassy field before hitting a large (30 inch-diameter) tree on the passenger side (see photos 5 and 6, and diagram 1). At around 1949 hours an eye witness (local homeowner) to the incident called the 911 center and reported the crash. Rescue and emergency medical service vehicles were dispatched to the incident scene. Upon arrival, the victim's condition was evaluated by emergency responders and he was pronounced dead at the scene. *Note: The victim was wearing his seat belt at the time of the incident.*

After swerving to miss the compact vehicle that entered the roadway from the left, crossing his path, the Chief's vehicle slid sideways across the intersection and struck a tree.

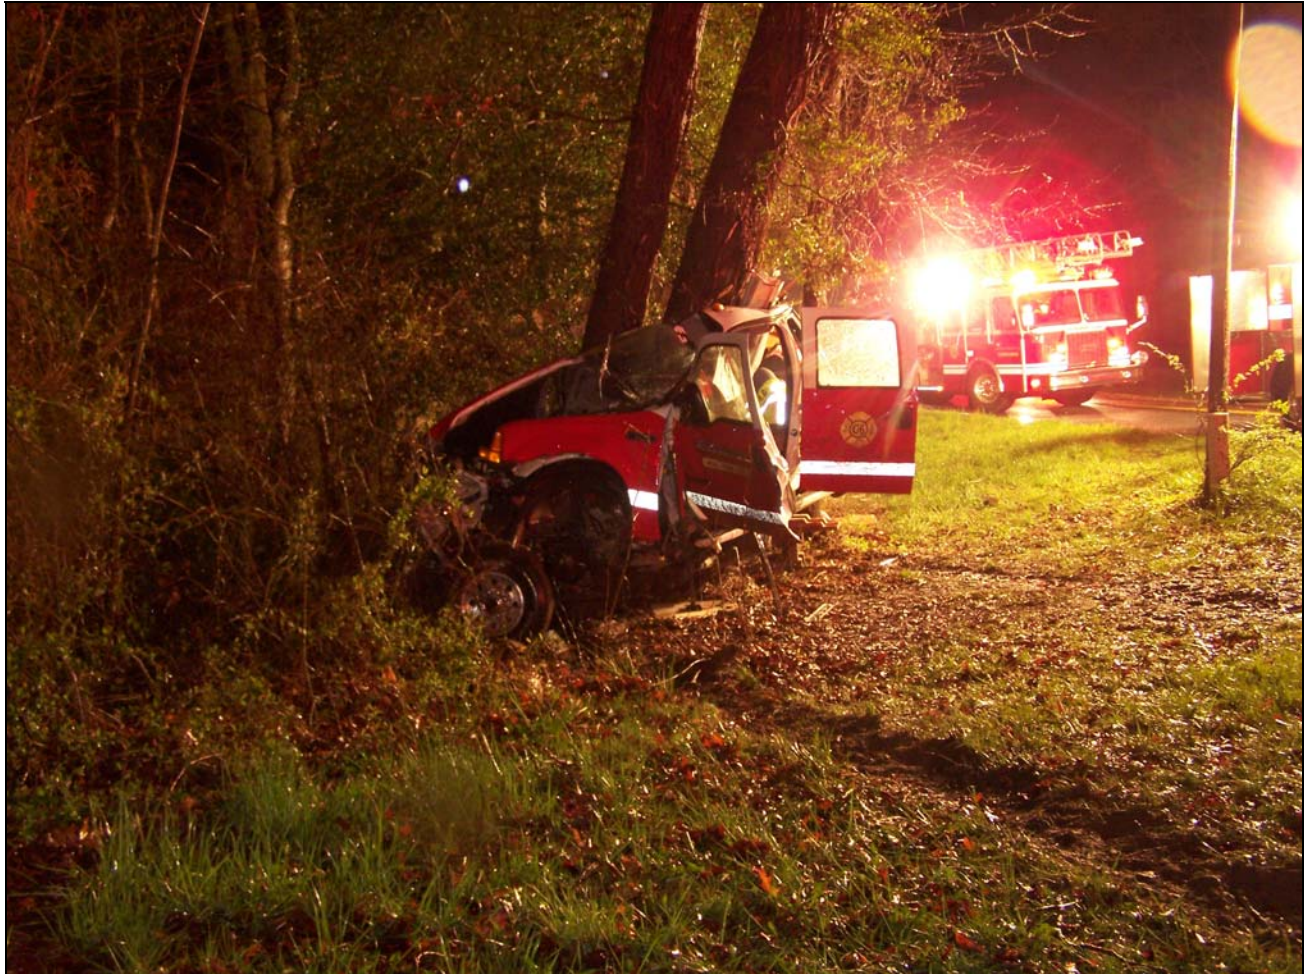
Photo 5.
Final location of victim's vehicle following collision with tree.
Photo courtesy of the County Sheriff's Office.

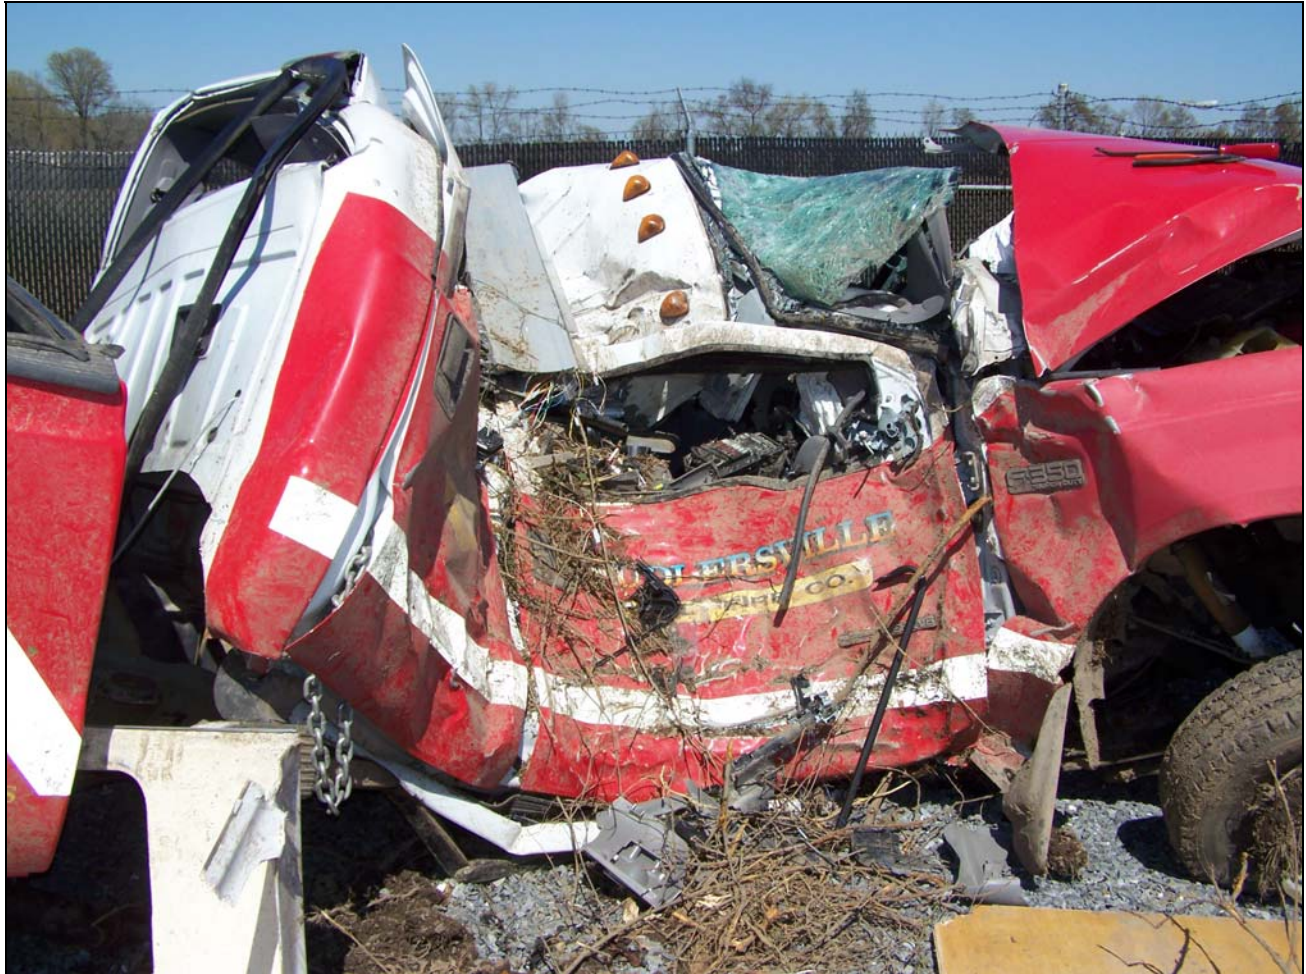
Photo 6
Passenger side of victim's vehicle that made contact with tree.
Photo courtesy of the County Sheriff's Office.

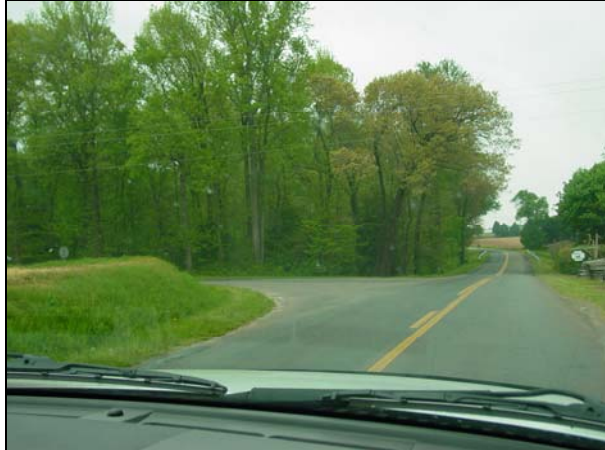
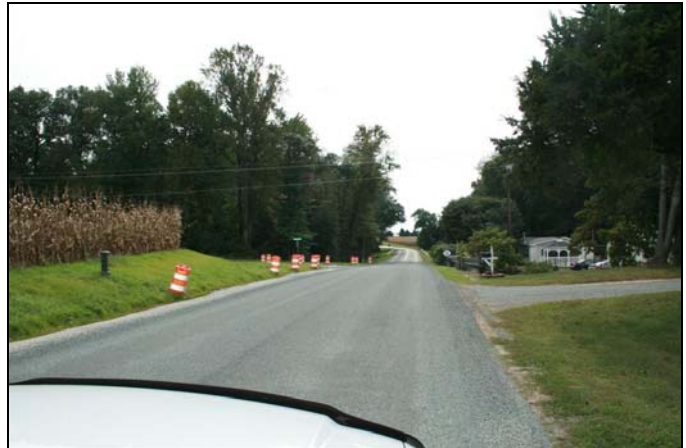
Photo 7.

Photos showing line-of-sight at the intersection before and after roadwork to improve visibility.

Viewed when traveling south on main highway.

Nationally recognized highway and transportation entities such as The American Association of State Highway and Transportation Officials (AASHTO),⁵ and the National Cooperative Highway Research Program (NCHRP),⁶ provide guidance on proper intersection design and methods to calculate safe line-of-sight distances at roadway intersections. Many state and local municipalities have developed specific ordinances outlining sight distance and roadway configuration recommendations for roadway intersections which are within their jurisdiction. *Note: The local County Highway Department has made changes to the intersection where the incident occurred. The embankment has been graded down, the stop sign was moved closer to the two intersecting roadways, and a white stop bar has been painted adjacent to the Stop sign on the intersecting roadway (see before and after photographs in Photo 7 & Photo 8).*

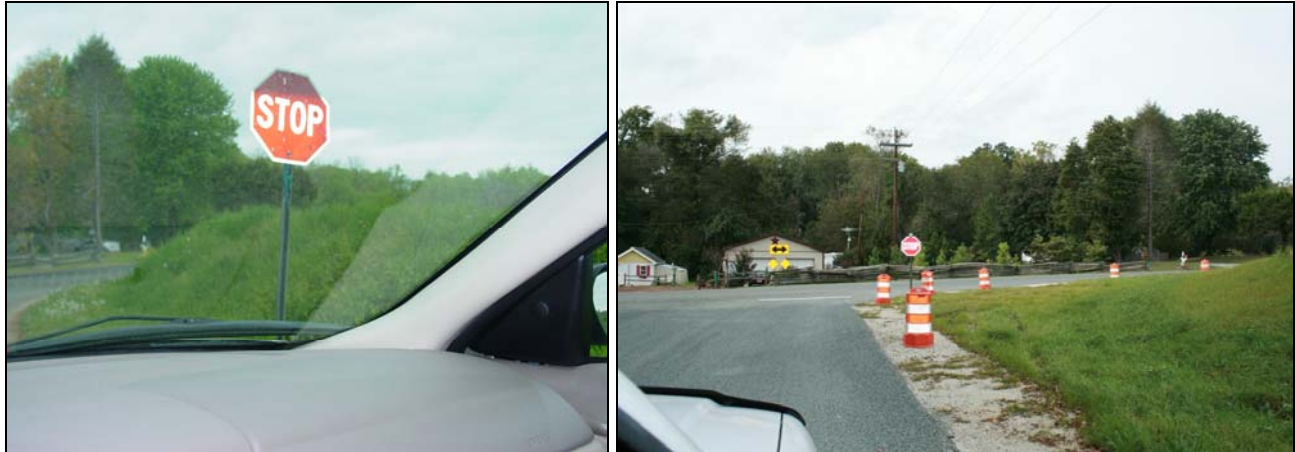
Photo 8.

Photos showing line-of-sight at the intersection before and after roadwork to improve visibility.

Viewed when traveling west on intersecting roadway.
