One Firefighter Killed and Two Firefighters Injured in Fire Apparatus Crash —Mississippi

Executive Summary

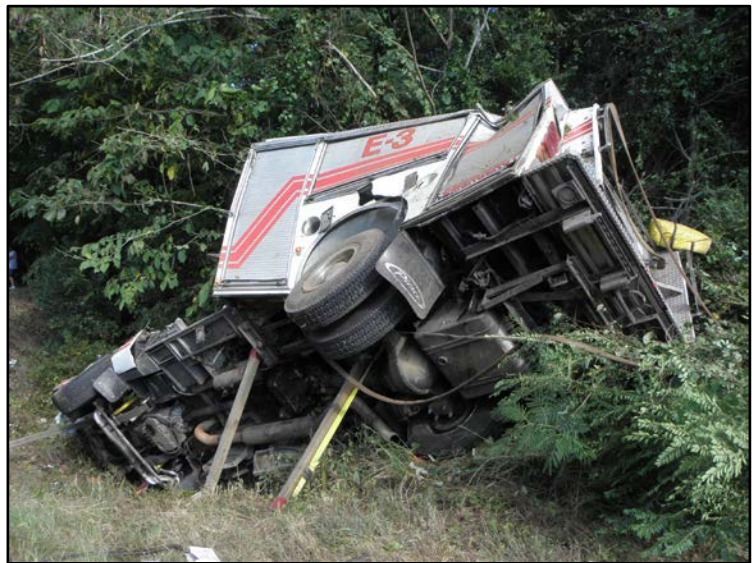
Engine 3 left the roadway and crashed into a large ditch on the right side on the roadway. (Photo by NIOSH)

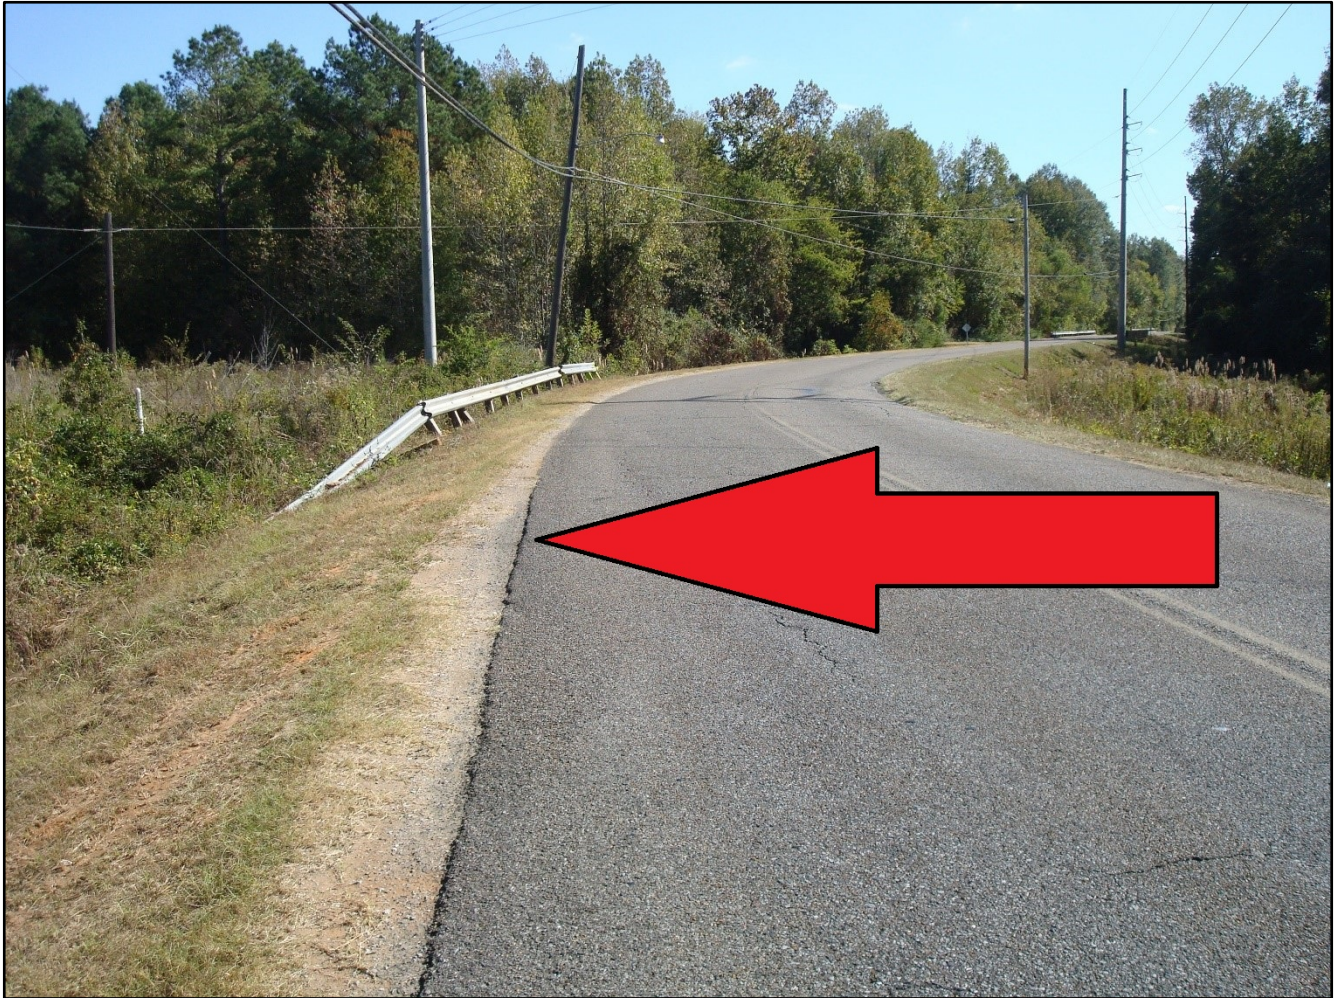
The road surface was reported as dry. The shoulder of the road falls away significantly into a deep ditch after exiting the curve and beyond the guardrail (see Photo 1). The unrepaired guardrail damage in the photo was reported by police as previous damage not related to this incident. The two-lane roadway has a posted speed limit of 40 miles per hour in this area and no recommended reduction in speed for the curve. There are curve-ahead warning signs in both directions approaching the curve. The local news, citing police sources, reported that several crashes had occurred on that stretch of roadway since 2006 claiming two lives.

Photo 1. Engine 3 left the roadway on the right side on the roadway just passed the guard rail, leaving tire track markings on shoulder. The damage to guard rail is from a previous crash.
(Photo by NIOSH)

In this incident, Engine 3 entered a left curve on a 2-lane asphalt roadway, failed to turn with the roadway (West bound), and ran off the right side of the road hitting a speed limit sign after coming out of the curve (See Photo 1). The apparatus’ right rear wheels were approximately 3 feet off the right side of the roadway and the driver was likely attempting to turn the truck back onto the roadway.

In this incident, the difficult road conditions encountered were a left curve after a bridge with very little shoulder and a very large ditch. This required a slowed controlled response after transitioning from a straight two lane 45 mile-per-hour roadway into the curve. There is very little roadway shoulder and recovery area in the area where the crash occurred. Although there were curve-ahead warning signs in both directions approaching the curve, there was no recommended reduction in speed for the curve. It was reported to the NIOSH investigator that there had been numerous crashes at this location in the past and in fact the guard rail showed evidence of a recent crash in the same curve area as this crash (See Photo 1).

Discussion: Authorities having jurisdiction should consider options such as recommended safe speed advisories for dangerous curves and/or conditions in roadways. Additional measures can also include extending guardrails (especially in situations where there is little or no shoulder) to keep vehicles from sliding down into a ditch if they were to run off the roadway. Rumble strips can also be used to provide an alert to drivers that they have or are getting ready to leave the roadway or crossing over the center of the roadway. The local news reported numerous crashes at the curve involved in this incident and the guardrail showed damage from a recent crash (See Photo 1).

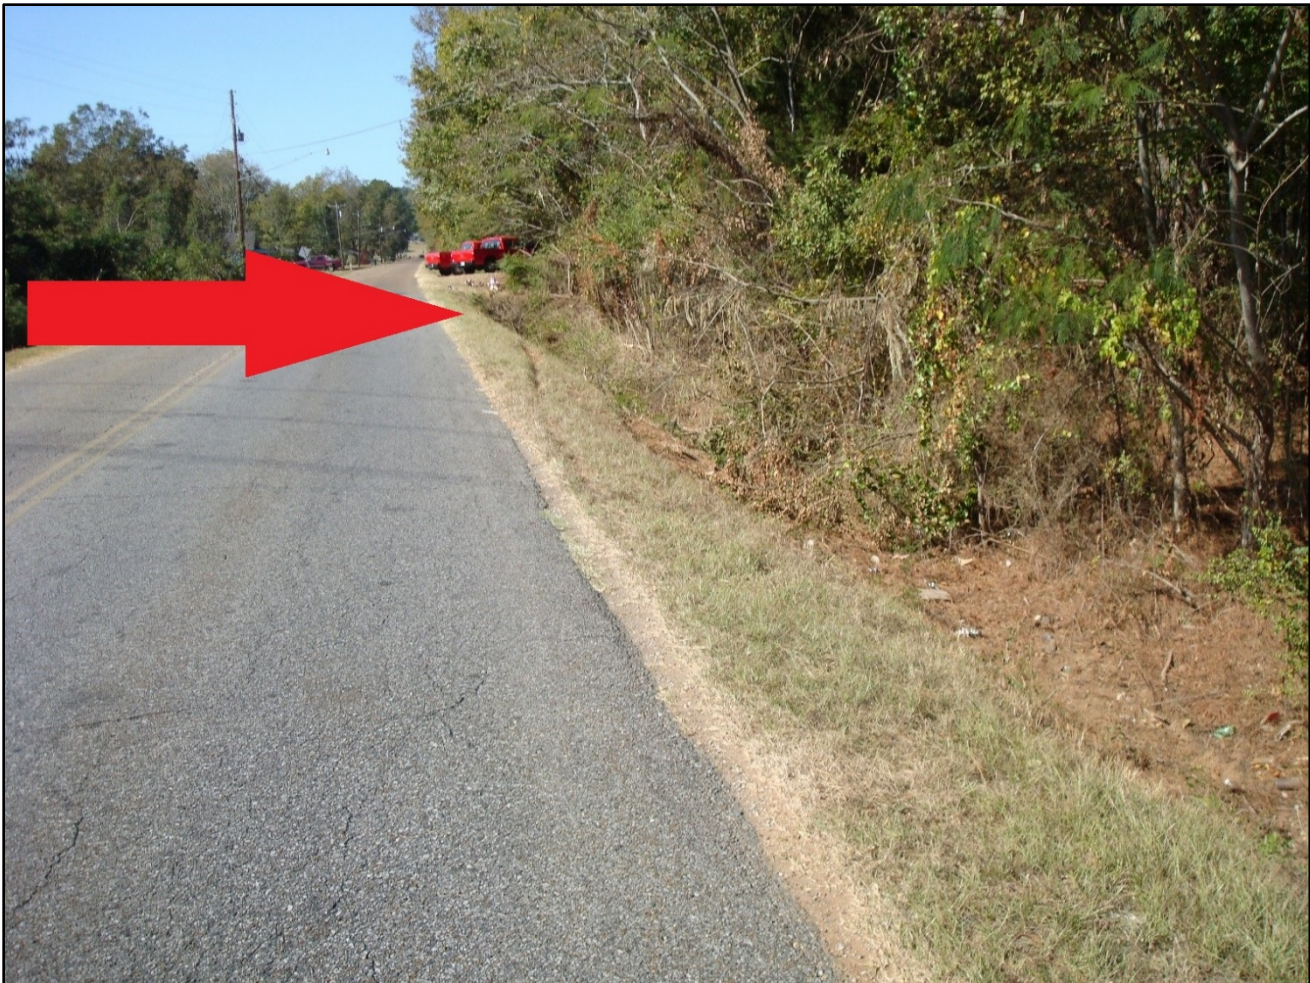
Photo 2. Engine 3 ran off the right side of the road into the ditch and then struck the berm causing the truck to roll over and an end over end flip. (Photo by NIOSH)

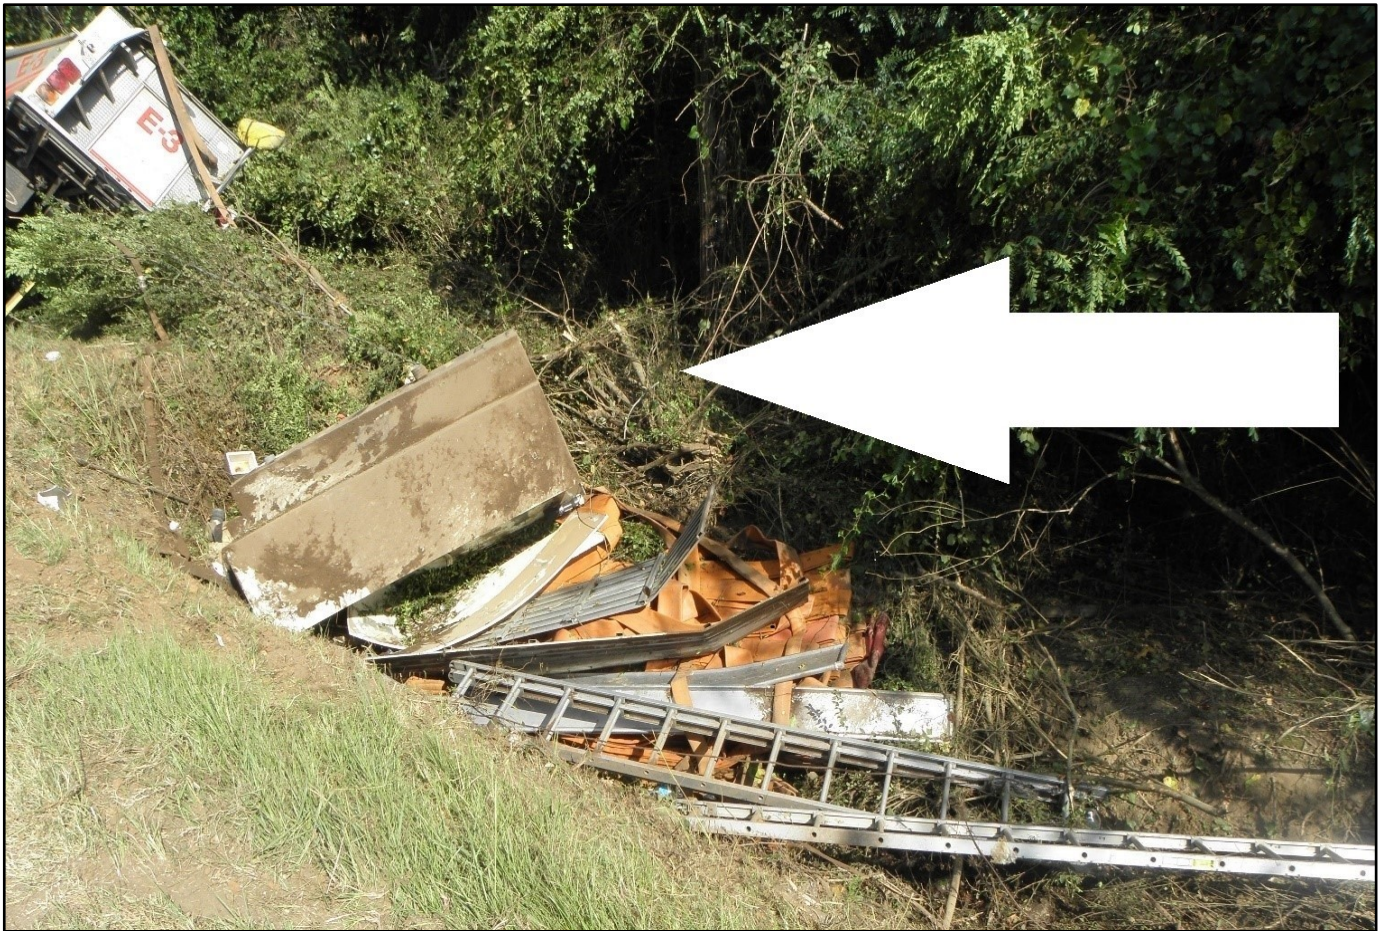
The roof of the cab of the truck was torn off and the 1,000 gallon water tank and multiple pieces of equipment and hose were separated from the truck, and scattered about the crash scene (See Photo 3).

Photo 3. Engine 3’s water tank, hose and equipment that were ejected during the roll over and end over end flip. (Photo courtesy of the fire department)

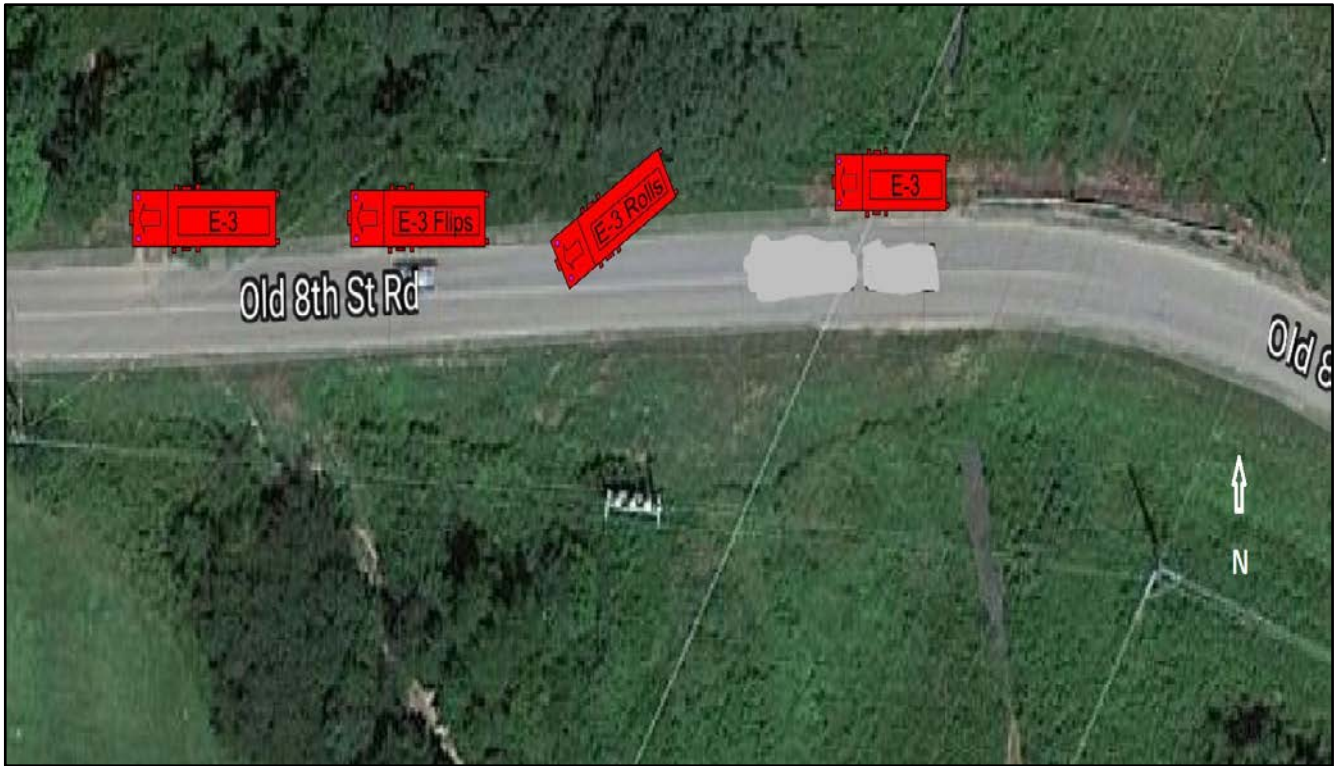
Much of the following description is taken from the police accident reconstruction report. The reconstruction report noted that the truck failed to turn with the roadway running off the right edge of the roadway. According to the police report it appeared that the driver was attempting to turn the truck back onto the roadway with the right wheel approximately 3 feet off the roadway. The rear of Engine 3 then began to go down into the ditch. The right front wheel re-entered the roadway as the right rear of Engine 3 rotated counterclockwise. The Engine 3 rear wheels then dug into the ground and caused Engine 3 to begin rolling side to side (rolling clockwise). While still rolling and upside down, the rear portion of the apparatus on the driver's side struck a tree which caused the water tank to be knocked out of the bed of the truck. The impact with the tree had enough force and angle to cause Engine 3 to catapult end over end while still rolling over in a clockwise direction. During the end over end flipping, the passenger side front corner of Engine 3 struck the side of the berm “with such force that it caused the cab of the truck to pop off of the engine” (See Photos 4 and 5). According to the police accident reconstruction report, “This violently threw Engine 3 over the berm” (See Diagram 1).

Diagram 1. showing the direction of travel and area where the crash occurred. Not to scale.
(Photo Courtesy of Google Earth/adaptation by NIOSH)

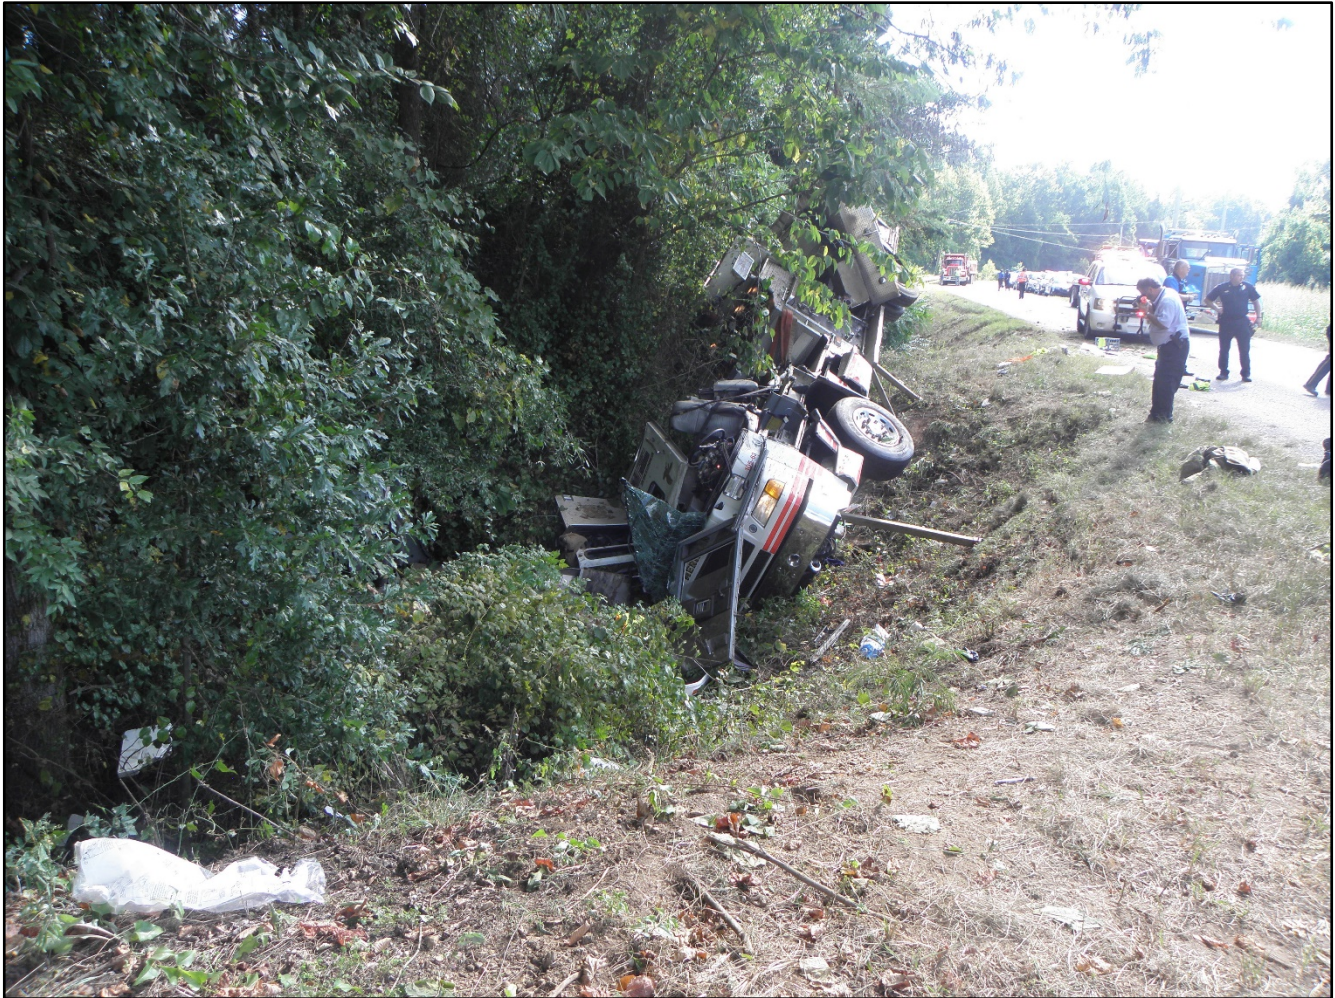
Photo 4. Engine 3 position after rolling and flipping end over end. The roof of the cab was torn off in the crash and not cut off by emergency workers. (Photo courtesy of the fire department)

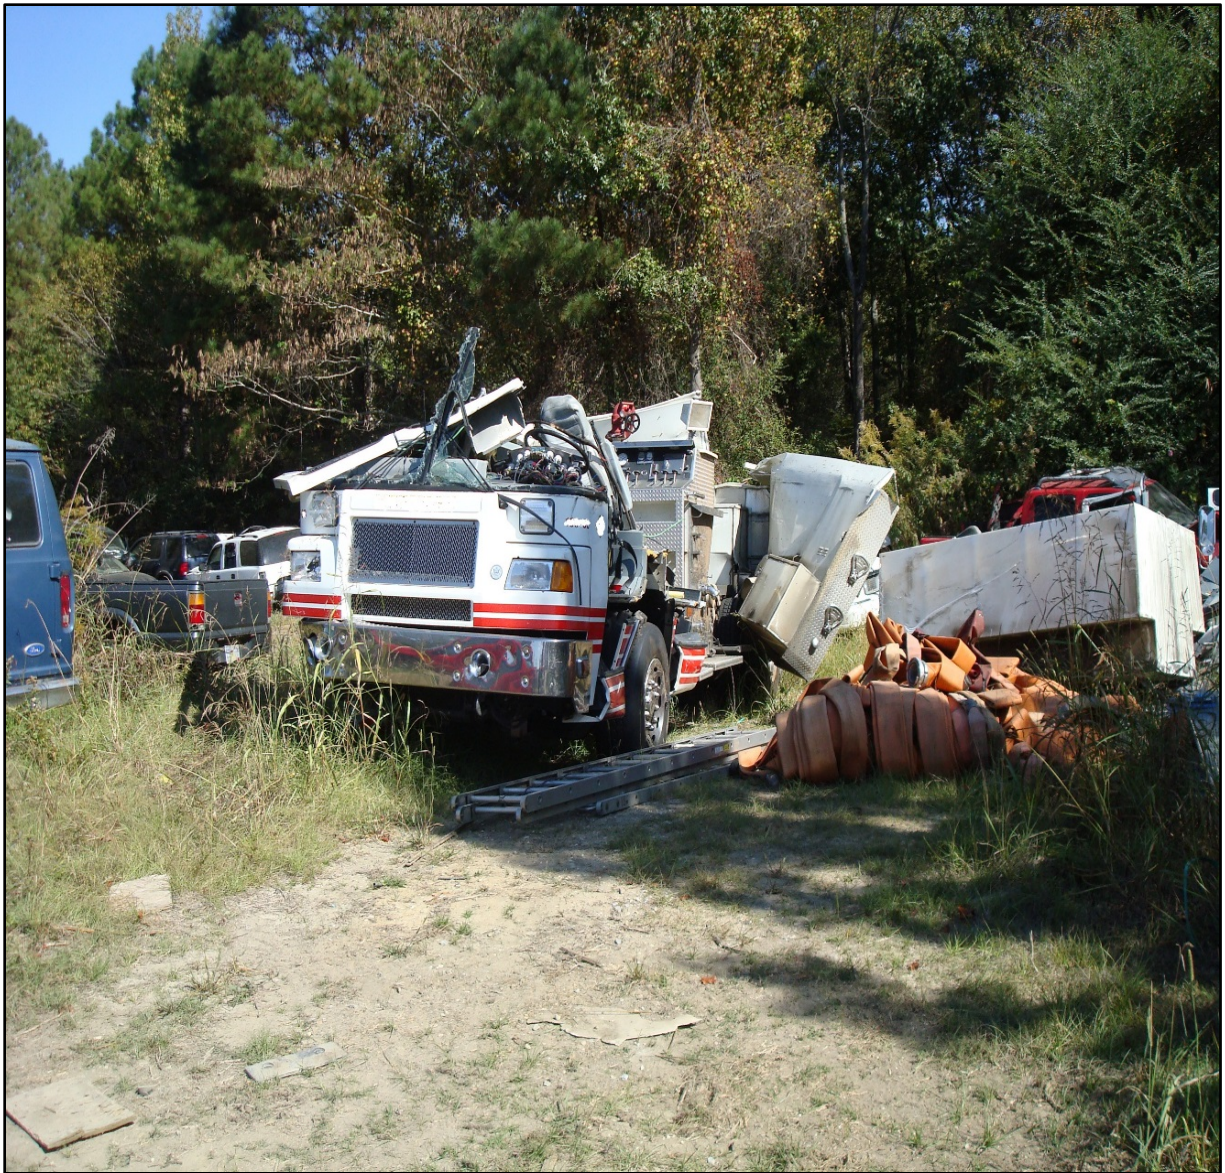
Photo 5. Engine 3 in the locality’s storage facility after removal. Note that the damage shown in photo is not due to extrication procedures, rather from the rollover and end over end flipping.
(Photo by NIOSH)

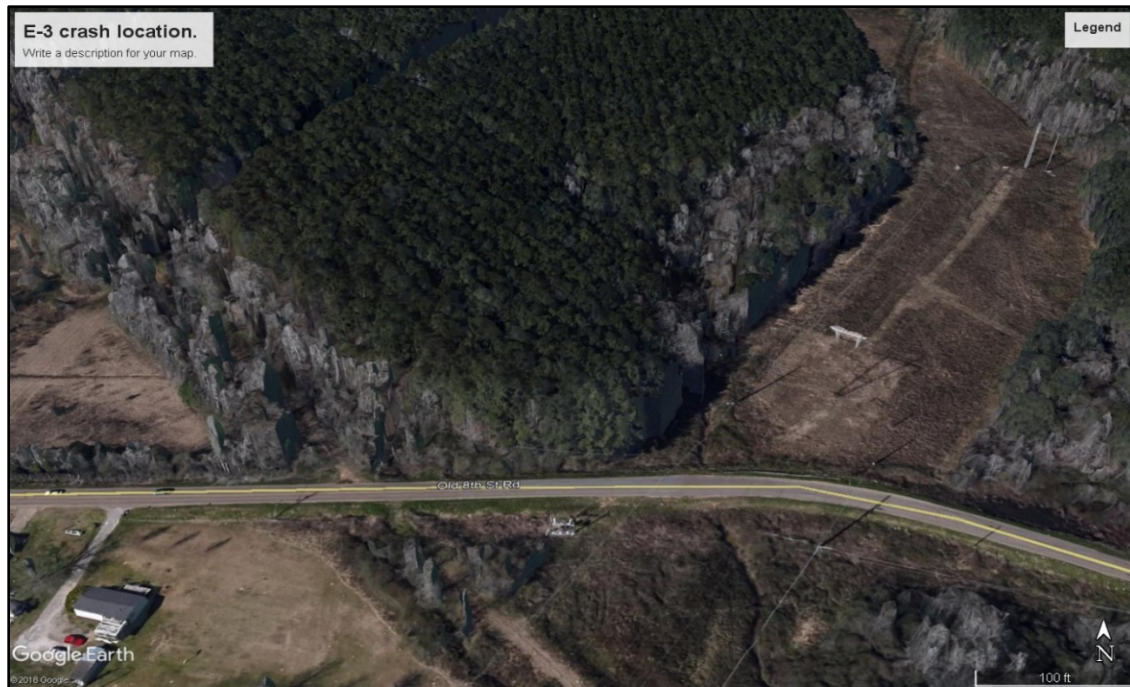
Photo 6. Overview of Crash Site, courtesy Google Earth.

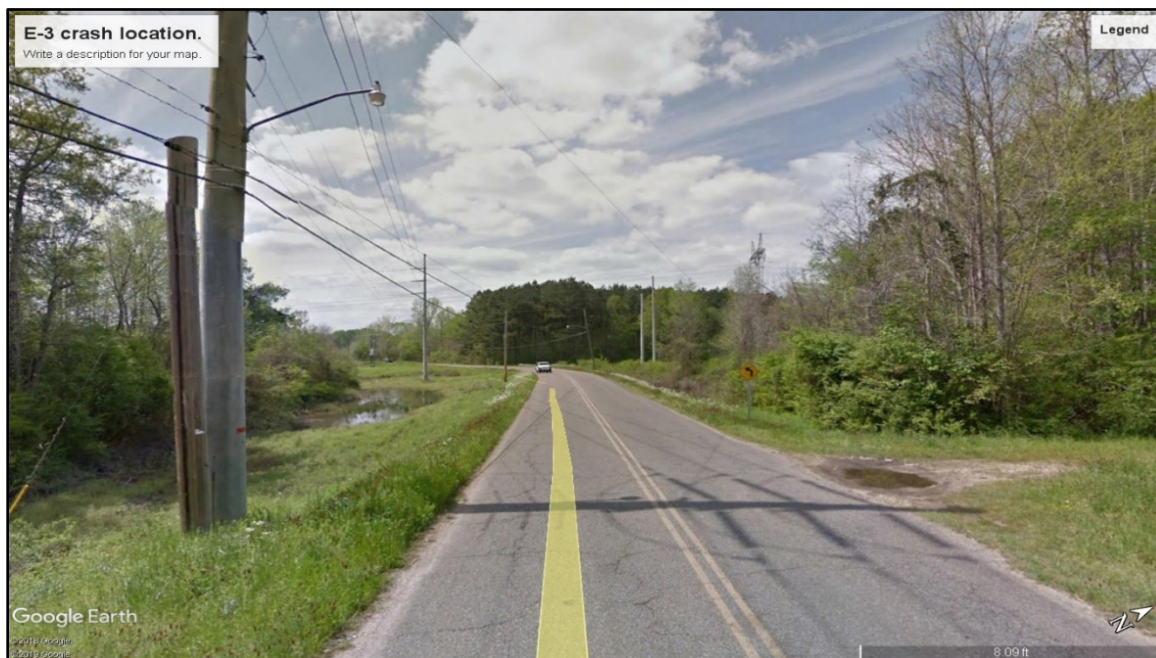
Photo 7. Curve ahead sign, but no recommended reduction in speed limit for the curve, courtesy Google Earth.
