Career Fire Fighter Dies and Another is Seriously Burned Fighting Arson Fire at a Commercial Strip Mall — Texas

Executive Summary

On May 18, 2017, a 31-year-old male career fire fighter died after fire conditions rapidly deteriorated inside a commercial strip mall.

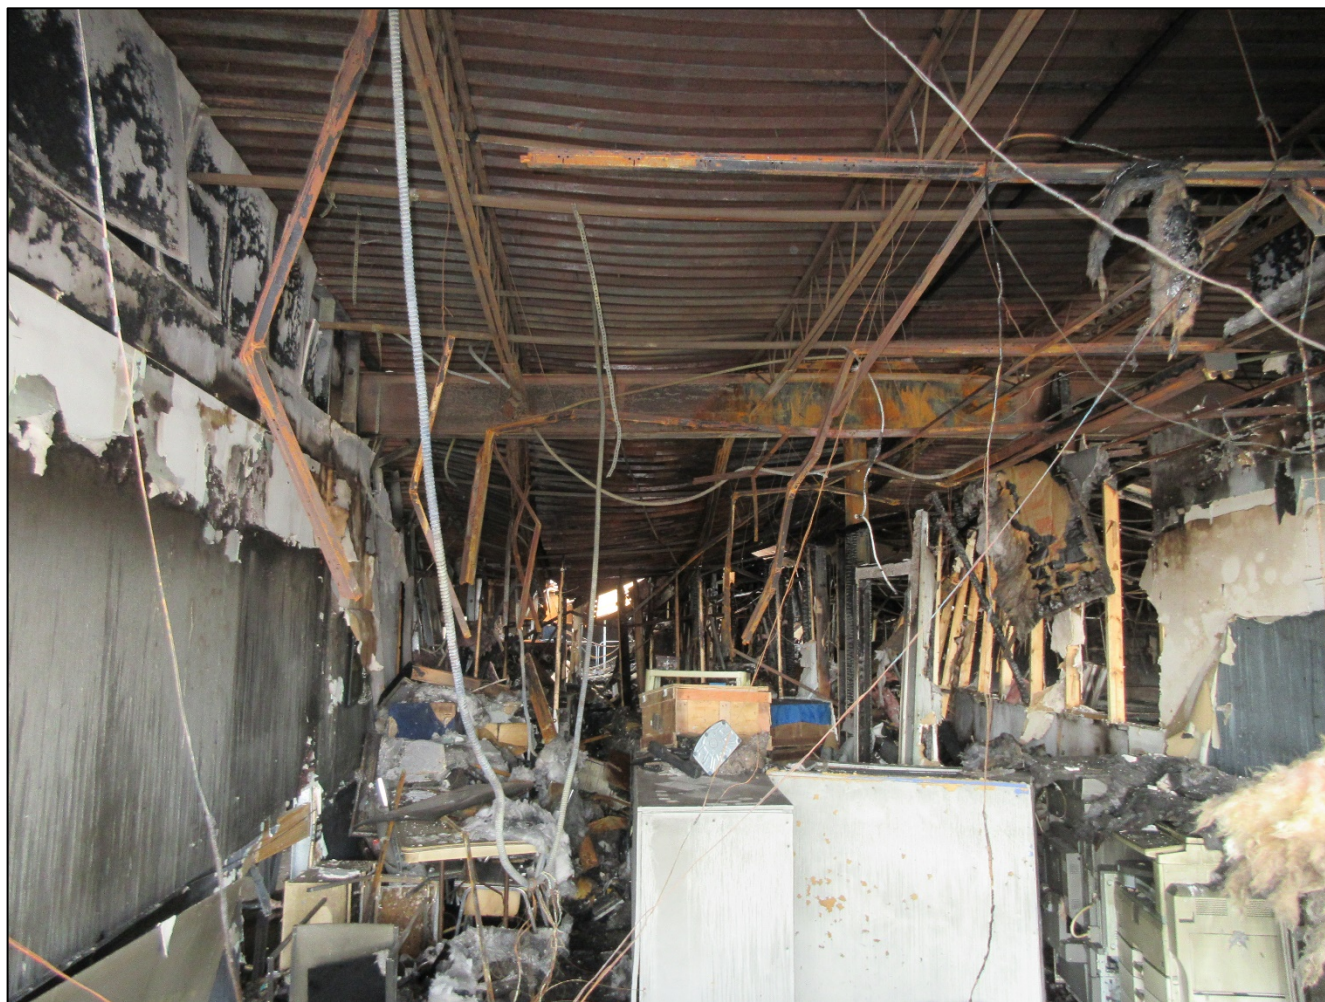
Photo 2. Interior of Side Delta exposure (computer business), looking from Side Alpha to Side Delta. Note roof support features including lightweight metal bar joists running from front to back supporting corrugated metal roof decking.

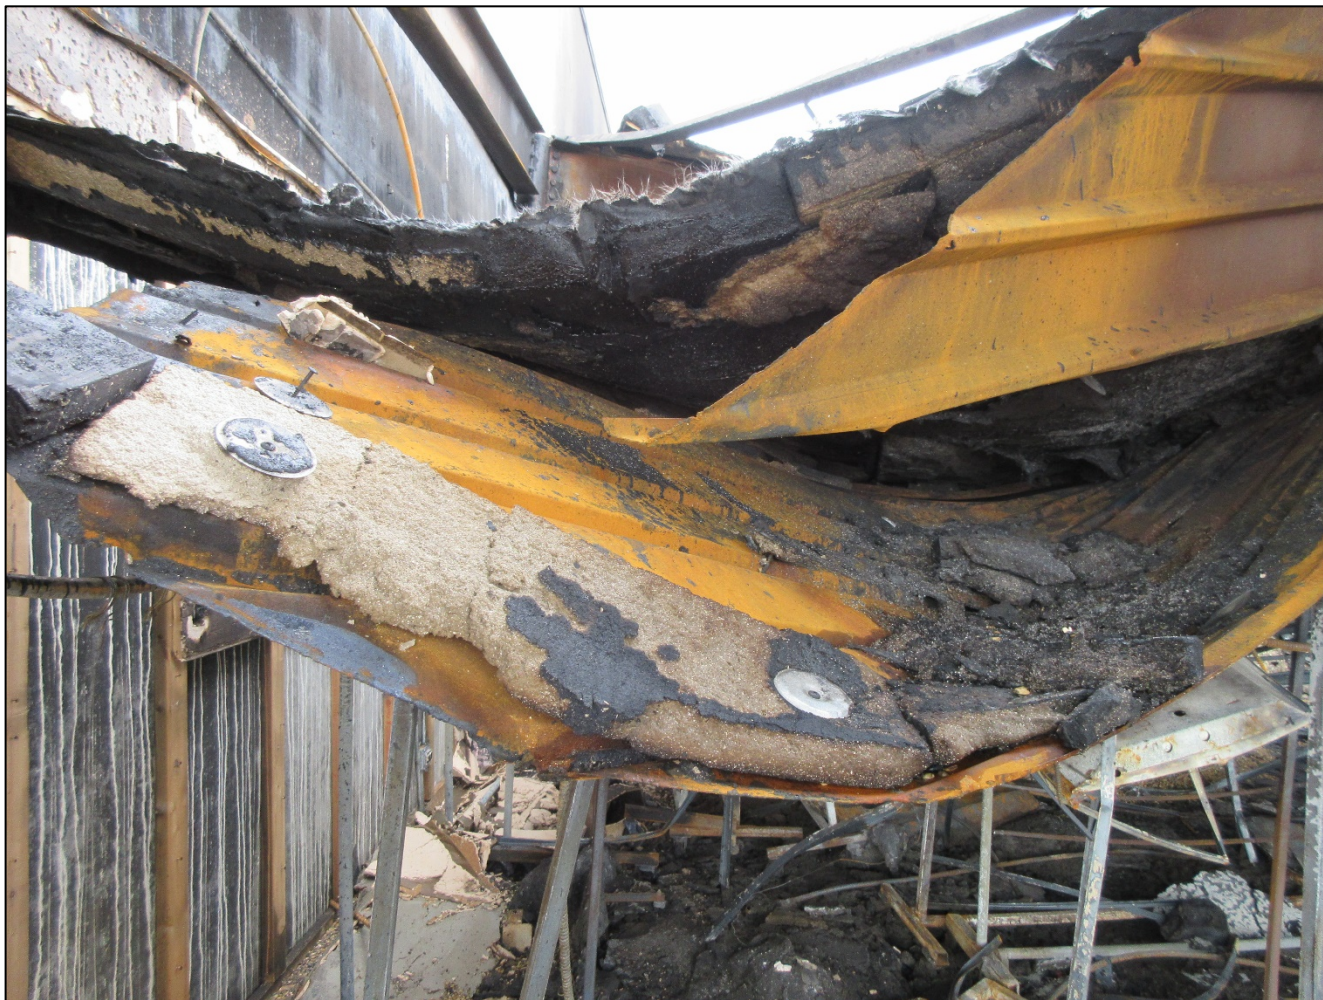
Photo 3. Close-up showing construction features of flat metal roof. Note layers of foam, waterproof membrane and asphalt.
(NIOSH Photo)

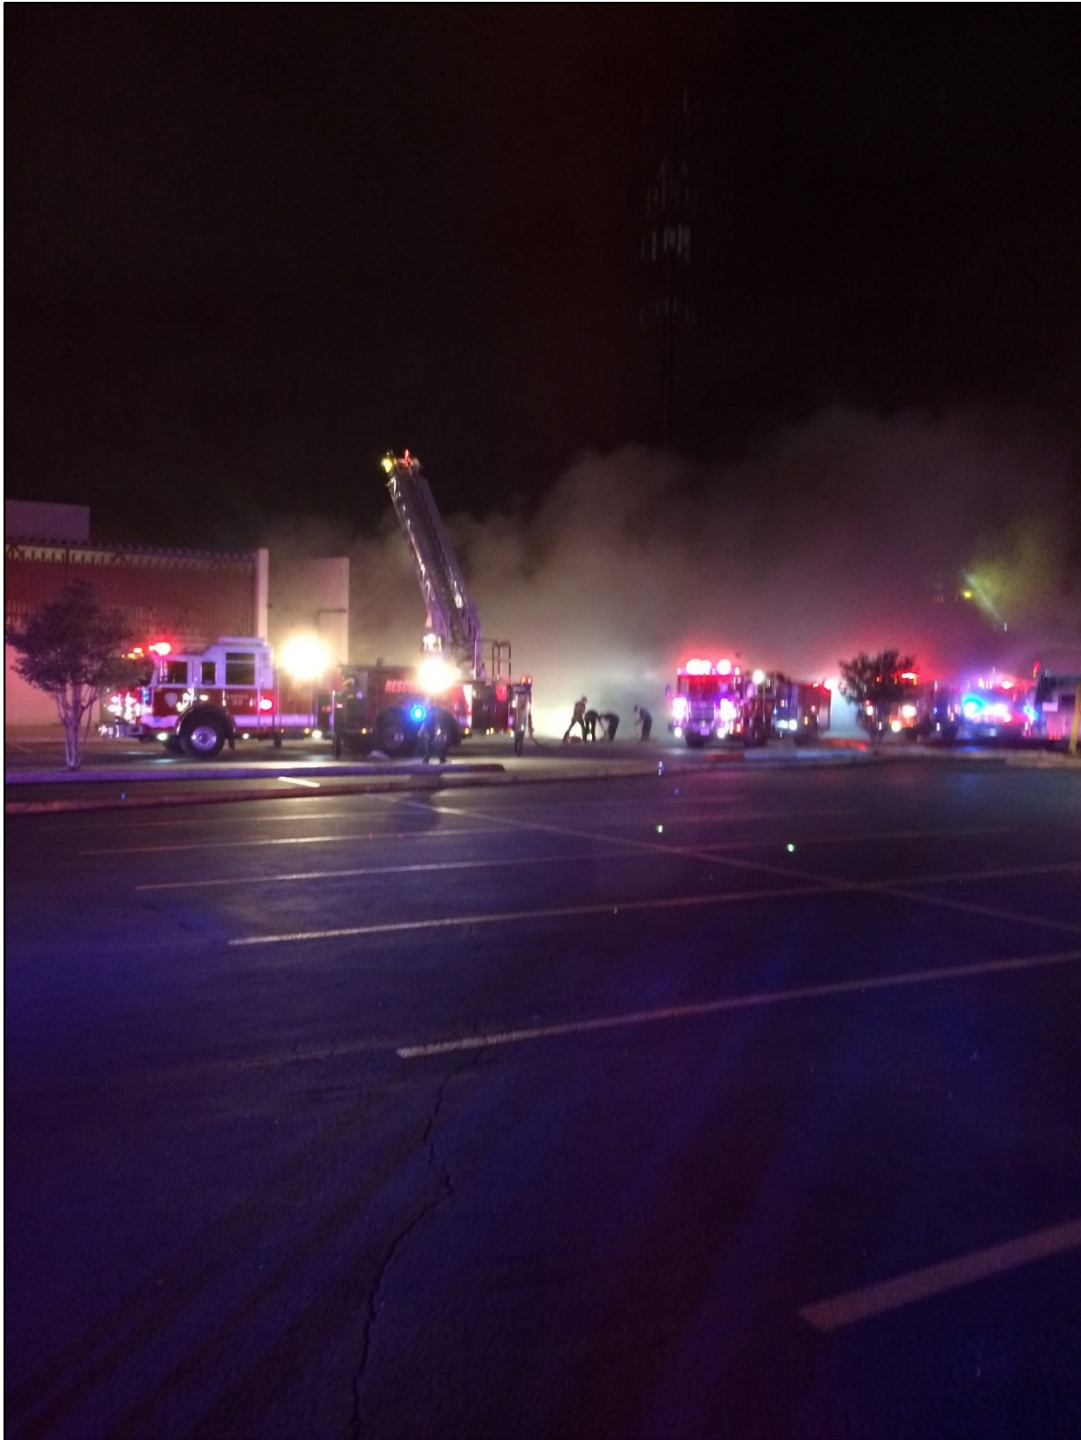
Photo 4. Incident scene. Note heavy smoke conditions on Side Alpha. Ladder 35 and Engine 35 are visible in center of photo.
(Photo provided by Fire Department member)

At 2135:38 hours, Battalion Chief 8 advised Command that two fire fighters from Ladder 35 were trapped inside and their location was unknown at this time. He also reported that conditions inside were starting to get very hot and RIT crews were staged on the Leeward side (sheltered from the wind) of the building to be sheltered from the smoke. Command acknowledged the report from Battalion Chief 8. *Note: Winds blowing from the Southeast at 17-24 miles per hour caused heavy smoke conditions in front of the fire building (see Photo 4 and Diagram 2).*

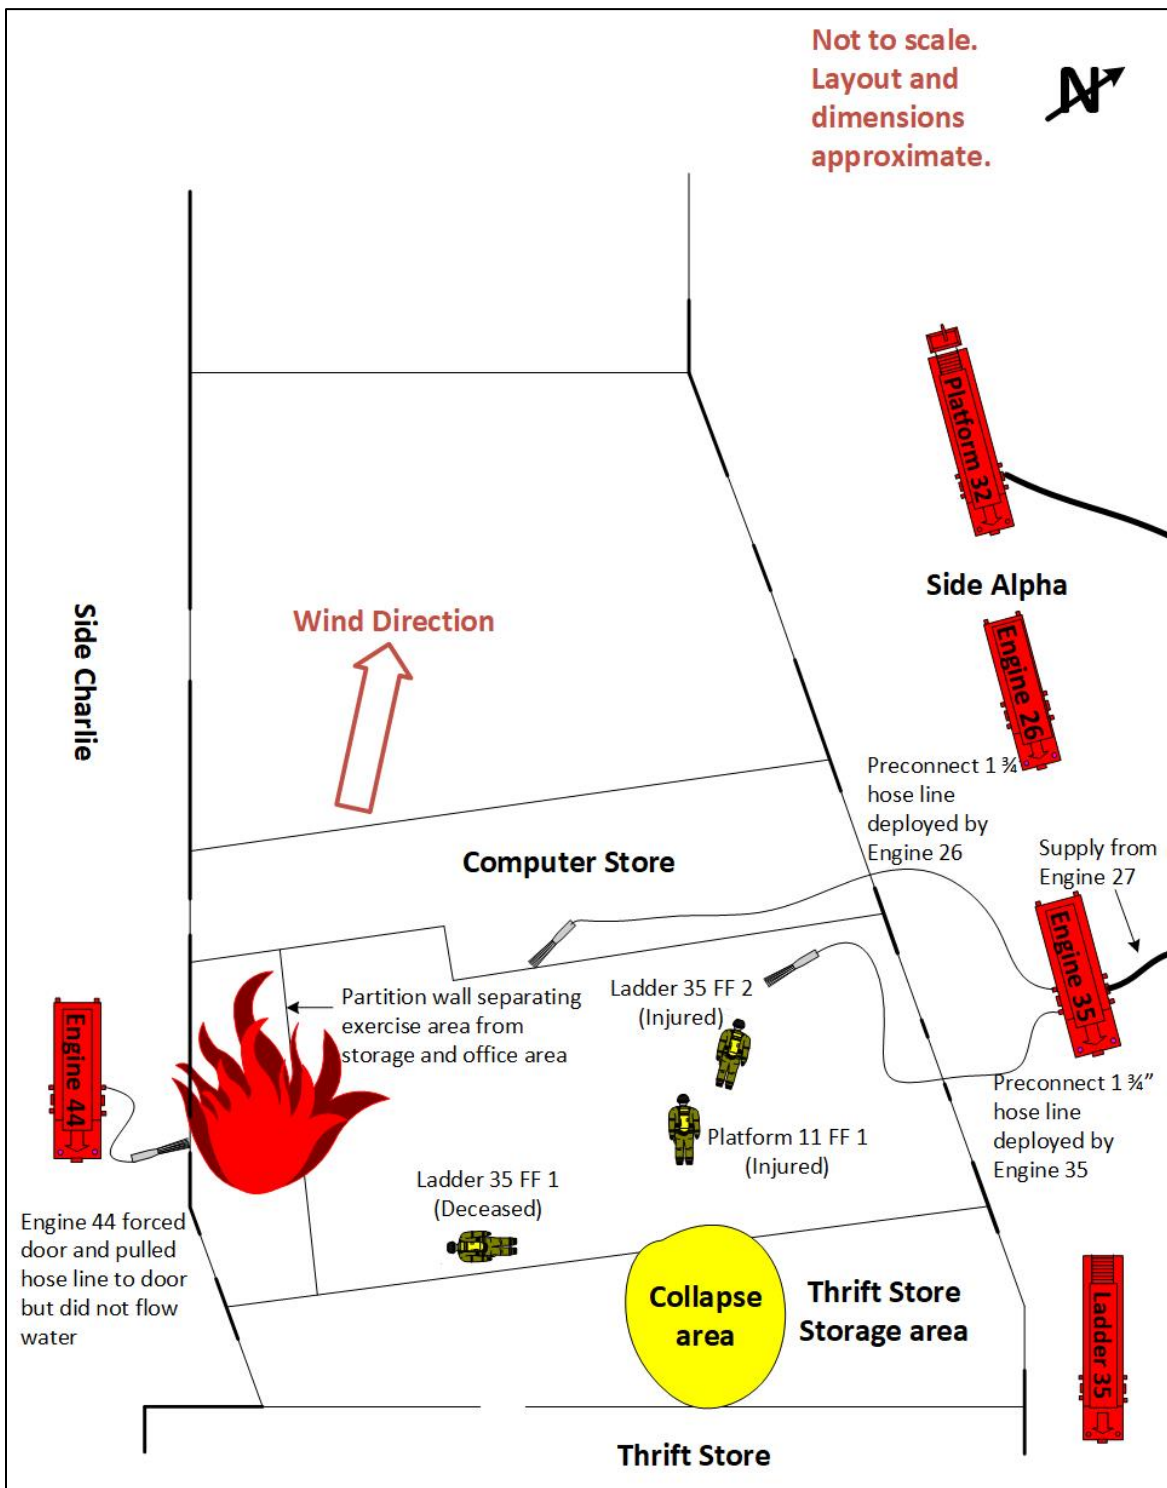
Diagram 2. Incident scene. Note locations of injured fire fighters.

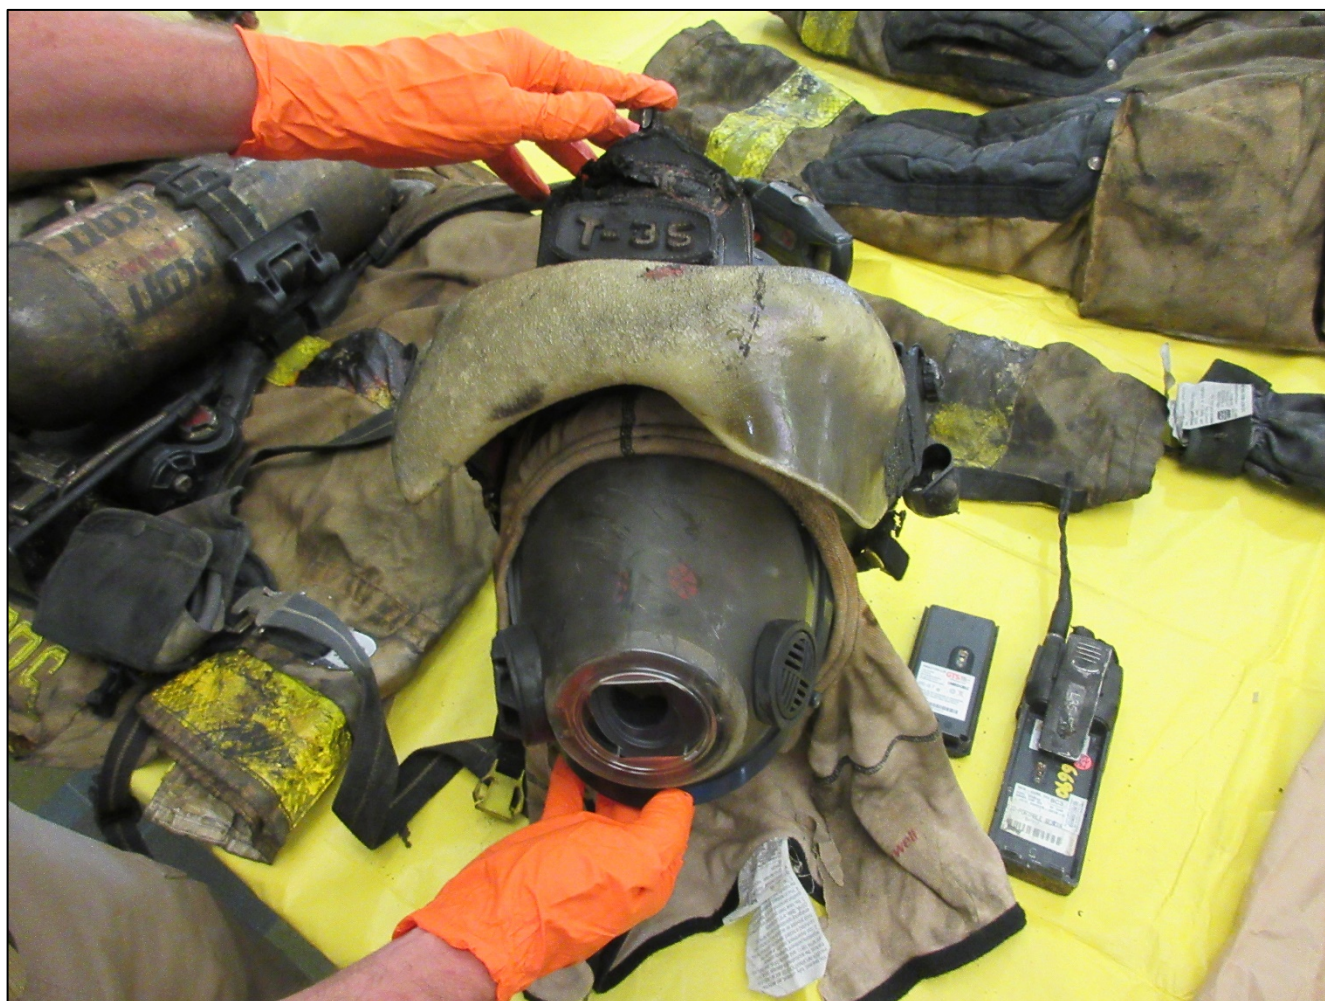
The following photograph is provided as a teaching-aid to highlight the fact that NIOSH and National Fire Protection Association (NFPA) certified self-contained breathing apparatus and personal protective equipment can only protect fire fighters for a limited amount of time. Extreme fire events often result in thermal conditions that will compromise a fire fighter's protective clothing and gear which can lead to injury and death (see Photo 5).

Photo 5. Photo shows thermal damage to the facepiece, helmet and hood worn by the injured Ladder 35 fire fighter. Similar damage has been observed on numerous NIOSH investigations. (NIOSH Photo.)
