**LINE OF DUTY
DEATH REPORT
REPORT SLIDES**

F2021-10

**Volunteer Firefighter Killed after
Becoming Trapped at an
Assisted Living Facility Fire and
Two Firefighters Injured – New
York**

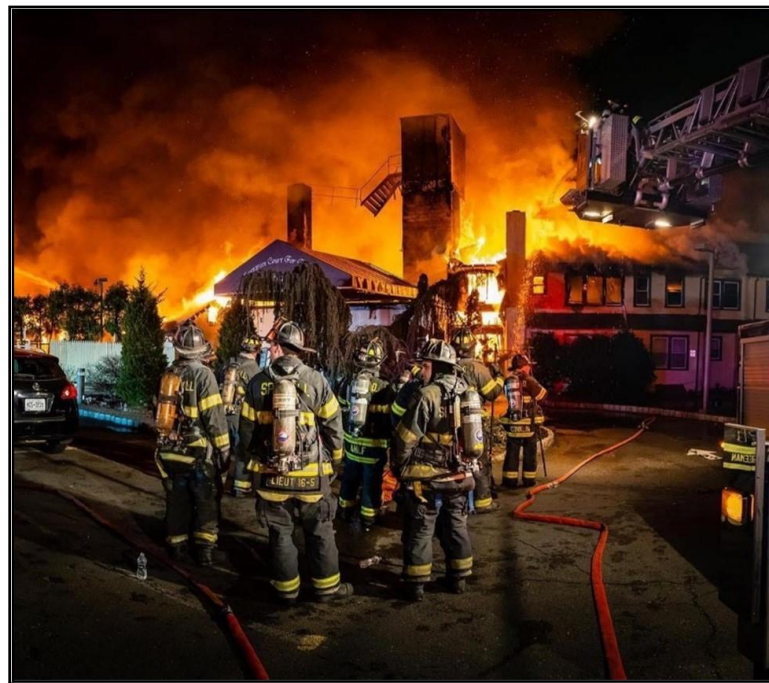
The collapse of Side Alpha/Side Bravo corner at 03:01 hours of the assisted living facility.
(Photo courtesy of Kenneth Flynn)

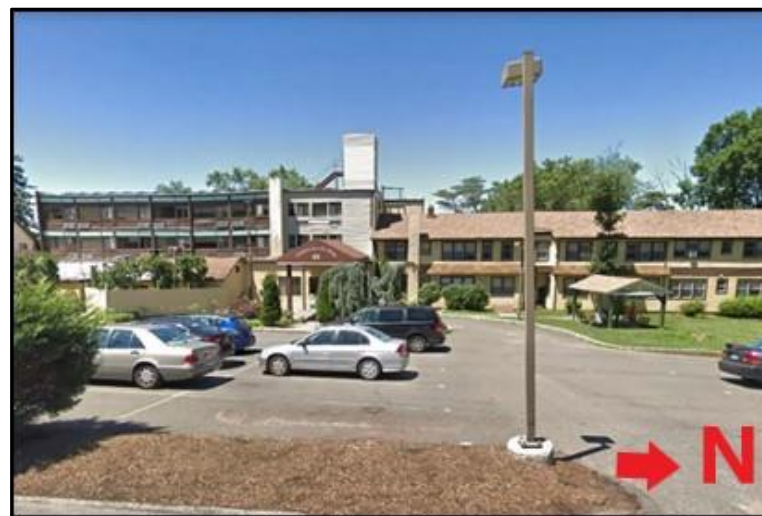
Side Alpha of the assisted living facility.
(Photo courtesy of the New York Post)

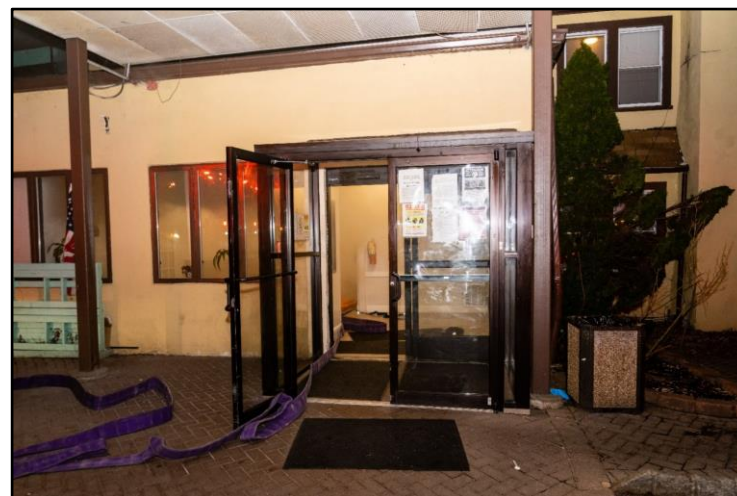
Photograph of smoke condition observed in the lobby. The 3-inch hoseline from Tanker 17 was stretched up the stairwell to the 2nd floor. The time was approximately 01:12 hours. (Photograph courtesy of Kenneth Flynn)

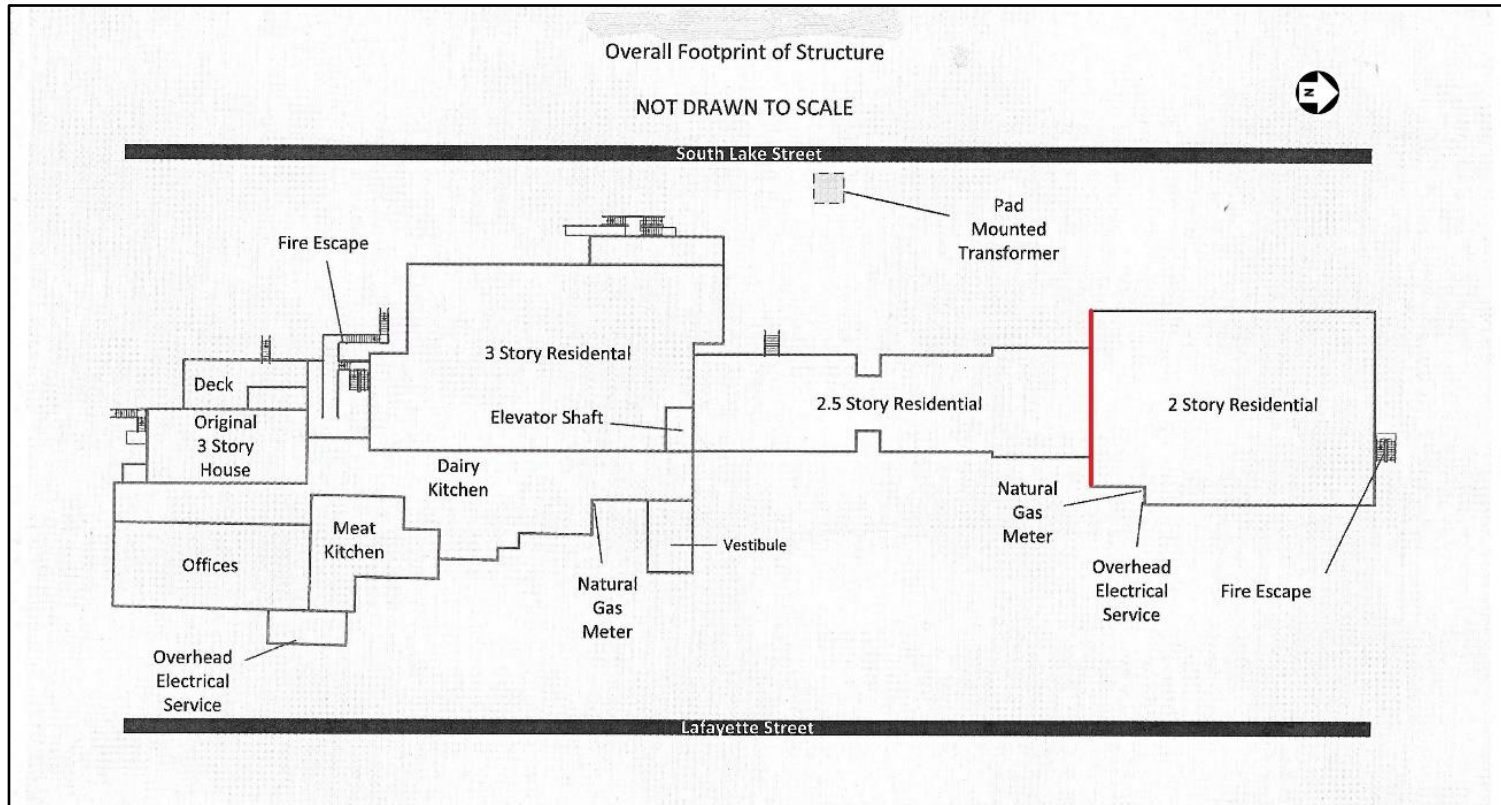
The site plan of the assisted living facility. The red line indicates the firewall between the 2½-story and 2-story buildings which prevented fire spread. (Photo courtesy of the NY Office of the State Fire Marshal)

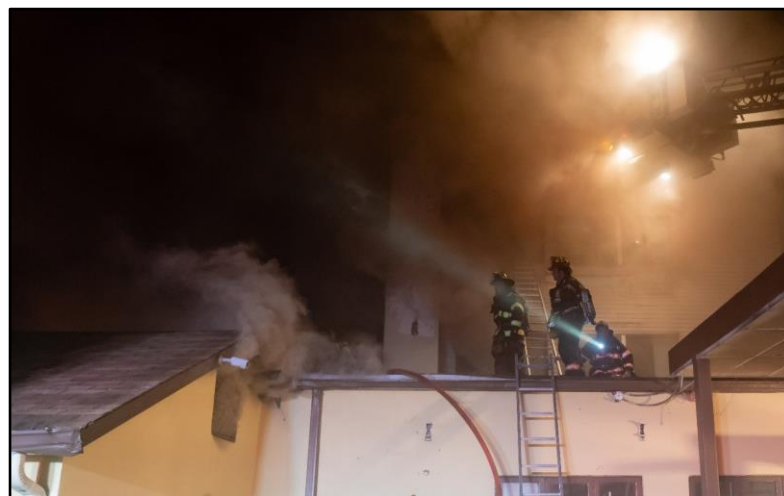
Firefighters using a ground ladder and Quint 17 trying to reach the occupant in Room 306. The time was approximately 01:51 hours. (Photo courtesy of Kenneth Flynn)

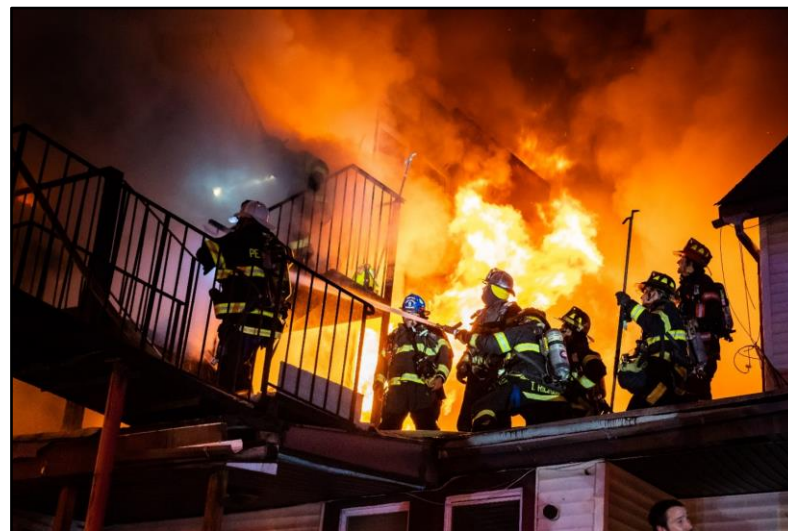
Firefighters on dairy kitchen roof using a hoseline to protect firefighters coming down from fire escape, 02:00 hours. (Photo Courtesy of Kenneth Flynn)

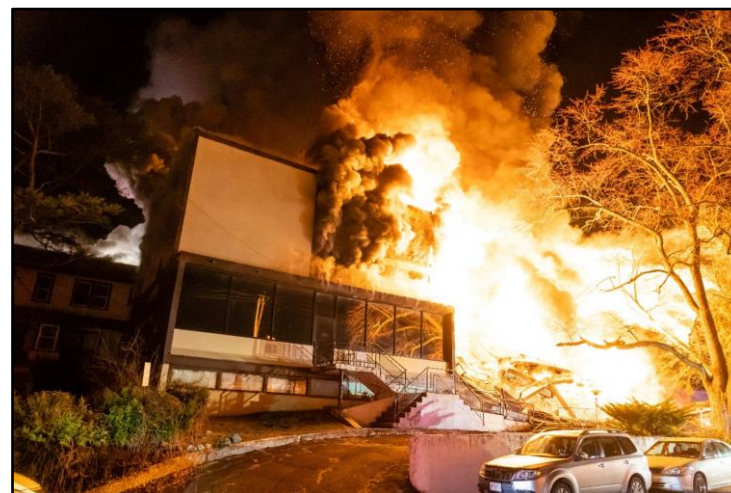
The cantilever collapse of Side Bravo/Side Charlie corner of the original building. The time was approximately 02:08 hours.
(Photo Courtesy of Kenneth Flynn)
