**LINE OF DUTY
DEATH REPORT
REPORT SLIDES**

F2022-04

Career Firefighter Killed in a Structural Collapse While Conducting Fire Attack and Search in a Derelict Single-Family Residence – Missouri

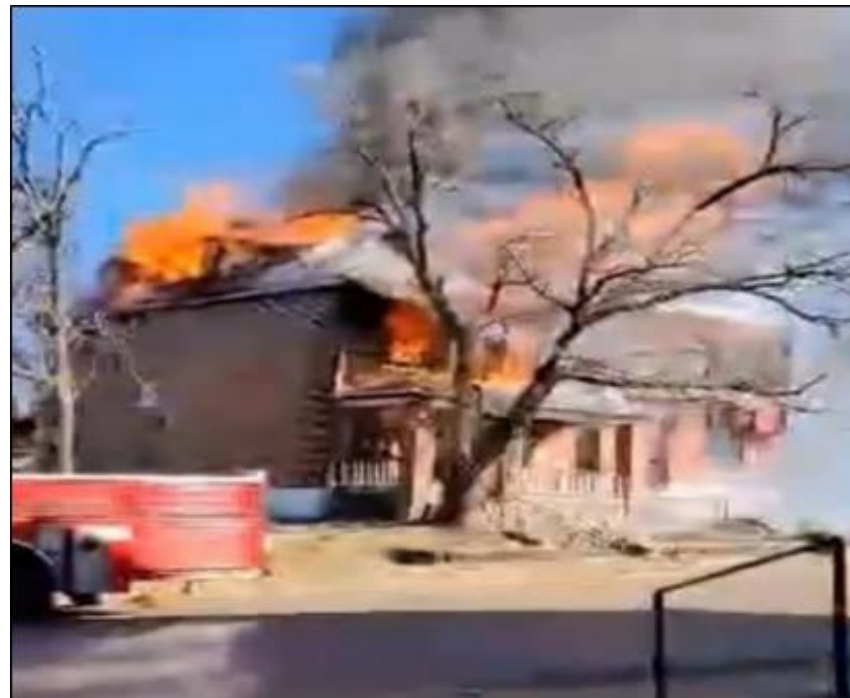
Conditions on the arrival of Truck 13 showing post flashover fire conditions throughout the second and third floors. Photo courtesy of FD.

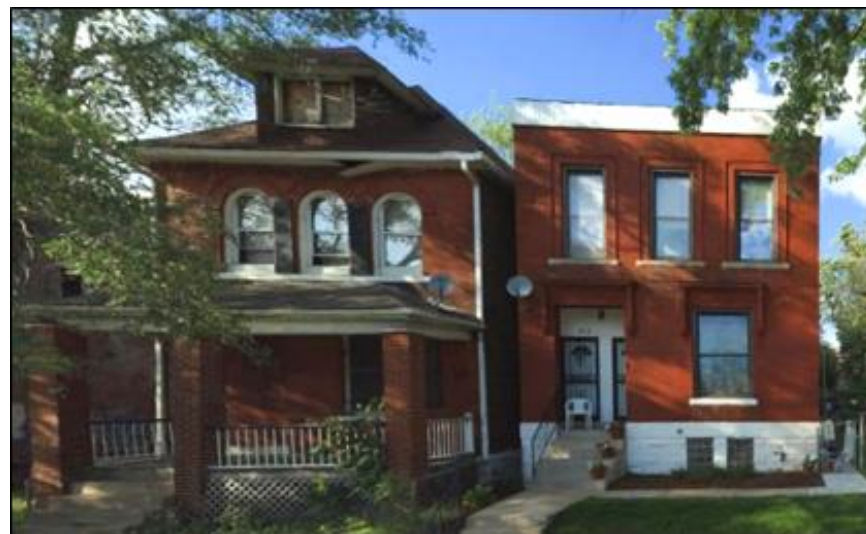
Fire building on the left, and the Side Delta exposure on the right, showing pre-fire conditions. Note indications of the fire building being a derelict structure with deteriorated conditions. Photo from Google Earth.

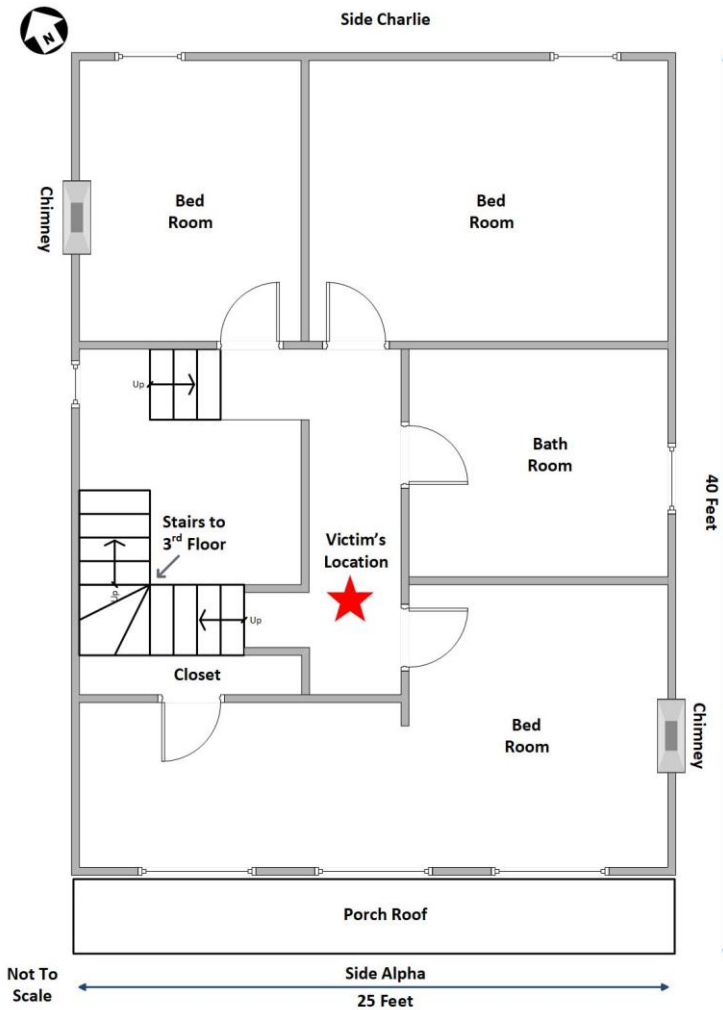
- Fire Alarm Dispatch reported hearing an open mic from the T-13B portable radio with no response at 11:52.
- Evidence from the investigation supports that a structural collapse of the area above the second floor occurred just prior to this time and it trapped T-13B on the second floor.

Second floor interior layout based on witness statements. Layout of the half story above the second floor is unknown.

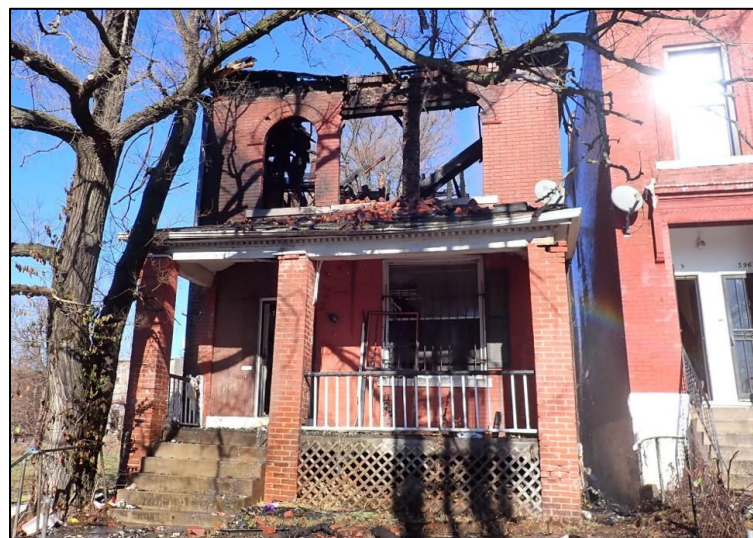
Side Alpha post fire conditions. Photo courtesy of FD.
