Evaluation of Indoor Environmental Quality Concerns Among Hospital Employees Working in a Radiology Department

HE Health Hazard
Evaluation Program

HHE Report No. 2016-0176-3326
September 2018

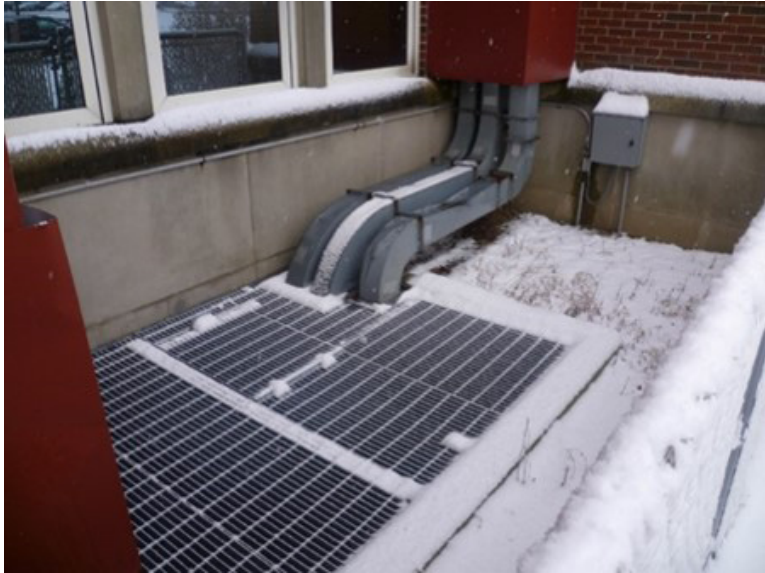
We found that the outdoor air intake for the Radiology Department was about 10 feet below grade in the front of the hospital (Appendix A, Figure A1). It was located about 25 feet from pollutant sources such as exhaust from idling buses at the bus stop and vehicles dropping off and picking up individuals (Figure A2). We found snow in the ductwork of the outdoor air intake near the first set of air filters (Figure A3). The resulting moisture had caused the filters to become misshapen, resulting in air leakage around the filters (Figure A4). The filters were heavily loaded with dust, which means that they needed to be replaced. We found that the gaskets around the two filter banks and the HVAC doors were missing or broken, which contributed to air leakage around the filters (Figure A5). A dent in the second door at the HVAC unit prevented the door from sealing properly to the HVAC unit and allowed air to escape from the unit. We found particulates throughout the HVAC unit (Figure A6) including near the humidifier and cooling coils, which was located after the filter system. Debris and other particulates downstream of the filters in the HVAC system are evidence of ineffective filtration or leakage around air filters. We asked about but did not receive any information about a preventative maintenance program for the Radiology Department HVAC system.

Figure A1. Outdoor air intake for Radiology Department ventilation unit, which was below grade. Photo by NIOSH.

1. Replace the filters in the Radiology Department HVAC unit and repair or replace the HVAC system gaskets.
2. Consult with a licensed professional mechanical engineer to reconfigure the outdoor air for the two HVAC systems so that the two intakes are located 6 meters above ground level, as recommended by ASHRAE intakes for hospital and medical facilities [ASHRAE 2013].

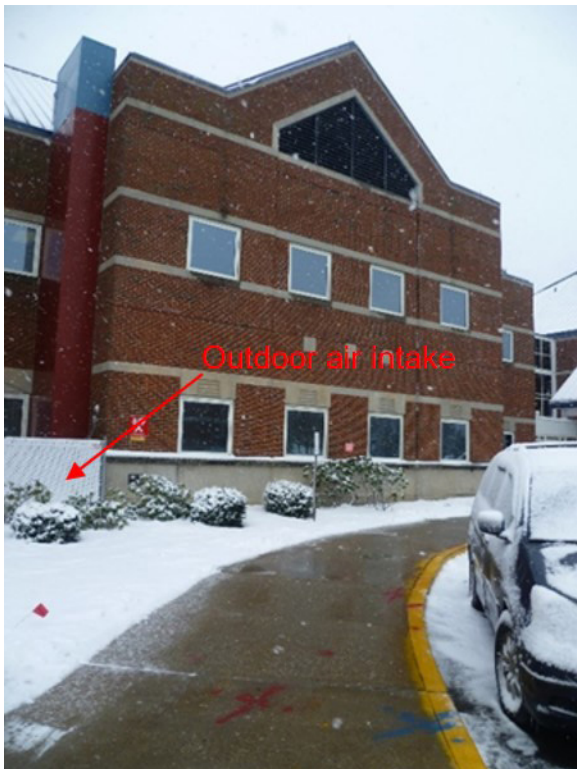
Figure A2. View of potential pollutant sources for outdoor air intake. Photo by NIOSH.

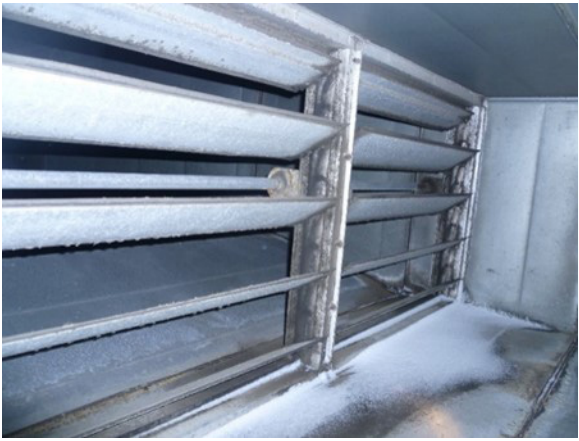
Figure A3. Snow on the downstream side of the outdoor air intake louvers of the Radiology Department HVAC unit. Photo by NIOSH.

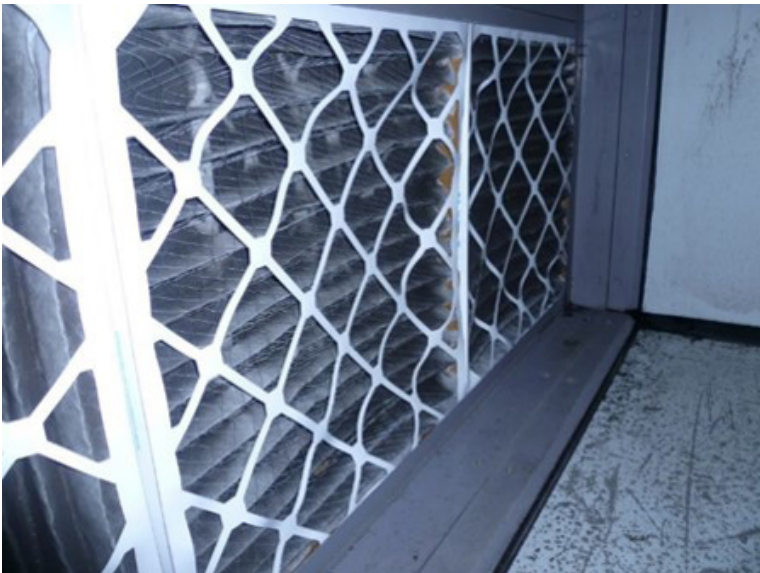
Figure A4. First bank of filters showing that the filters were bent, poorly fitting, and had damaged filter frames due to moisture. Photo by NIOSH.

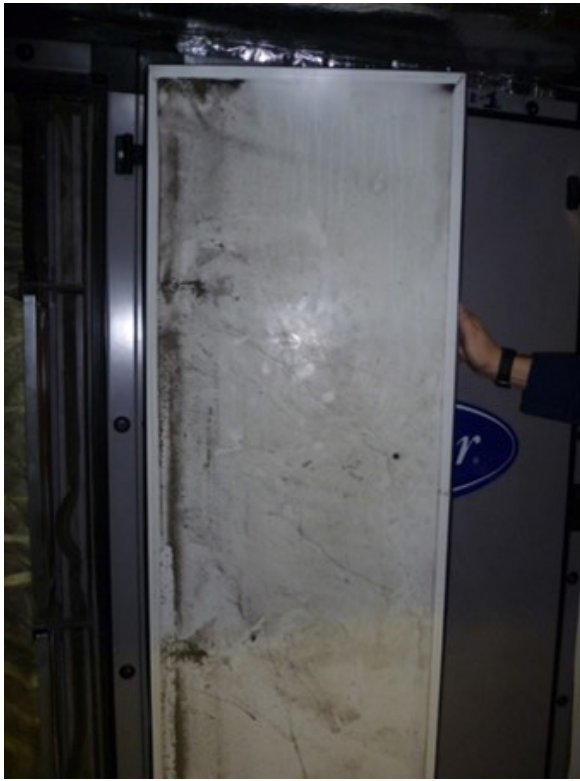
Figure A5. Door for second filter bank showing particles that had by-passed the filters. Photo by NIOSH.

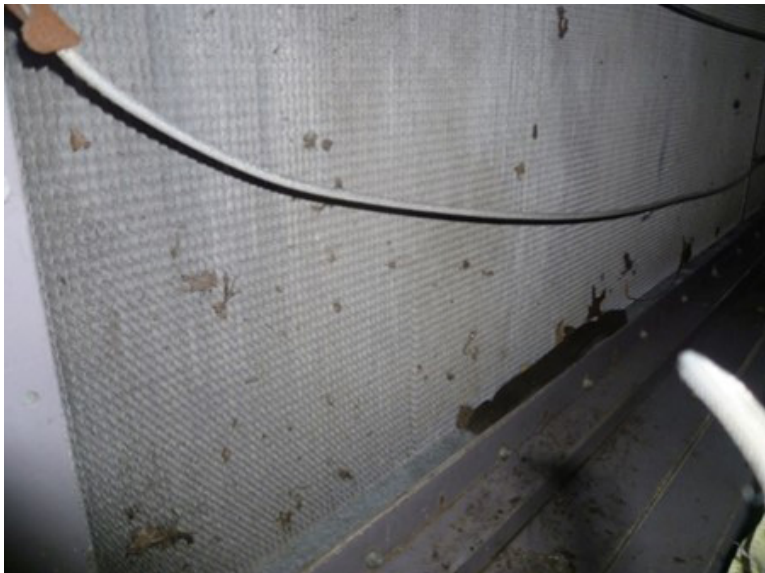
Figure A6. Debris including pieces of plant material on the cooling coils after the two banks of filters. Photo by NIOSH.

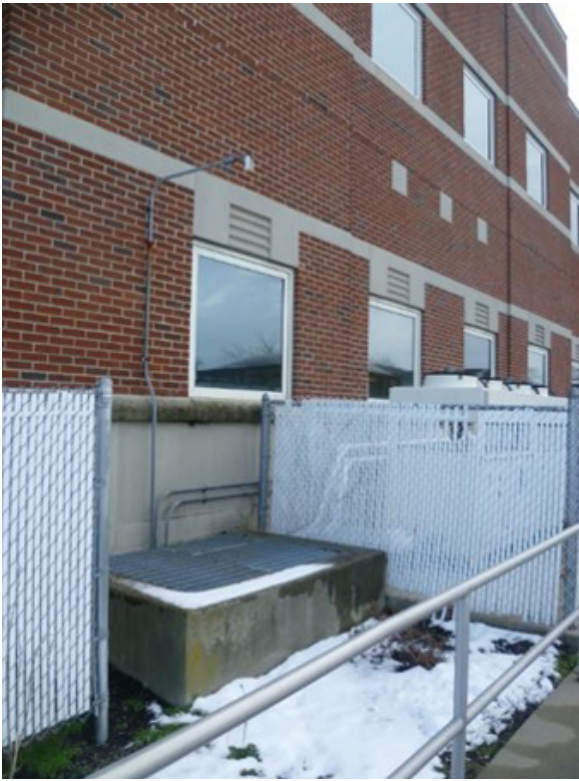
The outdoor air intake for the MRI Suites was located slightly above ground level on the west side of the building near the ground level cooling coils (Figure A7). The MERV 8 pleated filters for the MRI Suites HVAC unit looked clean and we did not find evidence of air bypassing the filters. The MRI Suites also had a separate recirculating cooling system for the MRI equipment.

Figure A7. Outdoor air intake for MRI Suites ventilation unit, which was at grade. Photo by NIOSH.

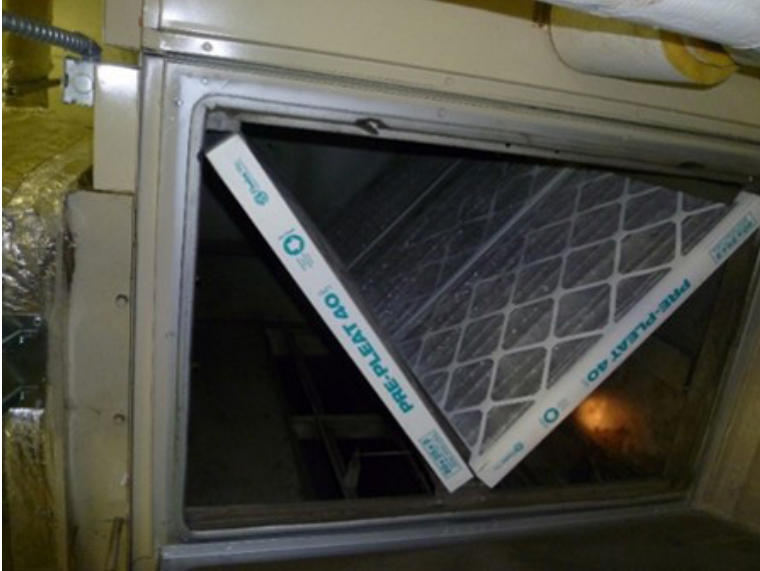
Figure A8. The filters for the MRI Suites ventilation system were tight-fitting and in a V-pattern. Photo by NIOSH.

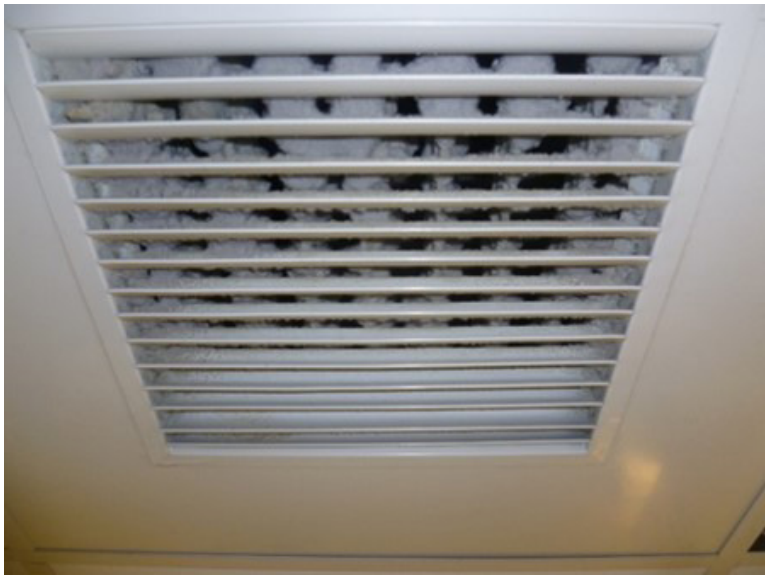
Figure A9. The supply vent shows a gray fibrous material inside the louvers. Photo by NIOSH.

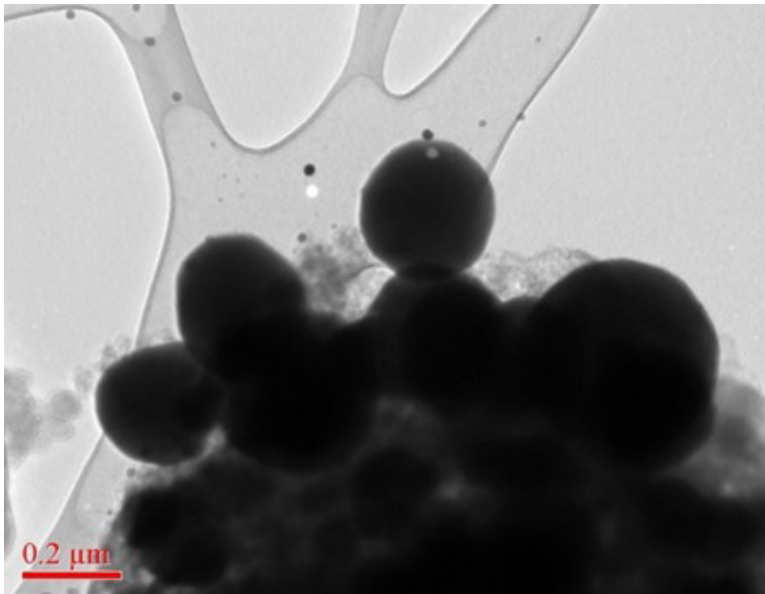
Figure A10. Transmission electron microscopy image of soot and polymer material from MRI changing area. Photo by NIOSH.

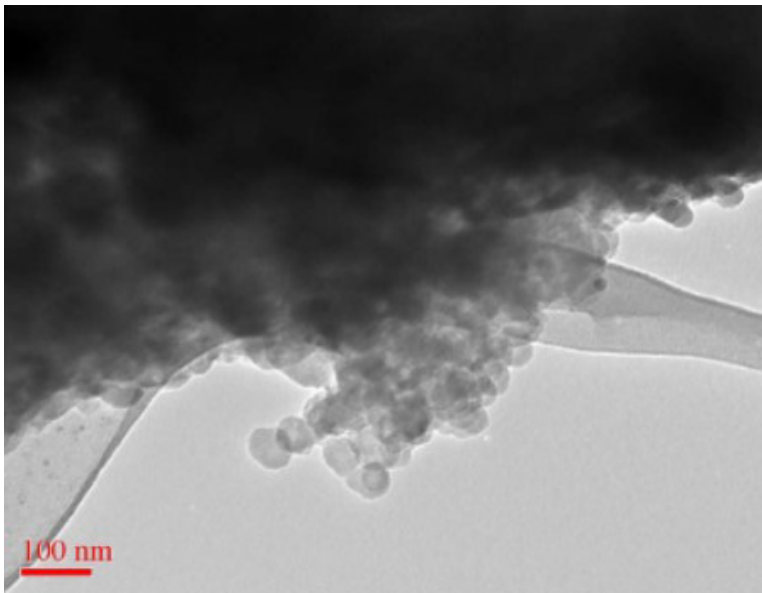
Figure A11. Transmission electron microscopy image of soot from MRI filing room. Photo by NIOSH.
