FATALITY ASSESSMENT AND CONTROL EVALUATION

Two Construction Workers Fatally Crushed when Cement Formwork Collapsed Case Report 13NY080

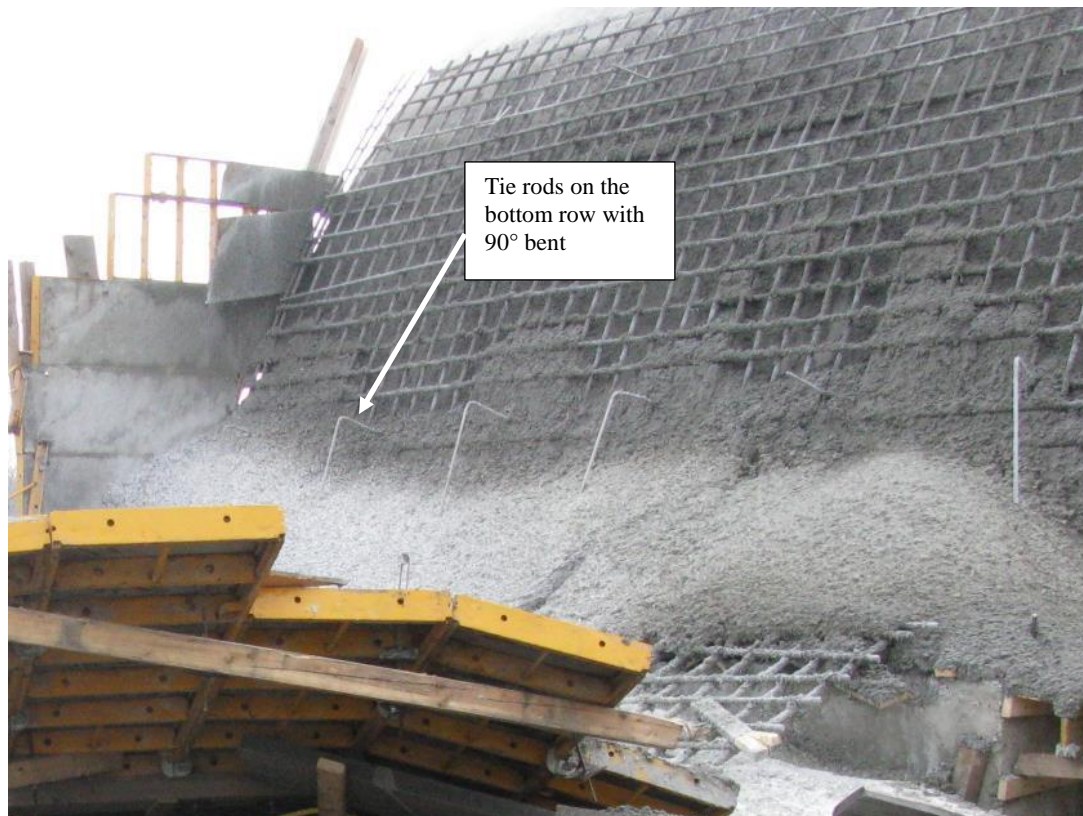
Photo 4. Tie rods that remained on the concrete bent at a nearly 90° angle suggesting a vertical drop in the retaining wall during collapse (photo courtesy of OSHA).
