Orchard Tractor Operator Dies When Run Over by Rotary Mower After Falling From Tractor

Investigation: 13WA01501

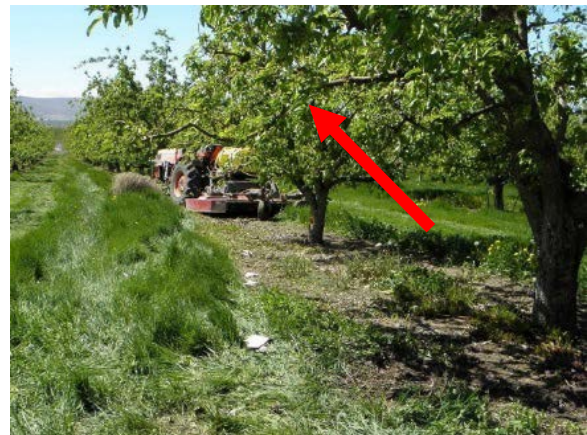
Photo 3: View of tractor from position of victim. Arrow indicates low-hanging branch that may have knocked victim's hat to the ground

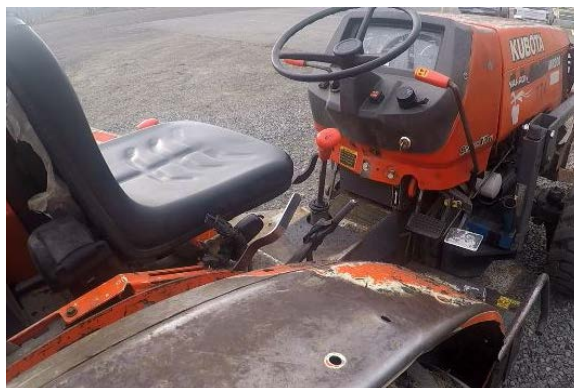
Photo 5: Gear selector placement in center of operator’s compartment.

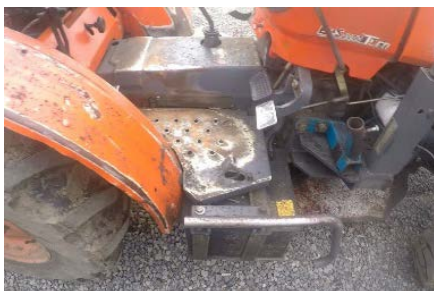
Photo 6: Right side of tractor without steps
