MIFACE Investigation Report: #14MI095

SUBJECT: Food Pantry Volunteer Pinned by a Table Against a Wood Cabinet When the Table was Struck by Backing Vehicle

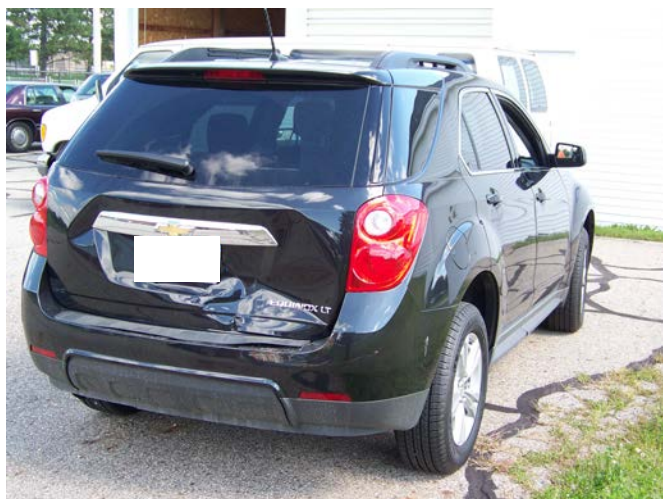
Figure 6. SUV involved in the incident. Note damage to the rear of the vehicle.
