A report from the NIOSH Fire Fighter Fatality Investigation and Prevention Program

November 1, 2017

Volunteer Fire Fighter Dies in a Floor Collapse While Working Above a Residential Basement Fire—South Dakota

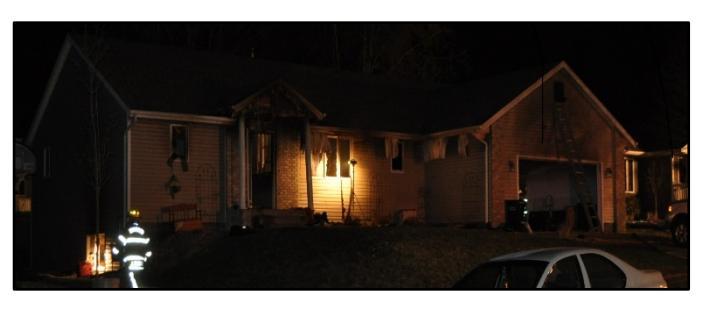
Fire structure. (Courtesy of Fire Marshall.)

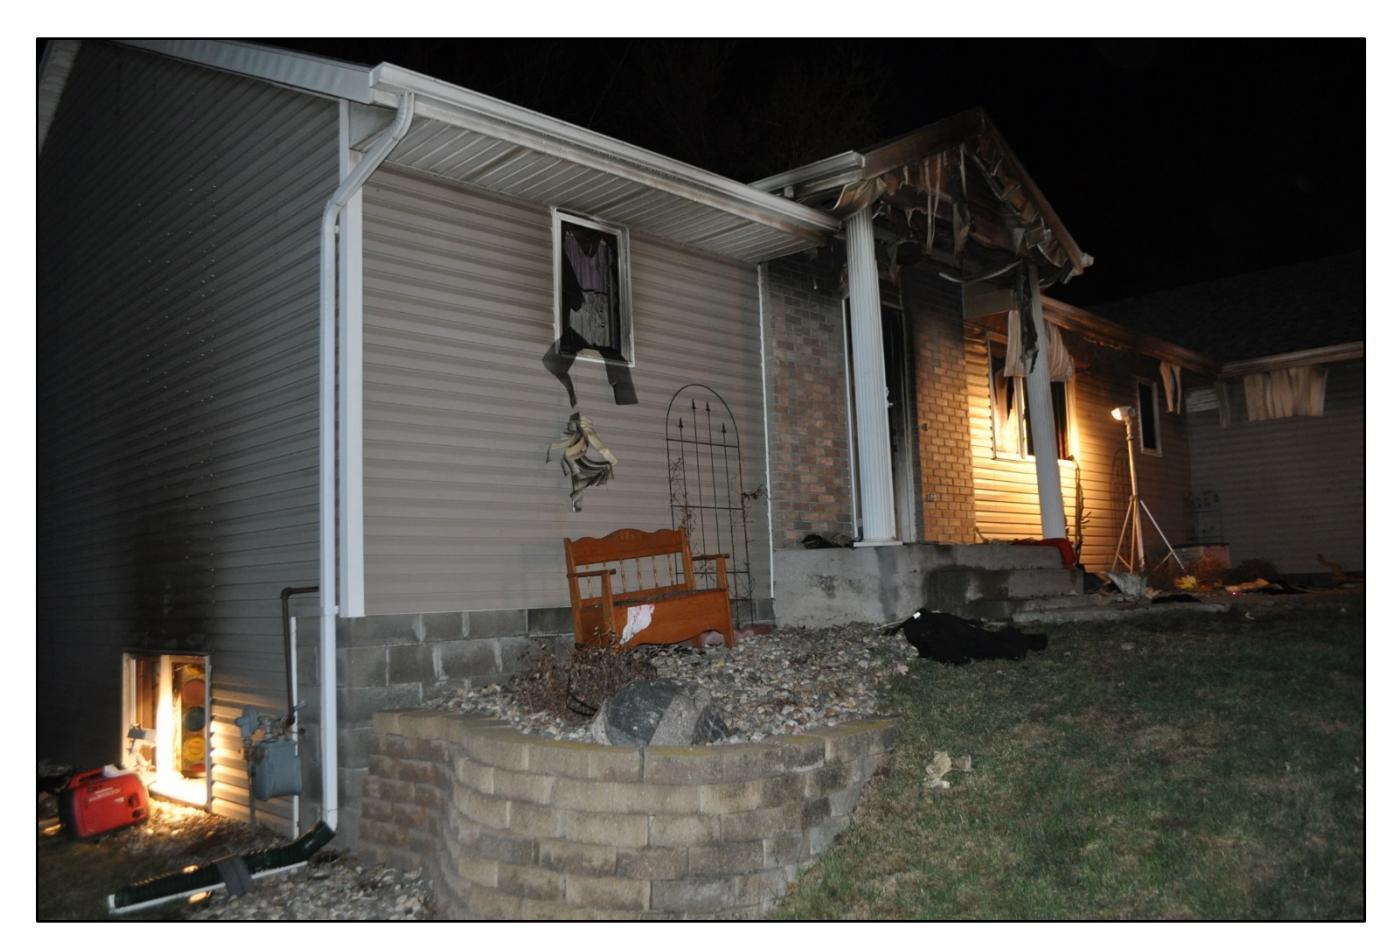
Photo 1. Front, side A, view of fire structure. (Courtesy of the Fire Marshall's Office.)

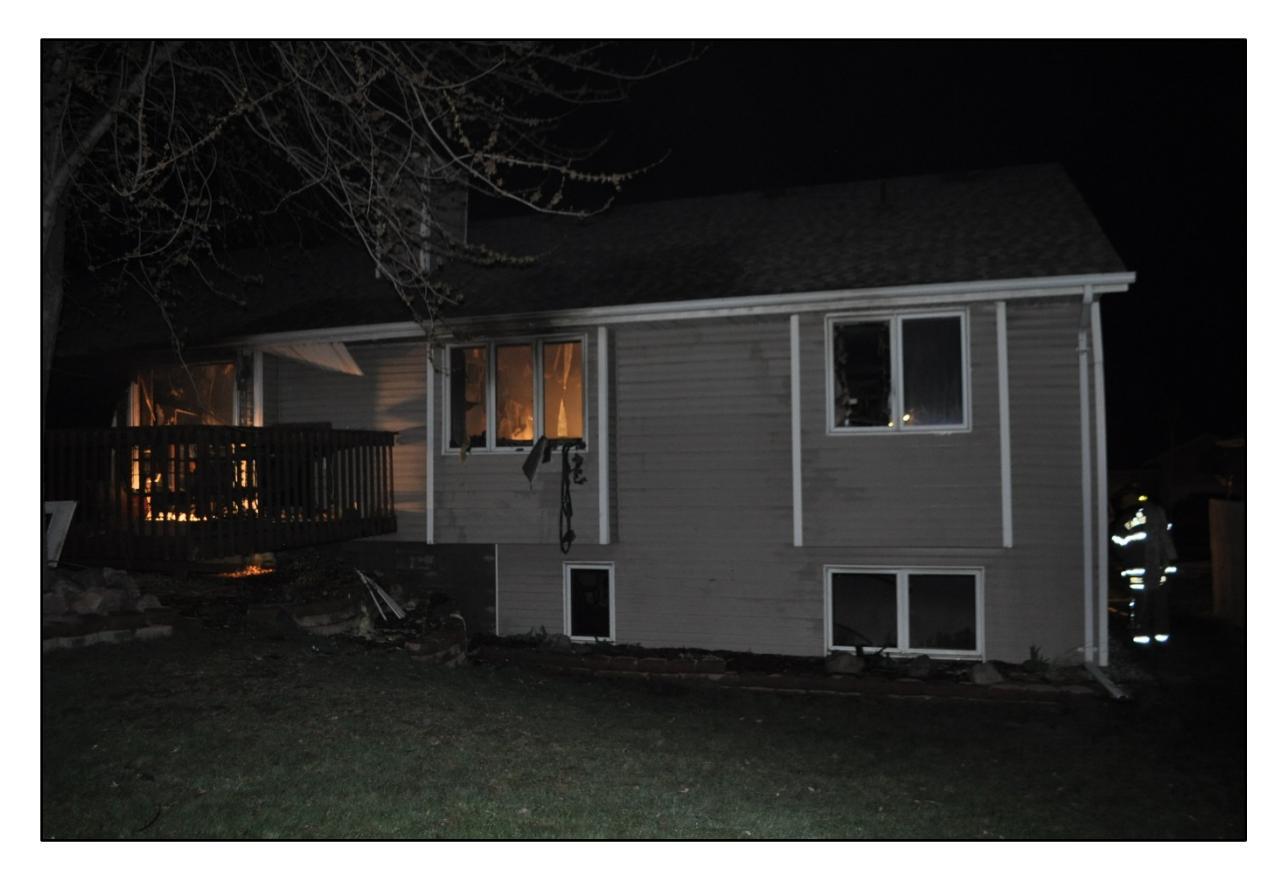
Photo 2. Partial Side C view of fire structure. (Courtesy of the Fire Marshall's Office.)

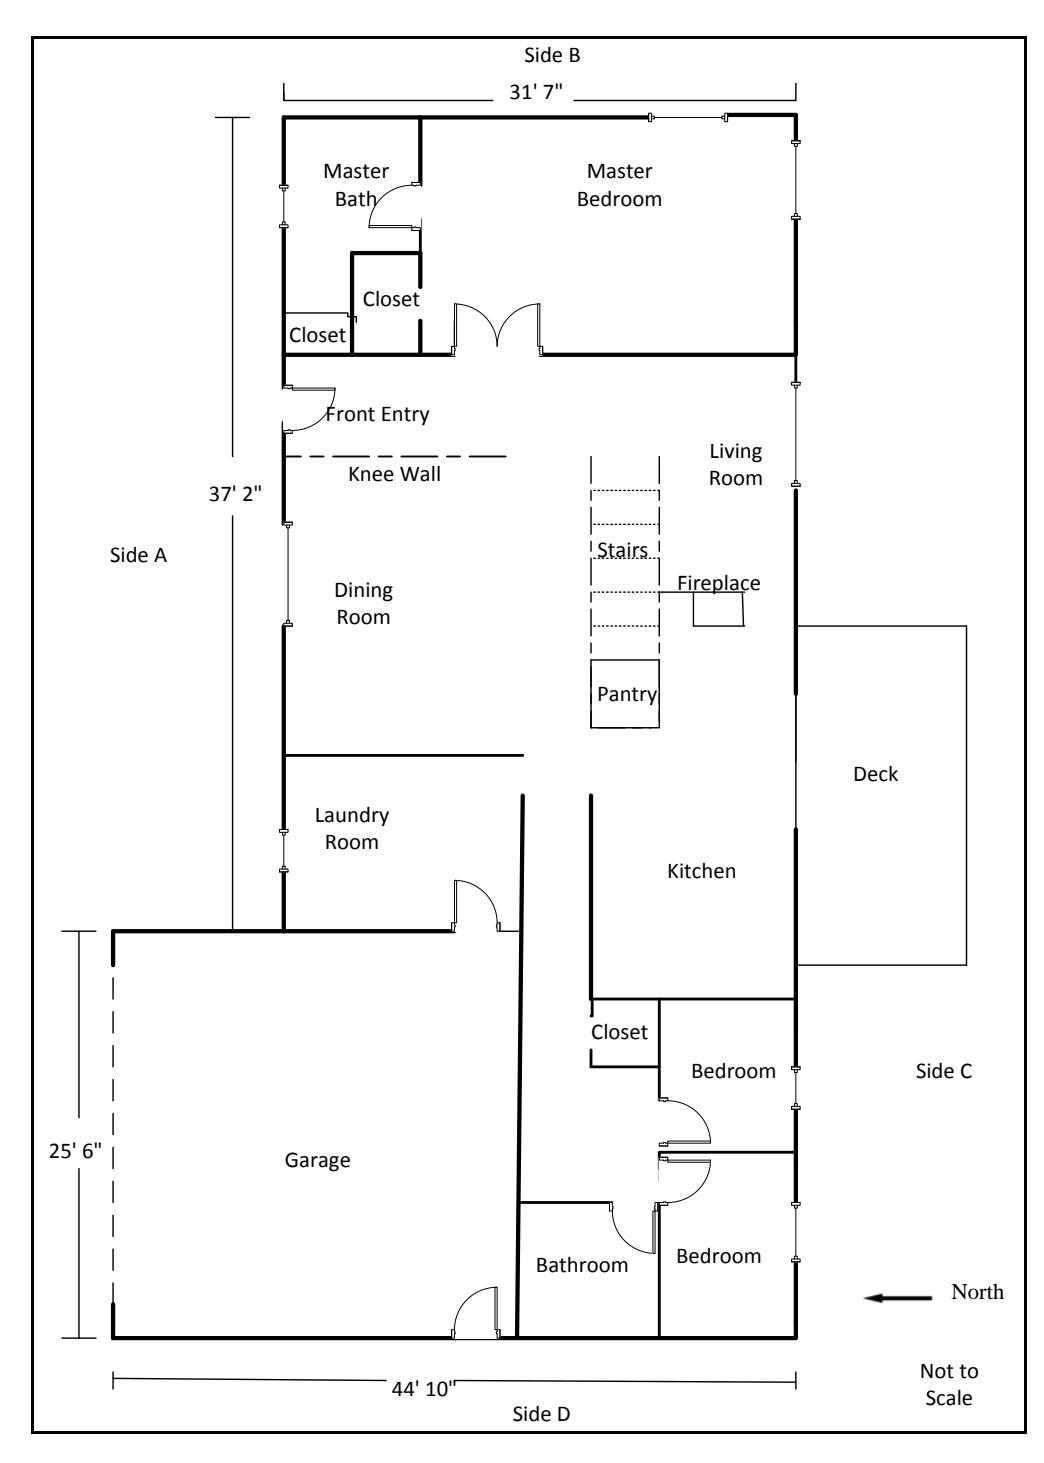
Diagram 1. First floor of fire structure.

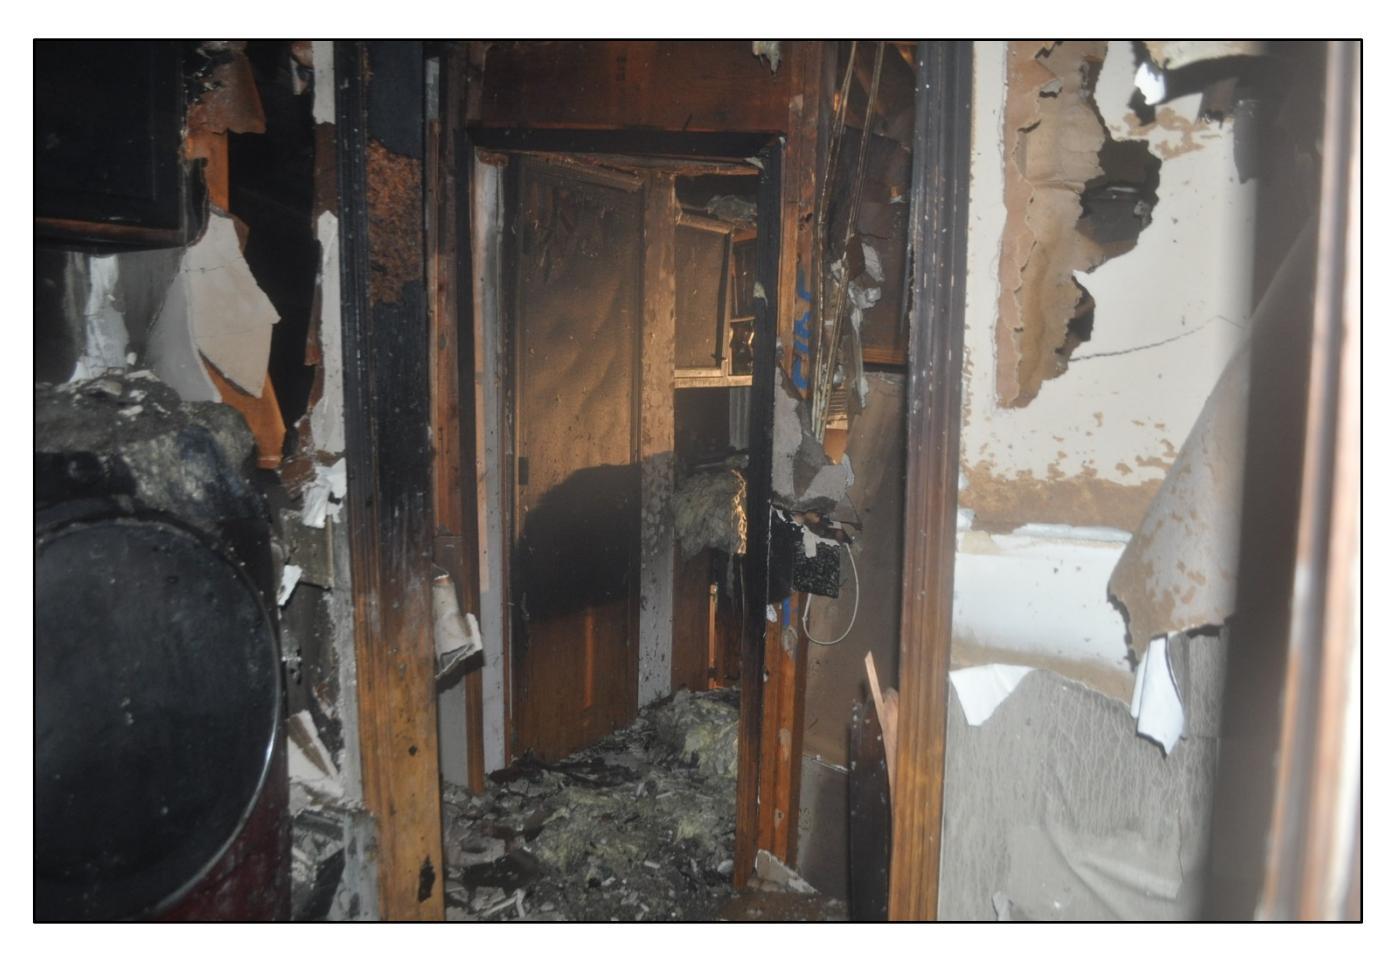
Photo 3: View from laundry room across hallway into the kitchen. (Courtesy of the Fire Marshall's Office.)

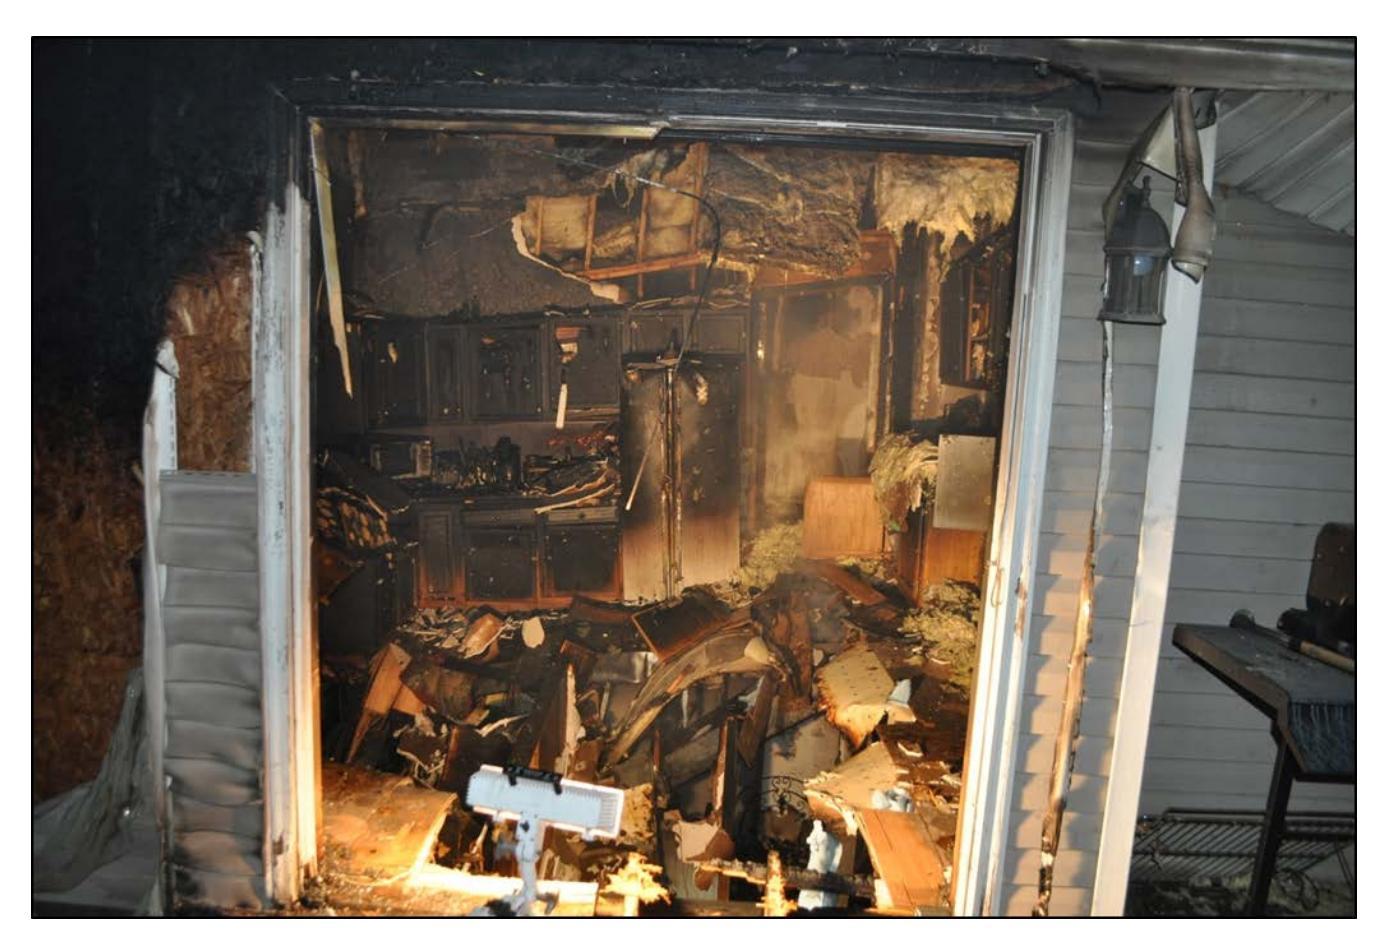
Photo 4. View from rear sliding doors looking into the kitchen and the floor collapse in the kitchen area. The entry into the kitchen is just to the right of the refrigerator. (Courtesy of the Fire Marshall's Office.)

According to the state fire marshal's office, the cause of the fire was accidental. The origin of the fire was in the basement's utility room near the ceiling around the exhaust vent pipe that served both the furnace and water heater.

During this incident, fire fighters were unable to access the basement, opted not to ventilate the basement fire, and were unaware of the fire load found within the basement. The use of a cellar nozzle, like a Bresnan distributor, or by putting hoselines through the basement windows during the initial stages of the basement fire may have assisted in containing the fire and/or allowing better operating conditions for fire fighters to access the basement [IFSTA 2013]. Attempts were made to flow water on the first floor where fire had vented, but this effort was not successful. Fire fighters should also recognize that fire venting through a floor is a late indication of a weakened floor system.

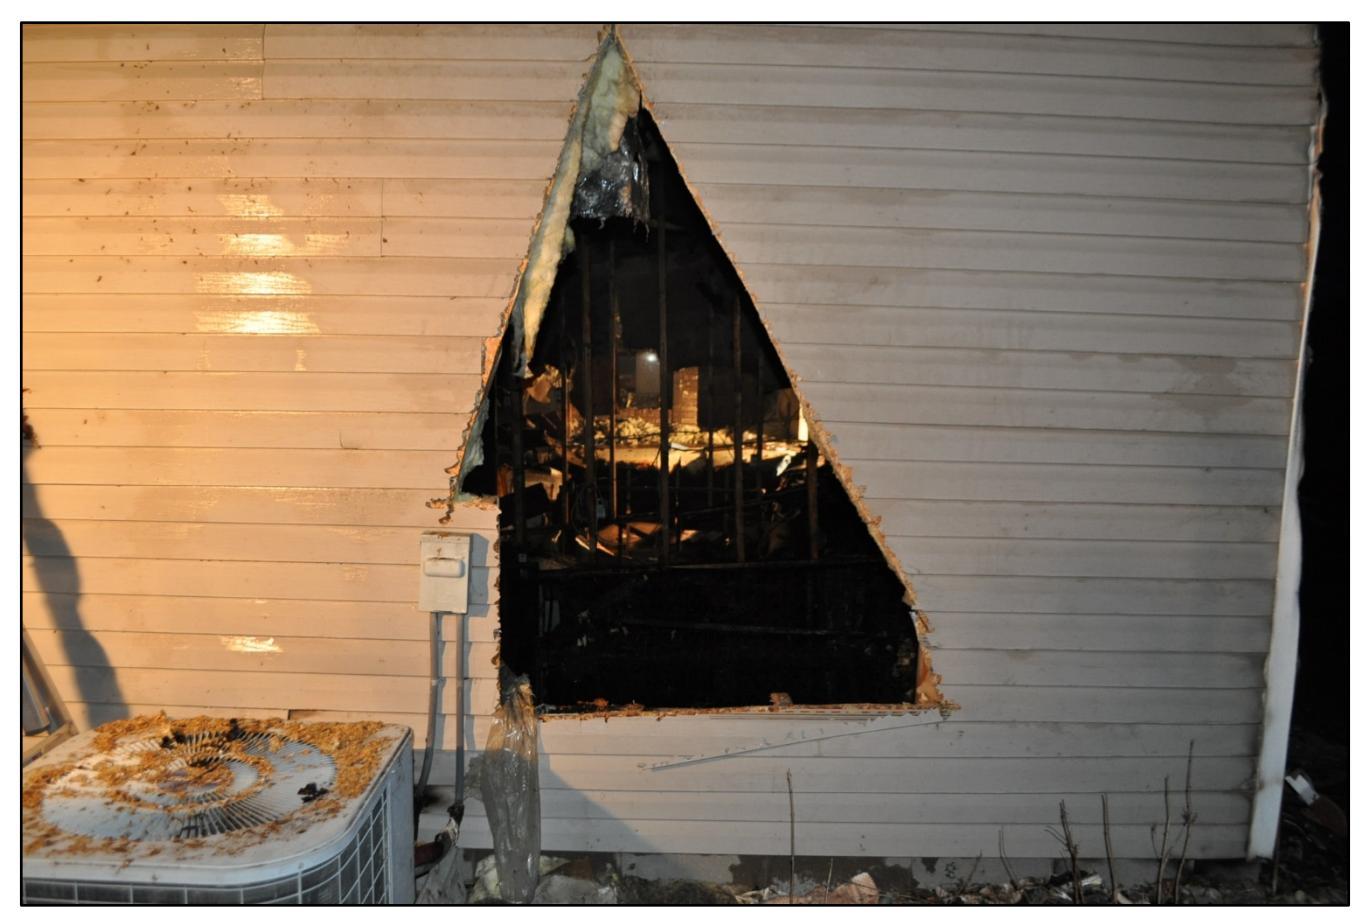
Photo 5. Initial hole cut on Side D to look for the missing fire fighter. (Courtesy of the Fire Marshall's Office.)

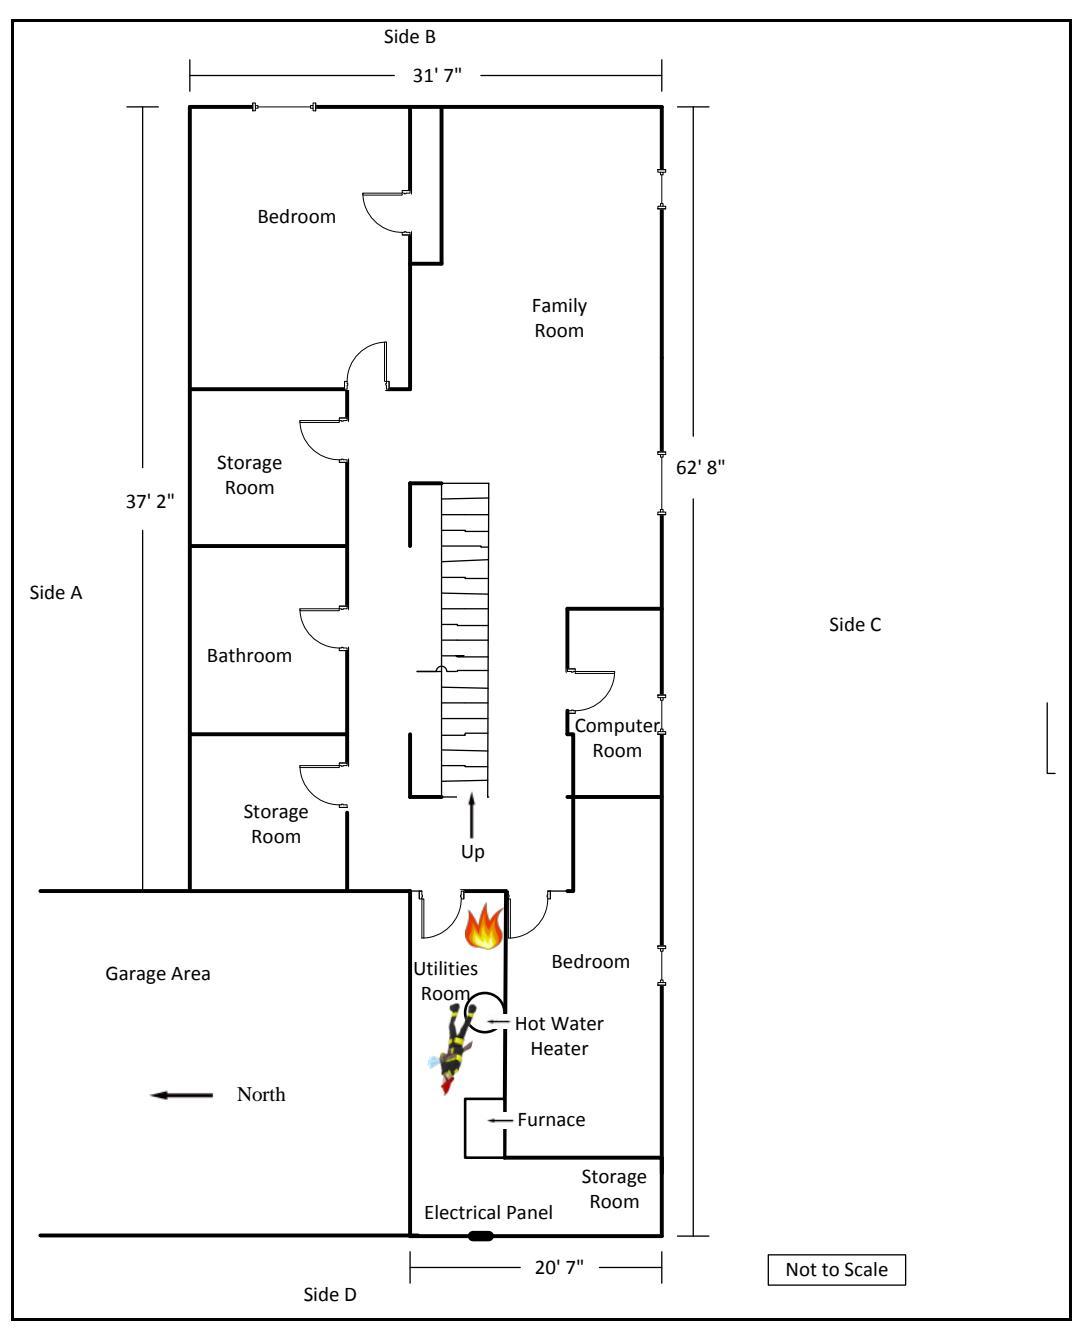
Diagram 4. Approximate location of fire fighter found in basement.
