Death in the line of duty... TIOS

A report from the NIOSH Fire Fighter Fatality Investigation and Prevention Program

Career Firefighter/SCUBA Diver Drowns While Searching for Civilian in an Industrialized River—Illinois

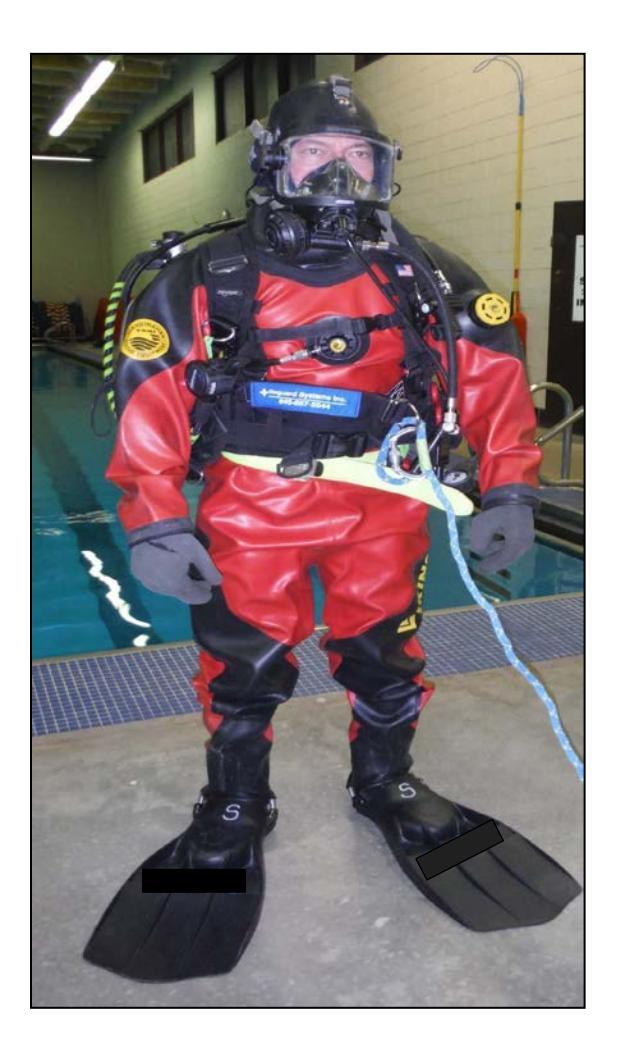
The fire department had a local dive shop evaluate the SCUBA gear as part of its investigation. NIOSH was informed that the results of that evaluation concluded that the SCUBA was functional. NIOSH investigators had a second independent expert in Boca Raton, Florida, evaluate the SCUBA gear. The expert concluded that the SCUBA equipment functioned as designed. The full report is provided in the Appendix. The SCUBA equipment used in this incident was owned by the fire department dive team and is issued personally to each diver (see Photo 1).

Photo 1: Example of a suited up diver. (Courtesy of the fire department.)

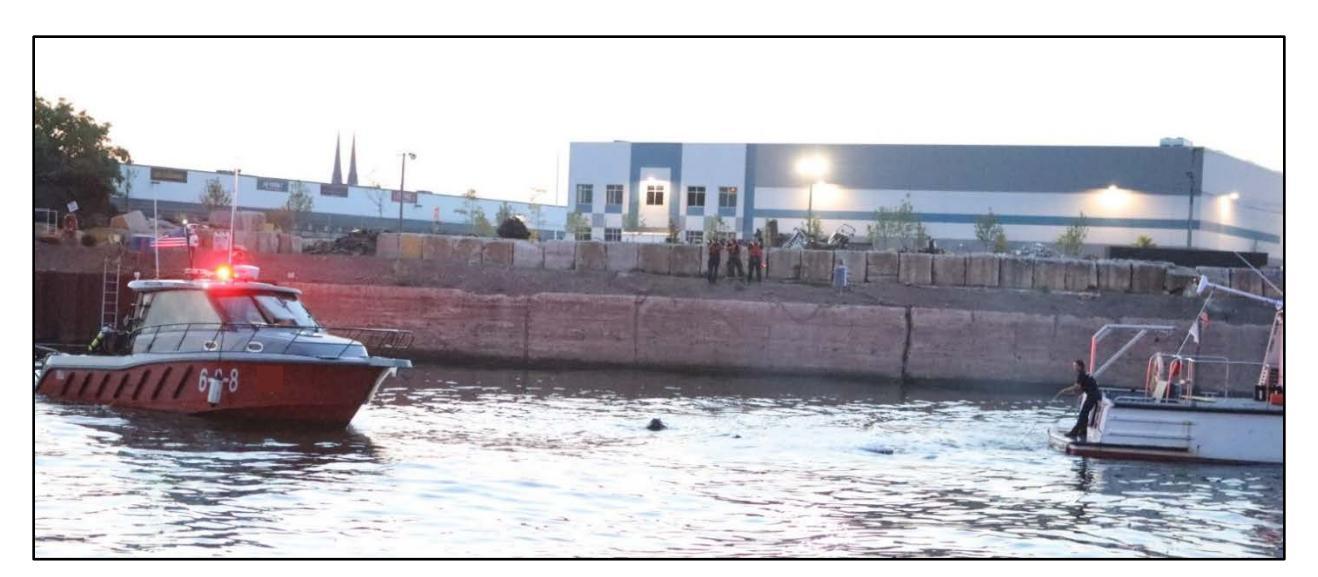
The dive group supervisor reported seeing Diver 2 surface first, and Diver 1 surfaced about 3 seconds later. Diver 1 had to reel up the tethered line on the reeling spool while surfacing near Diver 2. One of the police officers attempted to deploy a life ring to the surfaced divers several times (see Photo 3). *Note: Deploying the life ring to assist divers to the boat is a best practice used by the Police Marine Unit. NIOSH investigators were told the police officer believed Diver 2 was in distress.*

Photo 3: Officer on Police Boat M2 throws life ring to Diver 2. (Courtesy of the fire department.)

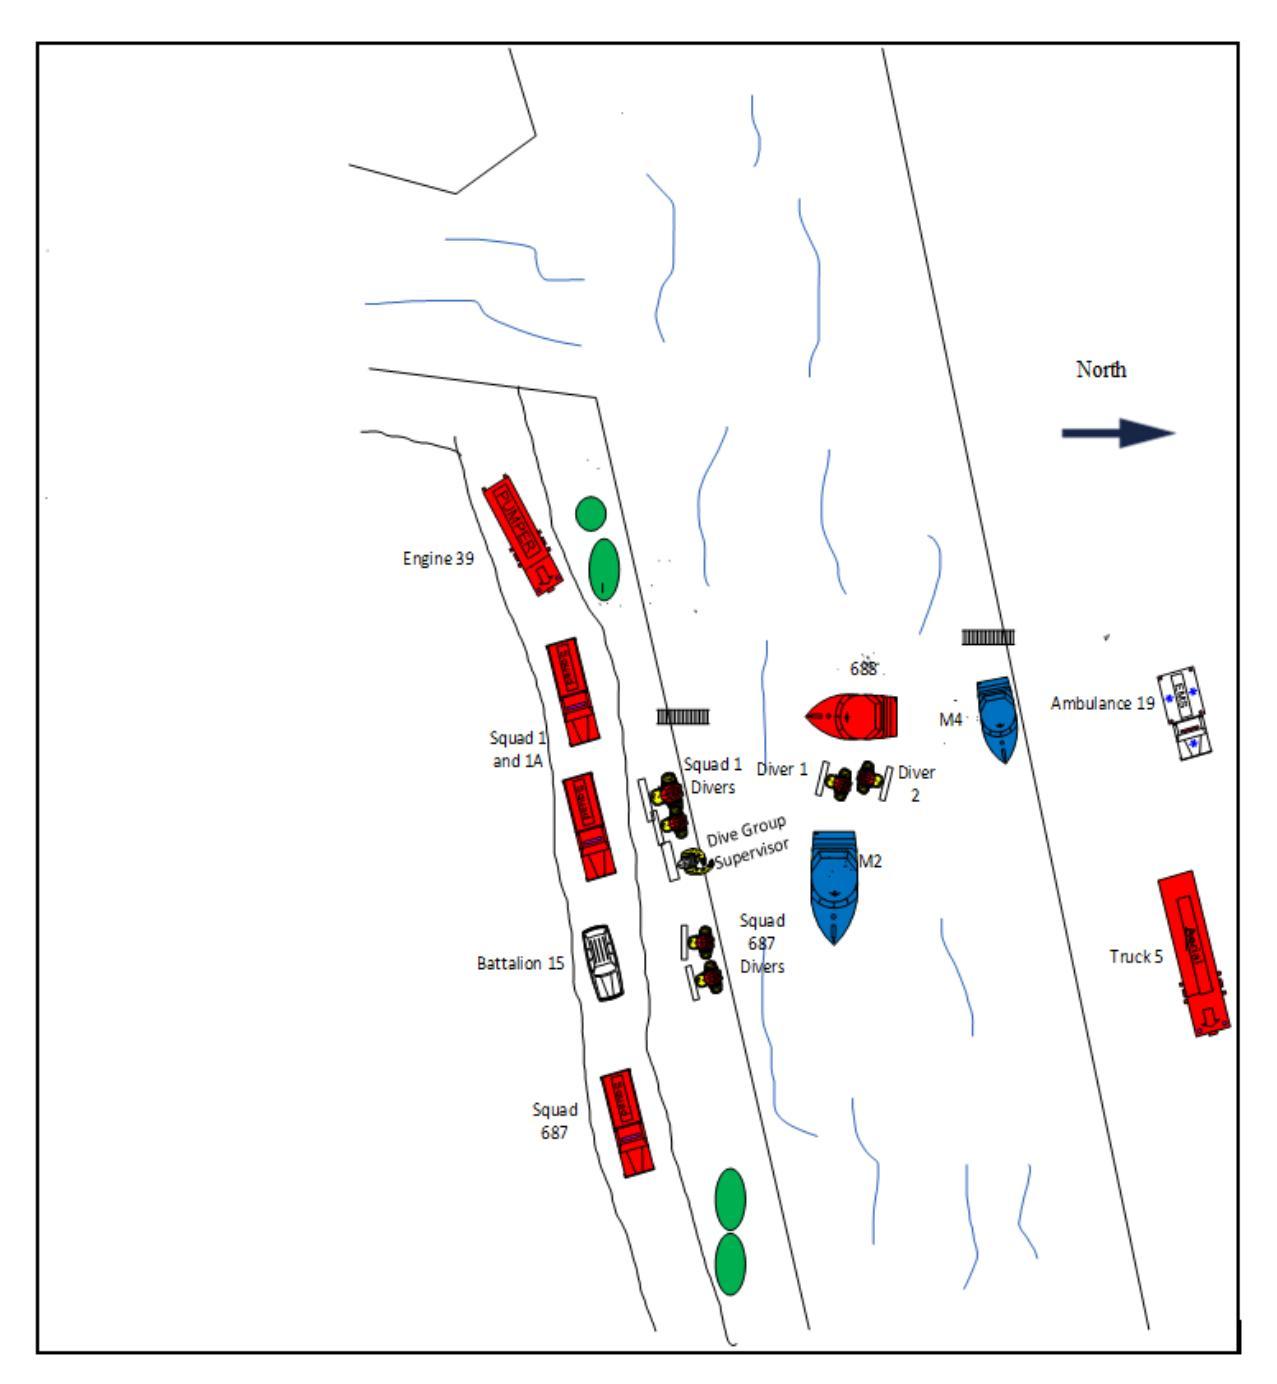
Figure 1: Apparatus and crew placement when helicopter drivers surfaced.

Diver 2 and Diver 1 came together, and Diver 1's left hand was on Diver 2's right shoulder strap (see Figure 1). Diver 2 appeared to have difficulty maintaining positive buoyancy. Fast Boat 688 approached the area by doing a 180-degree turn to face south and perpendicular to the river. The lieutenant of Fast Boat 688 told Police Boat M2 that it would pick up their divers. Police Boat M2, which was facing east on the river, briefly engaged its engines to avoid getting too close while Fast Boat 688 was trying to get the two divers to come toward them. The lieutenant on Fast Boat 688 yelled to both divers to come to the boarding door of the fast boat. The two divers then started to drift in a circular pattern toward the bow of the Fireboat 688. This was possible because of the positioning and movement of both Fast Boat 688 and Police Boat M2. Diver 1 was able to put a hand on the hull of Fast Boat 688. Diver 2 grabbed the Diver 1's mask and pulled it off of Diver 1's face. Diver 2 also pulled the line reel out of Diver 1's right hand. Diver 1 inflated the buoyancy compensating device (BCD) and stayed on the surface. Diver 2 disappeared beneath the surface of the water.

Diver 1 last saw Diver 2 lying flat on his back near the water's surface. Diver 2 was about 12 feet away from Diver 1 and drifting southwest of Fast Boat 688. Police Boat M2 radioed the dive group
