Evaluation of Potential Exposures to Railway Hazardous Material Inspectors

HHE Report No. 2022-0049-3387

August 2023

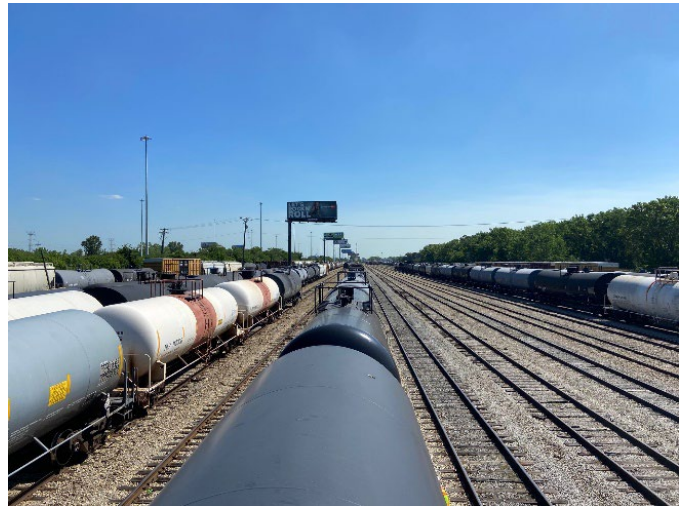
Figure 1. Rows of tank cars at the railyard, some containing hazardous materials, surrounded by active tracks. Photo by NIOSH.

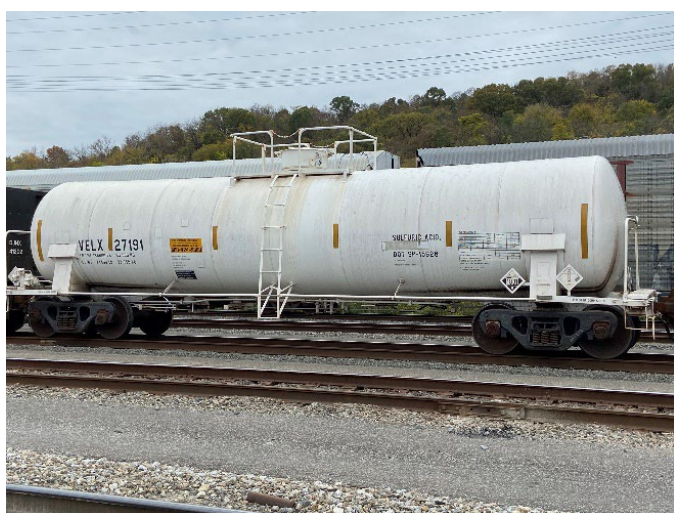
To complete the HM inspection of the tank car, inspectors first identified a train track that had HM-containing tank cars. Railroad tank cars (pressurized, non-pressurized, or low-pressure) were typically cylindrical and included top fittings with filling and inspection ports located inside a protective housing (Figure A2). In addition, most of the cars had a bottom outlet valve. Another type of tank car was more rectangular with multiple outlets on the bottom of the car (Figure A3).

Figure A2. Cylindrical hazardous materials tank car. Photo by NIOSH.

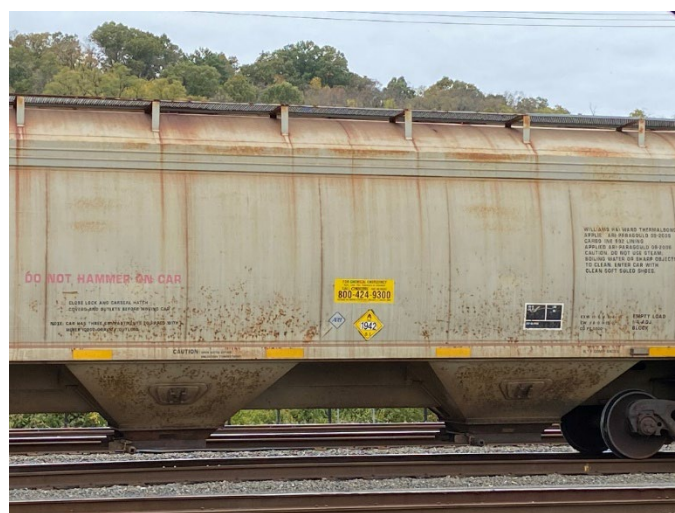
Figure A3. Squared tank car containing ammonium nitrate. Photo by NIOSH.

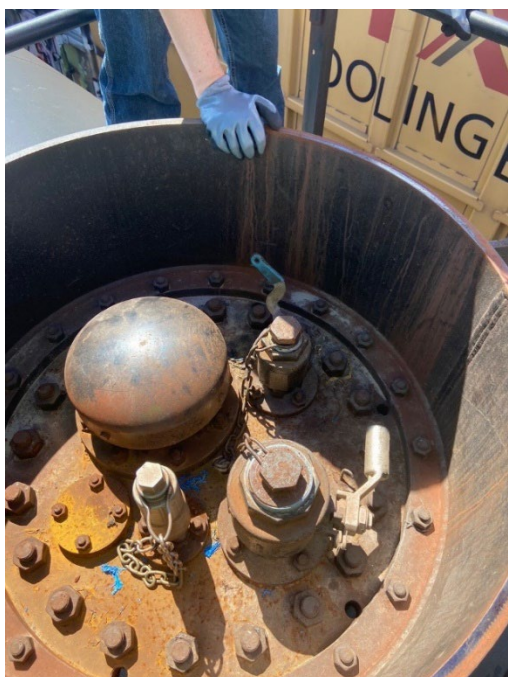
Figure A5. Inside the valve housing on top of the tank railcar containing hazardous materials. Photo by NIOSH.

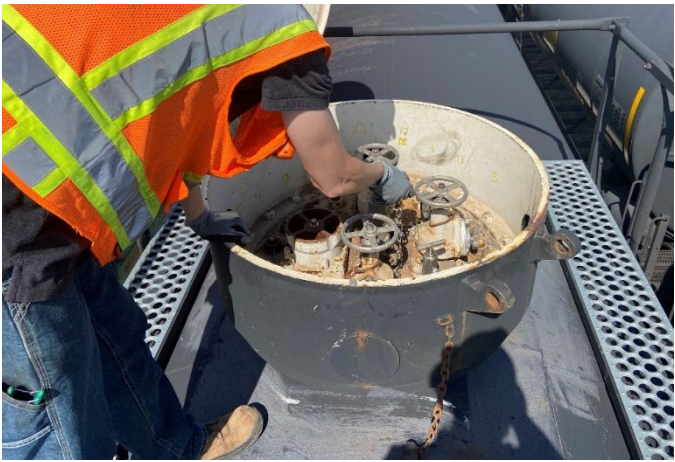
Figure A6. Inside the protective housing on the top of the tank car. Photo by NIOSH.

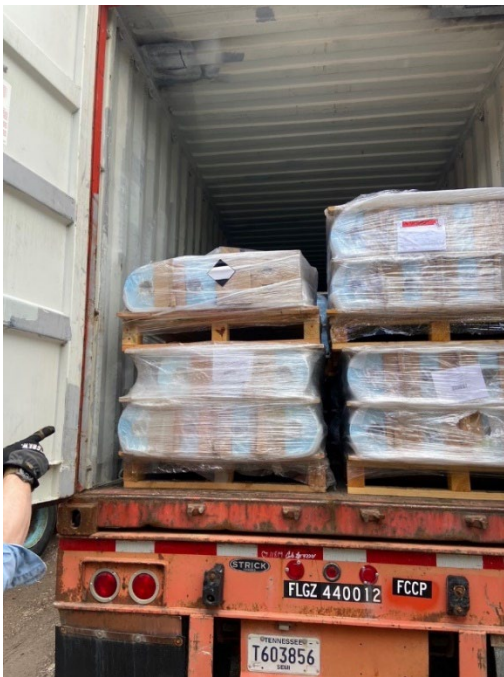
After the inspector identified an intermodal container with HM, the inspector noted the DOT Placard and UN number. The inspector attached a strap to the back of the container so that when it opened, the contents (which may have shifted during transportation) did not fall onto the inspector (Figure A7). The inspector then removed the metallic zip tie and opened the container. All intermodal containers are inspected from the outside because they are considered confined space, and the inspectors are not permitted to enter (Figure A8). After inspection, the inspector resealed the intermodal container with a zip tie.

Figure A7. HM inspector affixing a strap to the back of the intermodal container. Photo by NIOSH.

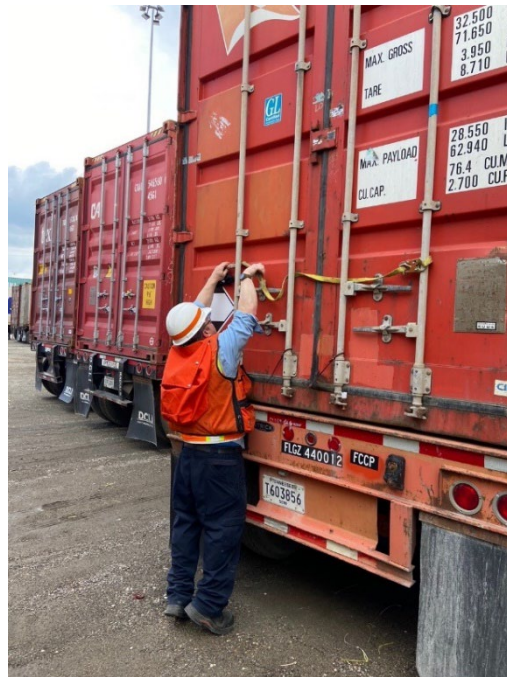
Figure A8. Inspection of an intermodal shipping container containing hazardous materials. Photo by NIOSH.

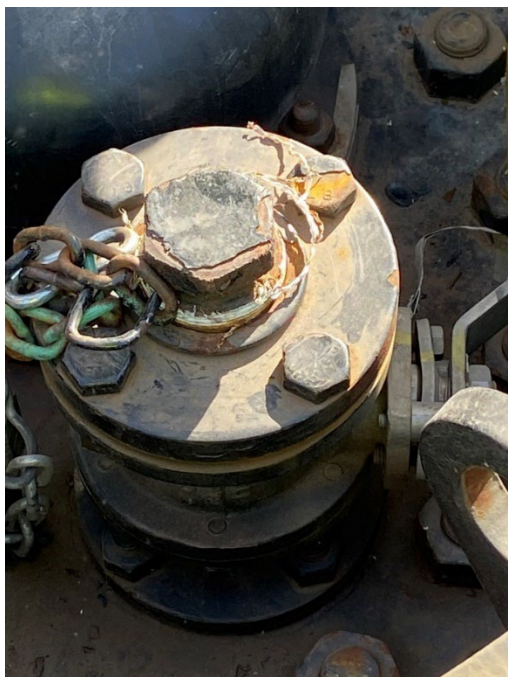
During the inspection of tank cars containing HM, an inspector encountered a damaged valve that could cause leakage around the seal (Figure B9). During another tank inspection, the inspector found a valve that was not closed “hand tight.” Upon further inspection, it was discovered that the valve threading had been stripped, likely because someone had used a tool to attempt to seal the valve. This damaged valve could no longer seal tightly, allowing fumes and vapors from inside the tank to expose the HM inspector (Figure B10). During this inspection, a prominent odor was detected. The inspector notified the yard master of these noncompliant cars to prevent them from departing.

Figure B9. Valve inside the housing with a damaged seal on the valve cover. Photo by NIOSH.

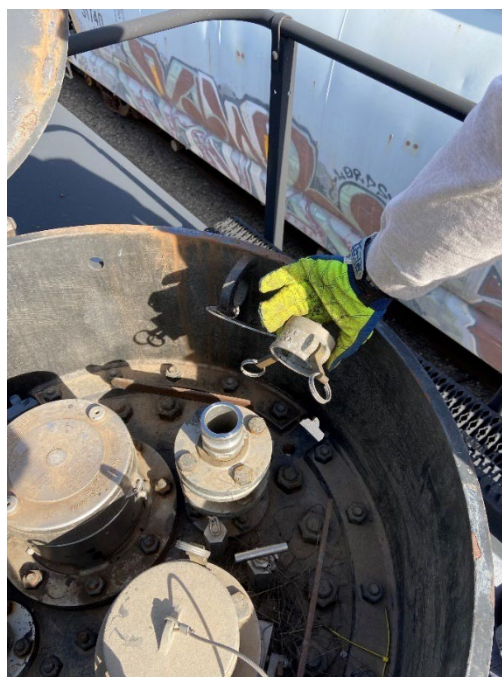
Figure B10. An open valve inside of the housing. Photo by NIOSH.

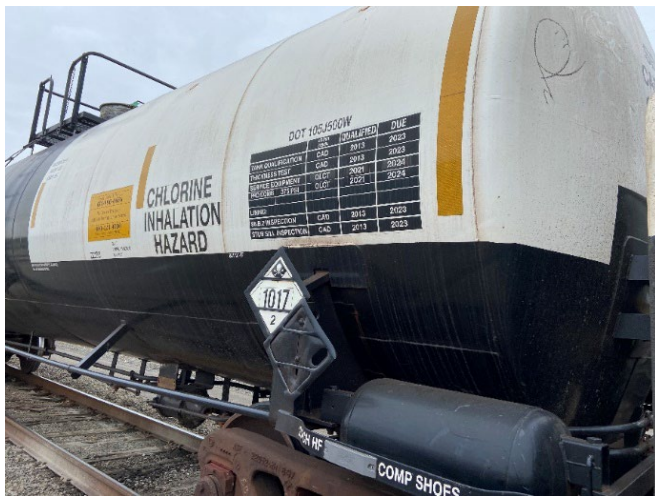
Some cars that contained inhalation hazards were clearly labeled as such (e.g., the chlorine car in Figure B11). However, for other tank cars that contained inhalation hazards, the information was not as obvious. For example, Figure B12 shows a tank car filled with fuming sulfuric acid, which is both corrosive and an acute inhalation toxicity. However, for this tank, the “fuming” label was covered with a magnet (Figure B13). Therefore, the only way to know that the contents were fuming sulfuric acid was to look up the UN number (1831) on the DOT placard. Because these tank cars can be used to transport both fuming and non-fuming sulfuric acid, the magnet was likely in place for a previous time when the car was filled with non-fuming sulfuric acid.

Figure B11. Chlorine tank car labeled inhalation hazard, including the inhalation pictogram on the DOT placard. Photo by NIOSH.

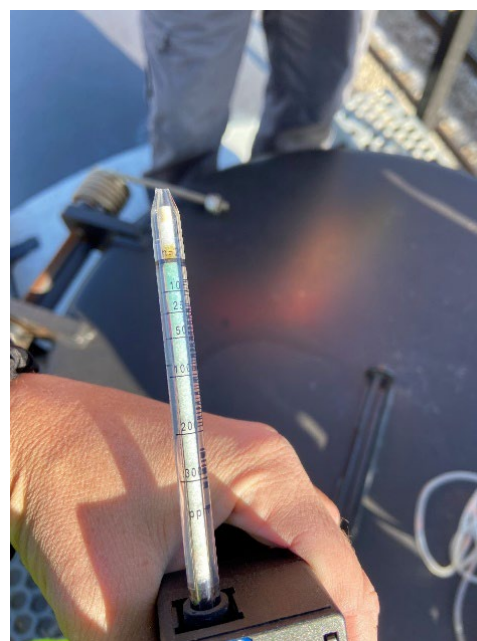
One of the five hydrocarbon indicator tubes had a detectable result of approximately 50 ppm (Figure B14). Once the housing was opened, there was a strong odor that dissipated after about 2 minutes. This was the inspection that had the stripped valves. None of the other indicator tubes showed a color change.

Figure B14. Colorimetric indicator tube for petroleum hydrocarbons showing ~50 ppm. Photo by NIOSH.
