A Case Study Examination of Two Blast Rounds at a Nevada Gold Mine

Ed Mchugh and Joel Warneke, National Institute of Occupational Safety and Health
and
Cristian Caceres, University of British Columbia

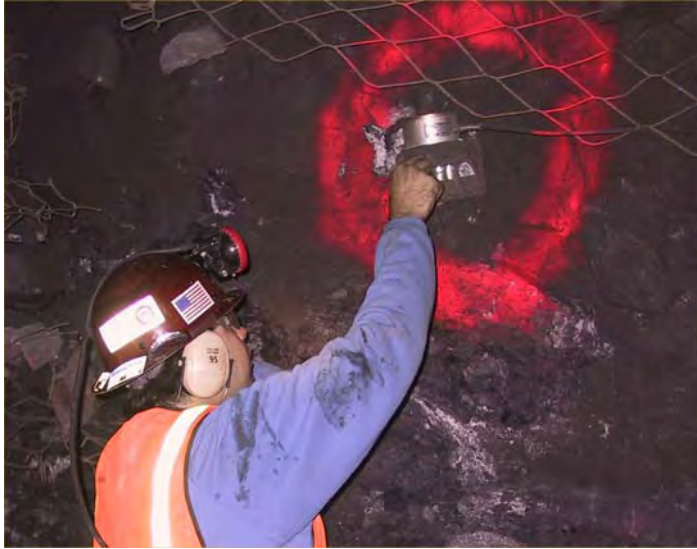
Figure 3. Installing a triaxial transducer and bracket on the rib in XC 11.

The geophones were mounted on aluminum brackets and anchored to the ribs of the entries (figure 3) with steel masonry bolts. Each geophone was then connected to a monitor with shielded copper cables. The monitors themselves were hung from the steel mesh along the ribs to avoid damage from blast effects and from mining machinery during the mucking and bolting cycles. Where blast effects were difficult to avoid, a steel-plate box that could protect one monitor and one geophone (figure 4) was used.

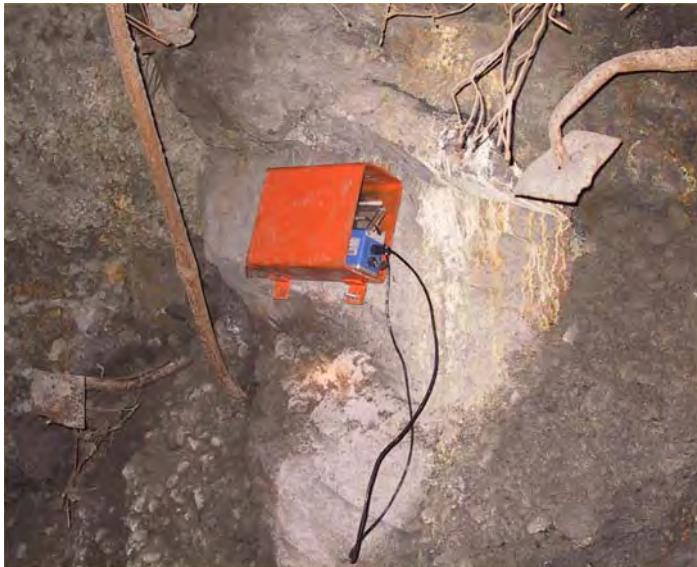
Figure 4. Seismic monitor C installed in an armored steel box in XC7

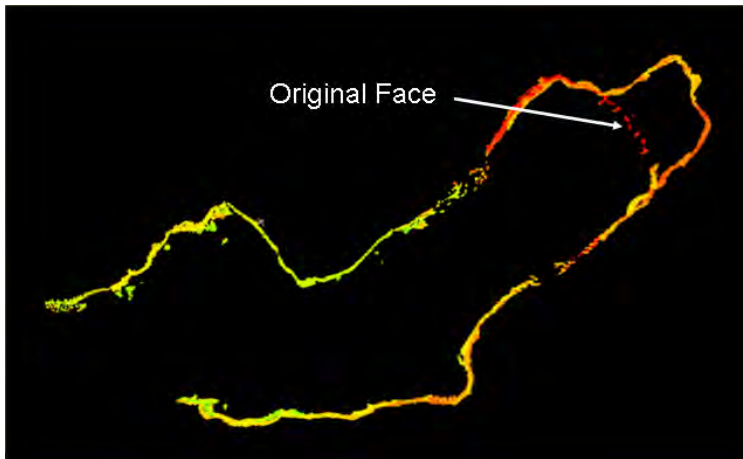
Figure 5. Plan view of XC 11, showing the original face and the area extracted by the shot on 11/7/06.

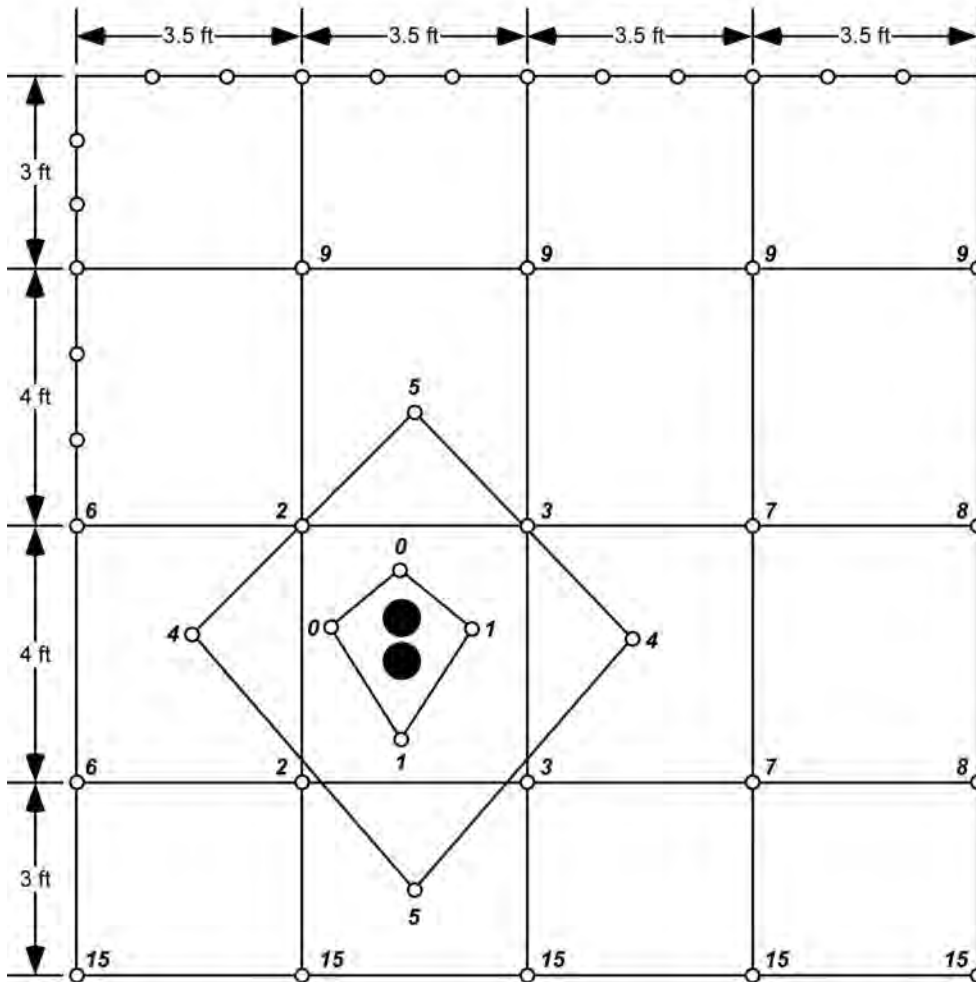
Figure 6. XC11 blast pattern diagram, November 7, 2006.

The XC11 entry was the end ore panel on the 7170 level. Panel number 10 containing cemented fill was located along the left side while the right side was formed by rock that will not be mined (see figure 2). The design for the November 7 blast is shown in figure 6. The blast holes were 2.2 cm (1-7/8 in) in diameter and the relief holes were 7.6 cm (3 in) in diameter. All holes were drilled to a depth of 3.7 m (12 ft). Perimeter holes were drilled along the back and upper left rib on nominal 0.3 m (1 ft) centers in an attempt to limit the extent of breakage. These were not charged with explosives. Except for the lifters, all blast holes were charged with ANFO. The lifter holes were charged with sticks of Unigel.

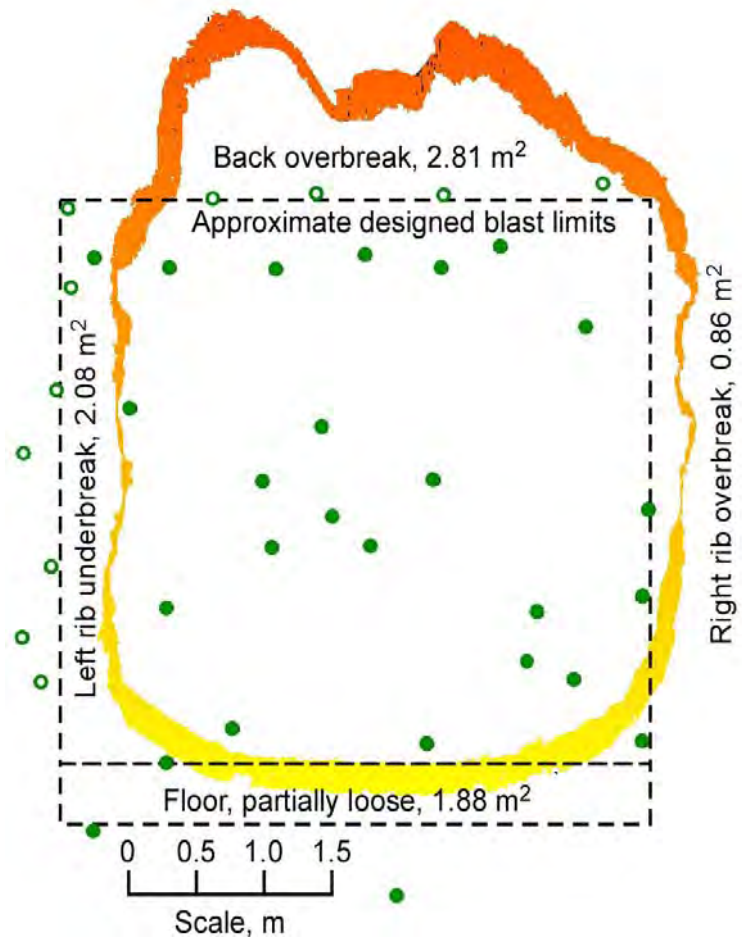
Figure 14. Cross section of the XC11 round at midpoint, showing over-break and under-break in relation to drill holes.

Figure 14 is a cross-section of the round generated by slicing a 0.30-m (1-ft) section of the laser scan. The drill hole locations projected to mid-round from the hole collars at the drilled face were used to align the designed blast round with the resulting excavation. Deviations from ideal positions for these locations reflect both the actual drilled deviations and errors in projecting the drill holes from the scan aids used to collect hole orientation.

Although the total cross-sectional area at mid-round was approximately as designed, the laser section at that point shows that over-break in the back accounted for 15.4% of the designed area. Over-break ranged from about 18 to 78 cm (7 to 31 in) in the back and averaged 59 cm (23 in) for a total of 2.8 m² (30.2 ft²). Less significant over-break along the right rib, based on perimeter hole locations, amounted to about 0.9 m² (9.3 ft²), with a range of 20 to 28 cm (8 to 11 in), and an average of 24 cm (9 in) or 4.7% of the designed area. At the same time, under-break occurred along the left rib as shown by the retained, unloaded perimeter holes. The under-break amounted to about 2.1 m² (22.4 ft²), with a range of 32 to 55 cm (13 to 22 in), and an average of 46 cm (18 in) or 11.4% of design. The remaining apparent under-break, about 10%, was in mostly broken material on the floor of the mucked opening.

The unloaded perimeter holes across the back of XC11 failed to prevent over-break in the blast round examined. The closely spaced line of holes across the back appear to have been accurately drilled, but an arched configuration for these holes might have helped to retain more of the back. Gravity certainly played a role in the failure as it acted on crosscutting fractures in the very poor quality rock mass where scaling of loose rock is likely to extend beyond design limits. At the same time, the unloaded holes along the left rib were still standing after the blast, indicating that they were also ineffective in controlling the final configuration. The blast round in XC7, with a relatively complex pattern in a tight space, was successful in continuing the excavation with only small amounts of over-break.
