Field Tests of Cable Bolts Using Instrumented King Wires

Lewis A. Martin

Spokane Research Laboratory, National Institute for Occupational Safety and Health, Spokane, WA

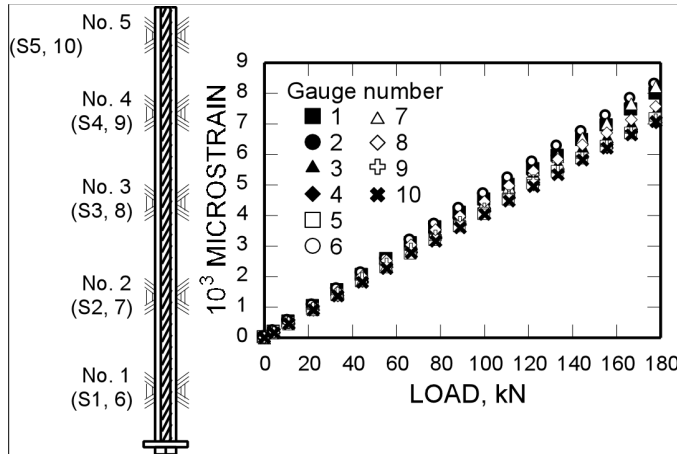
Figure 1.—Calibrated curve for instrumented king wire cable bolt.

Calibration tests at SRL provided correlation of microstrain to load to enter into the data collection system (figure 1). This technique was used successfully throughout the elastic load-strain range on instrumented rebar bolts by Signer et al. (1997).

The gages can either be set in pairs to detect shear load in the same plane or the flat stock can be set at 90° angles to detect loads in three directions. The cables are capable of sustaining an ultimate load of 251 kN and can produce reliable readings to 179 kN, as shown by the calibration curve in figure 1.

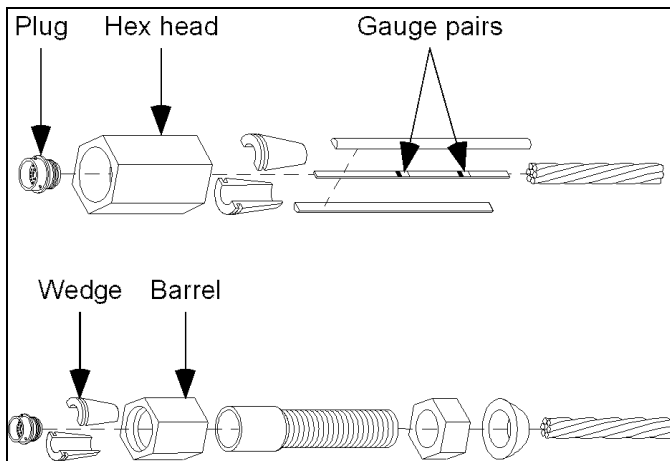
Figure 2.—Instrumented cable bolt assembly with and without pretension head.

epoxy-filled king wire, and the outer six strands are rewound around it, resulting in an instrumented cable bolt. The gage wires protruding from the center are then inserted into a 12-pin connector. This connector is recessed into a 4.4-cm hex head attached to the cable by means of a barrel-and-wedge assembly (figure 2).

To create an instrumented king wire cable bolt, strain gages are first installed on both sides of an 8-by 2.4-mm metal strip at various user-specified positions on the bolt (figure 2). The individual strain gages are connected to an instrument plug by 30-awg wire. This apparatus is then placed in a steel mold and injected the total specified length of the bolt with a two-part epoxy. This new king wire measures 8.3 mm in diameter.

The original cable is uncoiled strand by strand, the original center wire is replaced by the new king wire, and the outer six strands are rewound around it, resulting in an instrumented cable bolt. The gage wires protruding from the center are then inserted into a 12-pin connector. This connector is recessed into a 4.4-cm hex head attached to the cable by means of a barrel-and-wedge assembly (figure 2).

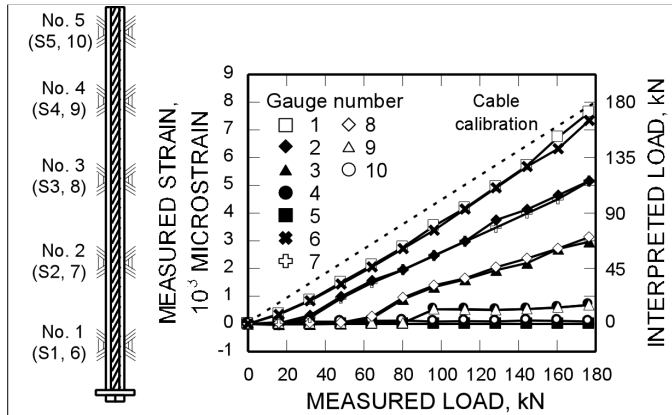
Figure 3.—Calculated load and strain on grouted cable bolt with instrumented king wire.

(figure 1). The cables were loaded to 179 kN using hydraulic pull test equipment. A strain-to-load curve is shown in figure 3 and is typical of what Goris et al. (1994) observed in pull tests with conventional cable bolts.

These tests aid in explaining how load on cable bolts is transferred from the cable to the grout and then into the rock mass. A “shelling” effect is shown whereby the grout-cable interface breaks down and the gage becomes unbonded as load is increased and is taken fully by the cable. Figure 3 shows results of the pull tests as a load profile along the cable length. The curve shows that a 128-kN (~12.8-tonne) pull load on the collar of the cable resulted in measured strain loads of 123 kN along gages 1 and 6 at a distance of 0.15 m from the collar. Researchers inter-

- Bolt 4 shows a load shelling profile similar to that shown in the laboratory (see figure 3). The greatest load was recorded 3.1 m above the back by gages 3 and 8. The ungrouted length (2.8 m) shows a low load primarily because load was distributed over a large distance, as discussed previously. It must be noted that loads were lower on the gages on either side of the bolt at 3.1 m. This implies that a crack was close by.

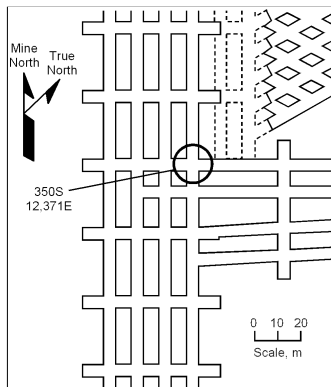
Figure 4.—Instrument locations in trona mine.

Cable bolts were installed in the roof of T.G. Soda Ash’s trona mine, a room-and-pillar operation in Wyoming, to measure roof loads in the intersection of 350S and 12371E (figures 4 and 5). This location was chosen because of drill access ahead of the mining cycle and because loads would be induced in the cable bolts as ore was extracted toward the intersection. Mine personnel were interested in determining the potential for instability in the back and the extent of any unwedged blocks.

Loads on the cable bolts were measured from April 29 through July 11, 1999. Mining activities influencing the intersection were progressing from northeast of the site to the south (figure 4). On June 9, mining reached a point one pillar width from the intersection (8 m). Figure 7 shows all load profiles measured by the 4.27-m-long bolts (bolts 1, 2, 4, and 5) and the 3.66-m-long bolts (bolts 6, 8, 9, and 11). Approximately the last 1.5 m of the bolt was bonded with resin grout.

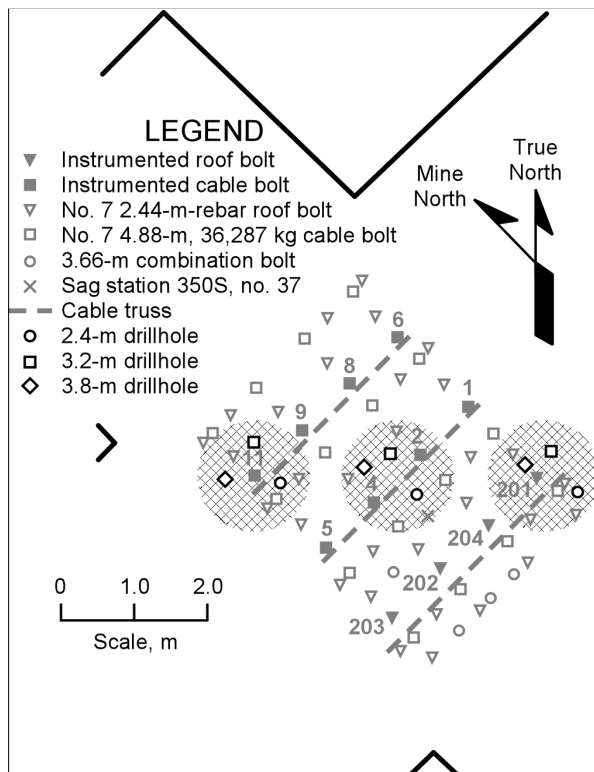
Figure 5.—Bolt and sagmeter locations.

Ground support was installed after development and during rehabilitation. Strain gages were positioned along rebar and cable bolts at depths that would ensure that loads in the resin grout would be measured. In addition, a set of gages was mounted at an ungrouted section to measure dead weight loads in the rock mass. Figure 6 shows the position of the strain gages with respect to the collar. The longest cable bolts were installed at the center of the intersection because these bolts would receive the greatest loads, while shorter cable bolts were installed north of the intersection closer to the pillar front. Resin-grouted rebar bolts were placed in the south part of the intersection to measure loads where the density of rebar bolts was highest. Sagmeter stations were set at three locations in the intersection (figure 5), and holes were drilled to depths of 2.4, 3.2 and 3.8 m. These sagmeter depths were chosen to correspond with the bolt gage profiles (figure 6), allowing correlations to be made between deformation recorded by the strain gages to deformation recorded by the

Three sagmeter stations were installed at three different depths (2.4, 3.2, and 3.8 m) at the intersection of 350S and 12,371E (figure 5). Figure 8 shows that sagmeters at the three stations generated similar curves with displacements ranging from 0.5 to 2.0 cm. In general, the most centrally located station had the greatest displacements at all three depths. Generally, the north-northwest and south-southeast sagmeter stations, which were near the boundary pillars, showed the least amount of deformation. Delamination was observed throughout all horizons with the largest amount of movement between 2.4 and 3.8 m of the back. This roof movement corresponded with data collected from the strain gages, showing that delamination was generally 3 m above the back. Sagmeter readings from the 3.2-m-deep hole at the center of the intersection would be comparable to readings from a 4.3-m-long cable bolt with 1.5 m of resin embedment. This would mean 2.8 m of unbonded cable length.

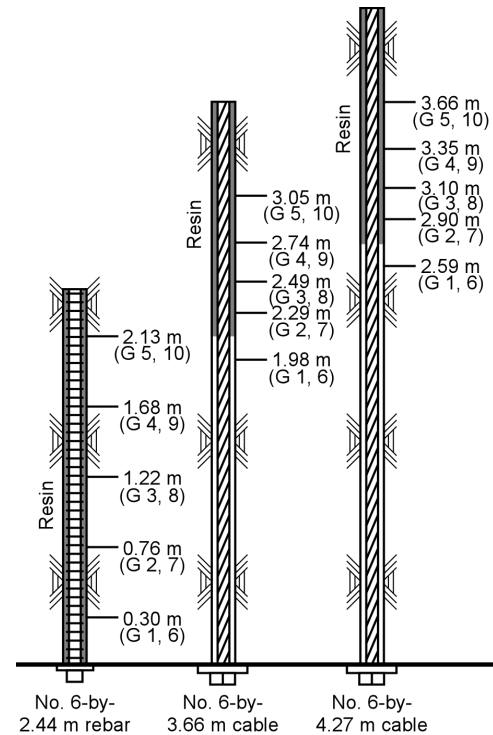
No. 6-by-2.44 m rebar No. 6-by-3.66 m cable No. 6-by-4.27 m cable

- Notes:
1. Assume 1.5-m resin anchor for cable bolts.
 2. All gauges are in pairs at given locations.
 3. Instrumented cable strength is 213.5 kN, yield at 177.9 kN.
 4. Load is 11 kN times microstrain for cables.
 5. Current inventory is: four no. 6-by-2.44-m rebar, four no. 6-by-3.66-m cable, four no. 6-by-4.27-m cable.

Figure 6.—Positions of strain gages on bolts (note two at each position).

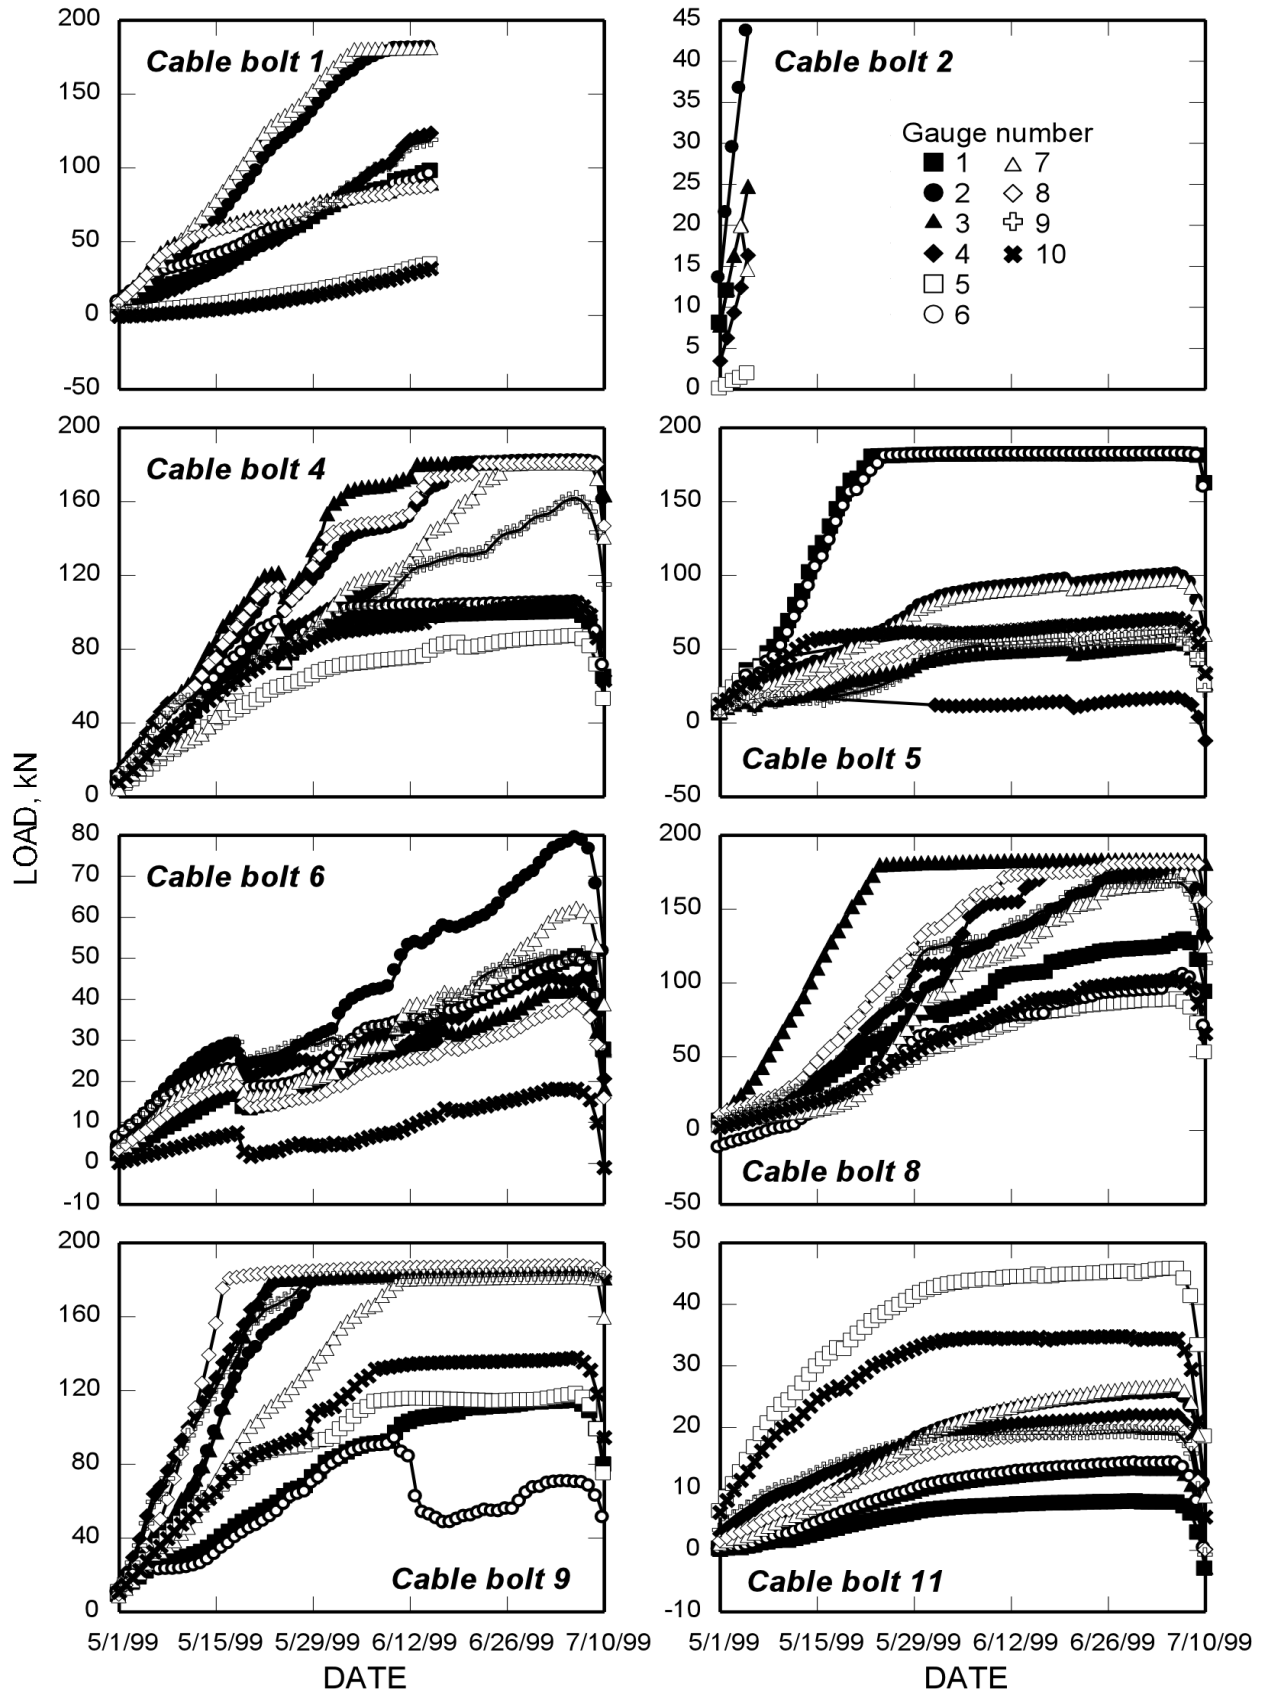
Figure 7.—Load profile versus time on 4.27-m-long bolts (1, 2, 4, and 5) and 3.66-m-long bolts (6, 8, 9, and 11).

- Gages 2 and 7 on bolt 1 were indicating loads up to the yield limit of the steel. These loads were higher than the axial dead weight loads on the ungrouted section of the bolt and loads on the grouted gages, indicating that some delamination was occurring close to the gage. The higher readings were most likely a result of the fact that concentrated load is measured over the gage length by a strain gage, whereas an ungrouted gage measures the sum of all delamination cracks over the length of the ungrouted section, which was 2.8 m. The result is an average load much lower than that of a bonded cable over a given distance.
- Bolt 2 was inspected by mine personnel, who determined the bolt had broken.

- Bolt 5 shows the classic load shelling profile. The highest load was recorded in the ungrouted section within 2.8 m of the back. The next highest load was at the bonded gage 2.9 m from the back. Readings again indicate that delamination was largely controlled by cracks within 3 m of the back.

- Loads on bolt 6 were uniform, with an average of 40 kN, excepting for gages 2 and 10, which were located 2.3 m above the back. This implies that delamination may have been occurring at this location. Note that this bolt was close to the pillar boundary and therefore the depth of cracking would be less.

- Gage sets 2 and 7 (2.3 m deep), 3 and 8 (2.5 m deep), and 4 and 9 (2.7 m deep) on bolts 8 and 9 showed a load profile approaching, and in most cases reaching, the yield strength of the bolt. This reading indicates that delamination was occurring throughout the horizon or that rock mass loading was higher. These two bolts were placed in the north-center section of the site, which experienced high loads such as those on bolt 4, which had also been placed in the center of the intersection. The deepest gages (5 and 10) at 3.1 m in the back recorded low values, indicating that the bond at depths between 2.7 and 3.1 m was sufficient to absorb most of the load.

- Bolt 11 was located at a pillar boundary and therefore was receiving more support from the mine rock, resulting in less delamination. Therefore, loads were lower. Representative load curves for the 3.1-m-deep gage resulted in the greatest amount of load. The second set of gages, at 2.3 m deep, showed the next highest load, and the first set of gages, at 2.59 m deep, had the lowest loads. Delamination was, however, occurring, albeit at low loads, approximately 3 m above the back.

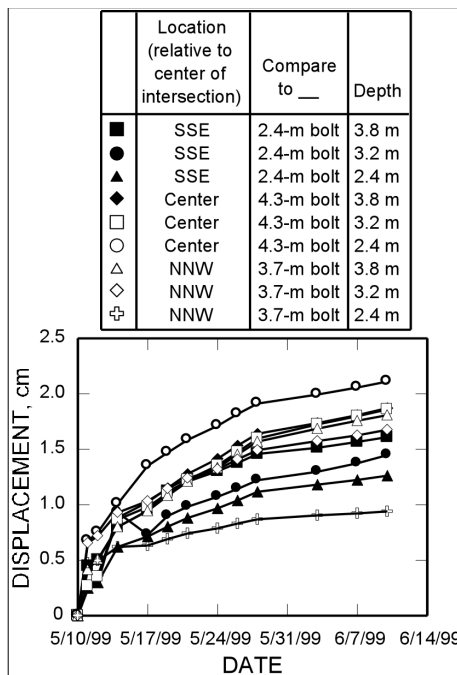
Figure 8.—Displacement of back over time.

Hook's law as applied to a cable with a steel modulus (E) equaling $2.3 \times 10^{11} \text{ N/m}^2$ and a cable area of 0.00011 m^2 would yield an elongation of 2 cm over 2.8 m. The calculated force would be approximately 180 kN. This force correlates with data from the cable bolt for the unbonded section of bolt 5, gages 1 and 6 (figure 7), and bolt 4, gages 2 and 7. Based on this information, it is likely that the resin bond was destroyed as a result of loading.

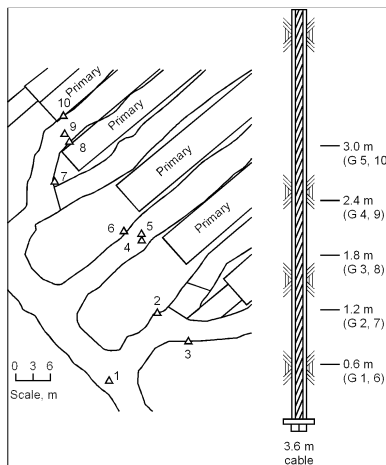
Figure 9.—Plan view of 4950 stope showing locations and depths of strain gages.

Ten 3.6-m-long instrumented cable bolts were installed at the Getchell Mine, which is a transverse, open-stopping operation in Nevada. Gages were spaced 0.6 m apart at five positions on the cable bolt. A tensionable head was placed on the bolt (figure 9), and the bolts were grouted with a cement-based grout into the back and ribs at the locations shown in figure 9. The bolts were then tensioned 10 kN on the cables and bearing plates. The instruments were placed after the primary cuts had been backfilled and the secondary drifts to the ore were about to be mined. This enabled analysis of the effects of secondary and tertiary mining effects.

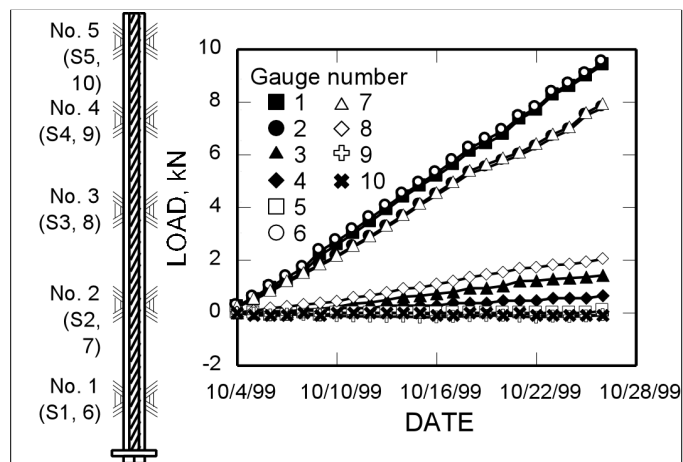
Figure 10.—Load on bolt 4 at Getchell Mine.

Preliminary data indicate that bolt 4 in the stope is showing a load higher than 10 kN (figure 10) while the rest of the bolts are not showing any significant loading (under 1 kN). Loading on bolt 4 suggests that a crack is most likely developing between gages 1 and 6 (0.6 m deep) and gages 2 and 7 (1.2 m deep). A borescope survey was conducted as part of this study and located a crack 0.9 m above the back. Based on a 1.2- by 1.2-m bolting pattern and a depth of 0.9 m (specific gravity = 2.6), a dead load of 38 kN is likely. Measurements and interpretations of the strain data were reinforced by subsequent visual observations intended to provide a higher level of safety for the operator. This area of the mine was reinforced.

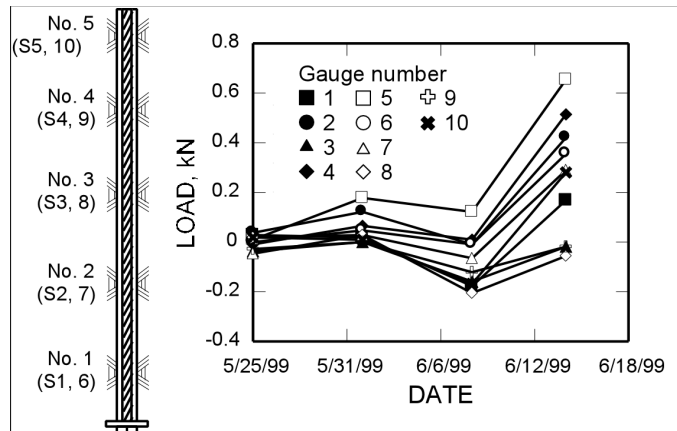
Figure 11.—Load on bolt 14 at K-2 Mine.

The cable bolt was placed into the mine back directly above the sublevel open stope. Preliminary data show low loads on all gages along the bolt (figure 11). The cable is approaching yield at gage 5 (3 m deep), and delamination appears to be occurring close to 3 m above the back. The immediate back exhibits minor loading (gage 1 at 0.6 m deep). The area where the cable bolt is installed is inaccessible since the open stope has yet to be backfilled. There is no concern for personnel because the stope below is nonentry.
