# Ground and Standing Support Interaction in Tailgates of Western U.S. Longwall Mines Used in the Development of a Design Methodology Based on the Ground Reaction Curve

Dennis Dolinar, Mining Engineer  
NIOSH Ground Control Branch  
Pittsburgh, PA

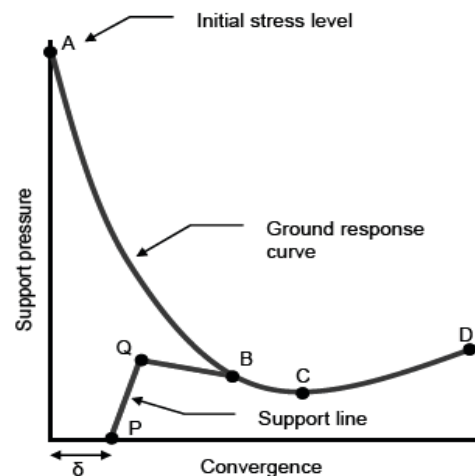
Figure 1. Conceptual ground reaction curve.

The support and rock interaction are also shown on Figure 1. Points PQB represent the load-displacement curve for a yielding support. The support is installed after some initial convergence, then develops load and yields before finally intersecting the ground reaction curve (Point B). Equilibrium between the support and the rock mass is then achieved. The minimum level of support necessary to achieve equilibrium is the amount required to reach the nadir (Point C). However, depending on the ground reaction curve, significant rock damage and convergence could occur as this point is approached. Further, there is no margin of safety in this design. The maximum level of support has been termed the support design threshold in a previous study (Barczak et al., 2008). This is the transition point on the curve between linear and non-linear behavior. Levels of support greater than the design threshold would provide little benefit because there is no rock damage and limited convergence.

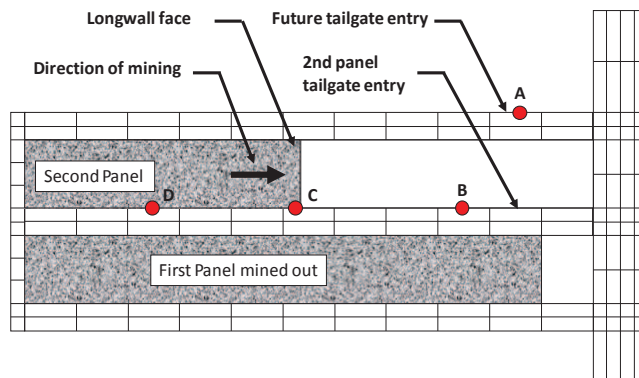
Figure 2. Generalized longwall panel layout indicating the four locations where the ground reaction curves should be determined. The points represent the following loading conditions: A-development, B-side abutment, C-front abutment at the face, and D-full extraction (Dolinar et al., 2009).

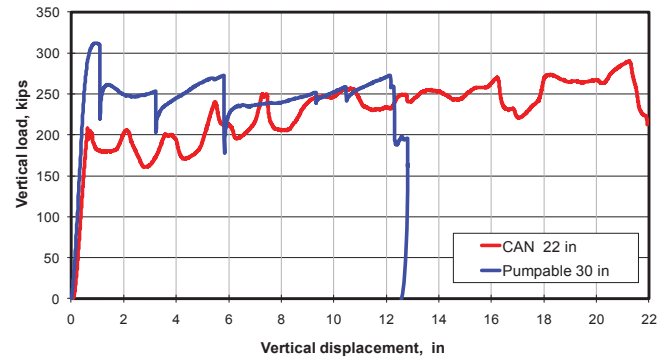
**Figure 3. Load-displacement curves for a 22-in diameter CAN and a 30-in diameter pumpable crib tested in the Mine Roof Simulator. Both supports were 6-ft high.**

Figure 3 shows typical load-displacement curves for each type of support based on tests conducted at the Pittsburgh Research Laboratory in the MRS. For both types of support, the yield or peak load is achieved between 1 to 2 in of displacement and each has a similar stiffness up to yield or peak load. The CAN exhibits an approximate elastic-plastic behavior with the support load still increasing after yield but at a reduced rate. After yield, the CAN will remain stable through 20 in of displacement. On the other hand, the pumpable crib demonstrates a strain softening behavior. The peak load is reached with less than 1 in of support convergence. As a result, in higher convergence environments, the peak load will be exceeded. Therefore, it is the residual strength and not the peak strength that must be considered in such conditions. In this test, the residual strength was above 200 kips. The pumpable crib will generally maintain a fairly high residual strength through about 10 in of displacement. Significant drops in residual strength are associated with the grout fracturing and loss of confinement by the containment bag and wire wrap.

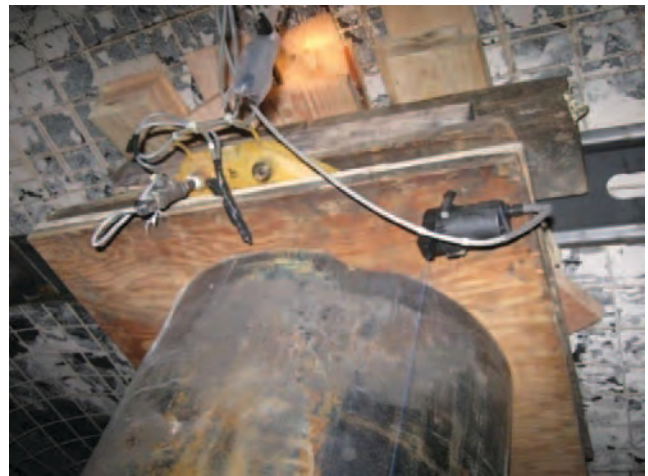
**Figure 4. Load cell and displacement transducer installed on a CAN.**

Instrumentation was installed to measure the support loads, the support, and the roof-to-floor convergence. All the instruments were read remotely using permissible data loggers. The support loads were measured by installing calibrated flat jacks with pressure transducers on the top of the support (Figures 4 and Figure 5). Displacement measurements were made with wire potentiometers. These have a displacement range of about 11 in (Figures 4 and 5). For the CAN displacement, the potentiometers were installed on a piece of plywood that had been placed on top of the support (Figure 4). For the pumpable cribs, the potentiometers were mounted about 6 in from the top of the support (Figure 5).

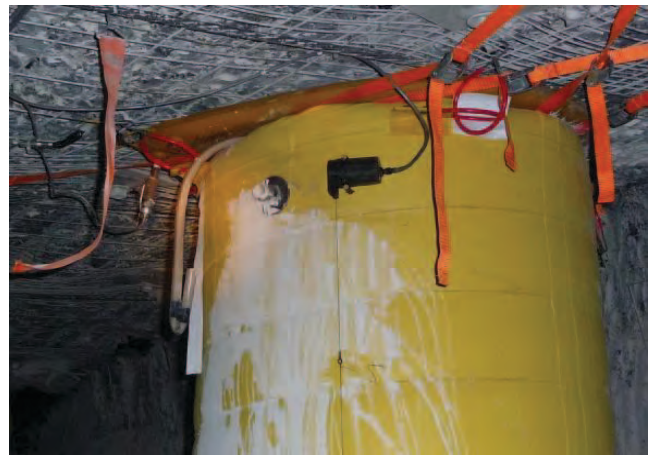
**Figure 5. Load cell and displacement transducer installed on a pumpable crib.**

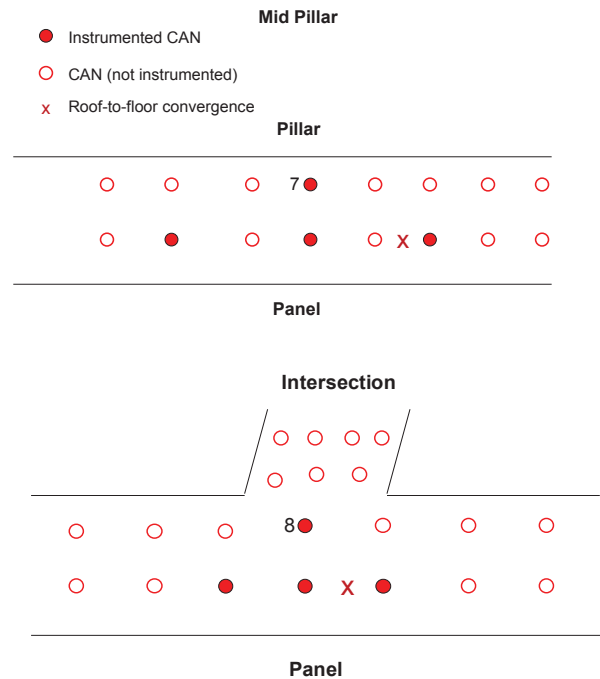
Figure 6. Layout for instrumented test sites in Mine A.

Figure 6 shows the layout of the test sites. A total of 8 CANs were instrumented. Initially, a single row of CANs was installed along the panel side of the entry (instrumented CANs 1 to 6). The support spacing in a row was between 8 and 9 ft center-to-center. Installed CAN heights ranged from 8 to 10 ft and were topped with 9 to 20 in of wood. To achieve the required heights, the CANs were made from 2 sections that were welded together with the top section being 5 ft long and the bottom section ranging from 3 to 5 ft long depending on the overall height of the CAN. The instrumentation and support were installed about 300 ft ahead of the first panel face. Because the depth was greater than 1,500 ft, a second row of CANs was installed about 700 ft in front of the face during second panel mining (instrumented CANs 7 and 8). As a result, the second row of CANs was subjected to front abutment loading only and not to the side abutment.

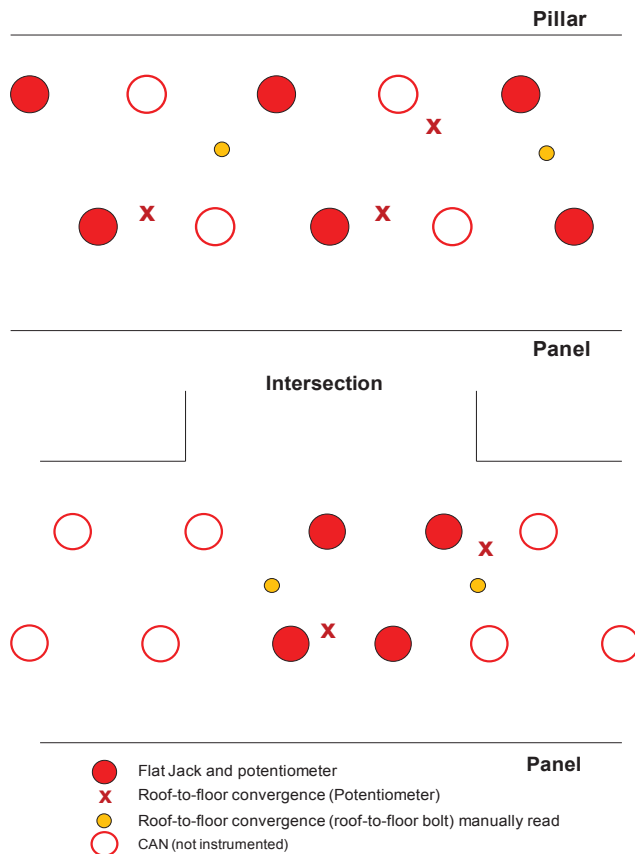
**Figure 7. Layout of instrumented test sites in Mine B.**

Figure 7 shows the layout of the test sites. Two offset rows of pumpable supports were installed with center-to-center support spacing between 8 and 9 ft. A total of 10 supports were instrumented: 4 in the intersection and 6 at a mid-pillar site. The supports and instrumentation were installed about 250 to 350 ft in front of the first panel mining.

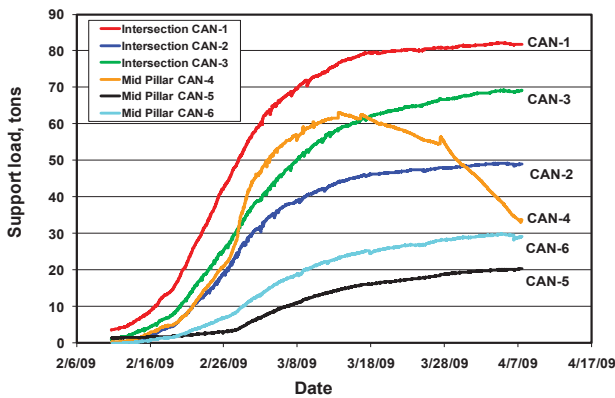
**Figure 8. Support load versus time, side abutment loading from first panel mining,**

The support load versus time for first panel mining is shown in Figure 8. The face passed the test sites between February 13 and 15. At the end of the first panel monitoring period, the average support loads developed in the intersection were 66 tons and at the mid pillar site 25 tons. In general the loads increased rapidly after the face passed then continued to increase but at a reduced rate (CAN 4 is the exception). The average support convergence in the intersection was 0.9 in and at the mid pillar site 0.5 in. All instruments used to measure the roof-to-floor convergence were lost, but based on this data in comparison to the support convergence, the estimated entry convergence in the intersection was 8 in and at the mid pillar site 4.5 in. (The instruments measuring the roof to floor convergence were lost within a week after being installed. During this period about 0.6 in of roof to floor convergence was measured.) The loads developed on the support during second panel mining with respect to the distance from the longwall face are shown on Figure 9 and Figure 10. In all cases, the support went into yield. Table 1 gives the yield, maximum, residual, and face loads, as well the distance from the face when the support yielded.

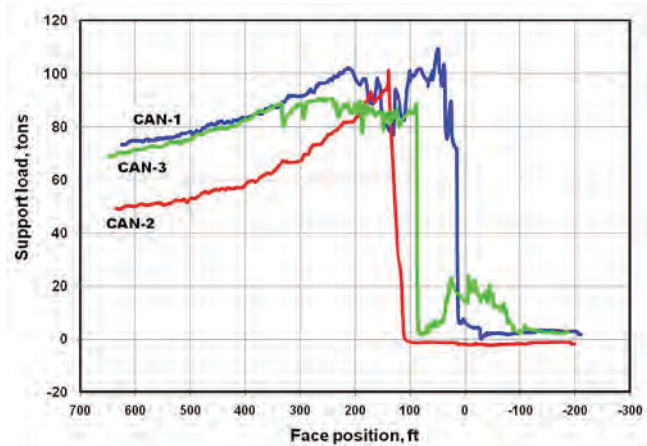
**Figure 9. The support load versus the face position for second panel mining for the intersection site at Mine A.**

During second panel mining at Mine A, all the CANs went into yield well out by the face. The average yield load for the support along the panel was 95 tons for those in the intersection and 94 tons for the mid-pillar site (excluding CAN 4). The yield loads are close to the 100-ton yield capacity for the support as determined in the laboratory. The average yield distance for the support was 230 ft and 75 ft for the mid-pillar site. Because of the stable yielding characteristics of the CAN, even after yielding out by the face, the CAN has sufficient capacity through the range of displacements that were measured. The yield load was sustained in several CANs over 100 to 300 ft of longwall panel mining (Figure 6). However, significant load shedding had occurred before the face reached the support with 5 of the supports having loads only between 0 and 15 tons when positioned at the face. Only one support along the panel side continued to have a significant post-yield load. For the five load shedding supports, the load shedding occurred very rapidly, but this was not the result of the failure of

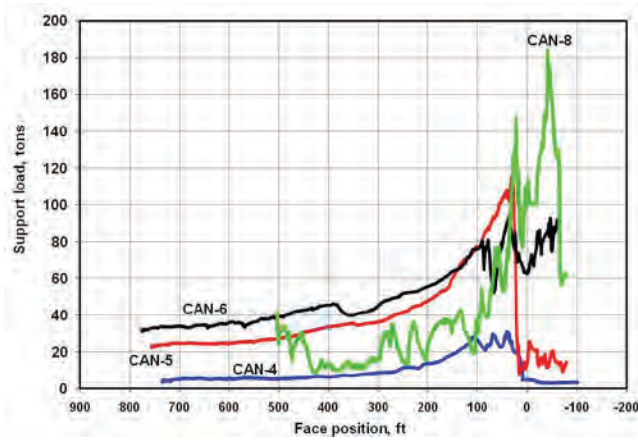
Figure 10. The support load versus the face position for second panel mining for the mid pillar site at Mine A.

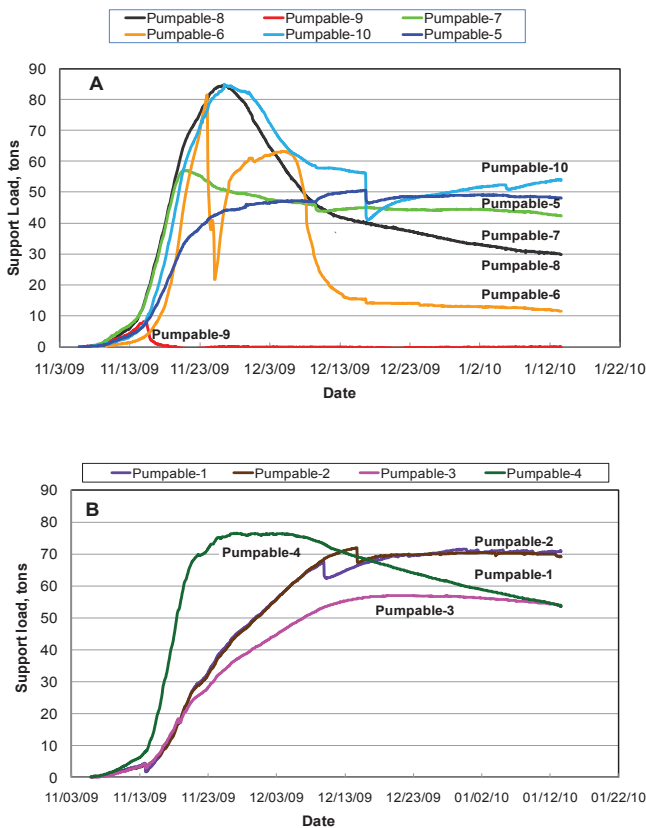
Figure 11. Support load versus time for first panel mining for Mine B—mid pillar (A) and intersection (B).

Figure 11 shows the support loads with respect to time from the first panel mining. The face passed the sites between November 11 and 14. The average support loads at the completion of first panel mining were 60 tons in the intersection and 37.5 tons at the mid pillar site. There was an initial rapid increase in the load development followed by a leveling off, and in 6 of the 10 supports, load shedding occurred. However, there was no evidence of damage to the pumpable cribs that would have suggested that they were loaded beyond their peak capacity. The average support convergence in the intersection was 0.22 in and at the mid-pillar site was 0.6 in. Measured roof-to-floor convergence in the intersection was 15 in and 17.5 in at the mid-pillar site. The second panel has yet to be mined past these sites.

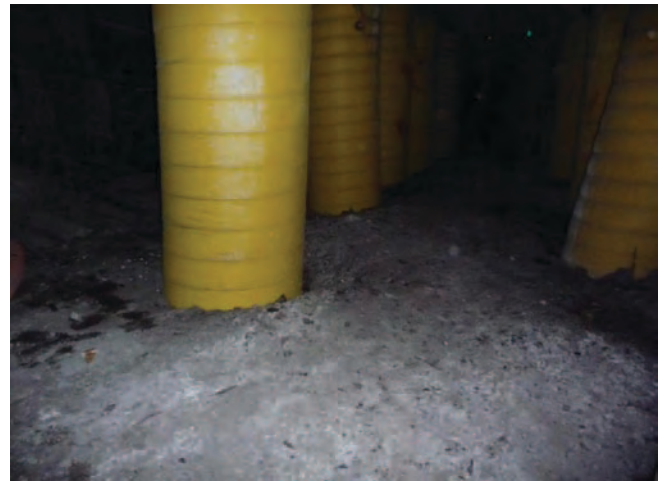
Figure 12. Floor heave developed during first panel mining from the side abutment at Mine B.

At both sites, floor heave pushed up around the supports (Figure 12). At the mid-pillar site, the roof started to fail in the middle between the two rows of pumpable supports. This resulted in bagging of the roof screen from loading due to failure of the immediate roof. Additional support in the form of Roc Props was then installed on 6-ft spacing.

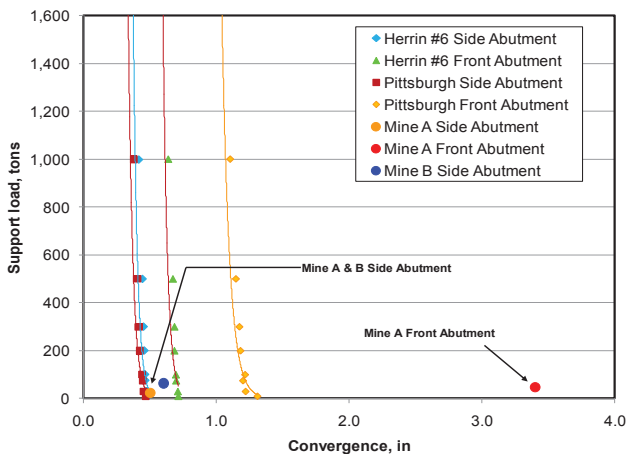
**Figure 13. Comparing the ground reaction for the two western mines to that from the Pittsburgh and Herrin #6 seams for the side and front abutment loading conditions.**

Based on data obtained from similar test sites as established in this study, ground reaction curves were developed for mines in the Pittsburgh Seam and the Herrin #6 Seam in the Illinois Basin (Barczak et al., 2008; Dolinar et al., 2009). Figure 13 shows these ground reaction curves for the side abutment loading and front abutment loading at the face for mid-pillar conditions. In the Pittsburgh Seam case, the depth is 750 ft, and in the Illinois case it is 500 ft.

The ground reaction points for the two western mines are also shown on Figure 13. For the mid-pillar site at Mine A, the support load for the side abutment loading was 3 tons/ft (24 tons) and for the front abutment loading at the face it was 6 tons/ft (48 tons). The support loads from side abutment loading for Mine B at the mid-pillar site were 8 tons/ft (64 tons). For the side abutment case from first panel mining, when only the support convergence is considered, the ground reaction is similar for Mine A and the Pittsburgh and Herrin #6 Seam sites despite the difference in depth. Also, there is only slightly greater convergence in Mine B than

in the Pittsburgh and Herrin Seams. Essentially, the position of the curves for the side abutment loading is similar to the Eastern mines. A significant difference does develop with front abutment loading. In this case, the position of the ground reaction curve has shifted significantly to the right for Mine A. This implies more convergence for the same level of support.
