IGNITION HAZARD

From internally-generated H₂ in sealed mining equipment

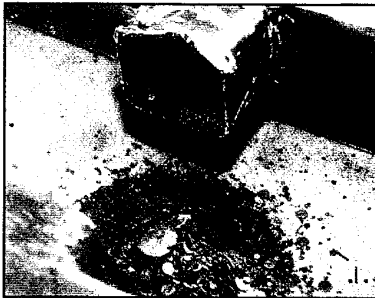
Fig. 1. The cut end of a filled plow frame section (4x4x142 in.) and the contained metal scrap.

in the state of New York in 1995 and 1996. Workers were drilling into sealed frame members that were filled with metal scrap (Fig. 1). They were thrown back for some distance by the force of the ignited jet and suffered burns. Both equipment frames had been filled with sundry metal scrap, including galvanized steel, that were generated by punching operations in machine shops. Hydrogen gas was found to accumulate in the resealed sections of both frames, and a rough linear increase of pressure with time was noted in the one frame that had been supplied to us for a detailed study. An absolute pressure of 185 lb/in.², predominantly from hydrogen gas, was found when the remaining sealed section of this frame was penetrated using a drill designed for the safe penetration of pressurized gas lines.

The lesson learned from these incidents is that sealed and filled equipment components must be treated as if they contained a flammable gas at considerable pressure. Penetration of such equipment should be done remotely, in a safe area, or with a drill used to penetrate high-pressure natural gas lines safely (the method that both NIOSH and the Australian investigators used). The above potential hazard can be minimized by providing a vent hole or valve in such sealed systems, or insuring that only clean and dry-carbon steel scrap is used. **ENR**
