ROOF SCREENING: BEST PRACTICES AND ROOF BOLTING MACHINES

Susan B. Robertson, *Mining Engineer*
National Institute for Occupational Safety and Health
Pittsburgh Research Laboratory
Pittsburgh, Pennsylvania USA

Gregory E. Hinshaw, *Vice President of Engineering*
J.H. Fletcher and Company
Huntington, West Virginia USA

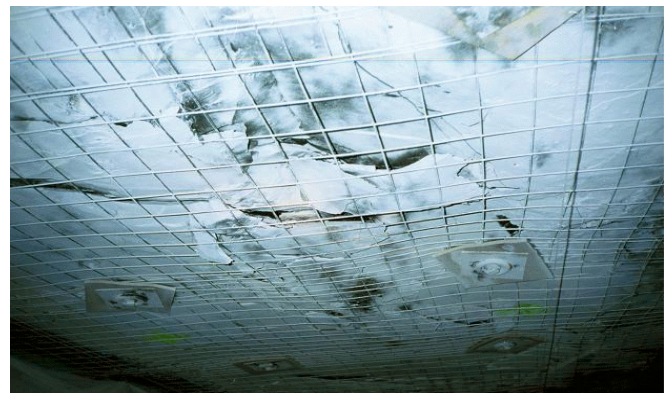
entry in which it was installed. Some roof is of such poor quality that nothing short of full coverage will provide the best protection. In such adverse conditions, roof screen can provide the necessary protection for miners. Figure 1 shows roof screen effectively controlling weak roof skin.

Figure 1. Roof screen effectively controlling weak roof skin.

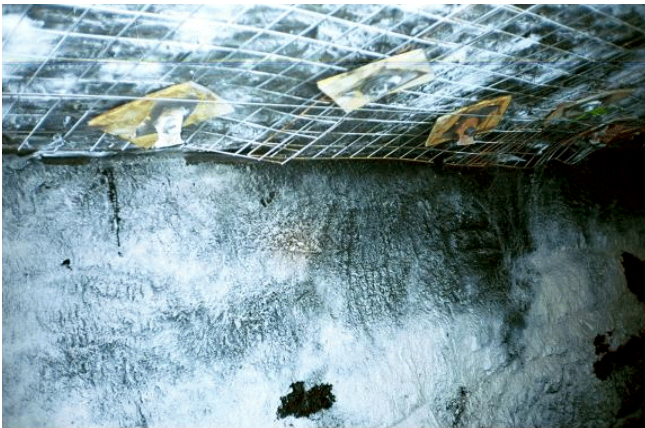
While some mines use plastic geogrid screen for surface control, most that are currently roof screening make use of steel wire sheets with a 4-in grid pattern. Screen can be ordered in many sizes depending on the coverage desired or attainable. One problem is that the reach of some bolting units limits how far screen can be bolted toward the rib. A gap may exist between the end of the last bolt and the rib, allowing guttering to occur. To combat this problem, brow tenders (also known as short straps or extended straps) can be used to extend the coverage of roof screen. Bolting machines capable of installing angle bolts also make it possible for the roof screen to be extended further to the rib. Figure 2 shows how roof screen can be supported to within in from the rib. In this figure, 94% roof coverage was achieved by roof screening.

Figure 2. Roof screen achieving up to 94% roof coverage.

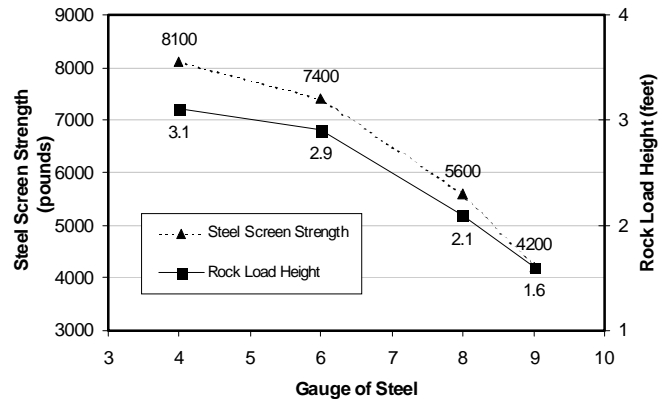
Besides screen size, sheets can also be ordered in different steel gauge strengths. These strengths (2) along with the rock load height they support are shown in figure 3. The rock density used to calculate rock load height was 162 psf. All the mines visited during this investigation used 8-gauge steel wire sheets with a 4-in grid pattern capable of supporting 2.1 ft of roof skin. This is quite sufficient to contain most skin falls, especially after weathering effects.

Figure 3. Different strengths and rock load heights for 4 gauges of steel screen.

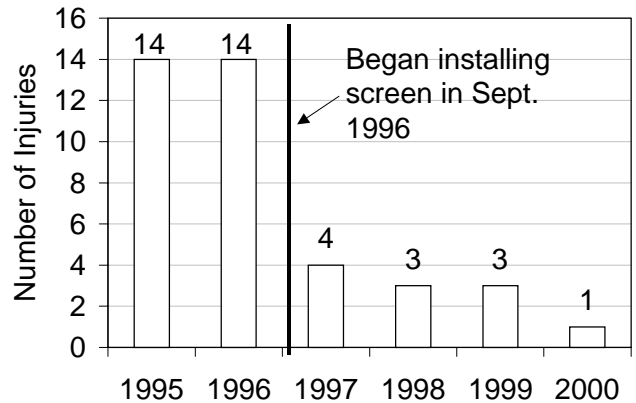
The Mine Safety and Health Administration (MSHA) injury data from two mines was analyzed to determine the effect of screening on safety. One, located in the northeastern U.S., had roof conditions that deteriorated to a point where roof screening was necessary everywhere. After screening was implemented, injuries dropped from an average of 14 to 3 per year (figure 4). At the other, in the central U.S., similar circumstances were encountered that required roof screening. Injuries there subsequently dropped from an average of 7.0 to 0.25 per year (figure 5). Clearly, screening can dramatically reduce rock fall injuries.

Figure 4. Number of skin fall injuries per year at a northeastern U.S. mine before and after the implementation of screening.

It takes an average of 0.42 minutes to handle each piece of screen per 4-ft advance. This time includes operators waiting for and taking the screen from the rib bolter operator, and then placing it across the ATRS. Any adjustment of screen position was also included. The total bolting time for a 4-ft advance, including drilling, installing, maneuvering, setting the ATRS, and screening, was 8.36 minutes. The screening time comprised only 5% of this total. For a bolting advance of 120 ft, screening would add an additional 12.6 minutes. Mine management feels that this is a small price to pay for superior roof coverage and decreased risk of injury (figure 4).

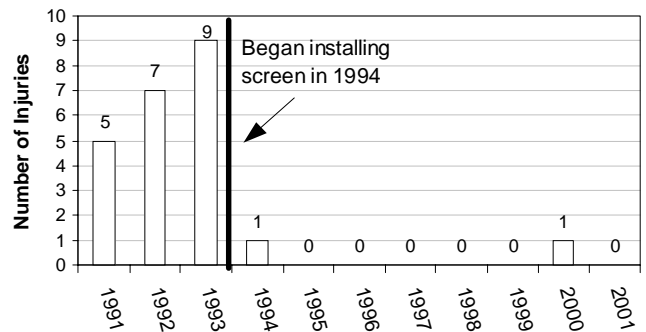
Figure 5. Number of skin fall injuries per year at a central U.S. coal mine before and after the implementation of screening.

due to rock falls dramatically decreased at this mine from an average of 7 to 0.25 per year (figure5).
