NJ FACE INVESTIGATION REPORT

FACE 14-NJ-74

Day Laborer, First Day On The Job, Struck and Killed by Backhoe Bucket

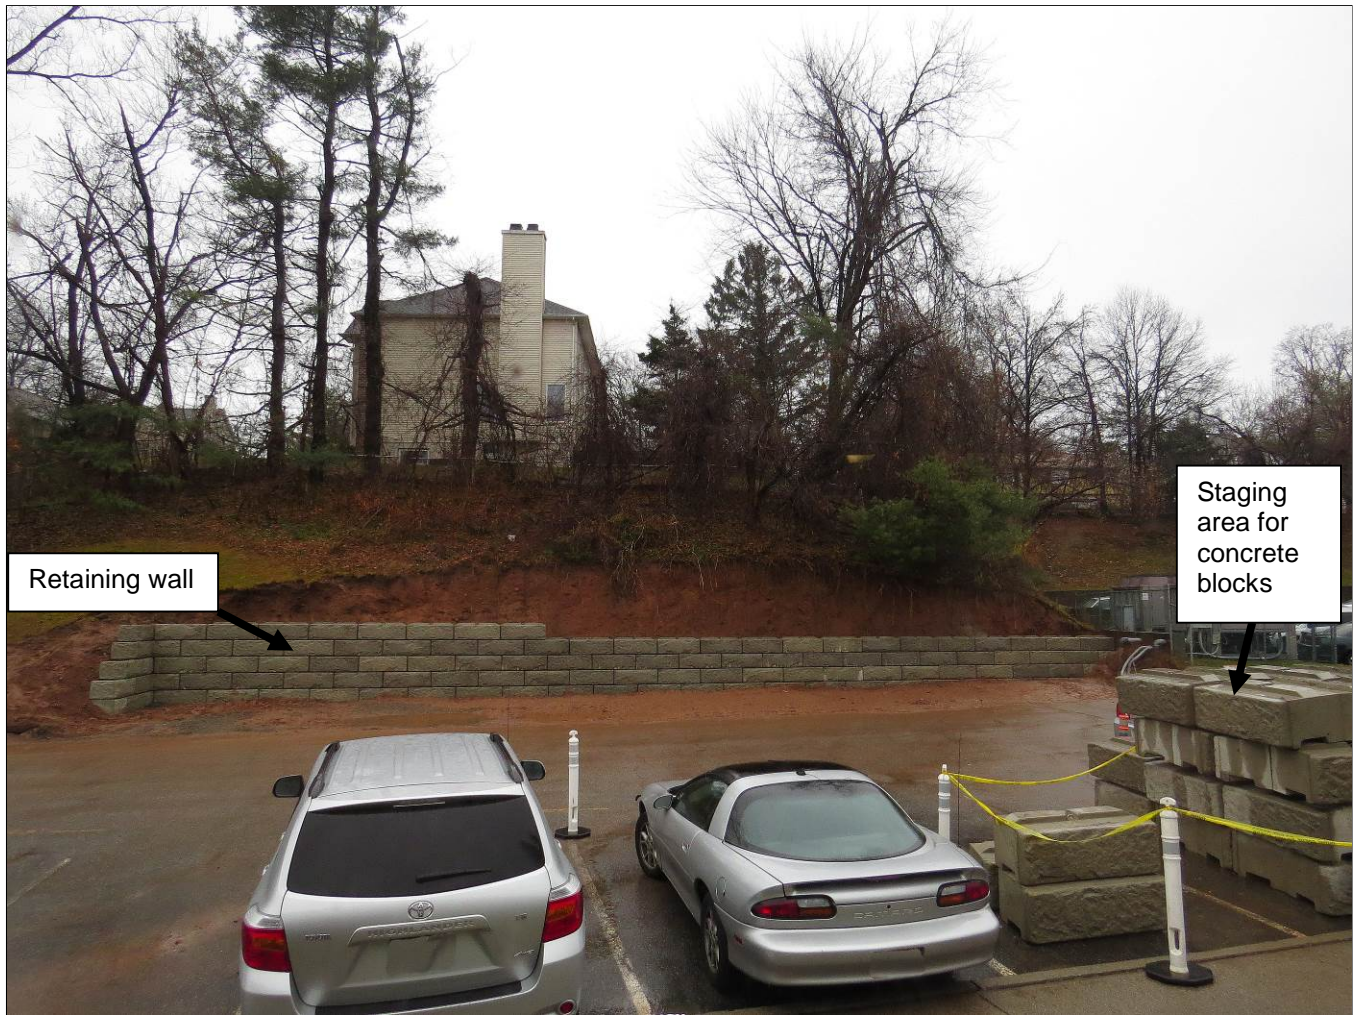
FIGURE 1. Incident site; a) parking lot of health care facility, b) closer view of retaining wall.

The incident occurred on a calm, dry, winter day (approximately 40° F at the time of the incident, wind speed up to eight mph), with no significant precipitation recorded. The incident site was located in the parking lot of a healthcare facility (Figure 1a). The facility hired the employer to build a sidewalk and a retaining wall (Figure 1b) as part of an expansion of the parking lot. The job was to take approximately a month to complete and they had been on site about three weeks when the incident occurred. Job training was on-site, and no personal protective equipment was worn. The only piece of equipment on site was a backhoe loader, which is a tractor with a loader in the front and a small backhoe with bucket in the back (Figure 2). This particular model has a seat that swivels 180 degrees so that the operator can control the backhoe (boom and bucket) and the stabilizers from one location.

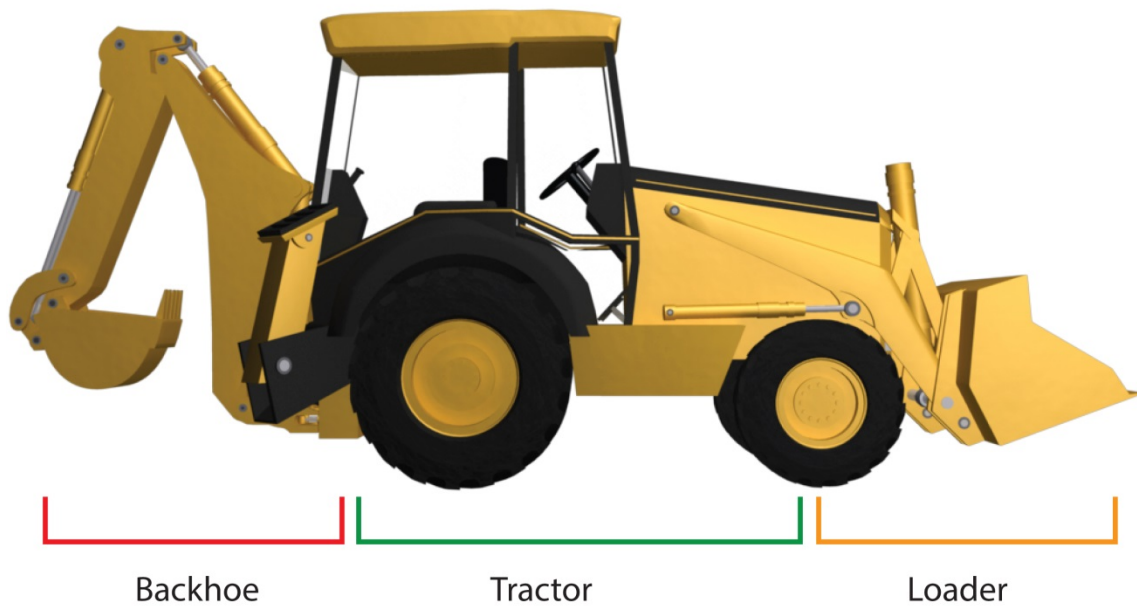
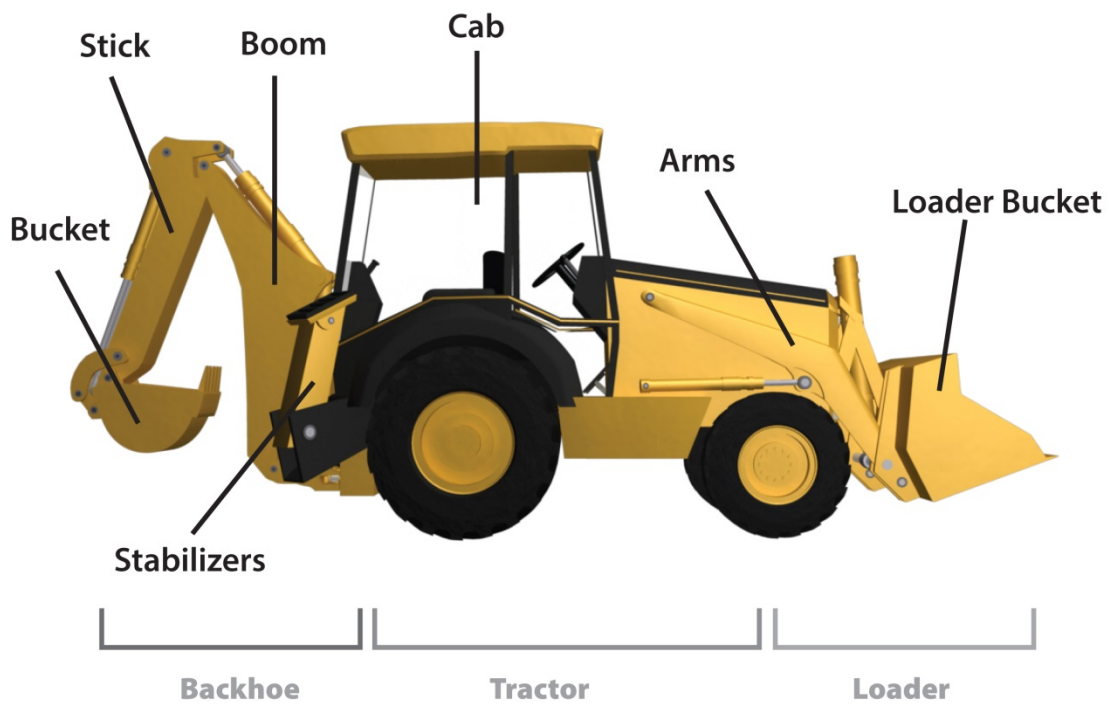
FIGURE 2. Illustrations of a Backhoe Loader.*

- 1) When the backhoe of a backhoe loader (see Figure 2) is in operation, no one should enter the full swing area of the boom. The operator's vision of this area can be limited and anyone entering may not be seen by the operator.
- 2) If a worker must enter the swing danger area, eye contact as well as confirmed communication (verbal/hand signal/radio/etc.) with the operator must be established (Figure 5). The worker then must wait until the operator signals that it is safe to enter this area. The operator should not move the backhoe until the worker has cleared the area. When it is necessary for the worker to remain

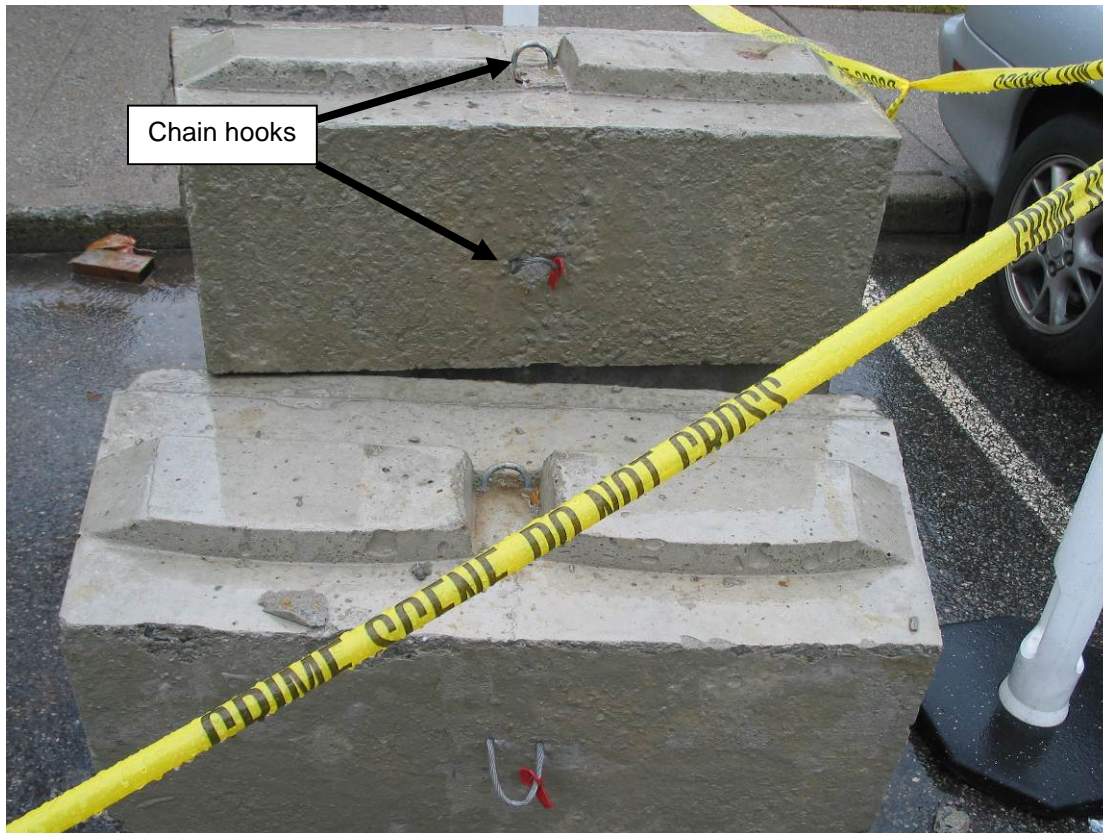
FIGURE 3. Concrete block with hooks to connect chain.

A three-person crew was originally assigned to the job site; a foreman and two other employees, all of whom were from Brazil and spoke Portuguese. After several weeks, the foreman had to leave to go back to Brazil and left one of the other employees, who had been on site (and had eight years of experience with the company), as foreman and backhoe loader operator. Needing additional help, the new foreman hired a day laborer. This employee, who spoke Spanish, worked on the site for three days, and his major task was to attach and detach the chain that was used to connect the concrete blocks to the bucket of the backhoe. The chain was connected to the blocks at fixed anchor points (Figure 3). The backhoe loader operator could then lift the block and move it from the staging area to the wall. The operator lowered the block into position and a worker would help guide this process and then detach the chain.

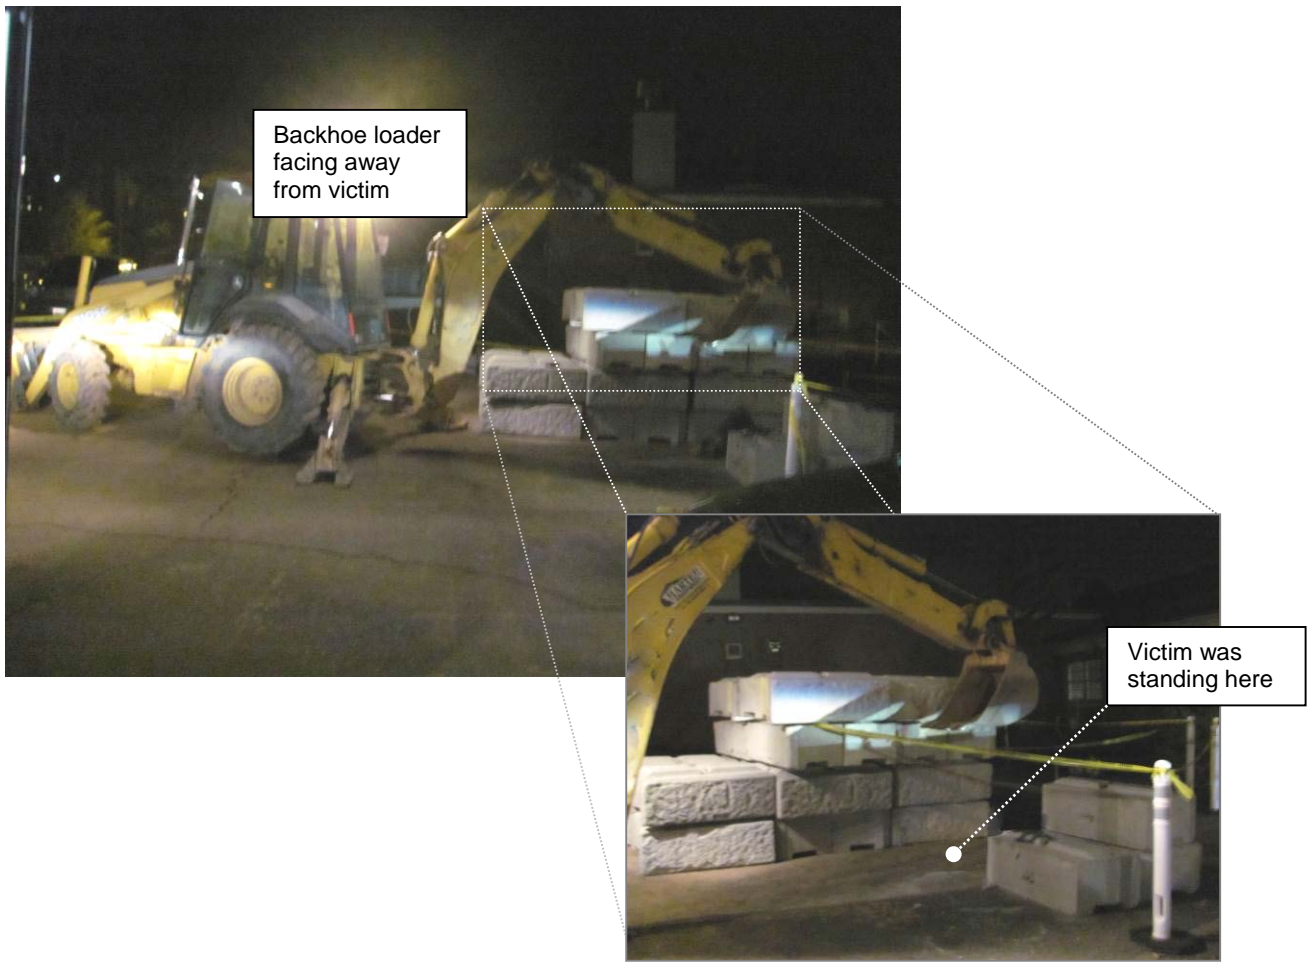
The incident occurred at about 3:50 pm. The crew of three had finished setting a block on the wall, and the victim walked back to the staging area with the chain to prepare for the next block to be moved. The foreman drove the backhoe loader forward a few feet then performed a three-point turn (a “K turn”) and backed in towards the staging area. He lowered the bucket to the ground, swiveled the seat 180 degrees to face the backhoe, and used the controls to lower the stabilizers to the ground. He then swung the backhoe boom to position it for the victim to attach the chain for the next block. (Figure 4). As the foreman swung the boom, it struck the victim in the head and crushed him against the pile of blocks. The victim suffered major blunt force head injuries, and was pronounced dead shortly afterwards at the site.

FIGURE 4: Location of victim and backhoe loader at time of incident*
