Field observations and numerical studies of horizontal stress effects on roof stability in US limestone mines

by G.S. Esterhuizen*, D.R. Dolinar*, and A.T. Iannacchione*

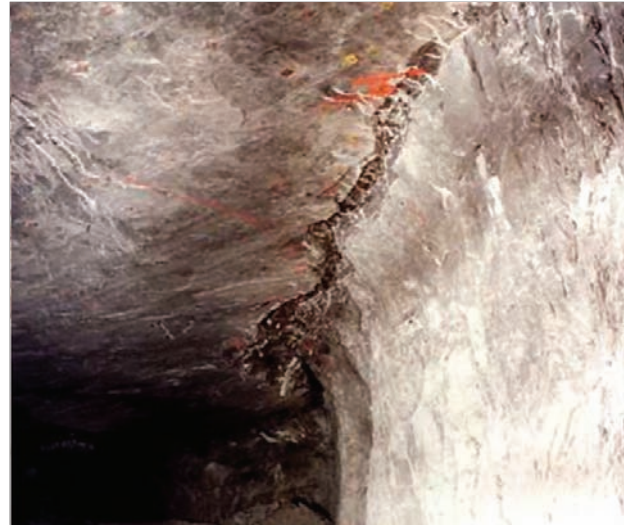
Figure 2—Roof guttering at the pillar-roof contact

Horizontal stress related damage can manifest itself as guttering along the pillar-roof contact area^{6,19} as seen in Figure 2. This is very similar to ‘cutter roof’ seen in coal mines that are subject to high horizontal stresses. Once the roof has been damaged at the pillar contacts, the confining stresses are relieved and the immediate roof layers can fail. The failure can extend across the width of the excavation if it is not well supported. This type of failure has been observed in mines located in both inclined and flat lying limestone formations.

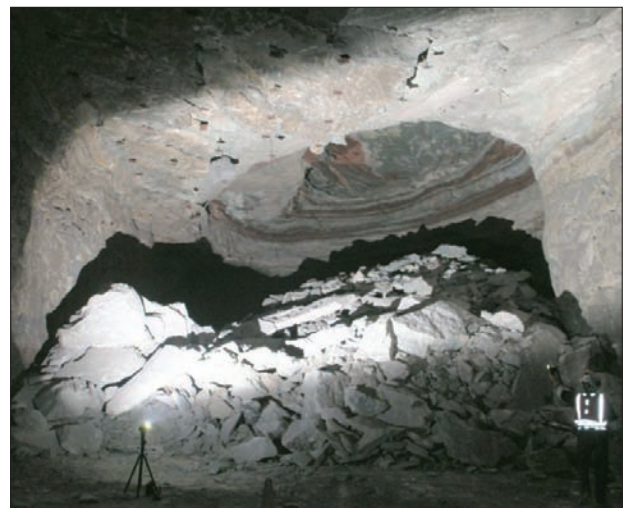
Figure 4—Large-oval shaped fall that has propagated upwards into weaker overlying strata in a limestone mine

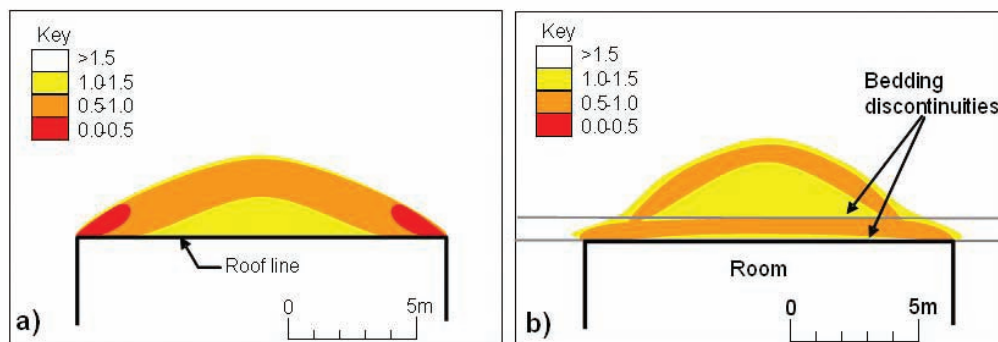
Figure 7—Vertical section along A-A in figure 5 showing rock failure index values (a) without bedding discontinuities and (b) with a bedding discontinuity 1 m above the roof line

The failure index results in Figure 7a show that, in the absence of bedding discontinuities, rock failure potential is a maximum at the pillar-roof contact and can extend over the room to form an arch of potential failure up to about 3 m above the roof line. If a single bedding discontinuity is introduced 1 m above the roof line, see Figure 7b, the stresses are re-distributed by the presence of the discontinuity. A reduction occurs in the horizontal stress in the 1-m-thick roof beam as it deflects downwards and some slip

occurs along the bedding discontinuities. Separation of up to 2 mm occurs across the bedding discontinuity near the centre of the room. The beam deflection causes an increase in horizontal stress as well as a reduction in confining stress in the overlying roof, which causes the potential rock failure to extend to 4 m above the roof line.

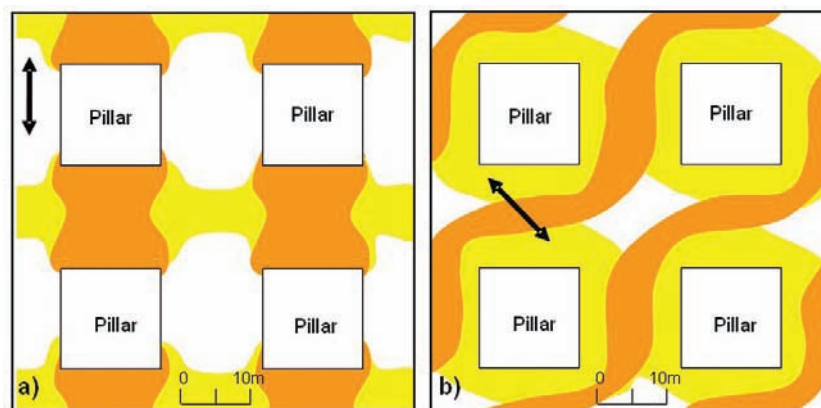
Figure 9—Plan view showing effect of a change in the orientation of the maximum horizontal stress potential roof failure in a room and pillar layout consisting of square pillars. Darker shading indicates initial failure and lighter shading indicates potential failure growth. The arrow indicates the direction of maximum horizontal stress

Figure 9 shows the initial failure and failure growth in the roof for a layout of square pillars that is (a) aligned with the direction of maximum horizontal stress and (b) the stress is rotated through 45°. These results show that for the first case, failure is likely to initiate between pillars and will grow in the direction perpendicular to the maximum horizontal stress, similar to the behaviour observed in limestone mines. A practical issue with this type of failure is that once failure starts, it is free to extend laterally across the width of the mine until a solid abutment or barrier pillar is encountered.

The results for the 45° case show that roof failure is likely to snake through the pillars, similar to the failure seen in the field study presented in Figure 5. Again, this type of failure can continue to extend laterally until a barrier or abutment is encountered. The model showed that ultimate roof failure can encircle the pillars, which was observed in one location at the mine site as shown in Figure 5.

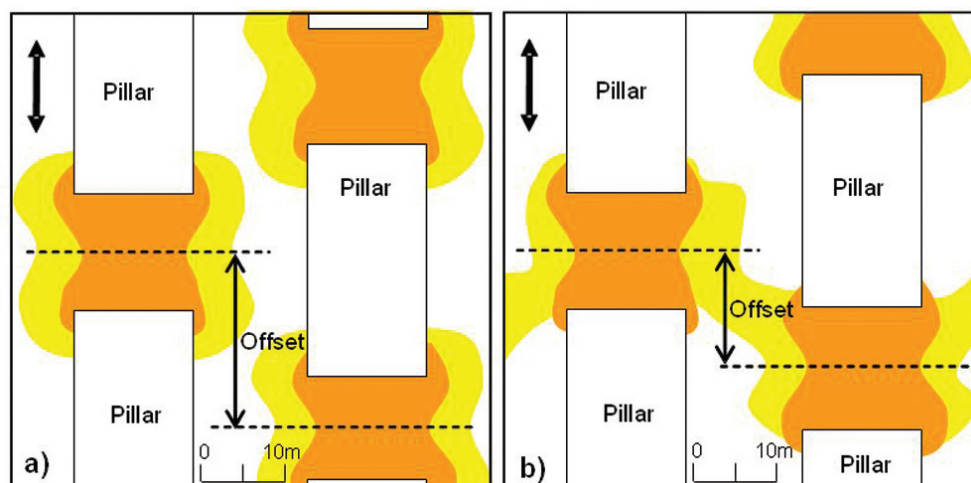
Figure 10—Plan view showing effect of a change in the pillar offset on potential roof failure in a room and pillar layout consisting of rectangular pillars. Darker shading indicates initial failure and lighter shading indicates potential failure growth. The arrow indicates the direction of maximum horizontal stress

The practice of aligning pillars and heading development parallel to the direction of maximum horizontal stress was simulated to determine whether the models would reflect the improved stability of this type of layout. The model was set up to simulate rooms and pillars that were the same width as those shown in Figure 9, except that the pillar length in the direction parallel to the maximum horizontal stress was doubled. In addition, the cross-cuts were offset, a common practice in the limestone mines, so that the lateral growth of roof failure is restricted. The results shown in Figure 10a, presents a case where the cross-cuts are located opposite the centre of the adjacent pillar, that is, the offset is a maximum. It can be seen that potential failure initiation is very similar to that shown in Figure 9a for the square pillar layout. However, failure growth is restricted to the vicinity of the cross-cut. Should the failure extend across the adjacent rooms, it will encounter the adjacent pillar, which will halt its growth. Figure 10b shows a case where the cross-cut offset has been reduced. Here, it can be seen that the initial failure is again similar to the previous case, but the failure growth cuts across the headings into the adjacent cross-cuts, resulting in the potential for a continuous band of failures across the width of the mined area.
