## Preprint 03-138

### FIELD PERFORMANCE TESTING OF FULLY GROUTED ROOF BOLTS

C. Mark
C. S. Compton
D. R. Dolinar
D. C. Oyler
Natl. Inst. for Occuptnl. Sfty. & Health
Pittsburgh, PA

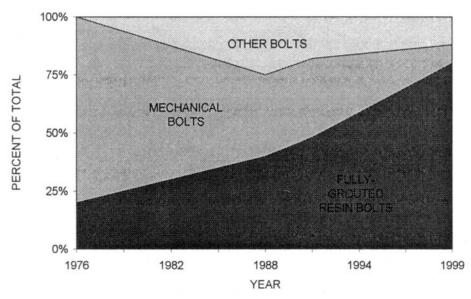
Figure 1. Trends in U.S. roof bolt usage (source: Dolinar and Bhatt, 2000).

Roof bolts have been the primary roof supports in U.S. coal mines since the late 1950's. Fully grouted resin bolts were introduced about a decade later. A survey conducted by NIOSH in 1999 (Dolinar and Bhatt, 2000) found that the coal mining industry used about 85 million roof bolts. Of these, approximately 80% were fully grouted. Figure 1 shows the historical trends in roof bolt usage in the U.S. For many years, the most common fully grouted bolt installation was a 19 mm (0.75 in) bolt in a 25 mm (1 in) hole. In recent years, however, 16 mm (5/8 in) bolts have become more popular. The 1999 survey found that about 80% of all fully grouted bolts were the smaller diameter.

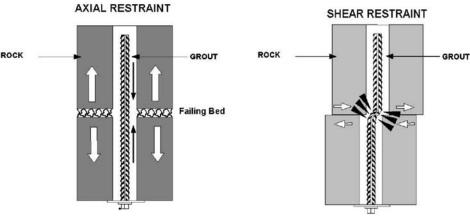
Figure 2. Loads in fully grouted roof bolts caused by roof movements. A) Tension resulting from bed dilation or bed separation; B) Tension and bending caused by slip on a bedding plane.

Fully grouted bolts are loaded by movement of the rock. As illustrated in figure 2, the movement may be vertical sag, shear along a bedding plane, or dilation of a roof layer buckled by horizontal stress (Signer, 2000; Fabjanczyk and Tarrant, 1992). The movements cause

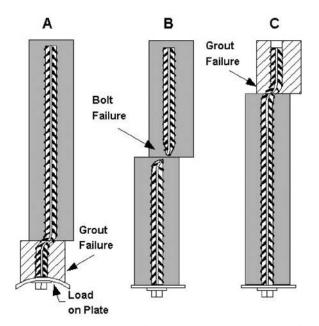
Figure 3. Failure mechanisms of a fully grouted roof bolt. (A) Roof movement near head; (B) Roof movement in central portion; (C) Roof movement in anchorage zone.

Depending on where the roof movements are concentrated, the bolts can fail in one of three ways, as shown in figure 3 (Serbousek and Signer, 1987; Mark, 2000):1

- 1. The head or the plate can fail;
- 2. The rod may break, either in tension, or a combination of tension and bending; or
  - 3. The anchorage may fail.

The anchorage can fail when roof movement occurs near the top of the hole, as shown in figure 3c. If the load applied to the bolt exceeds the strength of the grout anchor, the top of the bolt will be pulled out of the hole. If the bolt had been suspending weak or failed lower roof from intact upper rock, a roof fall can follow.

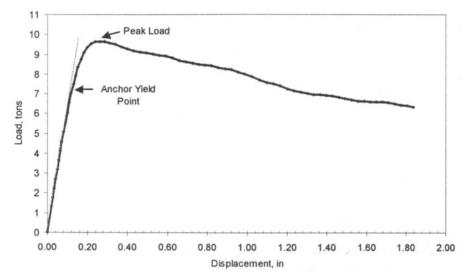
Figure 7. Load deformation curve for typical short encapsulation pull test.

Figure 7 shows a typical load deformation curve for a short encapsulation pull test in which the anchorage fails (and the rod does not yield). Initially the load deformation curve is linear. However, as the resin along the lower portion of the anchor begins to fail, the load deformation curve deviates from a straight line. As the applied load approaches and exceeds the peak anchor capacity, the anchor begins to slip. After the peak the anchor still carries on average about 70 pct of the peak load over 38-50 mm (1.5-2.0 in) of deformation.
