Investigation of Fully Grouted Roof Bolts Installed Under In Situ Conditions

Craig Compton, Engineering Technician
David Oyler, Mechanical Engineer
NIOSH-Pittsburgh Research Laboratory
Pittsburgh, PA

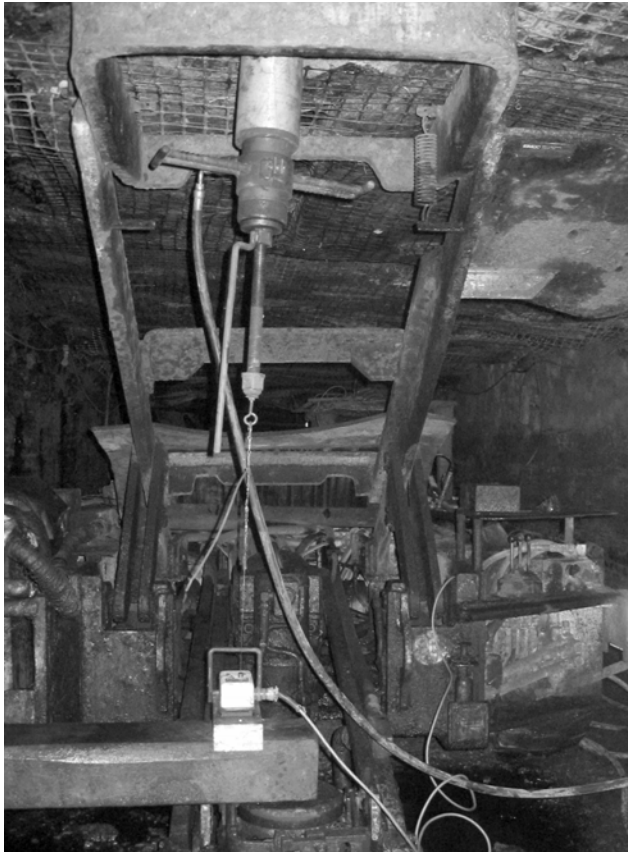
Figure 2. Pull test equipment showing reaction fixture, 20 ton hydraulic ram, 1-inch thread bar and string pot displacement sensor.

pipe used to simulate roof bolt holes, to measure bolt installation pressures. A datalogger and a laptop computer were used to collect and display the data during the tests. The pull equipment, including reaction fixture, pull claw, 20 ton hydraulic ram and 1-inch thread bar, is shown in Figure 2. The bolts were loaded using a hand pump.

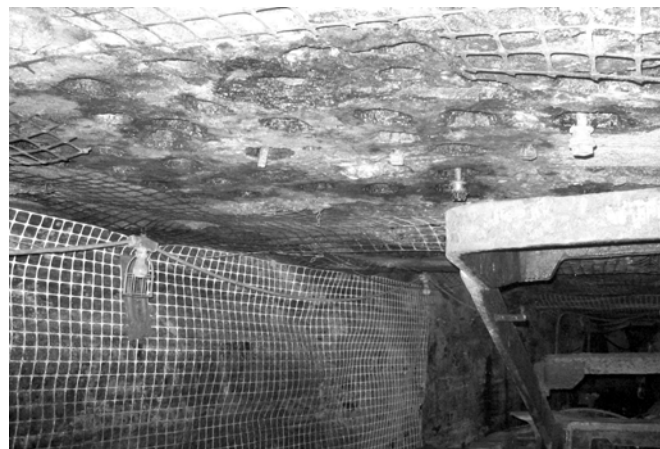
Figure 5. Bolt installation site in NIOSH Safety Research Coal Mine (SRCM), showing the 3 inch diameter holes from overcored bolts and several previously pulled bolts which were not removed from the roof

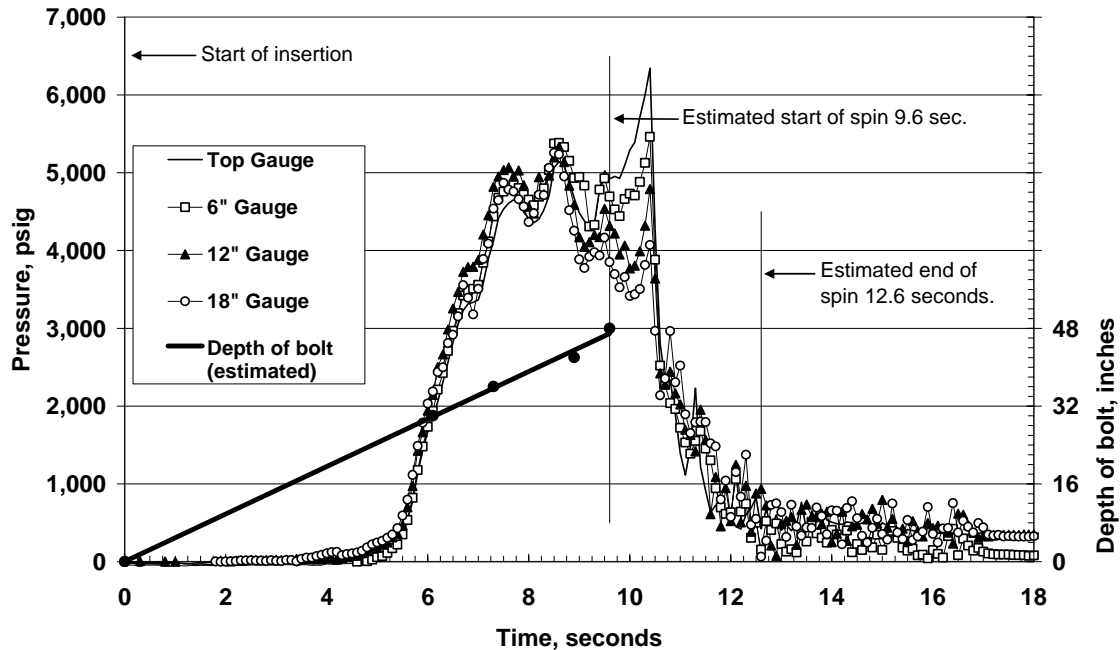
Figure 9 – Pressure at four locations in a schedule 40 1-inch pipe simulating a bolt hole during resin bolt installation. The straight line shows the position of the top of the bolt.

All four of the bolt installations produced high pressures in the pipes (Figure 9), with the maximum pressures for the 5/8 inch bolts ranging from 5,500 to 6,900 psig and a 9,900 psig maximum pressure for the 3/4 inch bolt. If the bolts are assumed to behave like a piston with an area approximately equal to that of the bolt, the maximum pressures generated would have been 14,700 and 10,200 psig, respectively for 5/8 and 3/4 inch bolts, given the 4,500 lbf maximum thrust developed by the single boom bolter. The difference may be assumed to be due to leakage of resin around the sides of the bolt during insertion. The leakage appears to have been significant for the 5/8 inch bolts, reducing the actual insertion pressure to less than half of the maximum possible pressure. The leakage for the 3/4 inch bolts appeared to be much less and the maximum insertion pressure was just slightly less than the maximum possible pressure.

Generally, all four strain gauges in each installation read similar pressures (Figure 9). Bolt pressures were generally low until about half of the length of the bolt was inserted in the pipe. The pressures in all gauges would then increase rapidly from a few hundred psig or less to around 4,000 to 5,000 psig. Although the travel of the bolter table was not measured during the tests, it was known to be about 5 inches/sec. The rate of pressure increase was found to be slightly lower below the top of the bolt than above it. The time at which this slight reduction in the rate of pressure increase took place allowed determination of when the bolt top passed each gauge. The estimated positions (large circles in Figure 9) agreed

with estimates based upon the known speed of the bolter table. The data suggested that pressures would be slightly higher above the top of the bolt, but that pressures would continue to rise along the entire length of the bolt as long as bolter thrust was being applied. The exact pressure profile to be expected in a real bolt hole could, of course, be modified by extrusion of resin into the roof rock.
