**THE IMPLEMENTATION  
OF UHF RADIO COMMUNICATIONS  
AND CCTV MONITORING SYSTEMS IN A  
ROOM AND PILLAR METAL/NON-METAL MINE  
FINAL REPORT**

**Prepared For:  
Bureau of Mines  
United States Department of the Interior**

**Contract No.: JO 377044**

**March 1981**

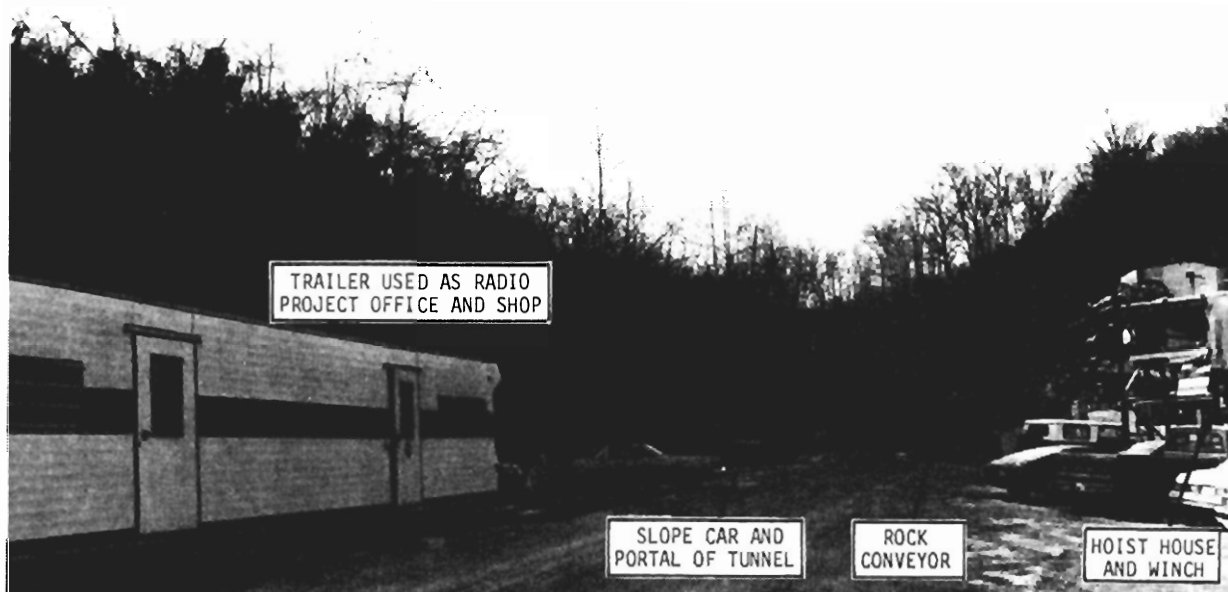
FIGURE 1.1 VIEW OF RADIO SHOP AND THE MINE PORTAL. THE MINE IS ENTERED THROUGH THE 2200 FOOT SLOPE TUNNEL WHICH HAS RAILS FOR THE SLOPE CAR AND A BELT CONVEYOR FOR CRUSHED LIMESTONE.

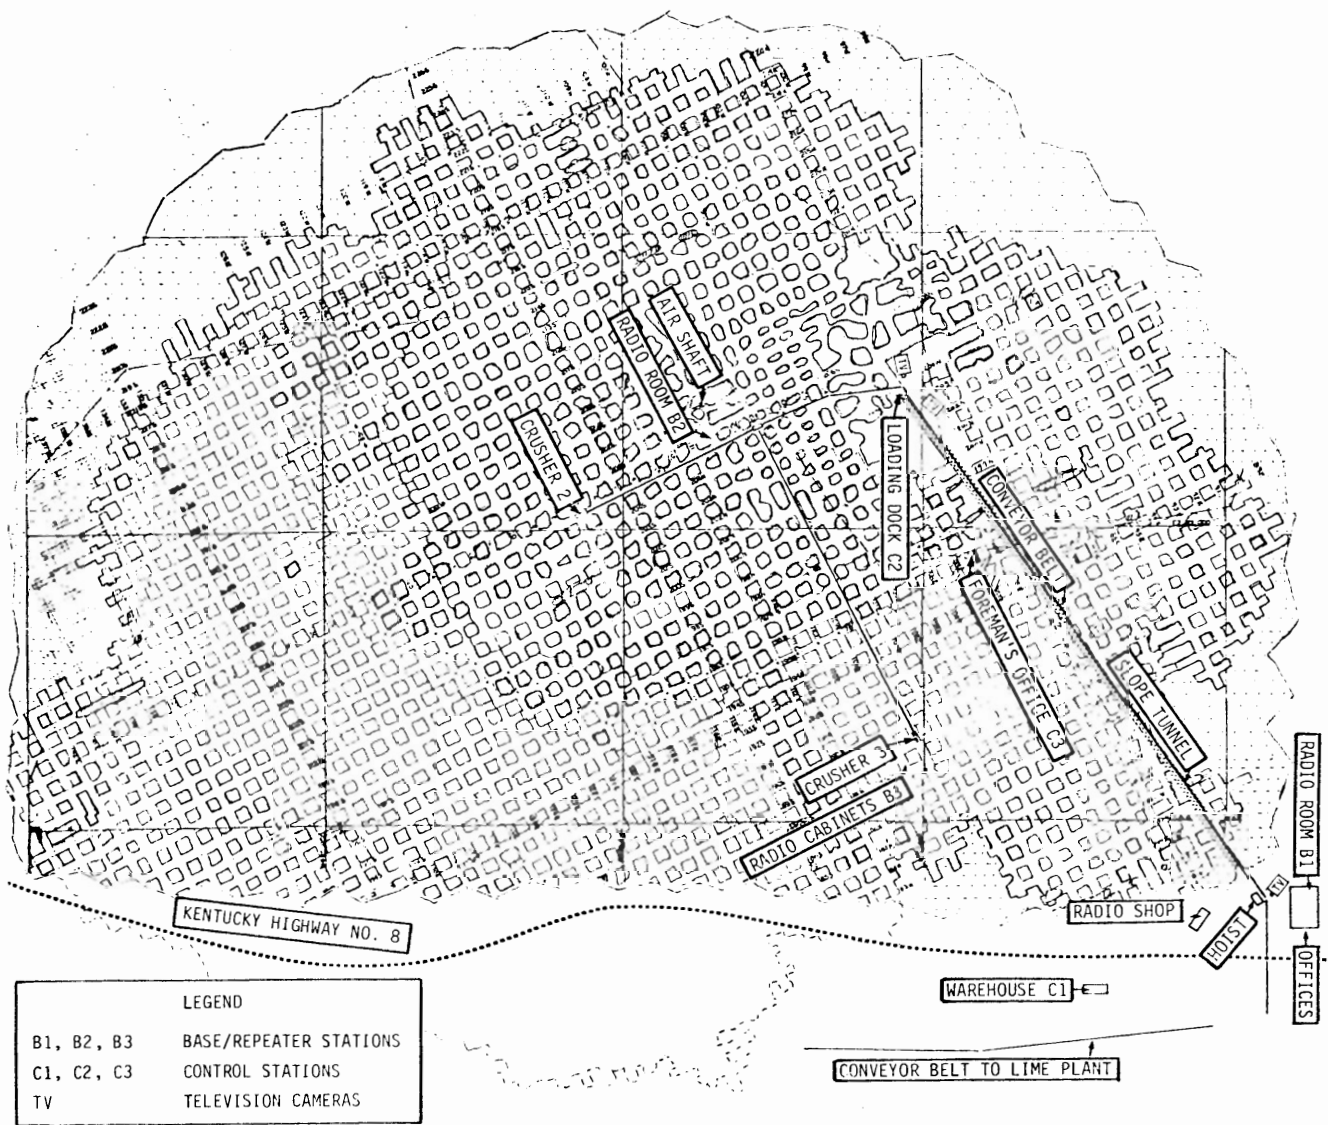
FIGURE 1.3 MAP OF BLACK RIVER MINE SHOWING LOCATIONS OF BUILDINGS, SLOPE TUNNEL CONVEYOR SYSTEM, ROCK CRUSHERS, AND RADIO STATIONS.

Black River Mine has a single level that is approximately six hundred fifty feet deep and it is nearly four thousand feet in diameter. It has essentially straight crosscuts approximately thirty feet wide and twenty four to forty feet high with pillars approximately thirty five feet square.

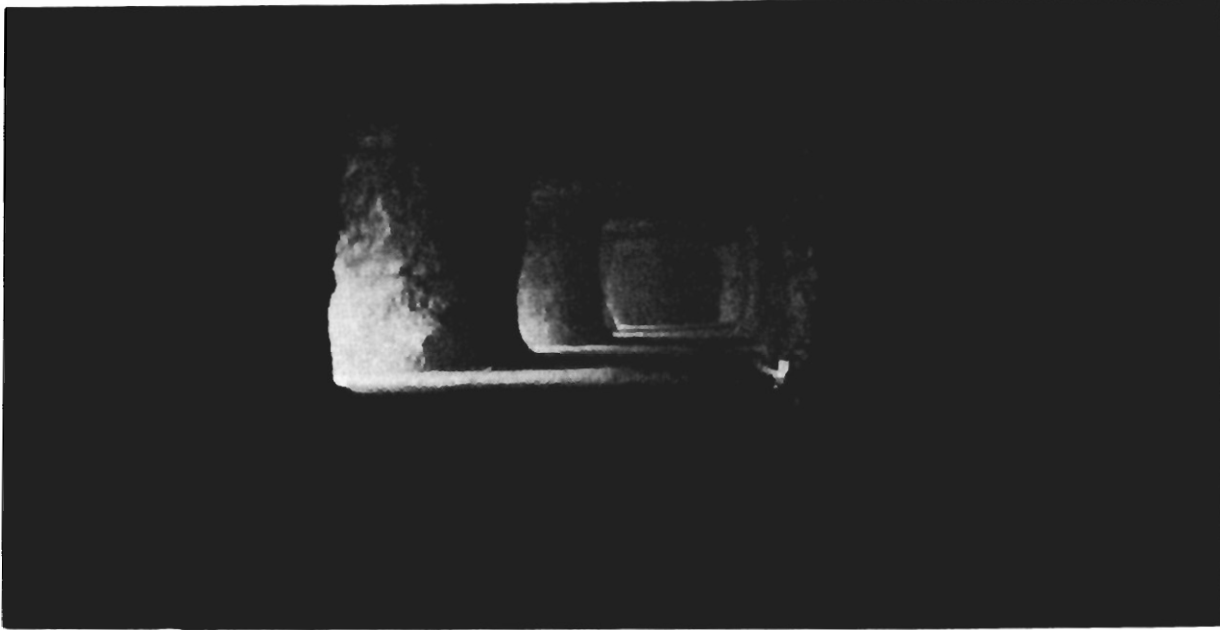
FIGURE 2.1 VIEW DOWN CROSSCUT 104E PAST LIGHTED SHOP AREA WHICH ILLUMINATED FOUR INTERSECTING CROSS CUTS.

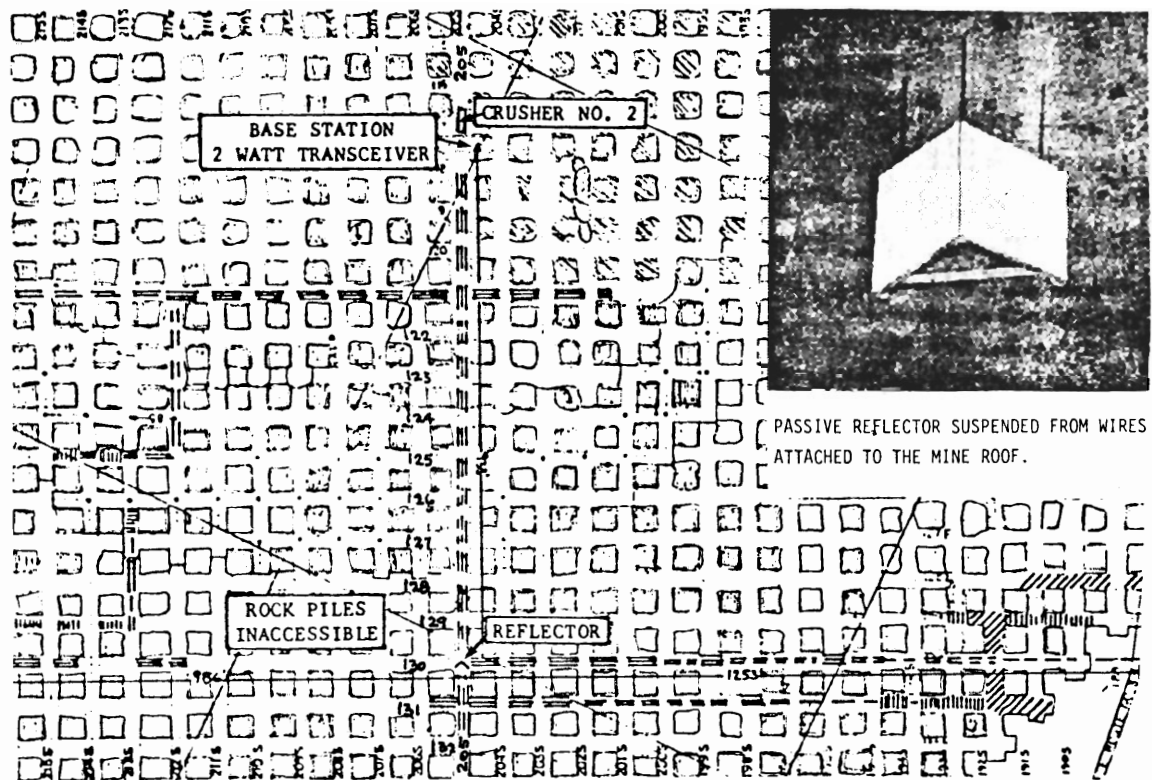
QUALITATIVE SIGNAL EVALUATION

- ≡ ≡ ≡ ≡ ≡ ≡ ≡ ≡ ≡ Excellent signal, full quieting, no multipath.
- = = = = = = = = = = Good signal, some impairment.
- - - - - - - - - - Satisfactory signal, some impairment.
- ||||| Marginal, critical squelch or multipath objectionable.
- ////// Unsatisfactory, occasionally breaking squelch.

In order to qualitatively verify that passive reflectors can be used for extending the range of 450 MHz communications in the mine, two 4' x 4' flat aluminum sheet passive reflectors were constructed and tested in the Black River Mine on October 26, 1977. Two reflectors were mounted on a wood frame so that the included angle between the reflecting surfaces was 90°.

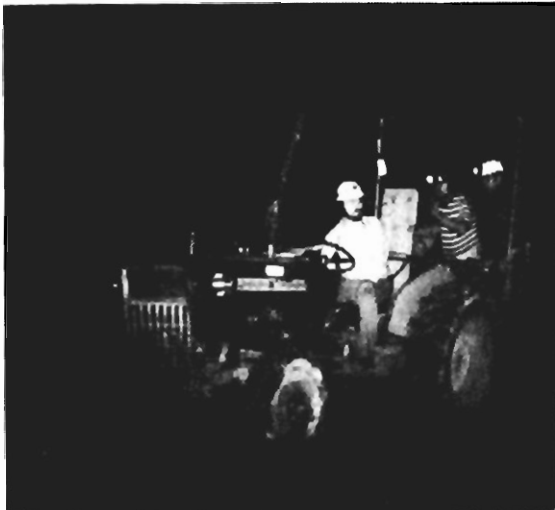
FIGURE 2.3 TRACTOR EQUIPPED FOR SIGNAL STRENGTH SURVEY

The mobile radio equipment was mounted on a plywood assembly which was strapped to the lift platform on a utility tractor as shown on Figures 2.3 and 2.4. This assembly included a lighted map shelf unit, and an audio tape recorder for recording voice transmissions received and transmitted as well as the field engineer's and driver's comments. The mobile radios transmitted simultaneously on 812 and 466 MHz while the tractor was moving and the signal strengths were recorded at the control center in the van.

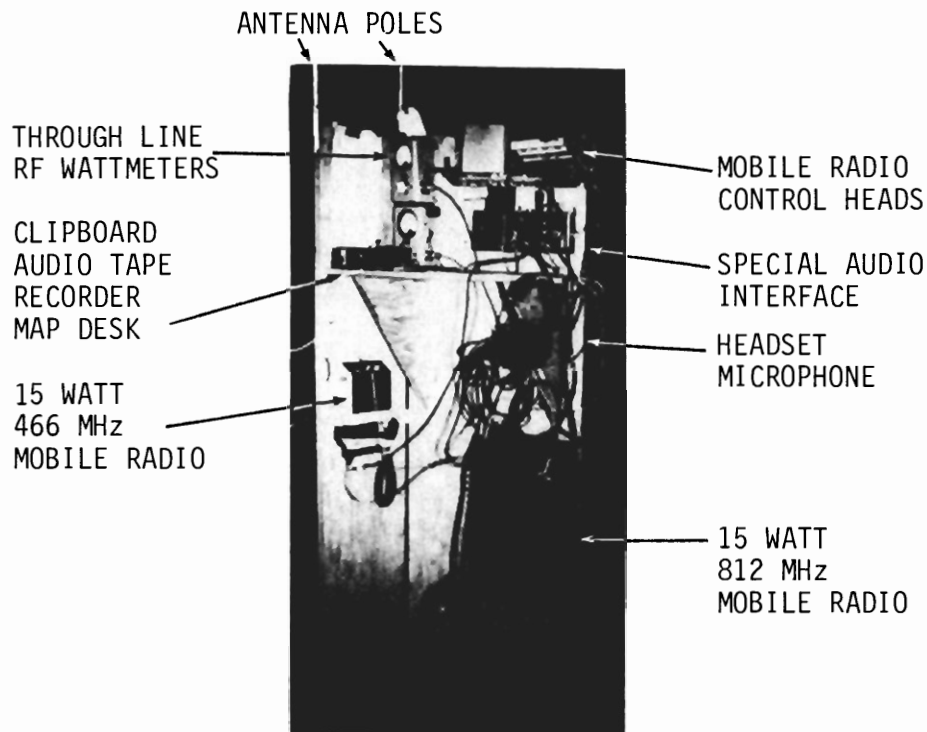
FIGURE 2.4 MOBILE RADIO ASSEMBLY THAT WAS MOUNTED ON LIFT PLATFORM ON TRACTOR FOR MOBILE SIGNAL STRENGTH MEASUREMENTS.

The special audio control unit shown on Figure 2.4 was constructed by Bureau of Mines' technicians for controlling the modulation of both transmitters and for interfacing the audio tape recorder and two headset microphones which were worn by the tractor driver and mobile radio operator. The audio tape recordings made on the mobile unit were very helpful for identifying the regions where the mobile unit was not heard at the control center. At each intersection, the tractor driver would announce the mobile unit's location. The signal strength measurements were made while the mobile unit was in motion and the median values were tabulated from the chart recording. Audio tape recordings were also made of all communications received in the control center which were later compared and correlated with the signal chart readings and positions of the mobile unit. By comparing the two audio tape recordings, the routes followed by the mobile unit were marked later on mine maps showing locations of all transmissions that were attempted as well as those which were received.

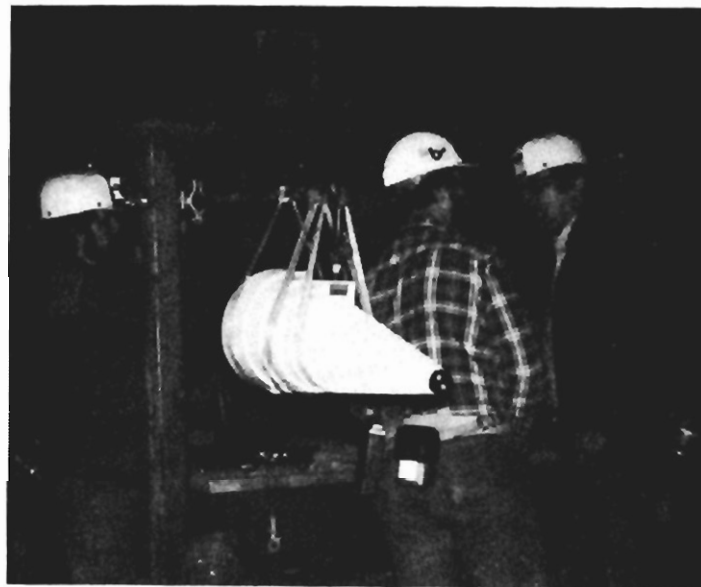
FIGURE 2.5. CIRCULARLY POLARIZED ANTENNA USED FOR SIGNAL STRENGTH MEASUREMENTS IN THE SLOPE TUNNEL.

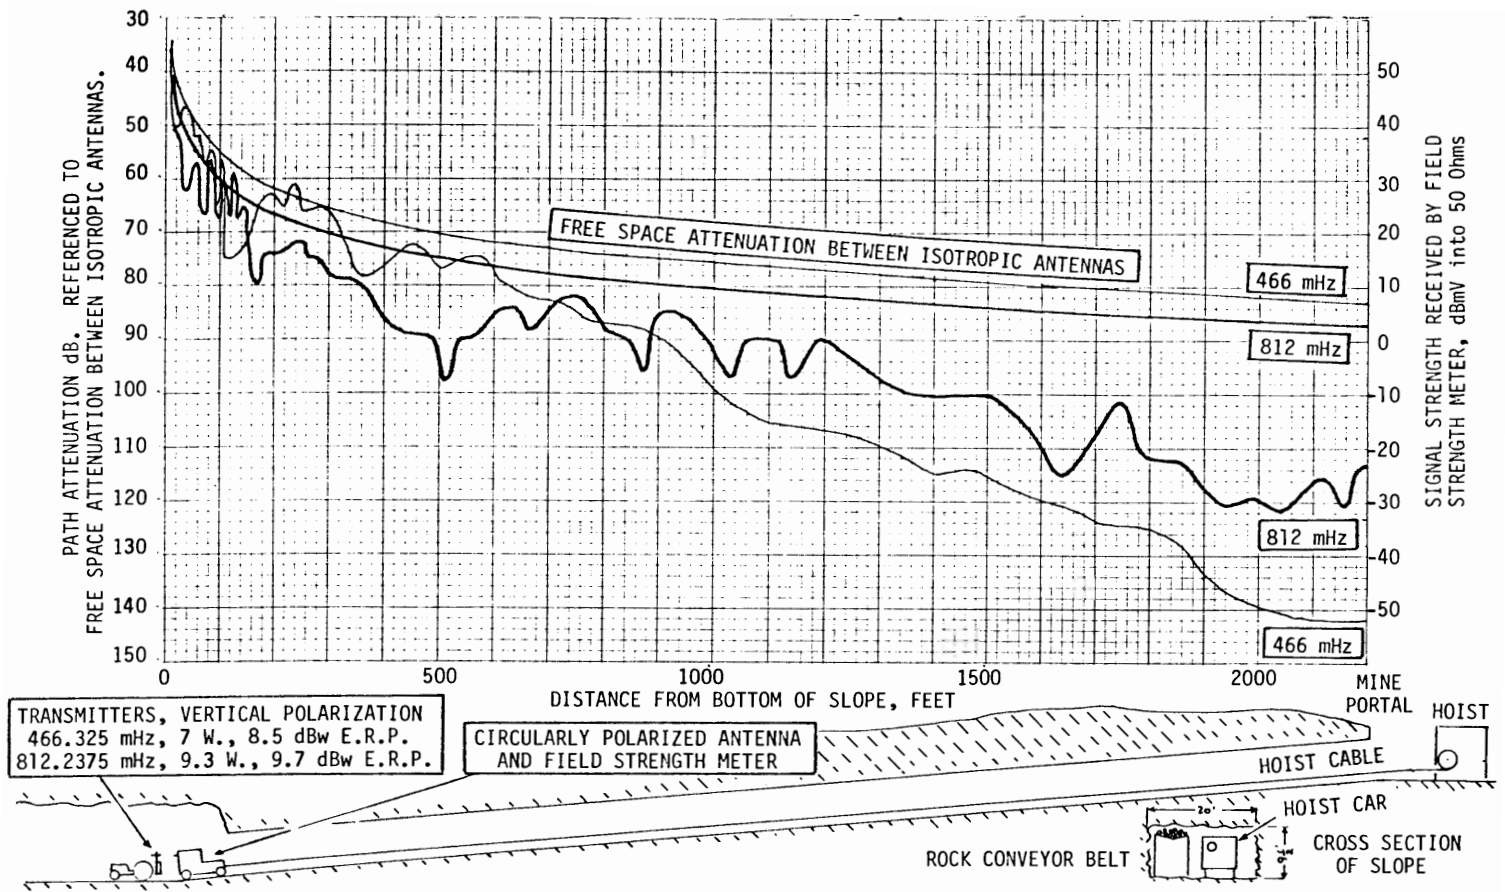
FIGURE 2.6  
 COMPARISONS OF FREE SPACE AND MEASURED PATH  
 ATTENUATIONS AT 466 AND 812 MHz IN THE SLOPE TUNNEL

The signal strength measurements that are shown on Figure 2.6 were recorded on a chart recorder. Measurements were made while the car was ascending the slope and were repeated while it descended. The two sets of chart recordings were compared and the average of the two readings was plotted on the graph.

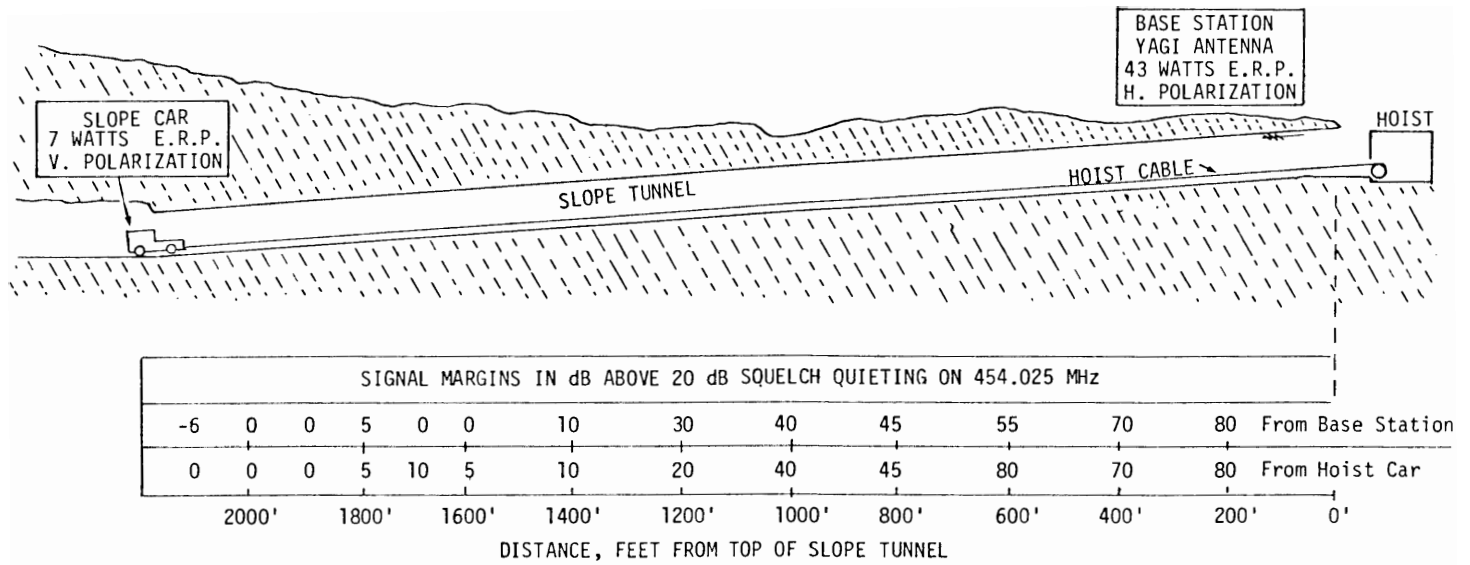
FIGURE 2.7. SIGNAL STRENGTH MARGINS ABOVE 20 dB CARRIER SQUELCH QUIETING IN THE SLOPE TUNNEL.

During the tests, a vertically polarized "hard hat" antenna was used on the slope car. It has been replaced by a horizontally polarized whip antenna which has noticeably improved the fade margins but they have not been re-measured.

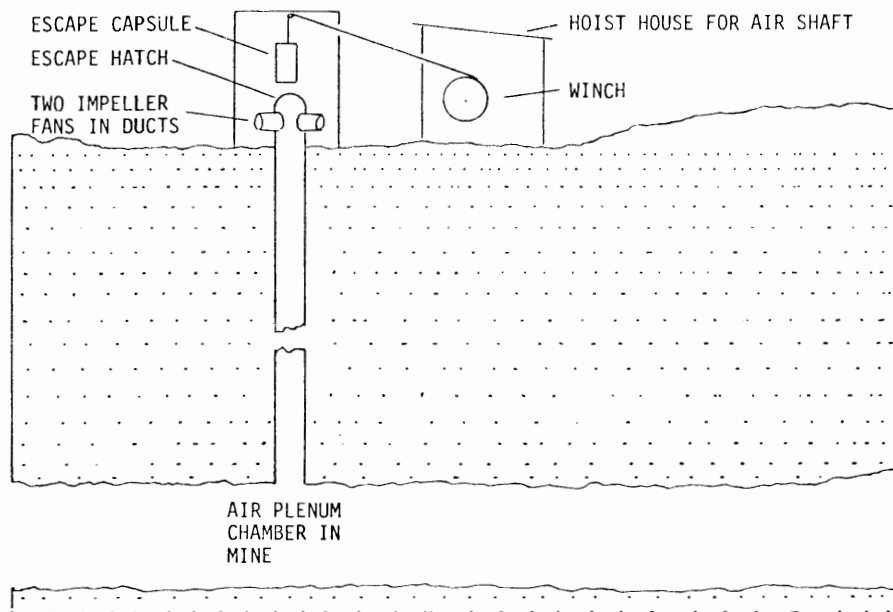
FIGURE 2.8 SKETCH OF AIR SHAFT USED AS EMERGENCY EXIT.

1. As expected, communications in the 450 MHz band is possible through a straight limestone air shaft which is six feet in diameter and 650 feet long. The transceivers were aligned near the axis of the air shaft and polarization was approximately vertical.
2. Communication was ineffective through three foot diameter fan ducts which join the air shaft at right angles.
3. Communication from the plenum chamber at the bottom of the air shaft to the interior of the hoist house was surprisingly good. This might have been due to the UHF induction into the hoist cable.

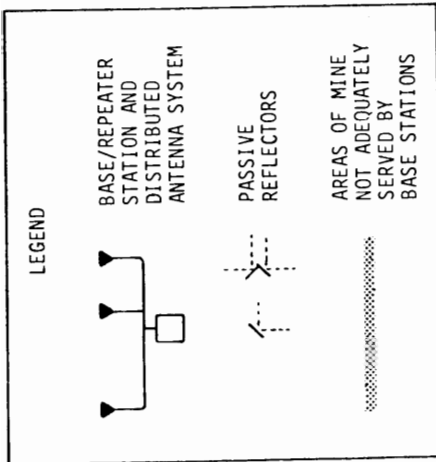
FIGURE 2.9A DISTRIBUTED ANTENNA SYSTEM AS IT WAS ORIGINALLY INSTALLED IN WESTERN SECTOR OF THE MINE AND THE COVERAGE IT AFFORDED.

Two underground antenna systems using a combination of distributed antennas and passive reflectors were to be located at intersections of main haulage ways as shown on Figure 2.9.

The principal haulage and travel roads through the mine were identified on a map of the mine. Two distributed antenna systems were designed, as shown by solid lines on Figure 2.9 to provide either an antenna or reflector at the intersection of principal haulage and travel roads. Each antenna system consisted of approximately 1,200 feet of 7/8" low loss foam dielectric transmission line which fed, through 2 to 1 power dividers, four 5 dB gain mobile whip antennas that were suspended above the centers of principal intersections. Two thirteen watt base stations were connected through hybrid combiners and a power divider to feed approximately 7.1 dBw (5.1 watts) into each branch of the tee section transmission line.

Twenty-seven passive reflectors, also shown in Figure 2.9 were installed at principal intersections to enhance signal strengths. The reflectors which received line of sight signals over paths that were less than 1,000 feet long were very effective but reflectors which were not within line of sight of a ceiling mounted antenna did not appreciably extend the range of communication.

Two distributed antenna systems are used. The original system for the central and western sector of the mine (see Figure 2.9) used approximately one thousand feet of 7/8" low-loss coaxial cable to feed four antennas through power dividers. Since coverage was inadequate at the perimeter of the mine, approximately five thousand, six hundred feet of 1/2" low-loss coaxial cable and nine additional antennas and power dividers were installed. Four two-way UHF signal boosters will be added to this system, as shown on Figure 3.10.

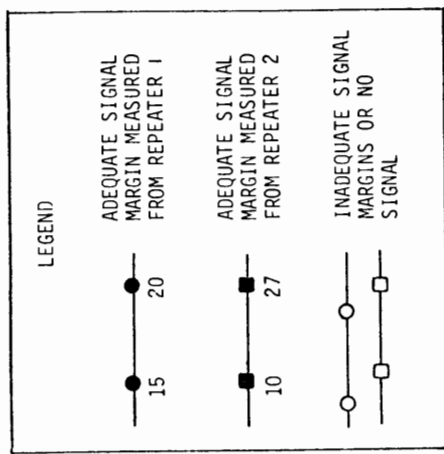
FIGURE 2.9B DISTRIBUTED ANTENNA SYSTEM AS IT WAS ORIGINALLY INSTALLED IN THE EASTERN SECTOR OF THE MINE AND THE COVERAGE IT AFFORDED.

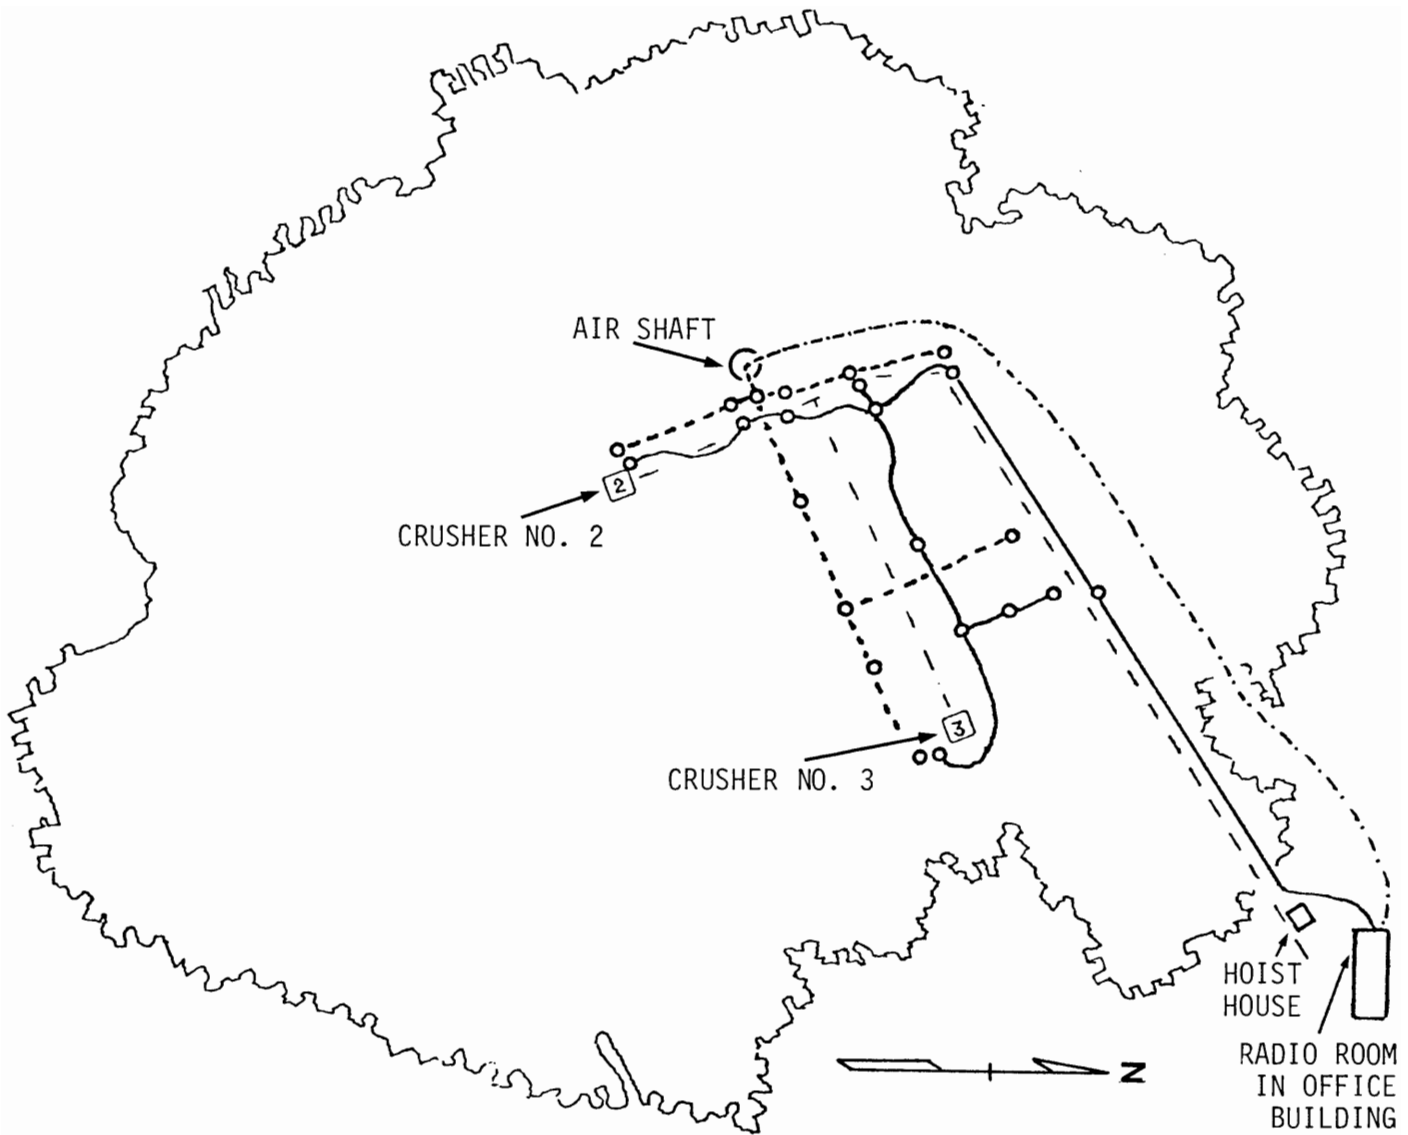
FIGURE 2.10 ORIGINAL PLAN FOR REDUNDANT BACK BONE COAXIAL CONTROL CABLE.

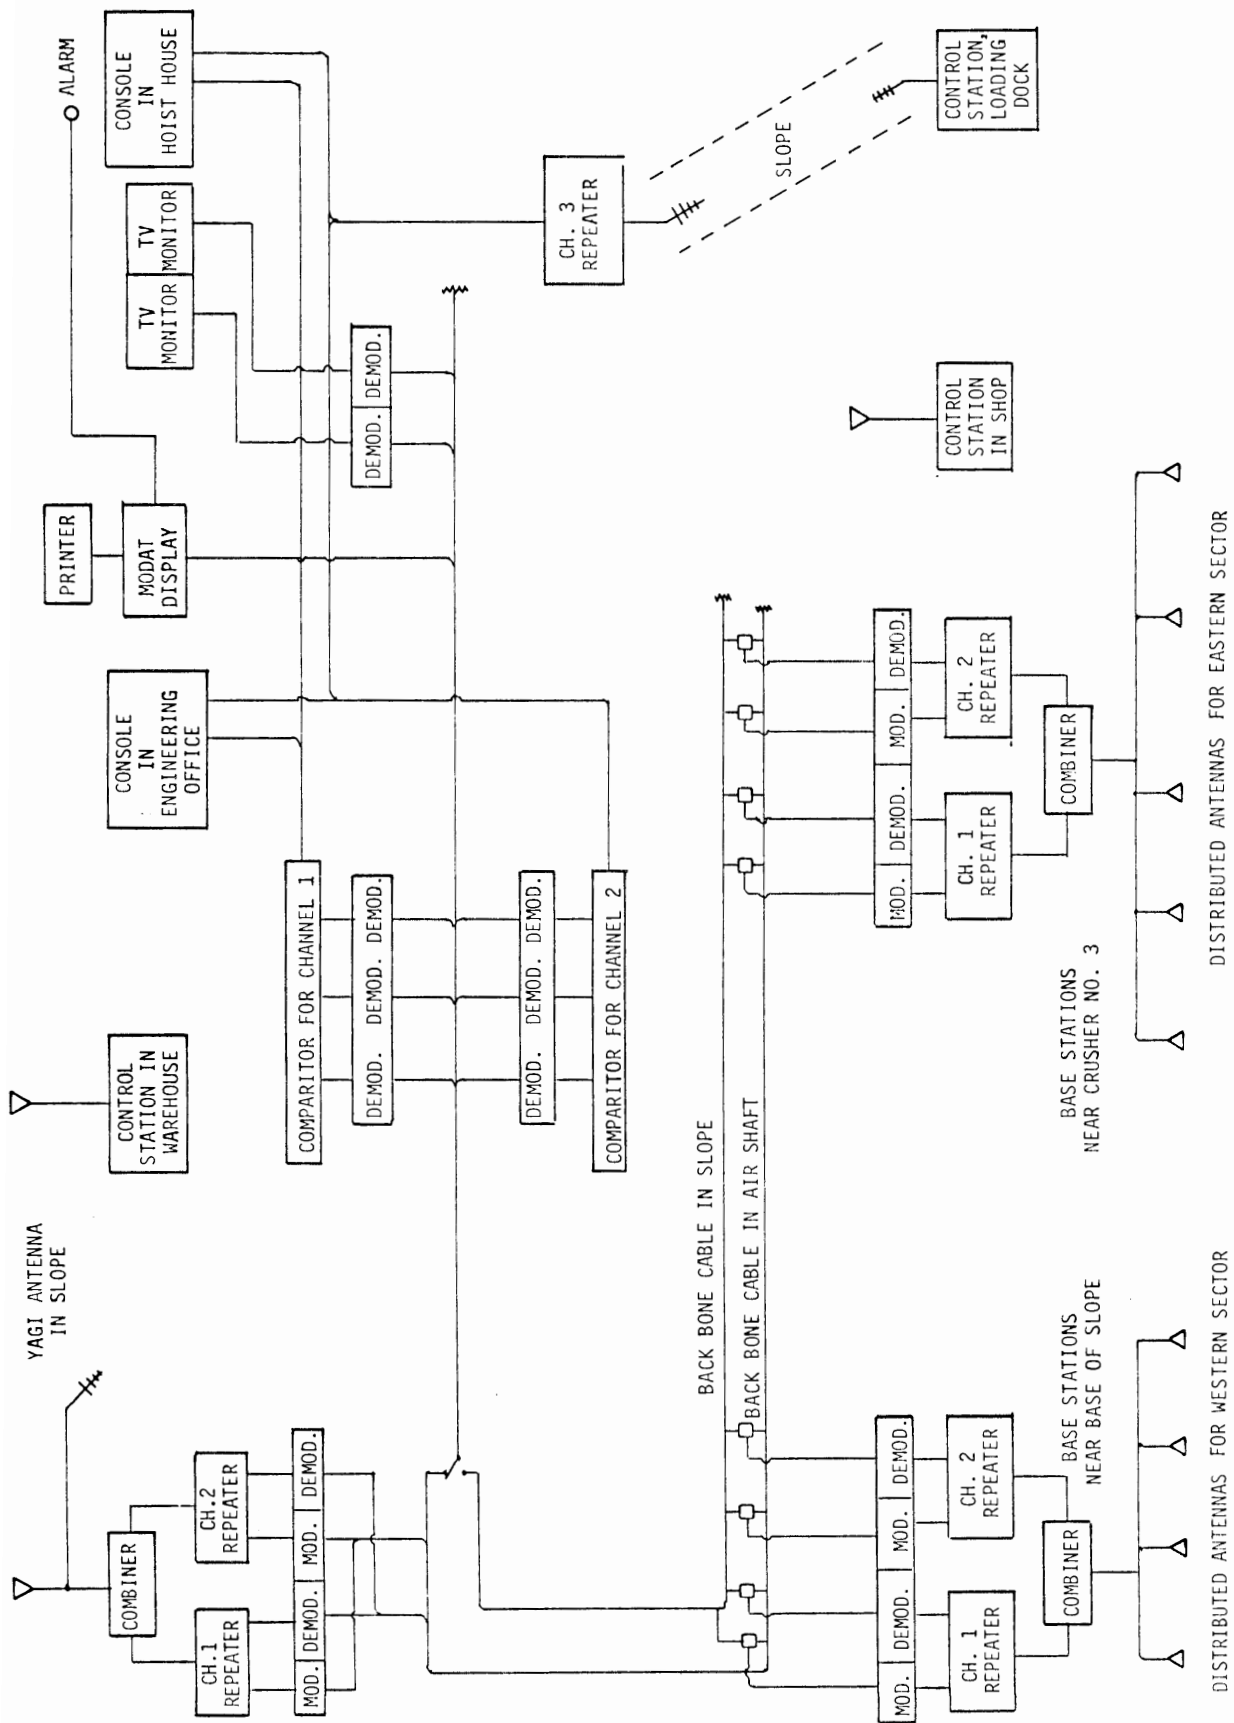
FIGURE 2.11. BLOCK DIAGRAM OF RADIO SYSTEM FOR THE BLACK RIVER MINE

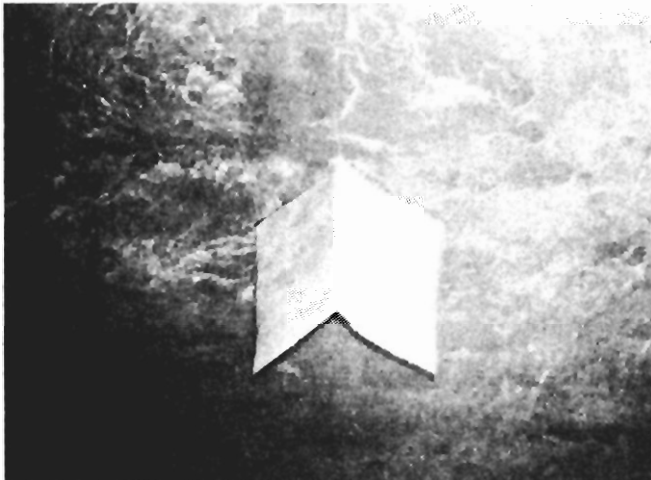
FIGURE 2.12 TYPICAL REFLECTOR

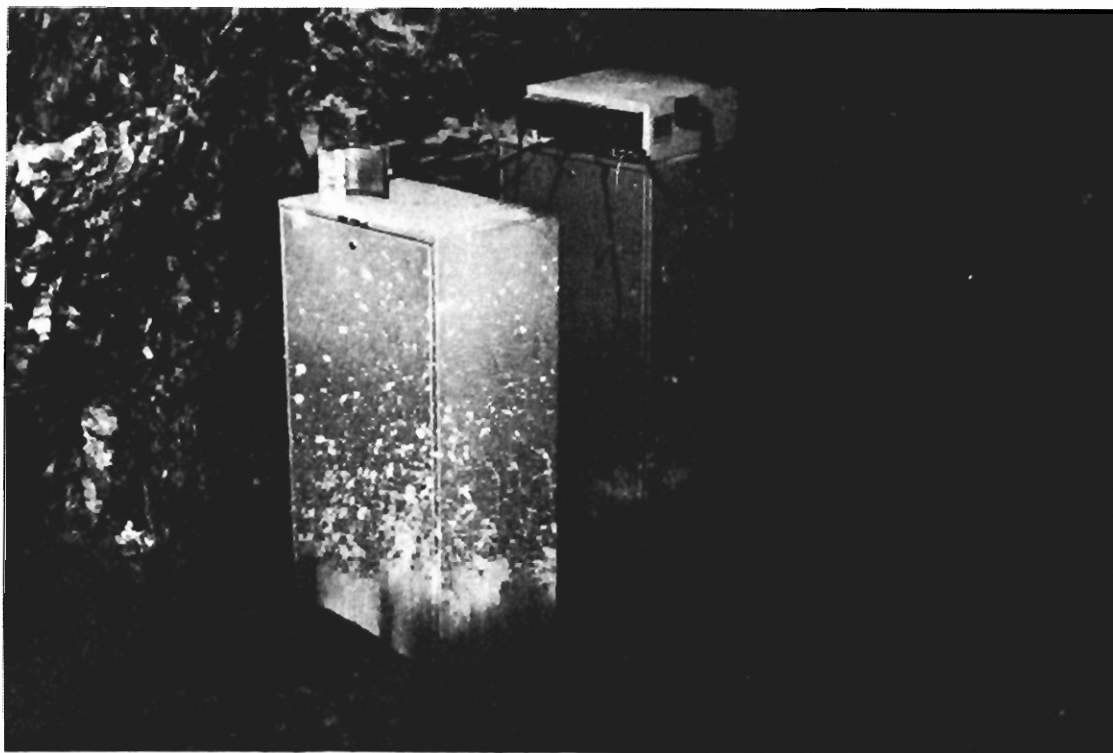
FIGURE 3.1. INITIAL INSTALLATION OF MULTIPLEXING EQUIPMENT AND BASE AND CONTROL STATIONS AT THE BASE OF THE SLOPE.

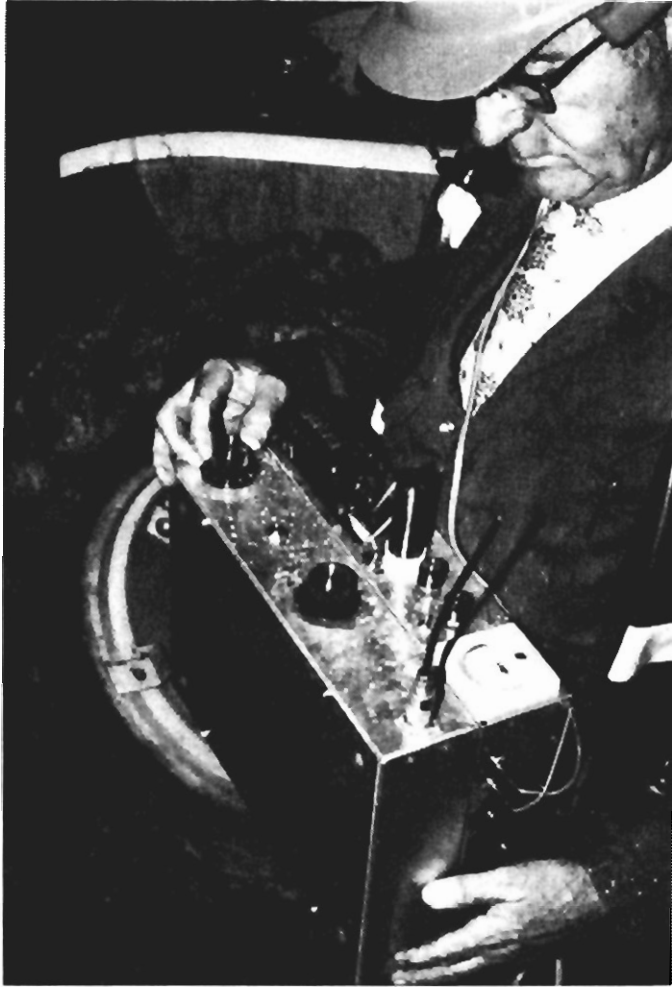
FIGURE 3.2A  
PORTABLE SIGNAL MARGIN MEASURING EQUIPMENT

The signal margin measuring set was constructed in two 10" x 14" x 3" aluminum chassis which are bolted back-to-back forming a shielded compartment for a portable receiver and two attenuators (0-70 dB and 0-10 dB) which are in series with the antenna lead. The unquelled audio is adjusted to 0dB on a VU meter and is mixed into the head set and tape recorder. The head set microphone audio also is mixed into the tape recorder input so voice recordings of location, data, etc., can be made. See Figure 3.5.

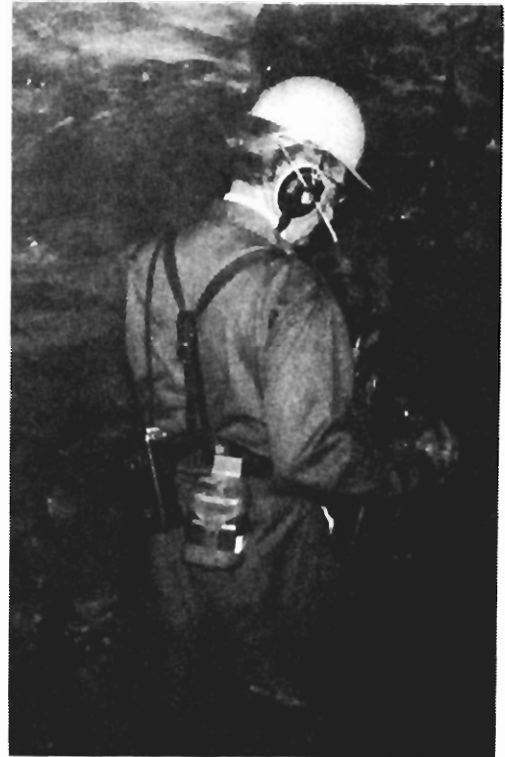
FIGURE 3.2B  
BACK VIEW OF SHOULDER HARNESS  
SHOWING ATTACHMENT TO BELT STRAP  
WHICH RELIEVES PRESSURE ON NECK.

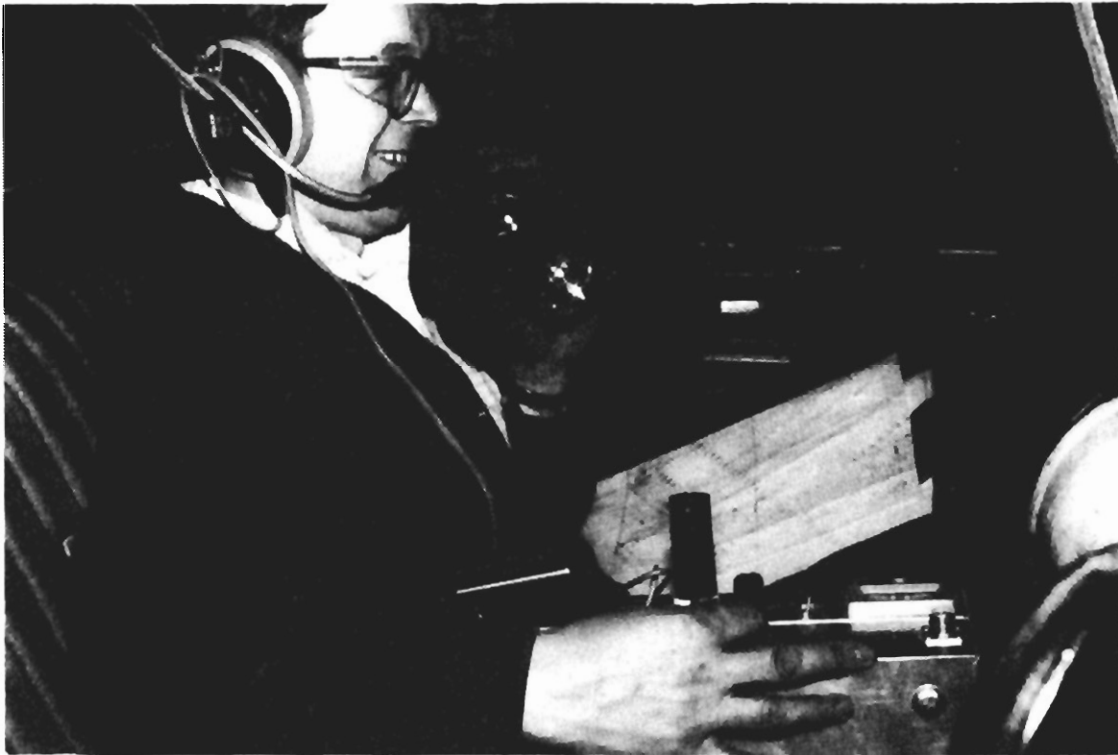
FIGURE 3.3 SIGNAL MARGIN MEASURING EQUIPMENT BEING USED IN A PICKUP TRUCK.

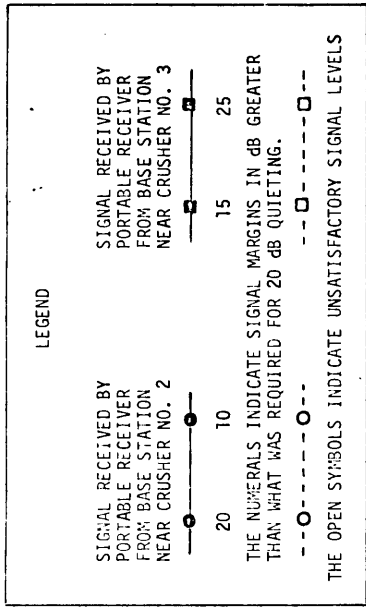
FIGURE 3.4B  
 SIGNAL MARGIN MEASUREMENTS MADE IN THE EASTERN HALF OF THE MINE, NOVEMBER 1979.

Signal strength fade margin measurements with respect to 20 dB carrier squelch quieting (20 dBq) were made on all haulage and travel roads in the mine in approximately two hours. The driver of the pick up truck read the coordinates of the East-West and North-South crosscuts and the Project Leader repeated into the headset microphone of the tape recorder the coordinates and the attenuator settings which were required to attain a median reading of -20 on the dB meter. The audio level of the unsquelched portable radio that was being used to receive the signal was initially adjusted to 0 dB on the meter. During the tests, the carrier of the base station that was being used was continuously keyed. Later, the signal margins were marked on the mine map, Figure 3.4, in less than three hours. This method of signal strength mapping is fast, inexpensive and repeated measurements produce similar results.

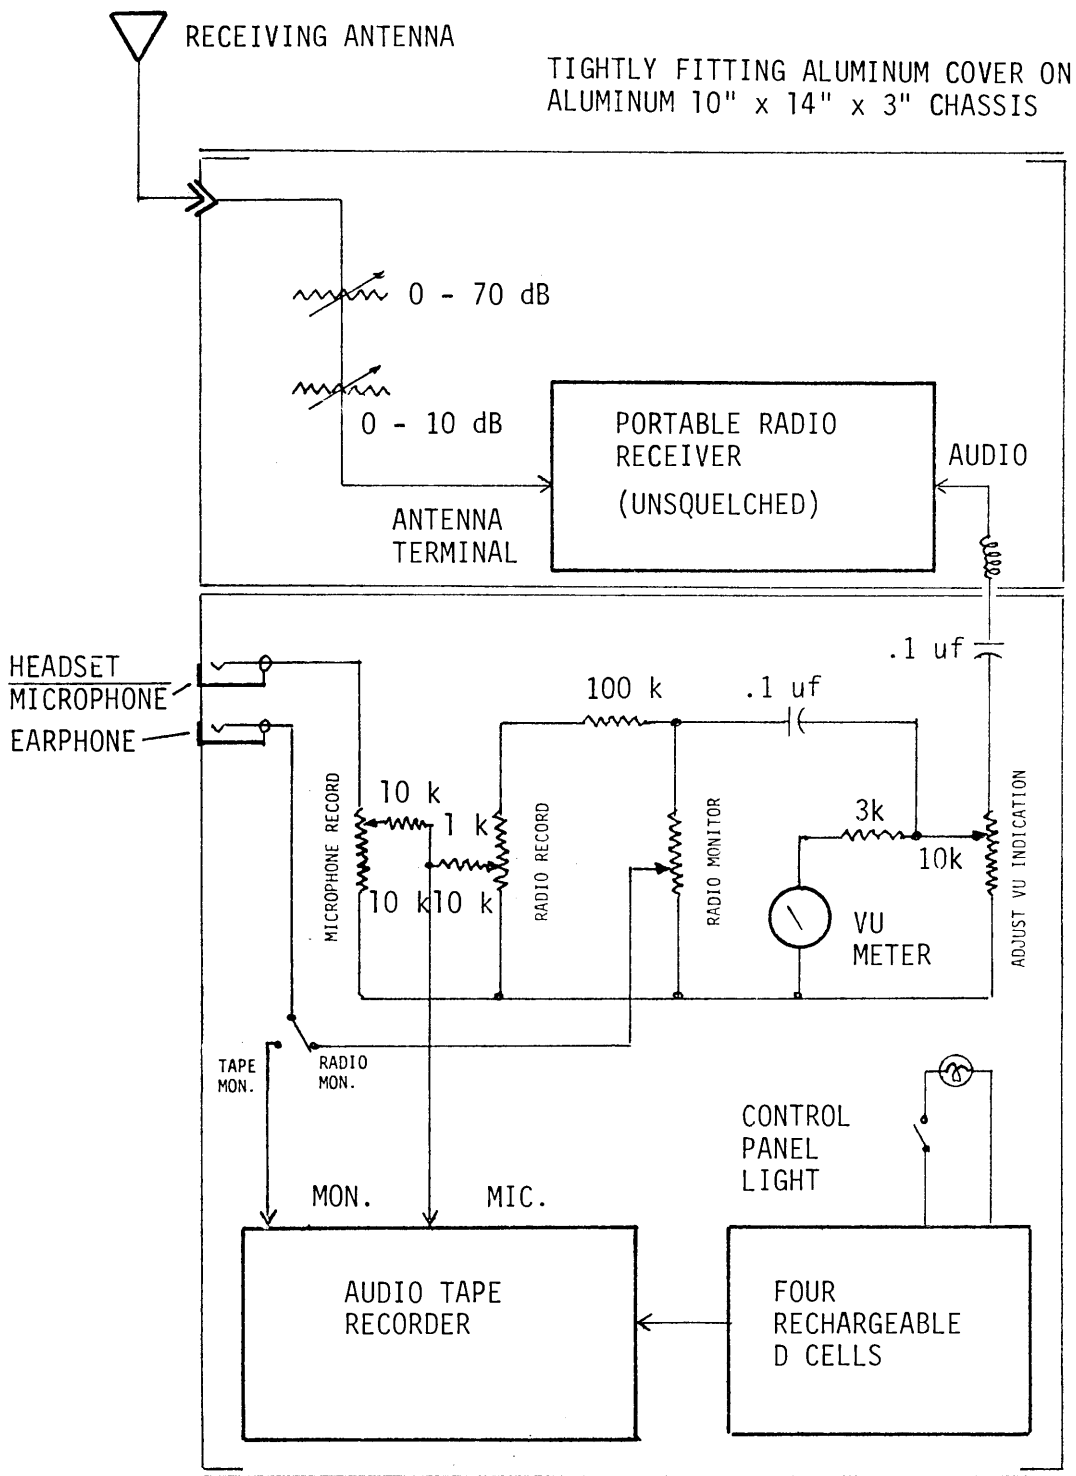
FIGURE 3.5. SCHEMATIC DIAGRAM OF SIGNAL MARGIN MEASURING EQUIPMENT

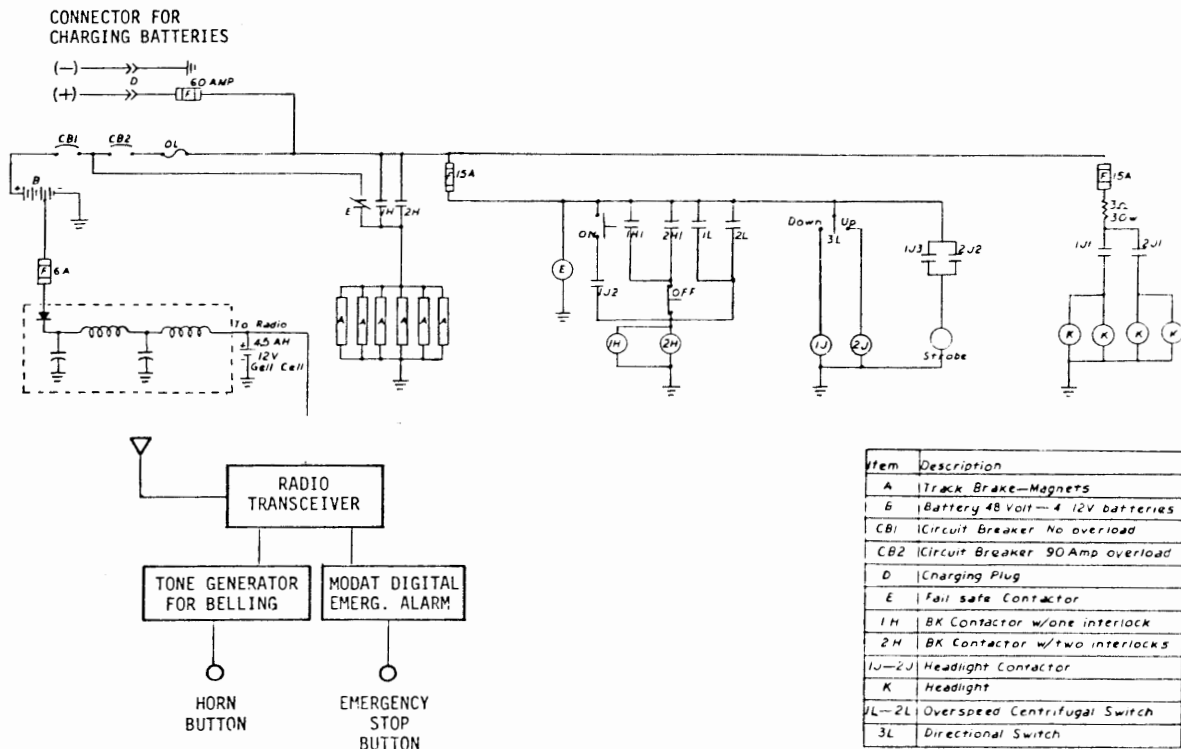
FIGURE 3.6. SCHEMATIC OF SLOPE CAR POWER CIRCUITS

1. A 48/12v dc converter which supplied power for the radio was subject to damage by high voltage transients when the magnetic brakes were operated.
2. A power failure occurred in the mine, and shortly thereafter, power on the surface also failed. The slope car was underway in the slope when the power failed on the surface which caused the car's battery operated magnetic brakes to be automatically energized. After fifteen minutes, the batteries on the car were discharged and would no longer supply power to the radio.

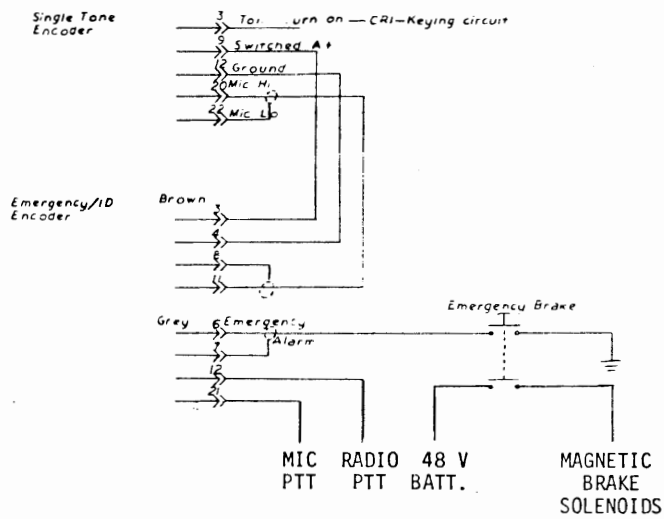
EMERGENCY ALARM CIRCUIT

When the Emergency Stop Button is depressed, a digital alarm signal is transmitted by the MODAT encoder.

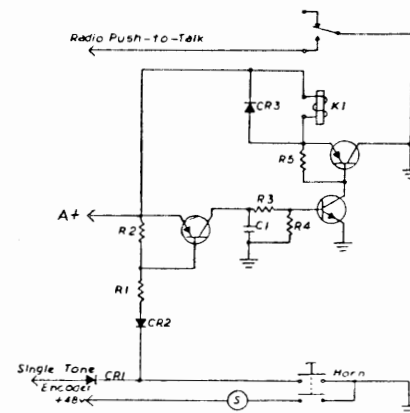
BELLING CIRCUIT

When the Horn button is pulsed, Relay K1 is energized & remains energized for 1 second after the Horn button is released. The delay is determined by C1, R3 & R4.

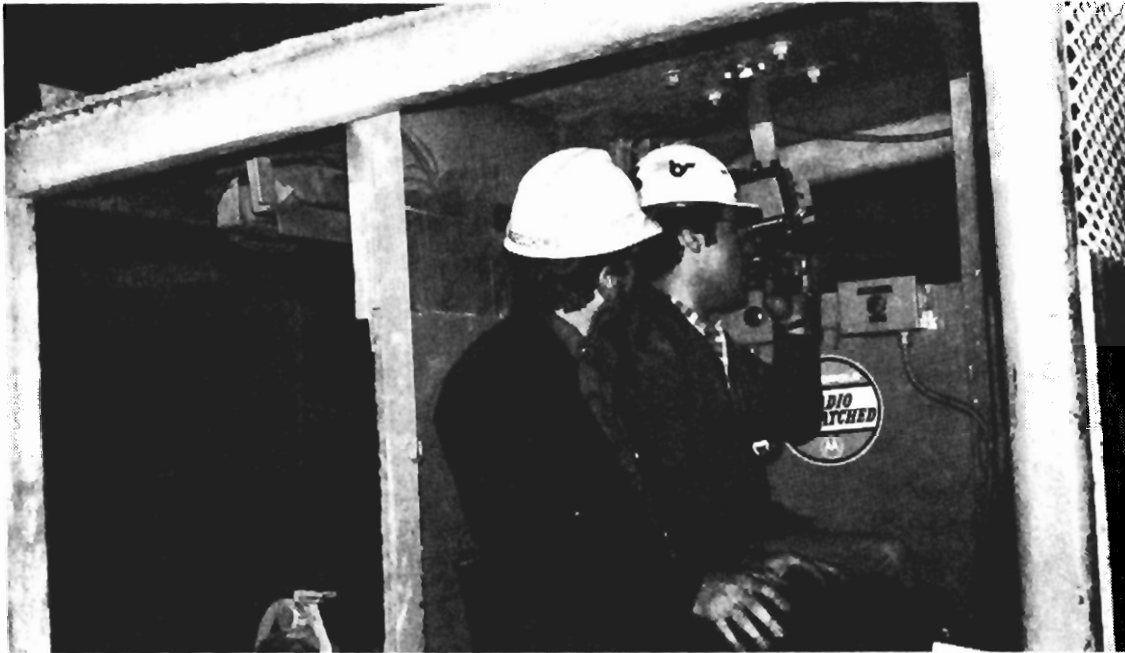
FIGURE 3.8A PASSENGER COMPARTMENT OF SLOPE CAR SHOWING RADIO BEING USED.

The horn signaling circuit includes a time delay relay which energizes the horn for a minimum of one second each time that the signal button is pressed. The schematic diagrams of the horn circuit and the MODAT brake alarm signal are shown on Figure 3.7 and the radio control head, horn signal and emergency stop and alarm buttons in the hoist car are shown on Figure 3.8.

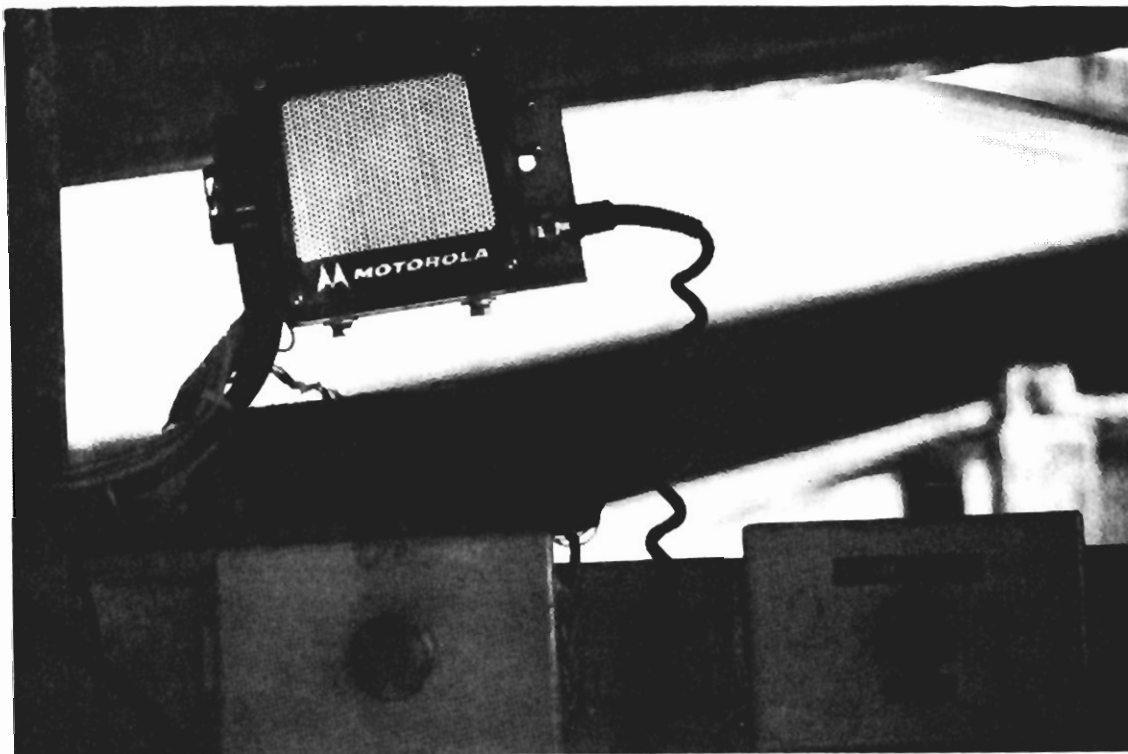
FIGURE 3.8B THE RADIO CONTROL HEAD, HORN SIGNAL AND EMERGENCY STOP BUTTONS ON THE SLOPE CAR.
