**THE IMPLEMENTATION  
OF UHF RADIO COMMUNICATIONS  
AND CCTV MONITORING SYSTEMS IN A  
ROOM AND PILLAR METAL/NON-METAL MINE  
FINAL REPORT**

**Prepared For:  
Bureau of Mines  
United States Department of the Interior**

**Contract No.: JO 377044**

**March 1981**

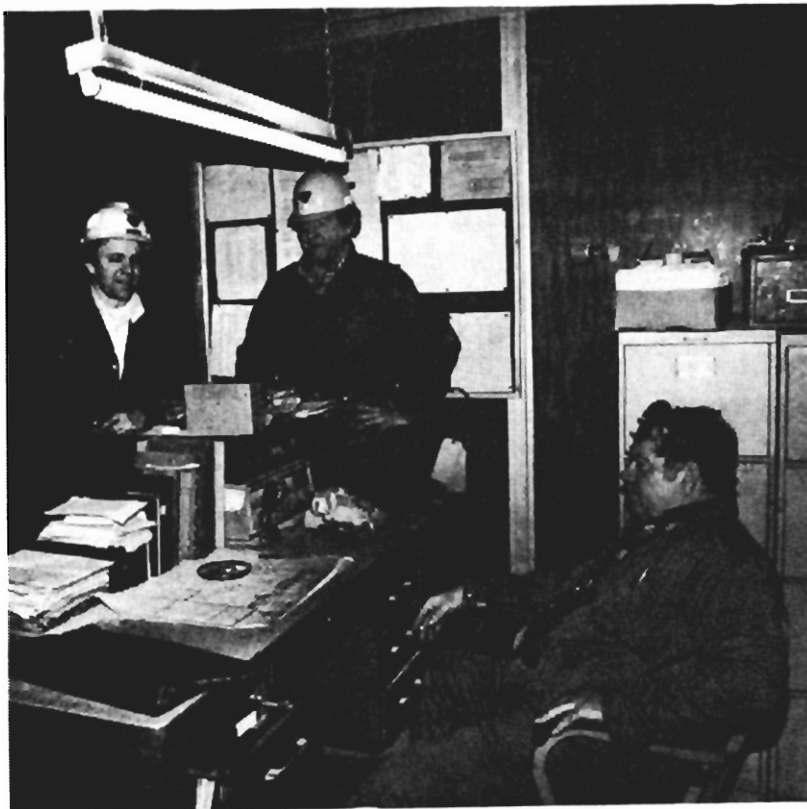
FIGURE 3.9A  
RADIO CONTROL STATION ON THE MINE FOREMAN'S DESK

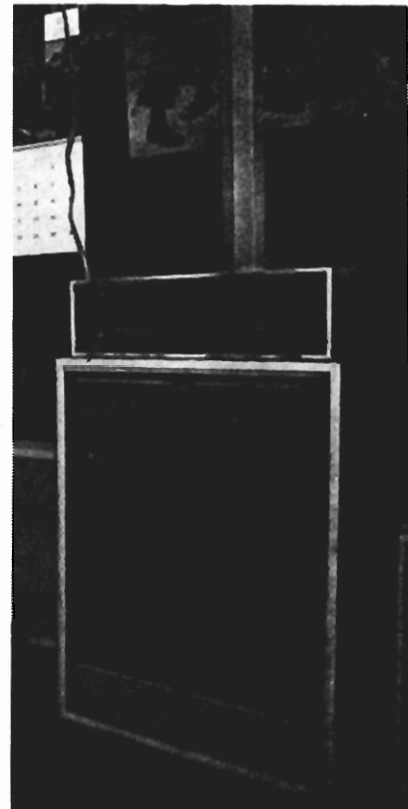
FIGURE 3.9B  
MODAT ALARM AND MOBILE  
UNIT IDENTIFICATION  
DECODER IN FOREMAN'S  
OFFICE.

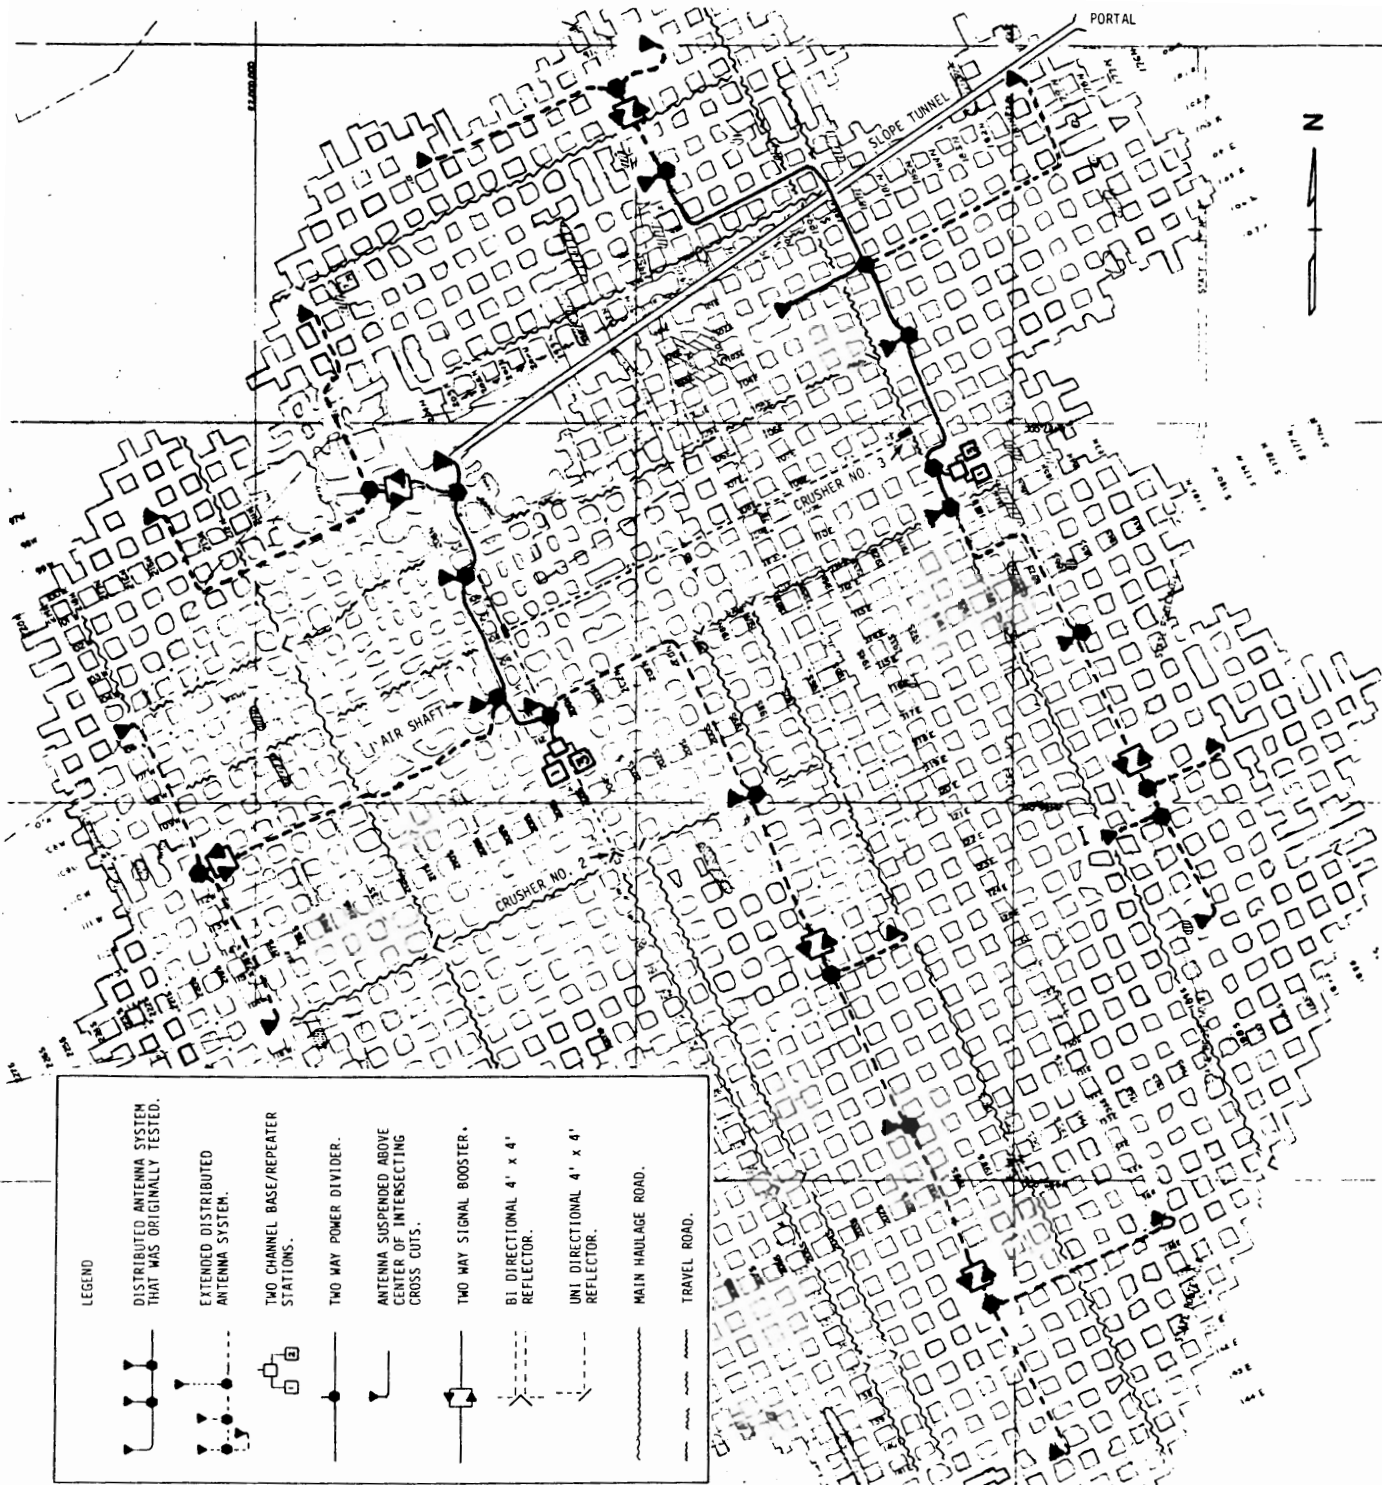
FIGURE 3.10. MAP OF BLACK RIVER MINE SHOWING EXTENDED ANTENNA SYSTEM AND LOCATIONS OF FUTURE SIGNAL BOOSTERS.

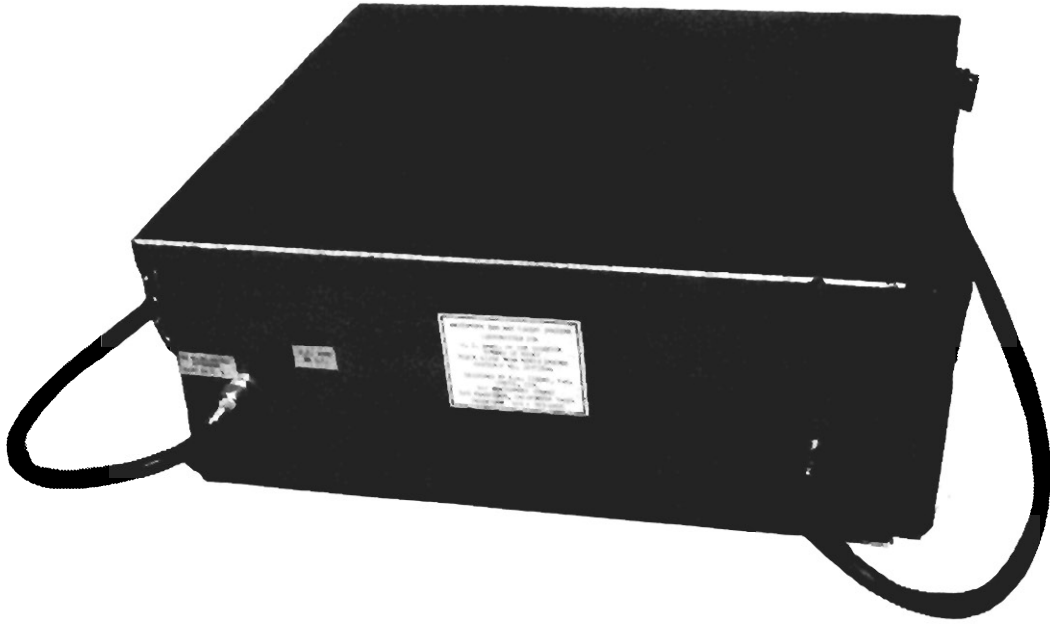
FIGURE 3.11.A PROTOTYPE TWO WAY UHF SIGNAL BOOSTER IN NEMA CLASS 4 ENCLOSURE

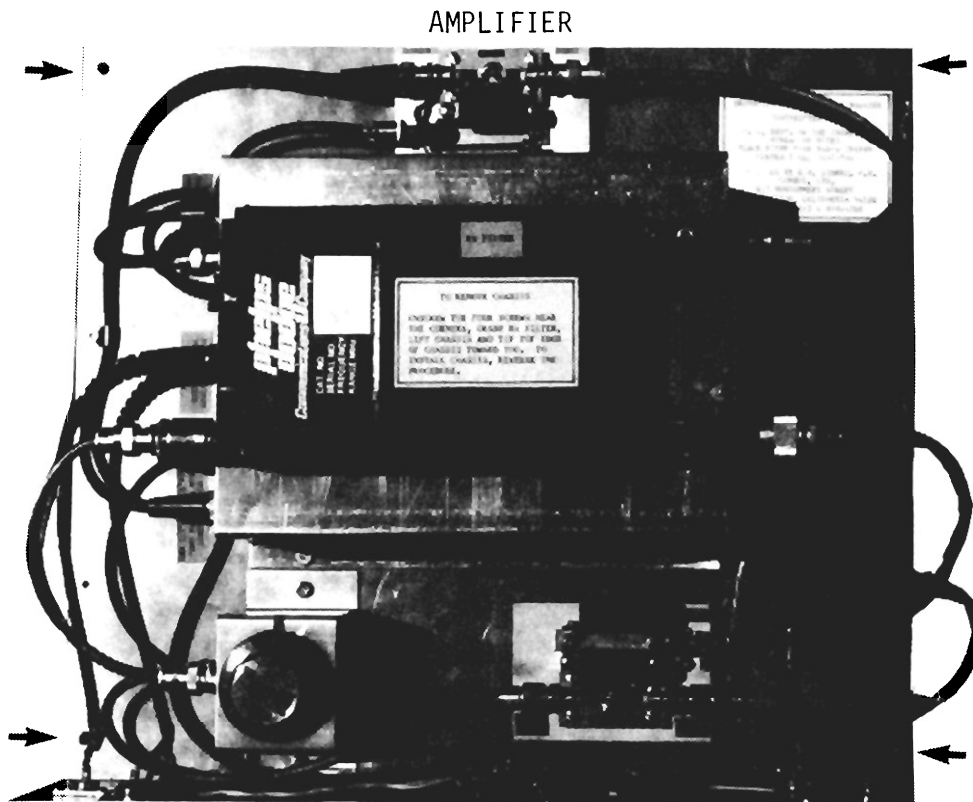
FIGURE 3.11.B CHASSIS FOR PROTOTYPE TWO WAY SIGNAL BOOSTER

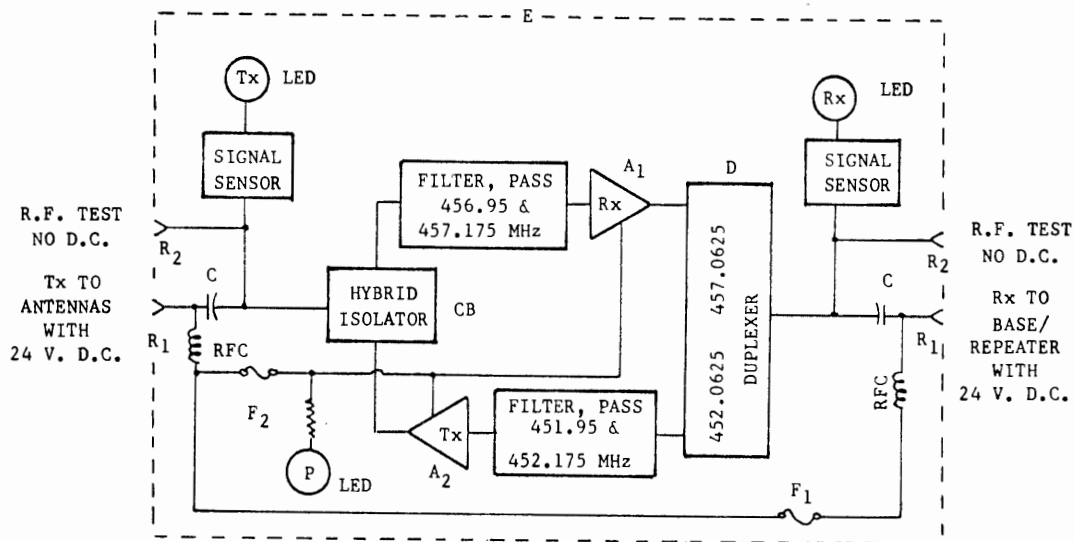
LEGENDS

- A<sub>1</sub>, A<sub>2</sub> TRW CA 2820 Linear Hybrid Amplifiers mounted on TRW TF06 test fixture assemblies.
- D Phelps Dodge mobile duplexer Cat. No. 633-6 for 406 - 470 MHz range.
- Filter Band Pass Filters, Phelps Dodge PD-941 PB4
- C Capacitor, 1000 mmfd, ceramic 100 volt.
- CB Power splitter combiner, 0° phase shift, Mini Circuits Model ZFSC-2-1.
- E NEMA type 4 dust and water proof enclosure.
- F<sub>1</sub>, F<sub>2</sub> Type 3AG fuse and fuse holder.
- LED Tx, Rx Light emitting diode, orange signal indicator.
- P Light emitting diode, green, power "on" indicator.
- R<sub>1</sub> Type N receptacles for transmission lines to other antennas or base station.
- R<sub>2</sub> UHF receptacle for test instruments (isolated from d.c. voltage on center conductor).

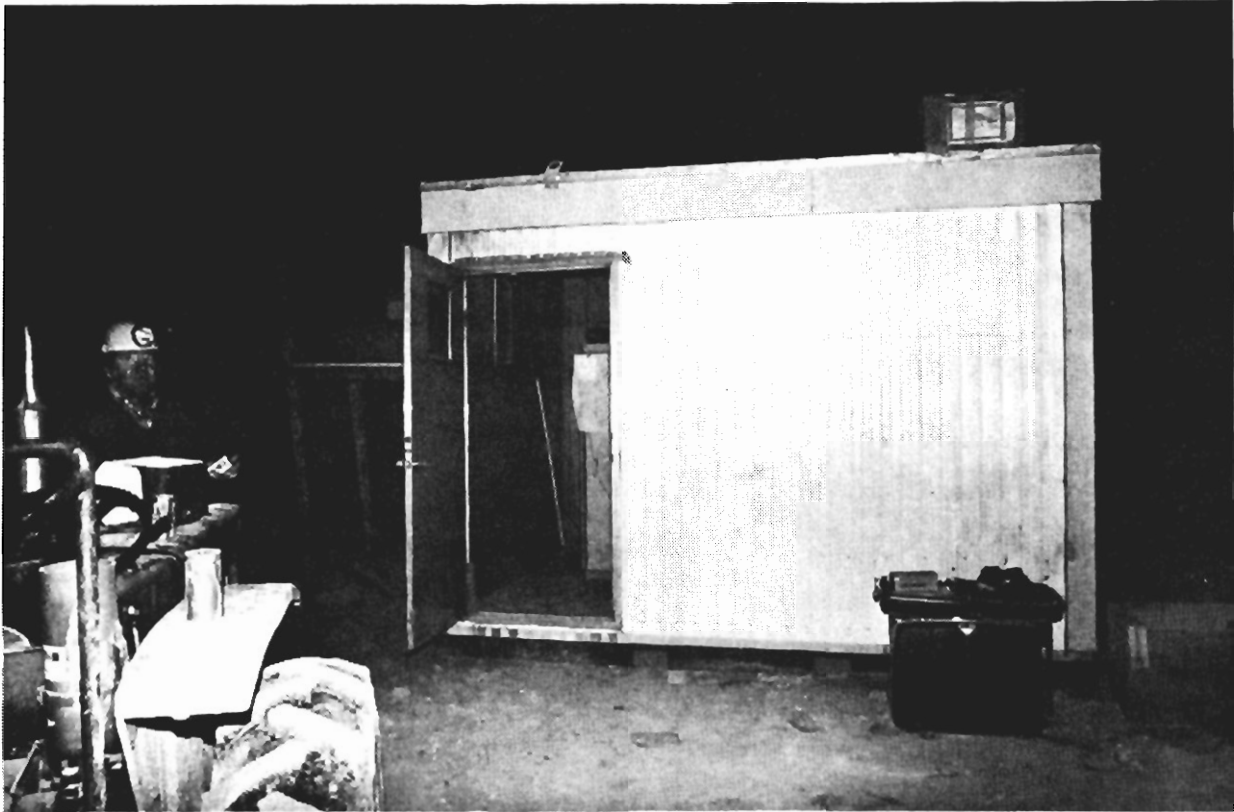
FIGURE 3.13. THE RADIO AND MONITORING EQUIPMENT ROOM IS LOCATED NEAR CRUSHER NO. 2 APPROXIMATELY AT THE CENTER OF THE MINE.

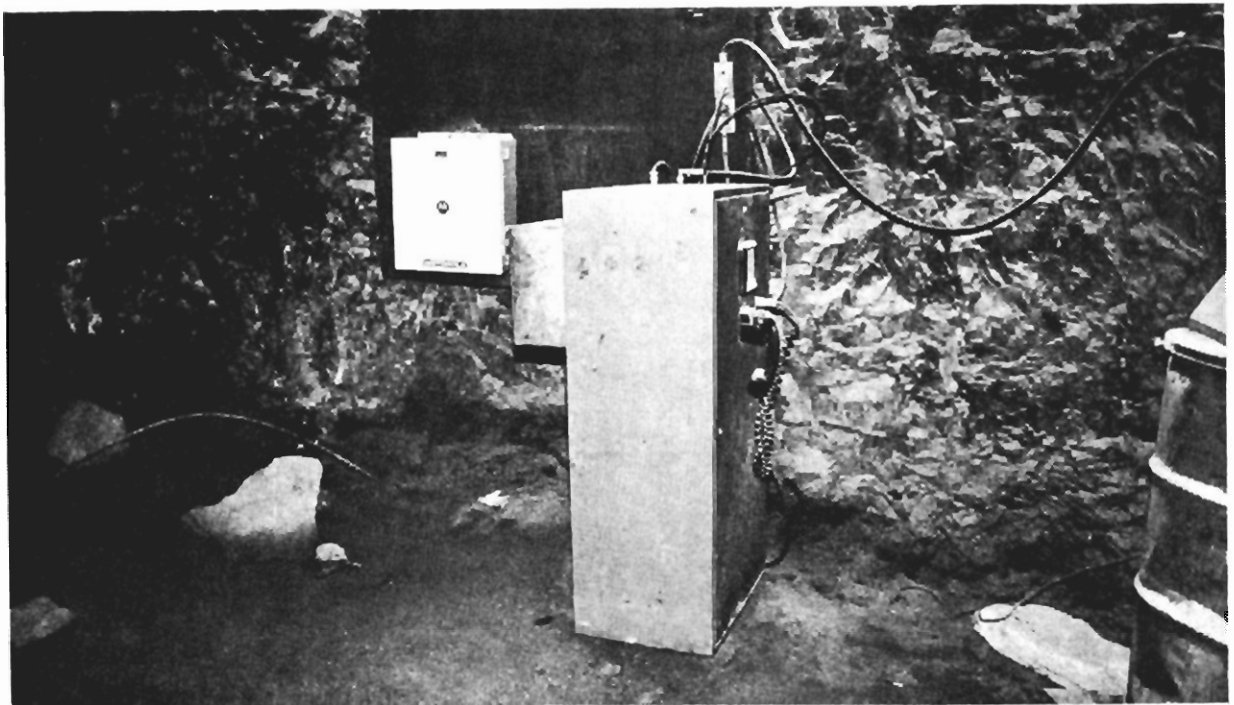
FIGURE 3.14. CONTROL STATION AND MULTIPLEXING EQUIPMENT IN A GASKETED WEATHER-PROOF CABINET IN THE LOADING AREA AT THE BASE OF THE SLOPE. AN EXTENSION WAS ADDED TO A WEATHERPROOF CABINET TO ACCOMODATE THE RACK MOUNTED MULTIPLEXER UNITS. THE CABINET ON THE WALL CONTAINS STORAGE BATTERIES WHICH PROVIDE UN-INTERRUPTIBLE POWER FOR THE MULTIPLEXING EQUIPMENT.

The need for properly gasketed enclosures (NEMA class 4) for electronic equipment in mines was emphasized by the failure of a CATEL amplifier that had been installed in an ungasketed enclosure. Moisture condensed on the cables, entered the enclosure and collected on its bottom surface. CATEL and Motorola were advised regarding this problem and the Project Leader has modified some gasketed enclosures which are on hand to protect the CATEL equipment, Figure 3.14.

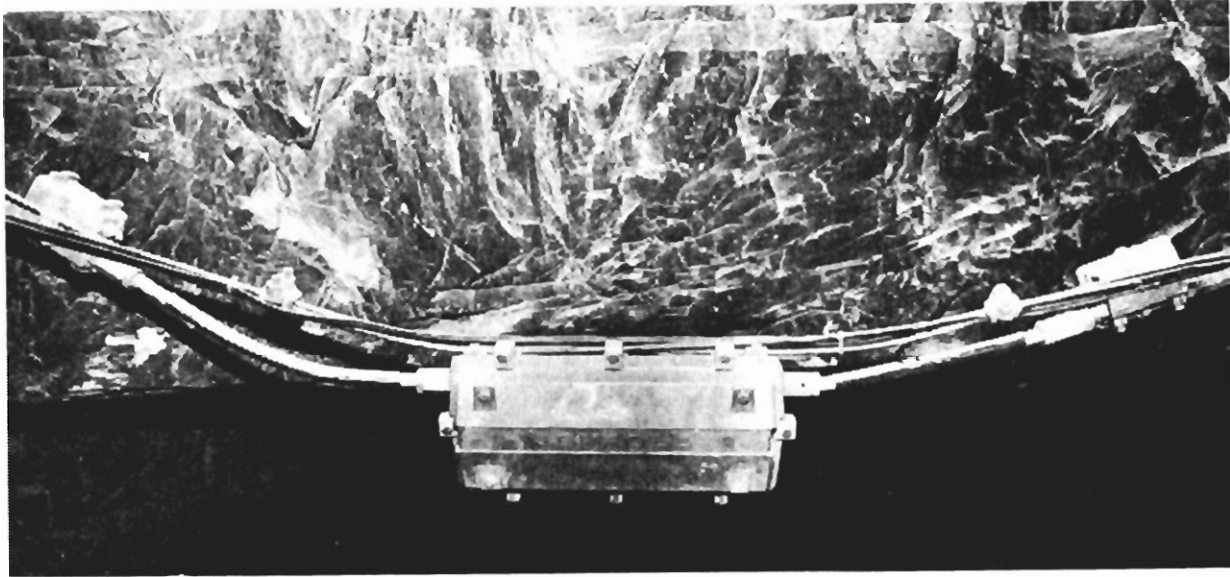
FIGURE 3.15. CATV LINE AMPLIFIERS FOR THE "BACK BONE" COAXIAL CABLE SYSTEM ARE ENCLOSED IN GASKETED WATER TIGHT CAST ALUMINUM HOUSINGS AND ARE SUPPORTED BY STEEL MESSENGER CABLES.

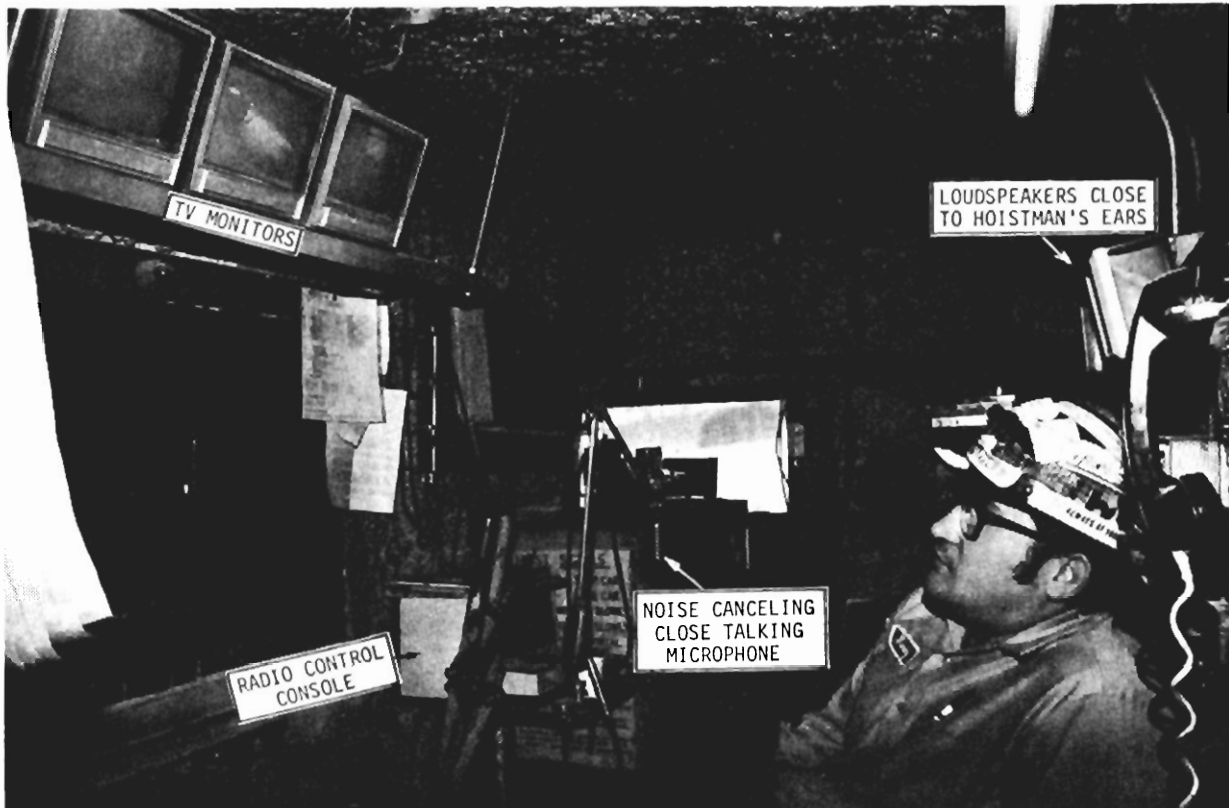
FIGURE 3.16. TV MONITORS AND RADIO CONTROL EQUIPMENT IN THE HOIST HOUSE.

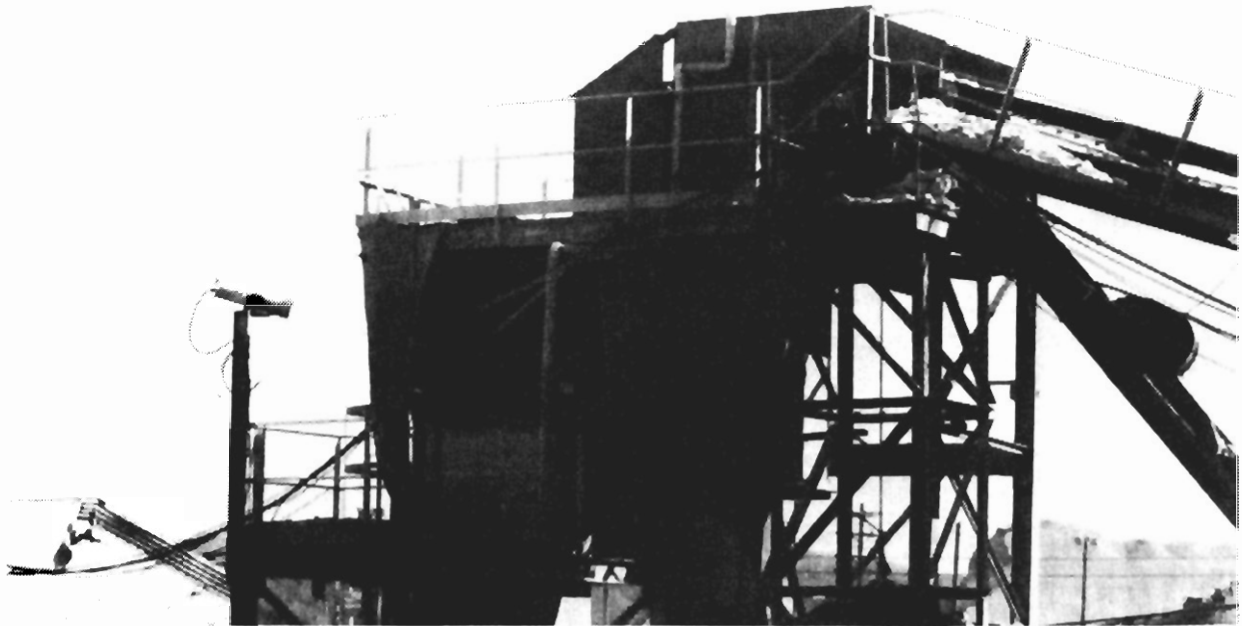
FIGURE 3.17. TV CAMERA VIEWING ROCK MOVEMENT AT THE TRANSITION OF CONVEYOR BELTS ABOVE THE MINE PORTAL.

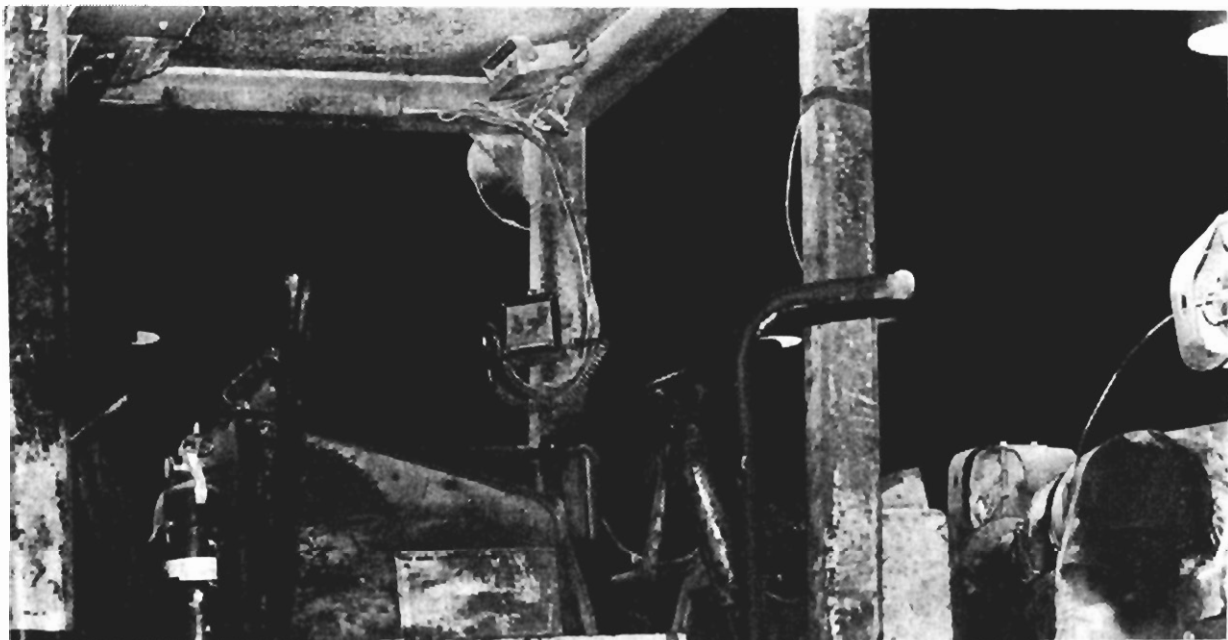
FIGURE 3.18. TYPICAL RADIO INSTALLATION IN A MINE VEHICLE SHOWING THE MODAT EMERGENCY ALARM, IDENTIFICATION AND STATUS ENCODER UNDER THE ROOF AND THE RADIO CONTROL HEAD MOUNTED ON THE COLUMN.

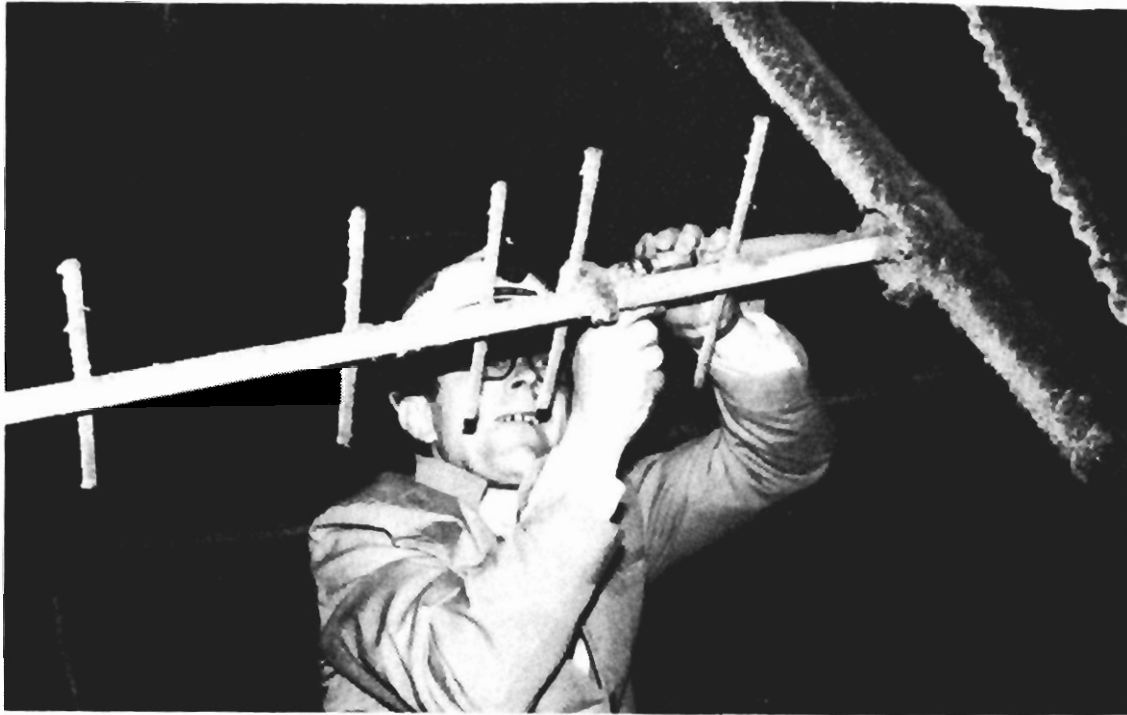
FIGURE 3.19. VIEW OF YAGI ANTENNA INSIDE THE PORTAL SHOWING SEVERAL MONTHS' ENCRUSTATION OF LIMESTONE DUST AND SMOKE PARTICLES ON THE ANTENNA RODS. THE ANTENNA VSWR WAS NOT READABLE WITH 2.5 WATTS FORWARD POWER AND PERFORMANCE EVIDENTLY WAS NOT DEGRADED.

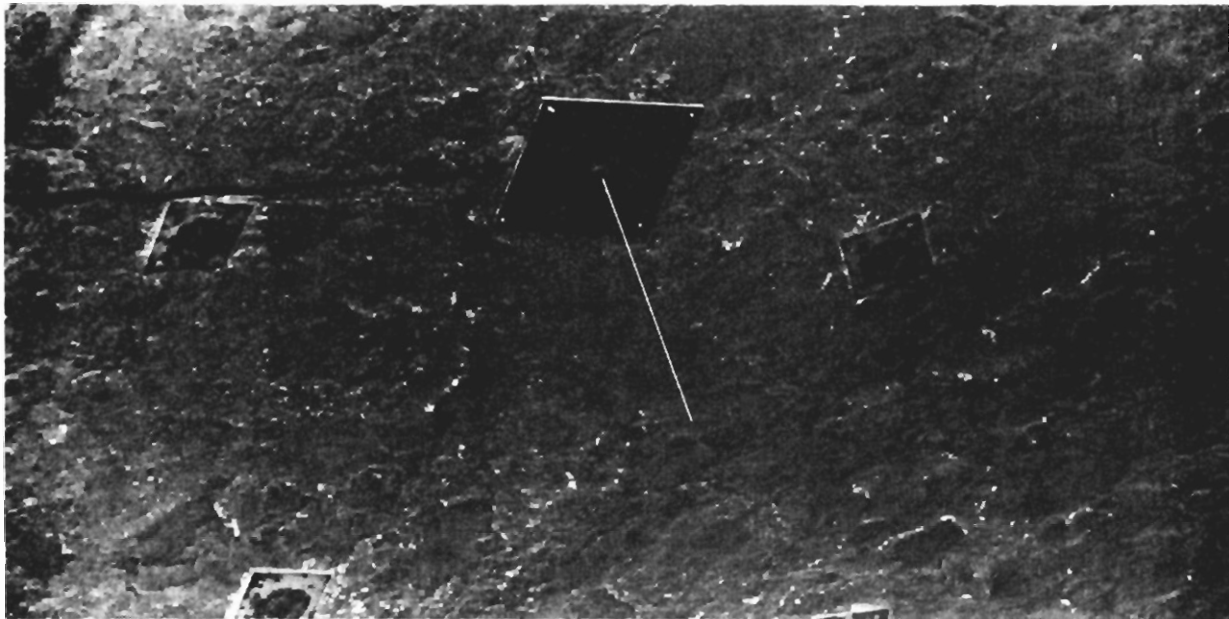
FIGURE 3.20. TYPICAL MOBILE ANTENNA USED FOR DISTRIBUTED ANTENNA SYSTEM MOUNTED ON TWO FOOT SQUARE METAL PLATE THAT IS ATTACHED TO ROOF NEAR THE CENTER OF INTERSECTION OF TWO CROSSCUTS.

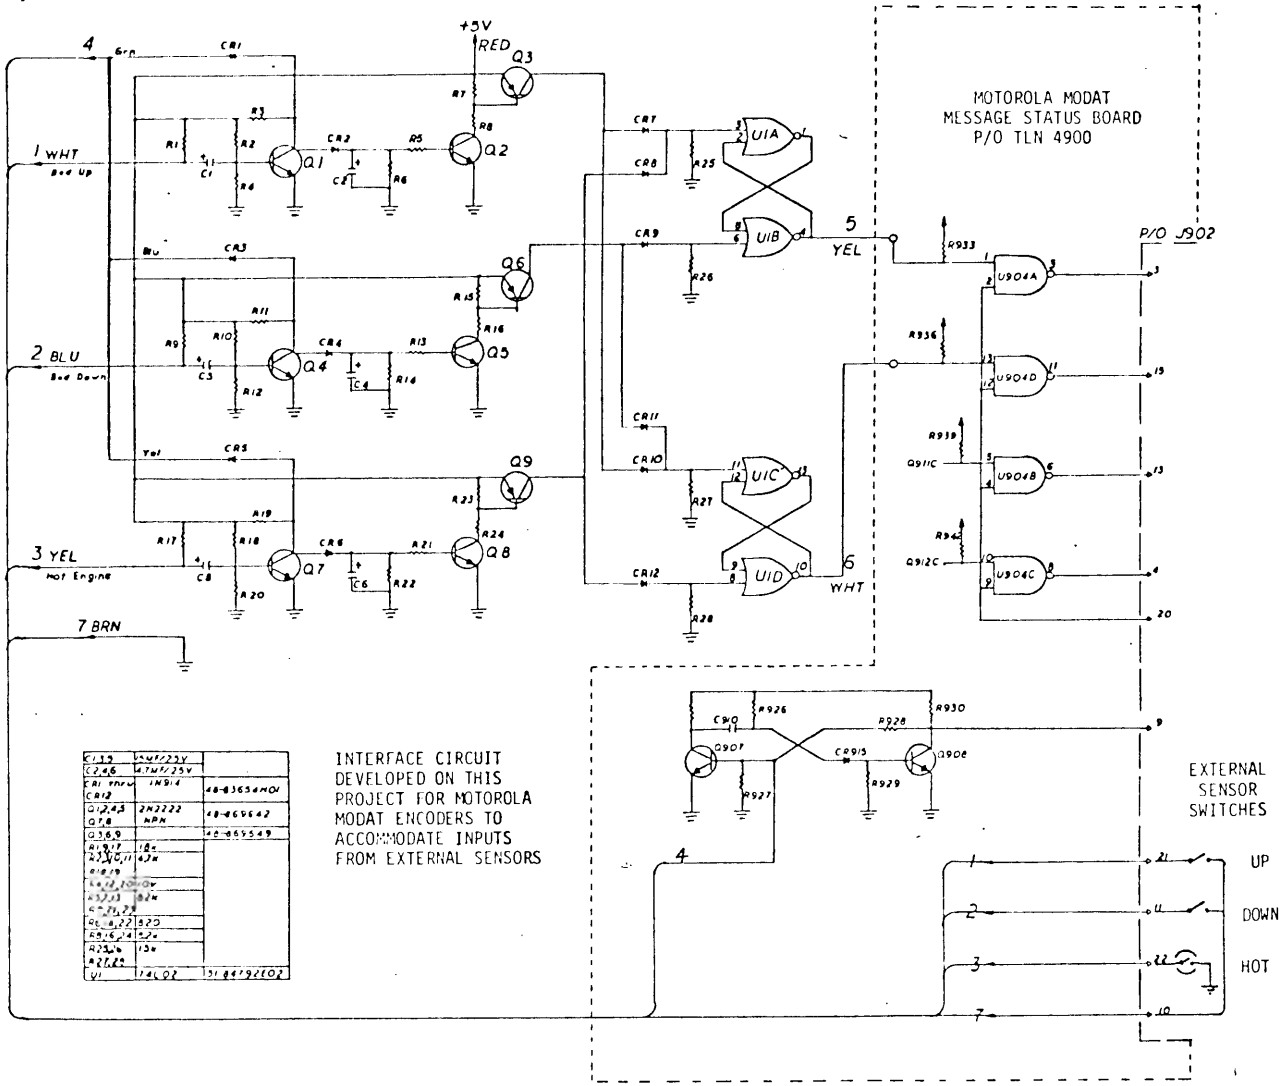
FIGURE 3.21 SCHEMATIC DIAGRAM OF INTERFACE UNIT FOR MOTOROLA MODAT DIGITAL STATUS ENCODER USED ON MINE TRUCKS TO AUTOMATICALLY SEND BED-UP, BED-DOWN, AND HOT ENGINE STATUS MESSAGES FROM EXTERNAL SENSOR SWITCHES.

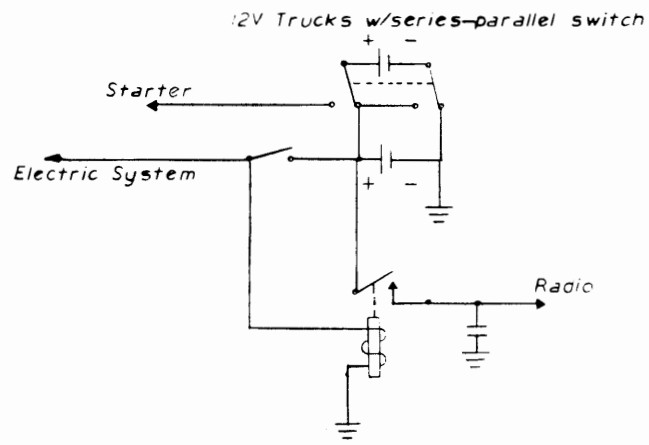
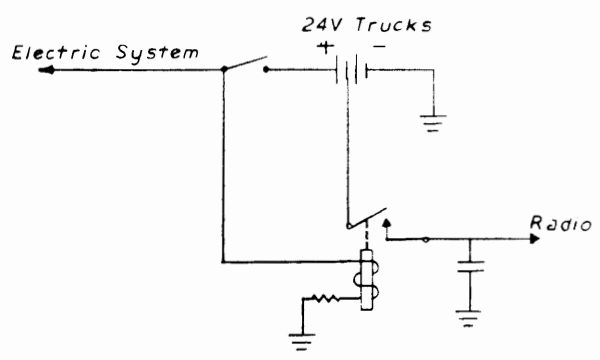
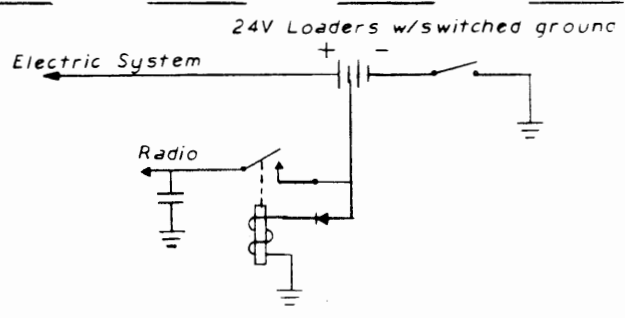
FIGURE 3.22

POWER CIRCUITS FOR MOBILE RADIOS ON MINE VEHICLES

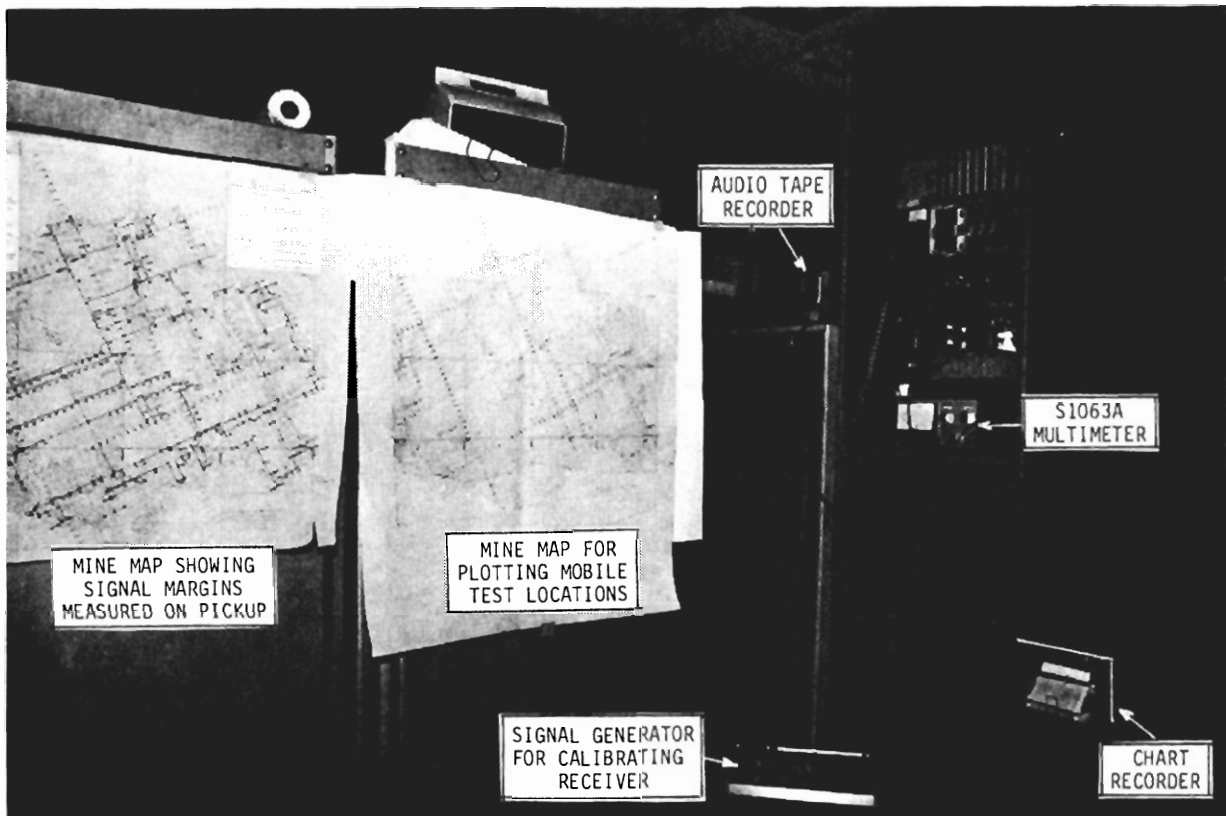
FIGURE 3.23 INTERIOR OF RADIO AND MONITORING EQUIPMENT ROOM SHOWING BASE STATIONS AND TEST EQUIPMENT USED FOR MEASURING SIGNAL MARGINS FROM A HAND HELD TRANSCEIVER.

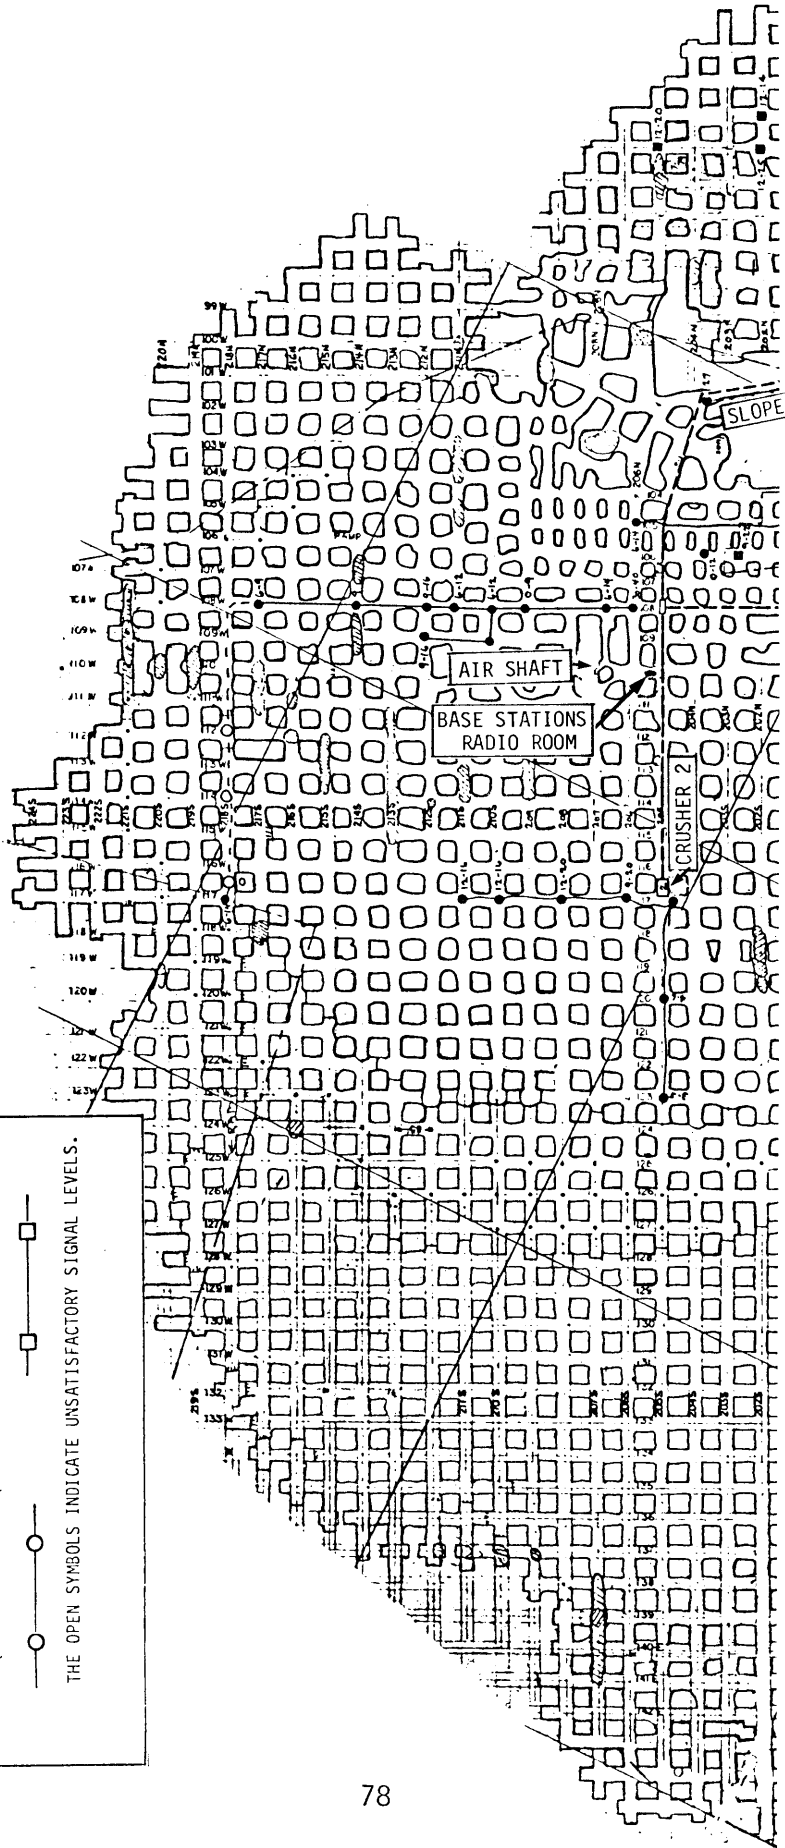
FIGURE 3.24A  
A MINE MAP SHOWING SIGNAL MARGINS ABOVE 20dBq MEASURED AT A BASE STATION IN THE MONITORING BUILDING FROM A  
HAND HELD TWO WATT TRANSMITTER OPERATED ON A VEHICLE IN THE WESTERN SECTOR OF THE MINE. THE SIGNAL AND  
QUALITY EVALUATIONS ARE LISTED ON TABLE 3 IN APPENDIX C.

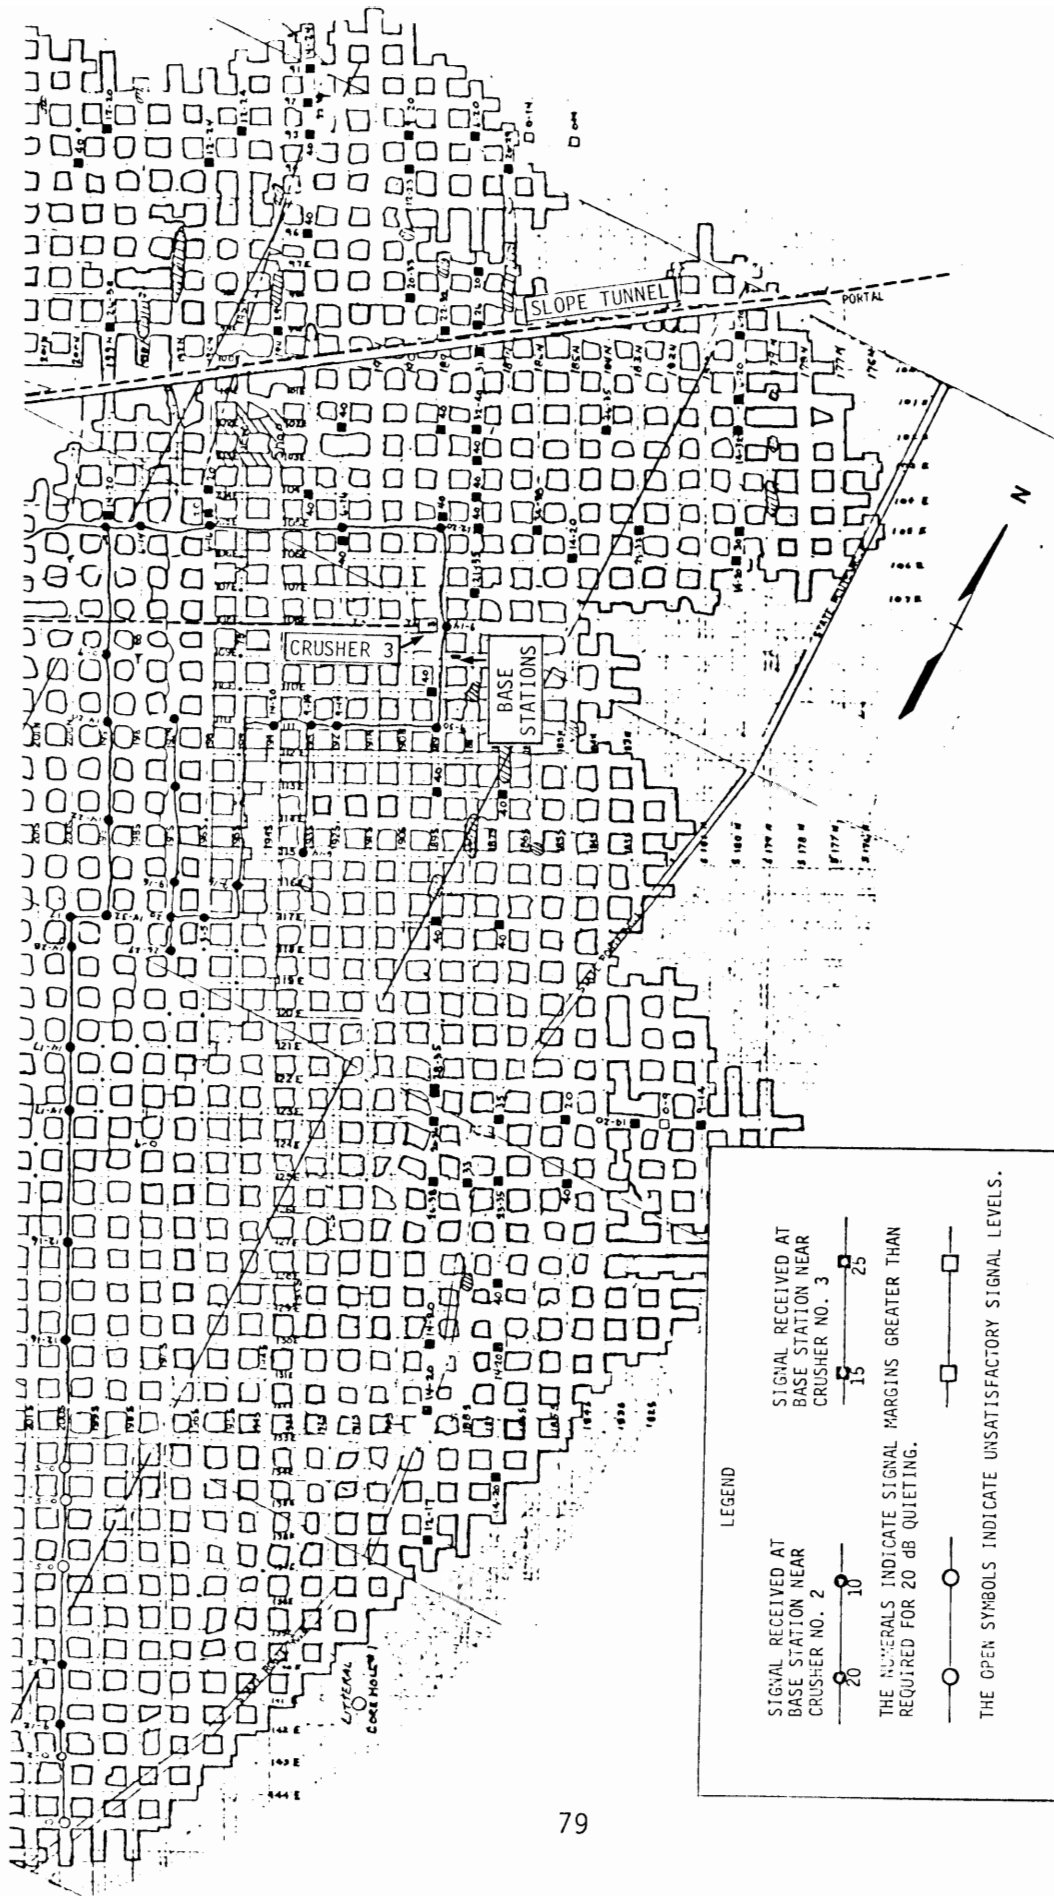
FIGURE 3.24B  
 SIGNAL MARGINS ABOVE 20dBq MEASURED AT A BASE STATION NEAR CRUSHER NO. 3 FROM A HAND HELD TWO WATT TRANSCIVER OPERATED ON A VEHICLE IN THE EASTERN SECTOR OF THE MINE. THE SIGNAL LEVELS AND QUALITY EVALUATIONS ARE LISTED ON TABLE 4 IN APPENDIX C.

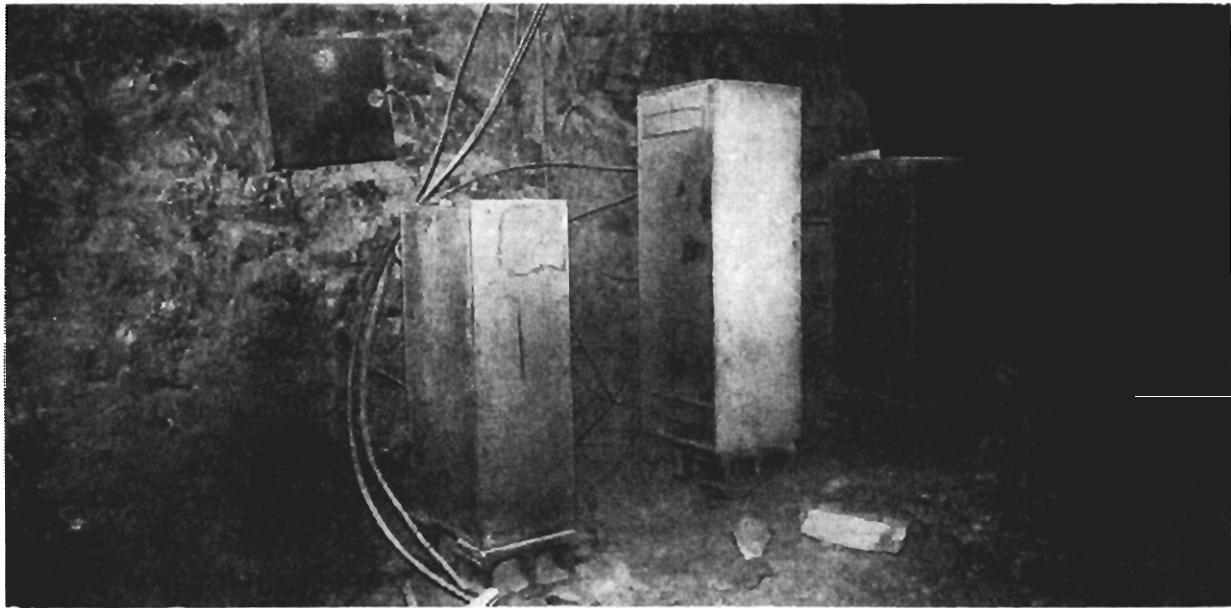
FIGURE 3.25. BASE STATIONS AND COMBINER NEAR CRUSHER NO. 3. THE CABINETS ARE WEATHERPROOF AND THE ENCLOSURE ON THE WALL CONTAINS STORAGE BATTERIES FOR UNINTERRUPTIBLE POWER.

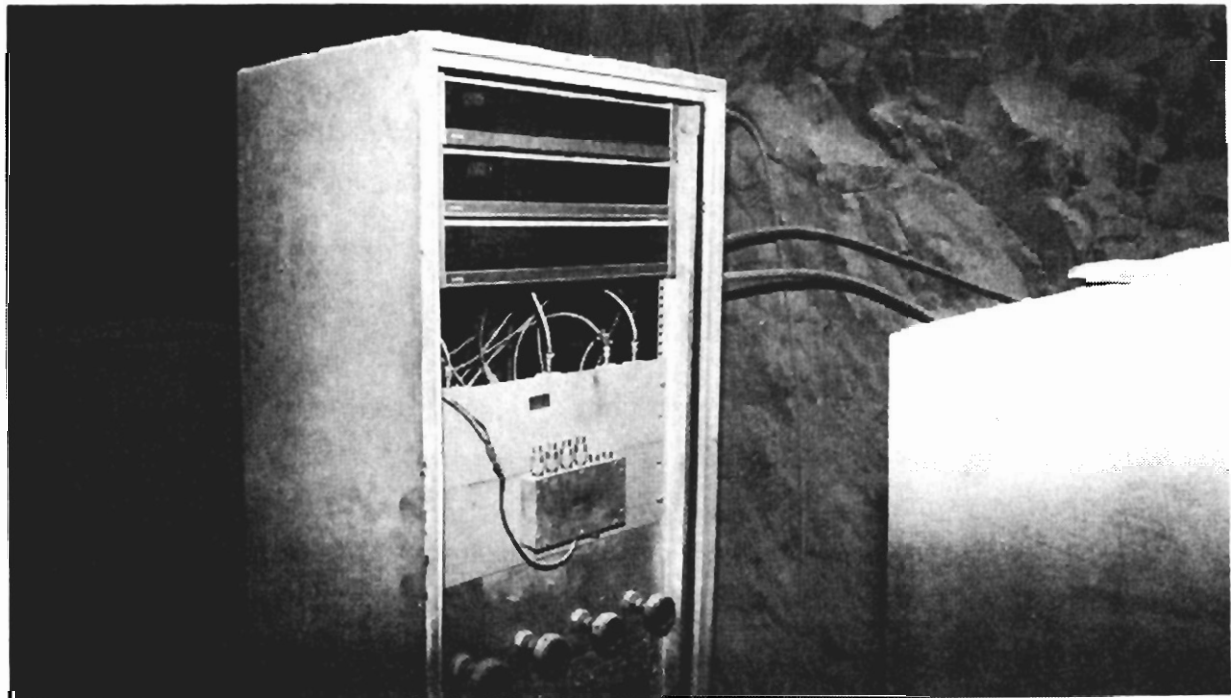
FIGURE 3.26. COMBINER CABINET WITH GASKETED DOOR REMOVED TO SHOW CATEL FM MODULATORS AND DEMODULATORS (TOP PANELS) AND THE TRANSMITTER COMBINER AND DUPLEXER.

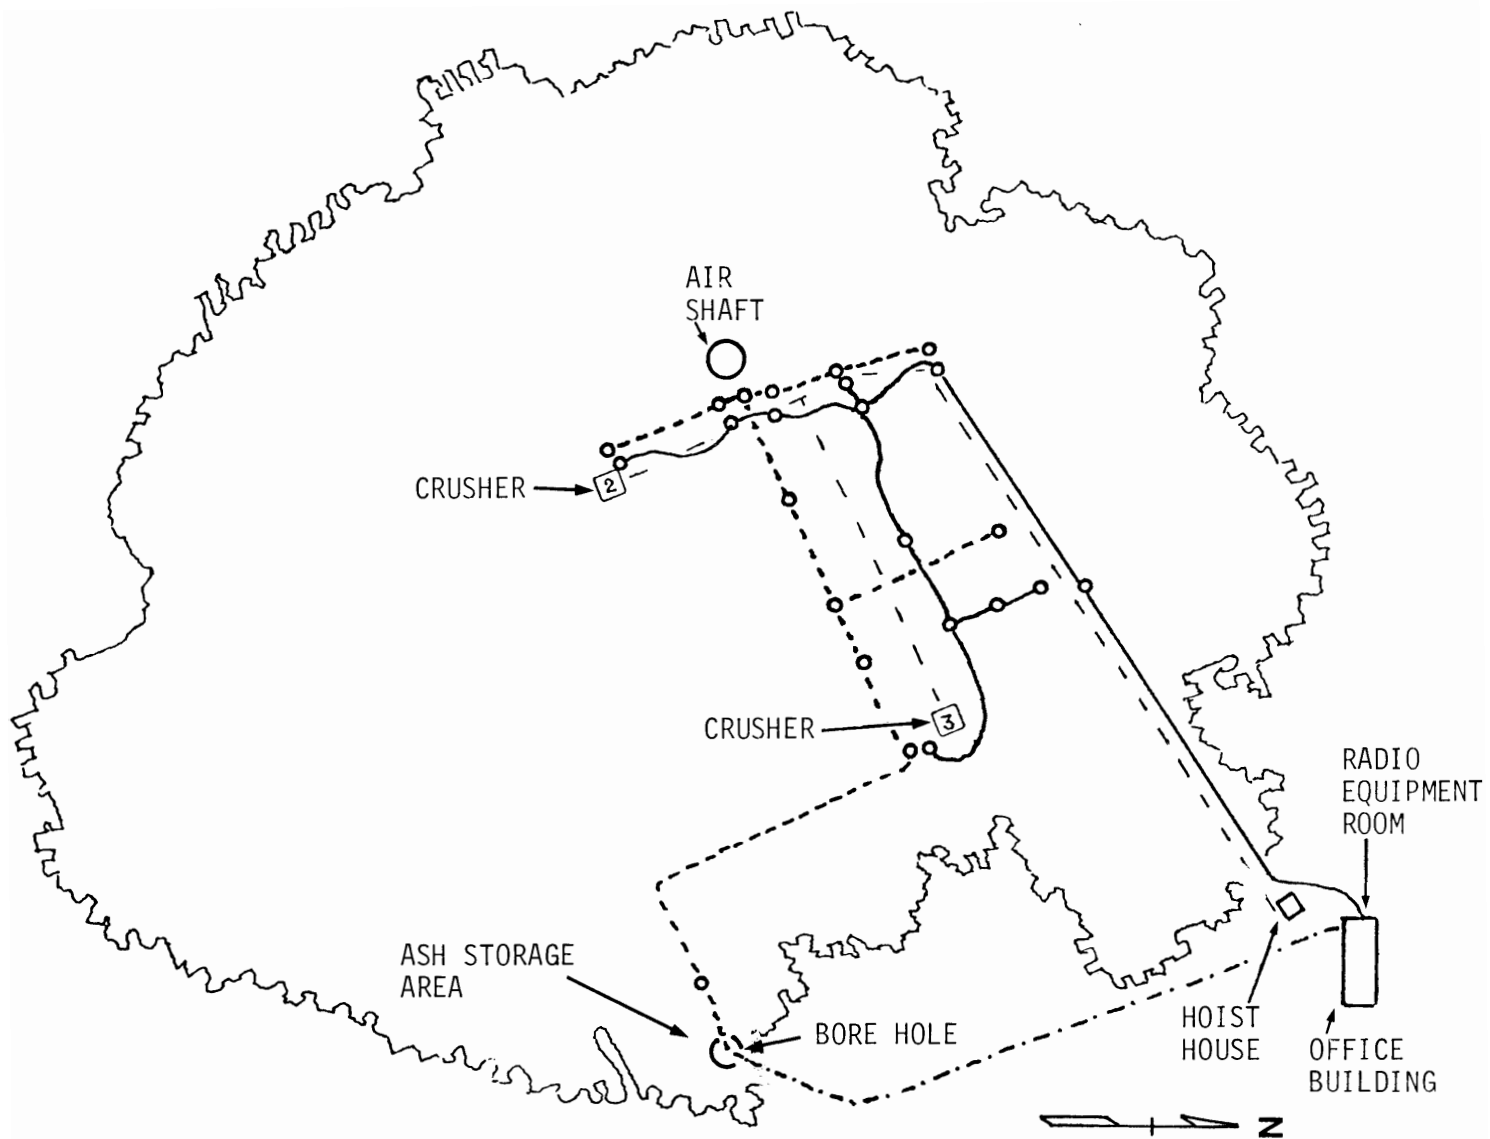
LEGEND

- BACK BONE CABLE NO. 1 INSTALLED THROUGH SLOPE.
- -○- - BACK BONE CABLE NO. 2 INSTALLED IN MINE.
- · - · - BACK BONE CABLE ABOVE GROUND TO RADIO ROOM.
- The circles in the cable represent multicouplers for connecting multiplexing FM modulators or demodulators
- - - - - ROCK CONVEYOR BELT.

Twenty-seven CATEL FM modulators and demodulators are used to multiplex the control, audio, digital and video signals on carrier frequencies ranging from 6.2 to 175.1 MHz, as is shown on Figures 3.28 through 3.31 four additional modulators and demodulators have been proposed for a future digital environmental monitoring system.
