**THE IMPLEMENTATION  
OF UHF RADIO COMMUNICATIONS  
AND CCTV MONITORING SYSTEMS IN A  
ROOM AND PILLAR METAL/NON-METAL MINE  
FINAL REPORT**

**Prepared For:  
Bureau of Mines  
United States Department of the Interior**

**Contract No.: JO 377044**

**March 1981**

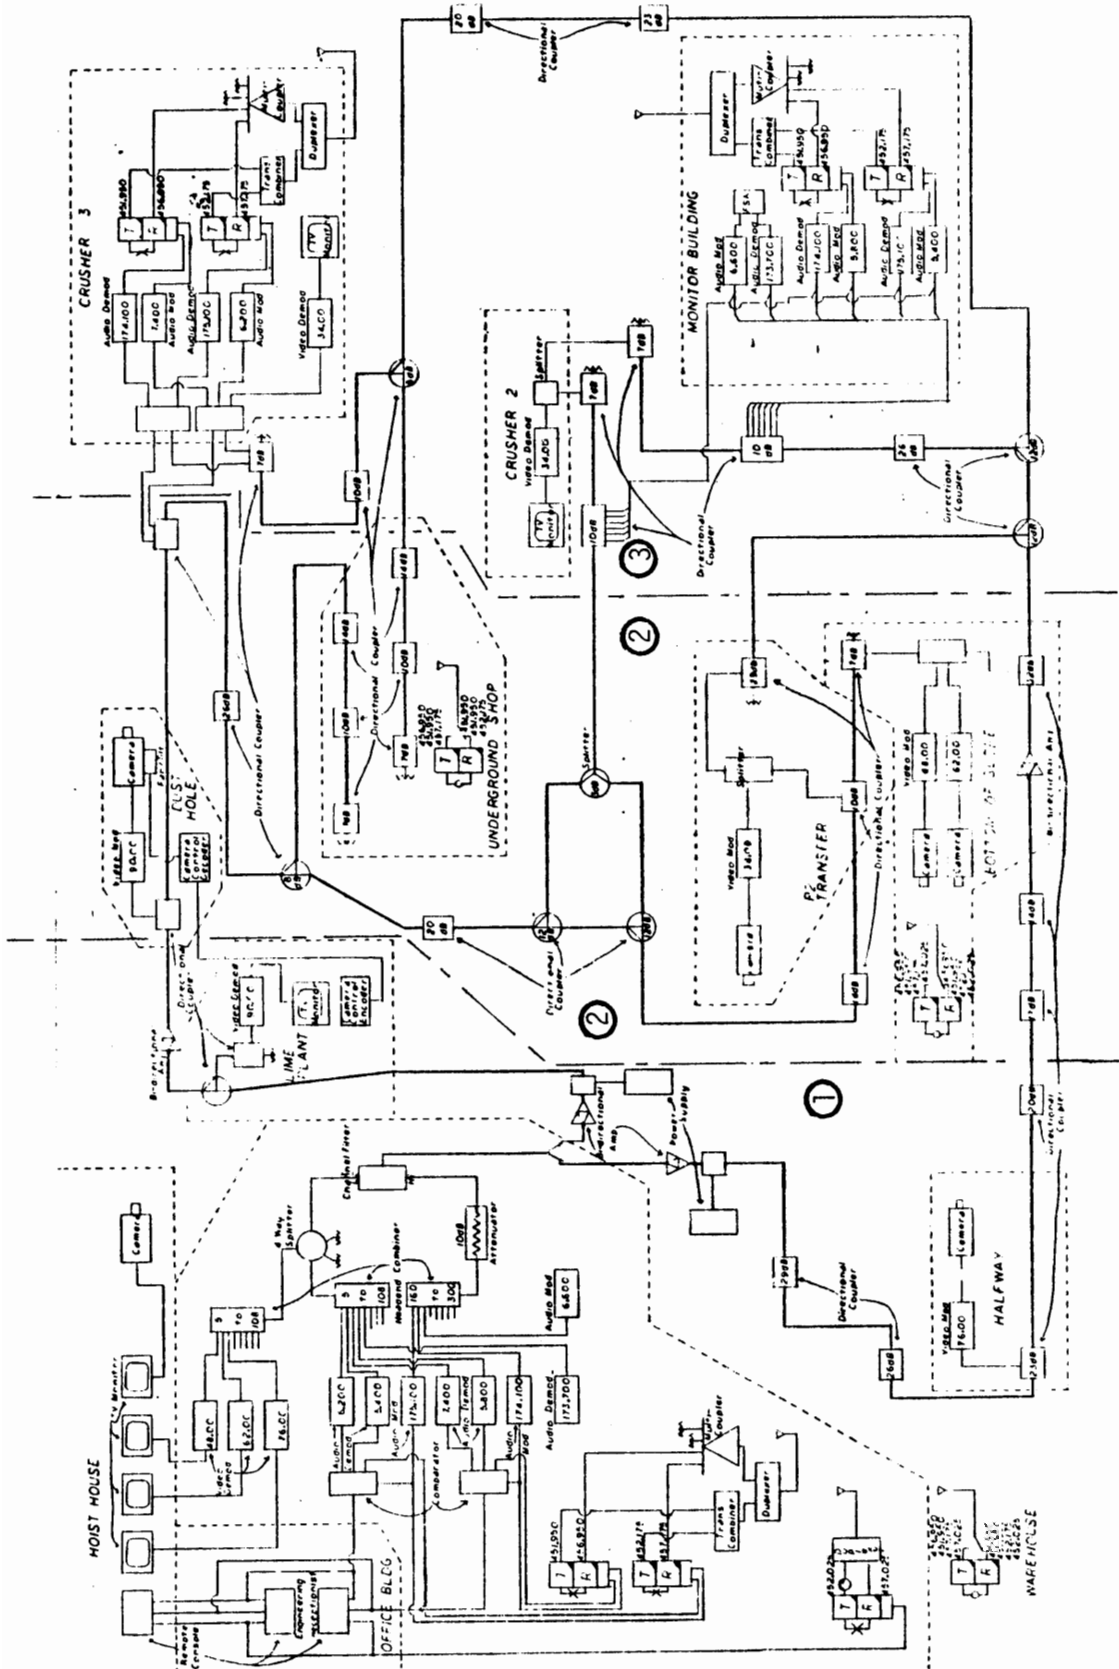
FIGURE 3.28 COMPOSITE BLOCK DIAGRAM OF RADIO AND CCTV SYSTEM IN FEBRUARY 1981. ENLARGED SECTIONS OF THIS DRAWING ① ② ③ ARE SHOWN ON FIGURES 3.29, 3.30 AND 3.31.

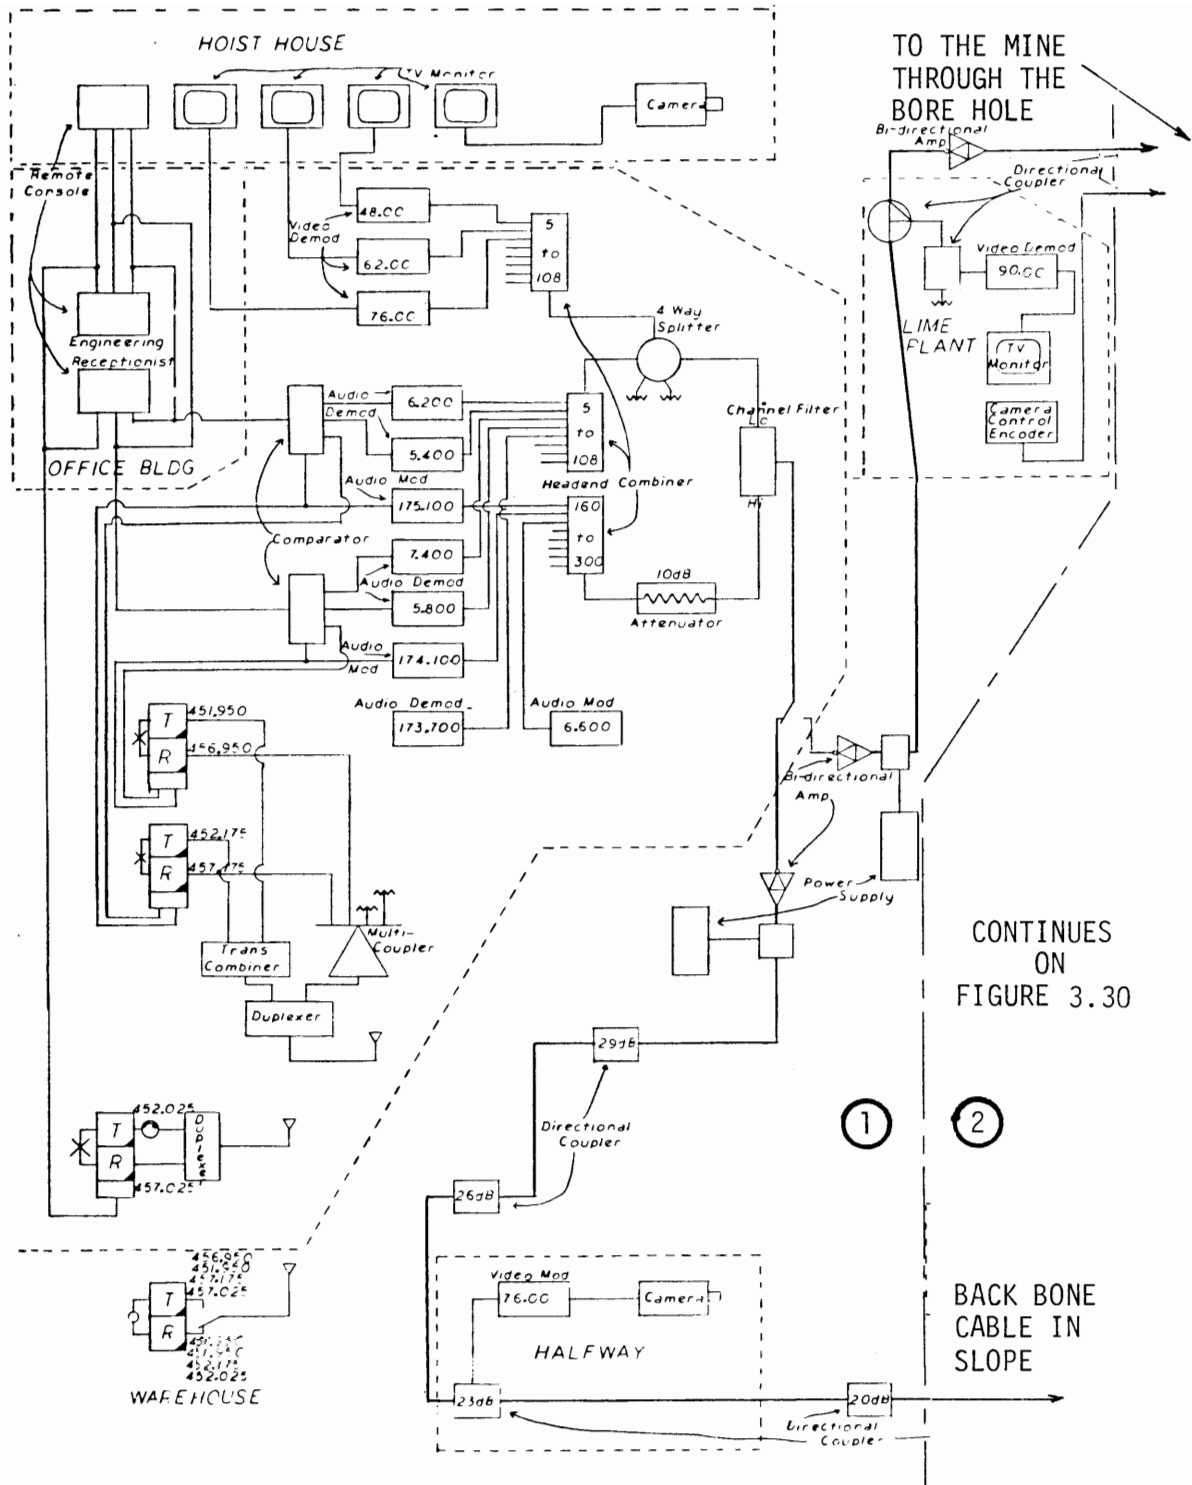
BACK BONE  
CABLE IN  
SLOPE

FIGURE 3.29 BLOCK DIAGRAM OF RADIO AND CCTV SYSTEMS THAT ARE ABOVE GROUND. THIS DRAWING IS AN ENLARGEMENT OF THE LEFT HAND SECTION 1 ON FIGURE 3.28.

Six Motorola V-10003C CCTV cameras, seven Motorola 51252 nine-inch TV monitors and accessory equipment are used for observing critical areas at the mine. Each of the cameras feeds its composite video signal to a CATEL modulator and a CATEL demodulator feeds each TV monitor as shown by Figures 3.28 through 3.32. Following is a summary of the equipment and how it is used:

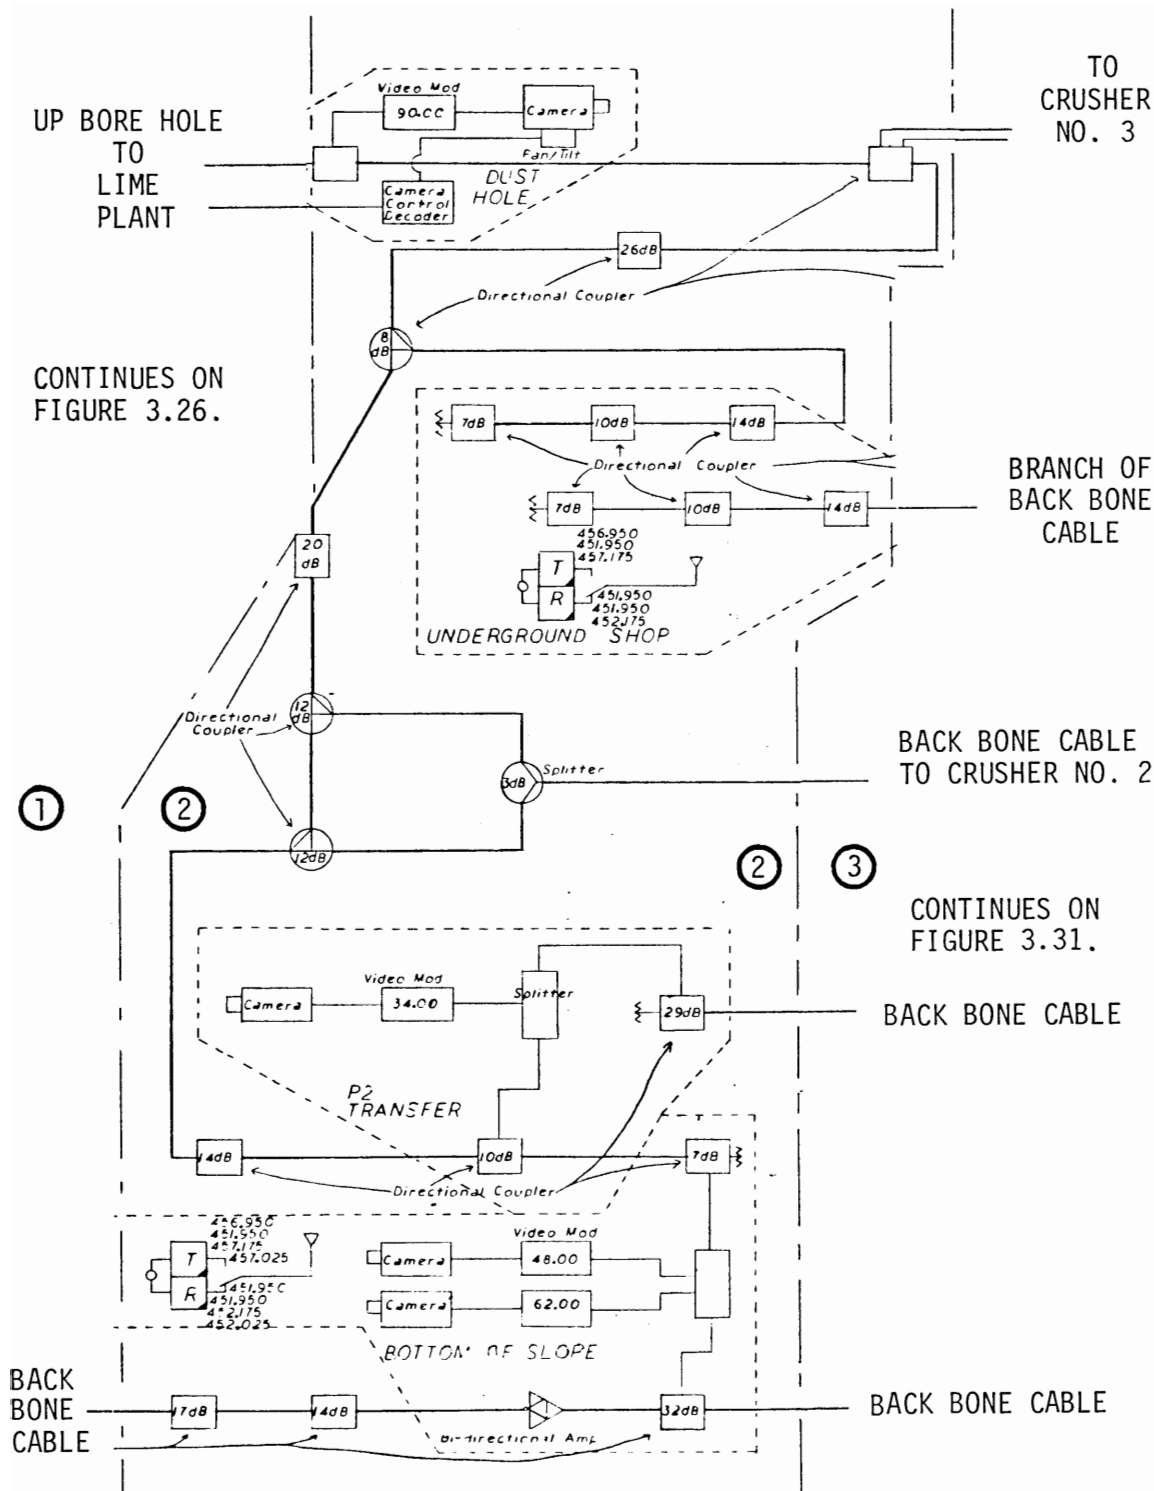
FIGURE 3.30. BLOCK DIAGRAM OF A PORTION OF RADIO AND CCTV SYSTEMS IN THE MINE. THIS IS AN ENLARGEMENT OF SECTION ② SHOWN ON FIGURE 3.28.

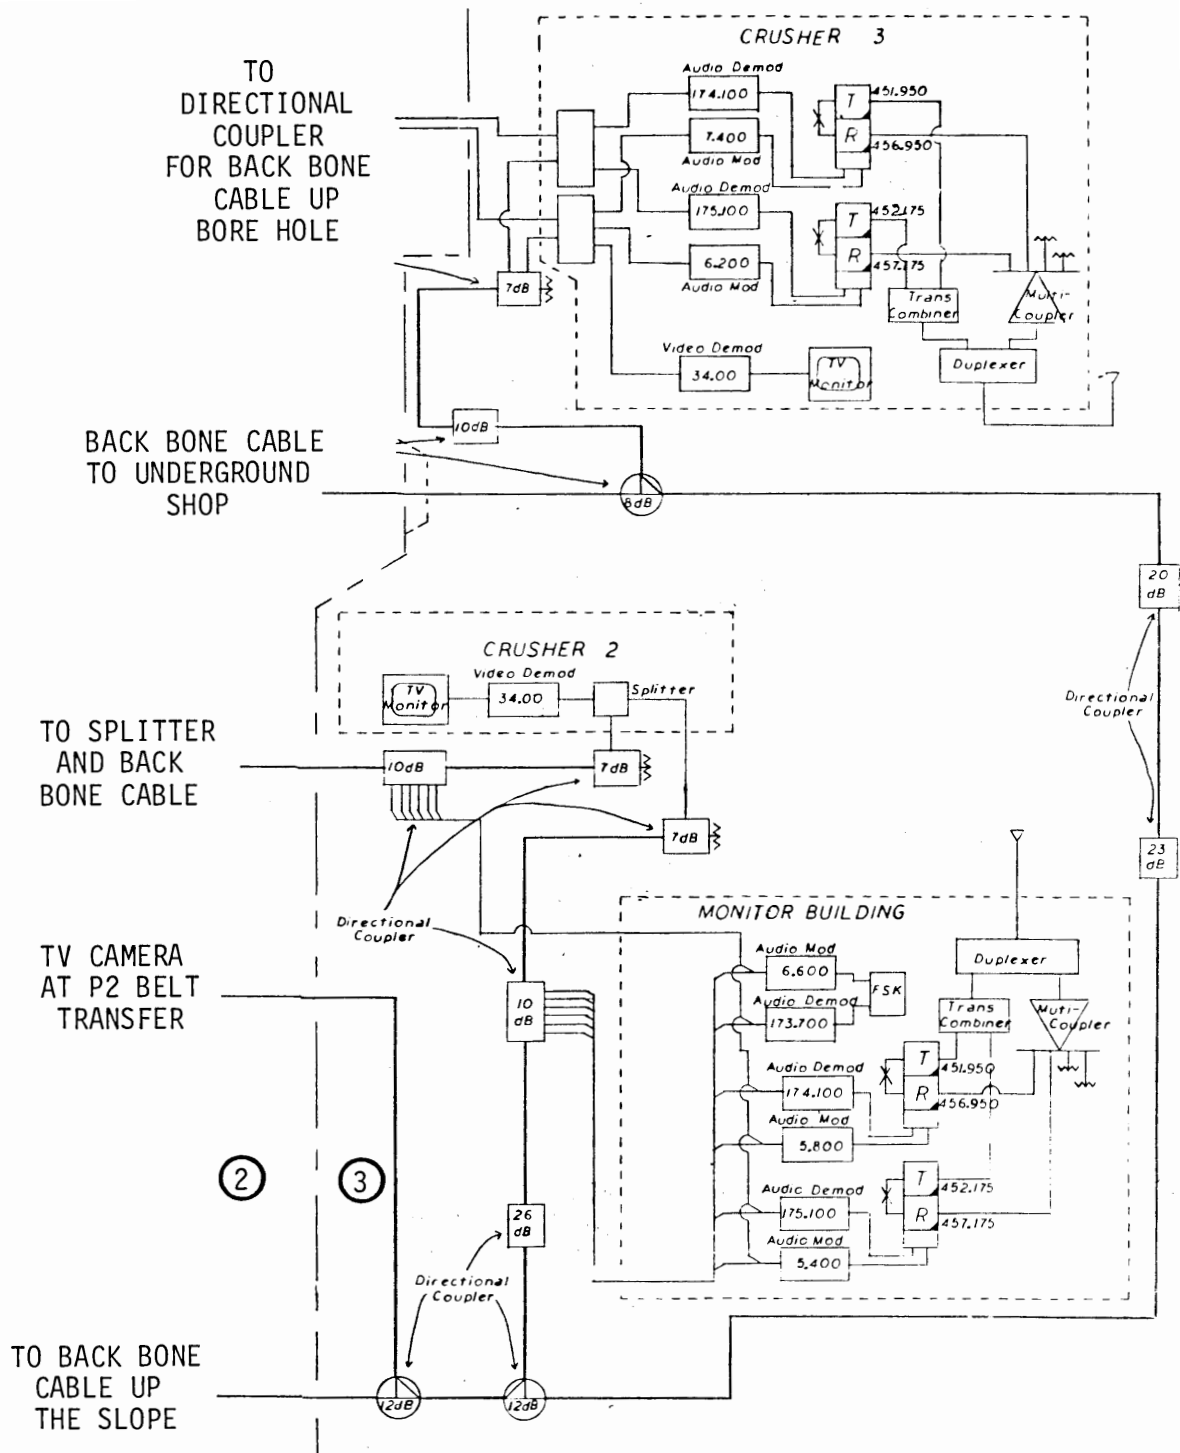
FIGURE 3.31. BLOCK DIAGRAM OF A PORTION OF RADIO AND CCTV SYSTEMS IN THE MINE. THIS IS AN ENLARGEMENT OF SECTION ③ OF FIGURE 3.28.

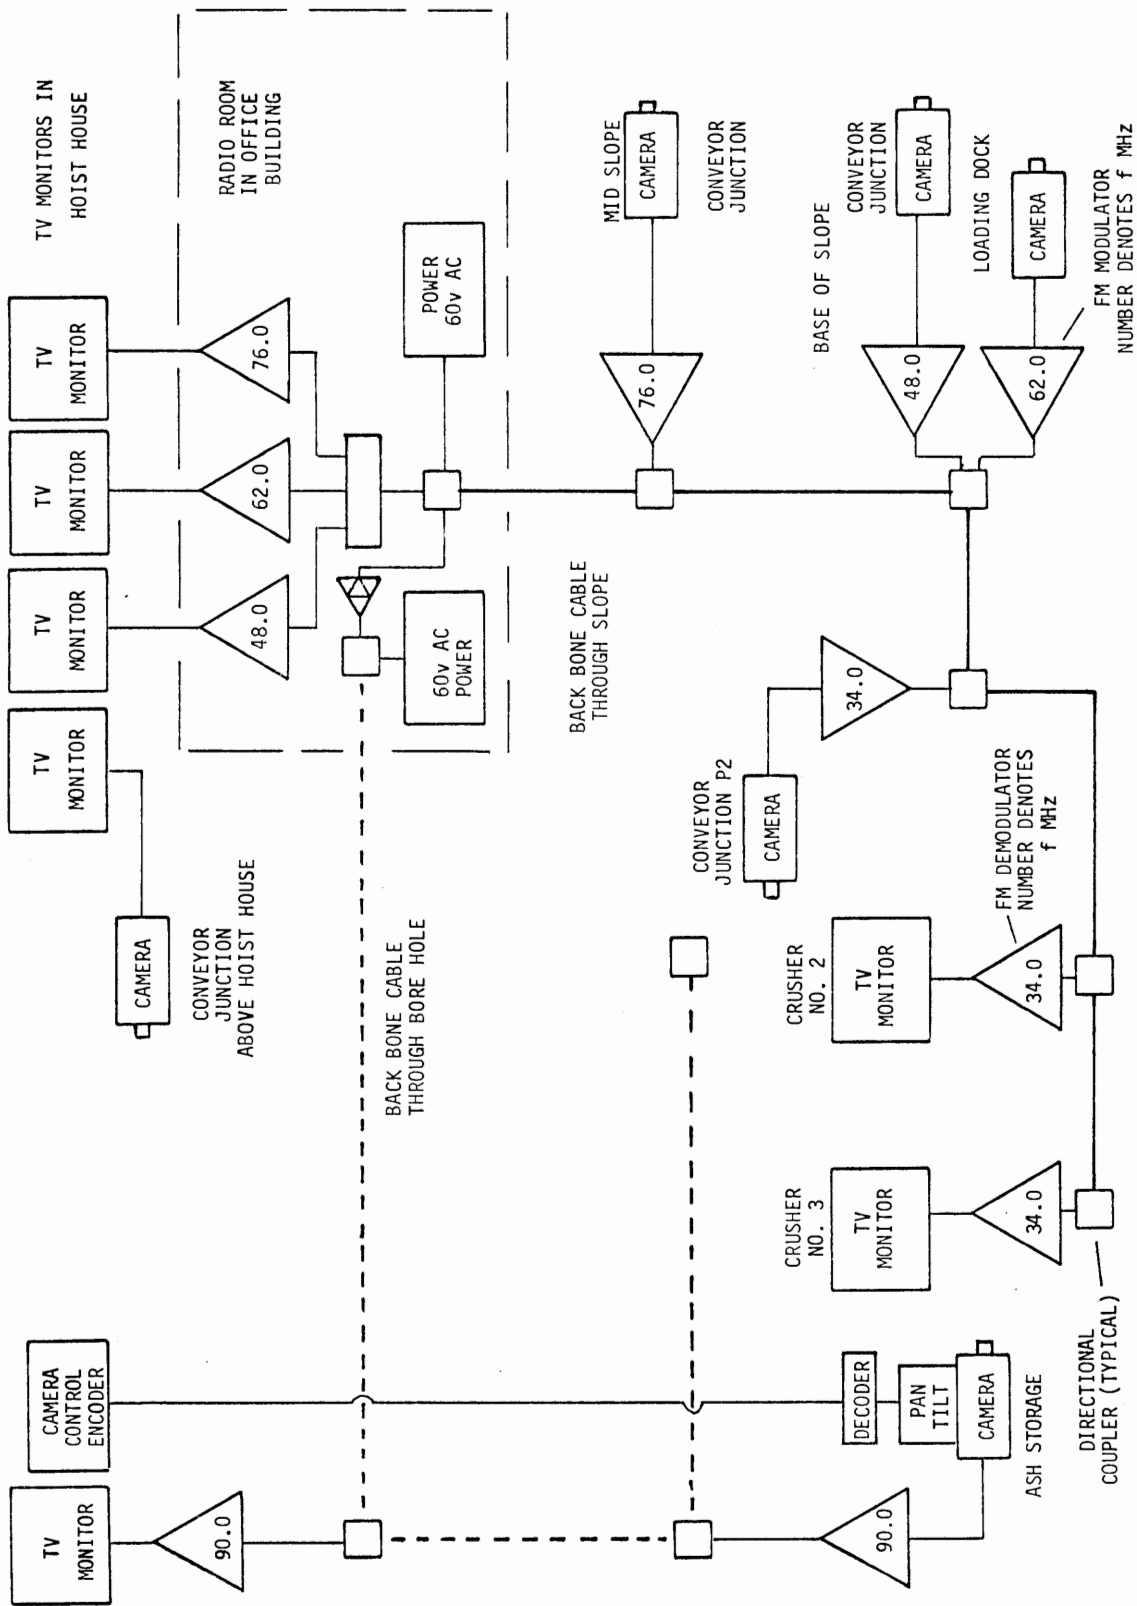
FIGURE 3.32 SIMPLIFIED BLOCK DIAGRAM OF CCTV SYSTEM

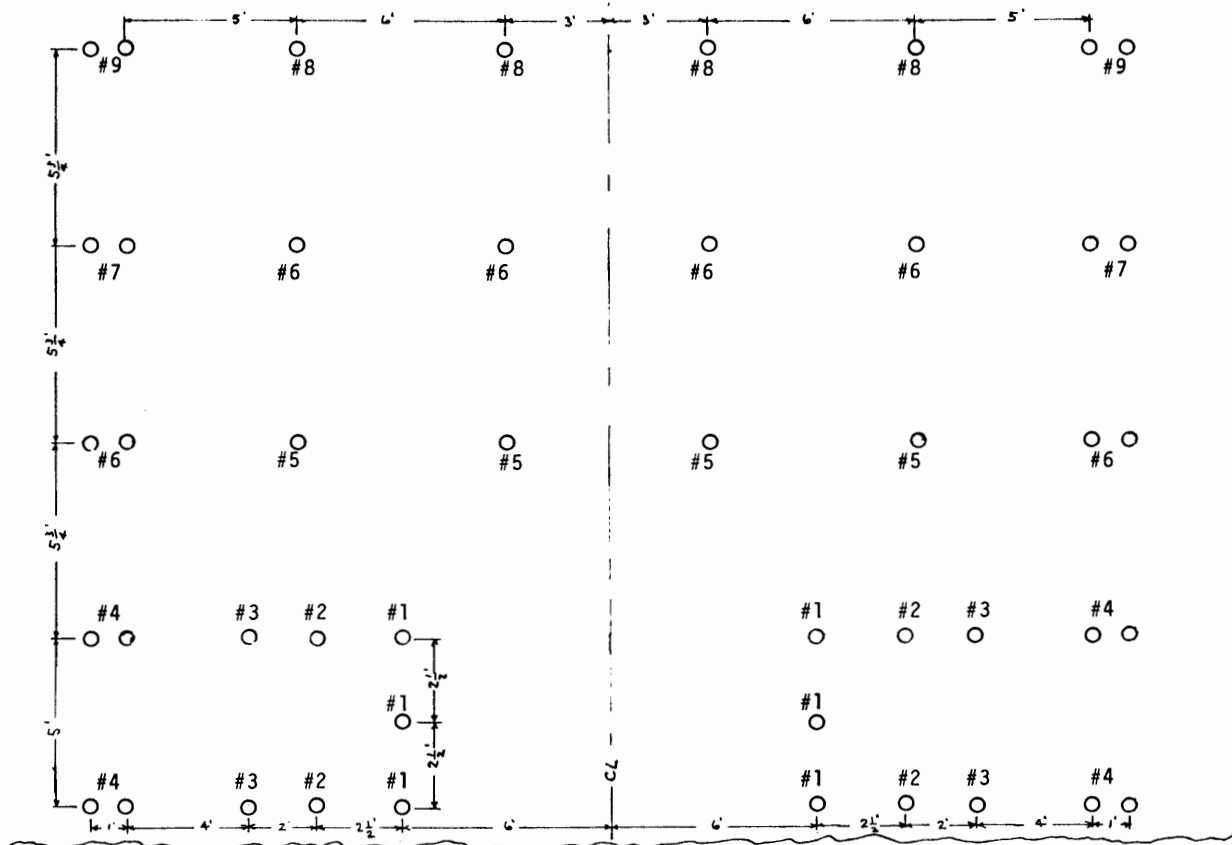
FIGURE 4.1 PATTERN OF HOLES DRILLED IN LIMESTONE FACE FOR BLASTING CAPS USED FOR DEMONSTRATING SAFE RADIO OPERATION OF MOBILE AND PORTABLE UHF RADIOS IN THE VICINITY OF ELECTRIC BLASTING CAPS AND ASSOCIATED WIRING.

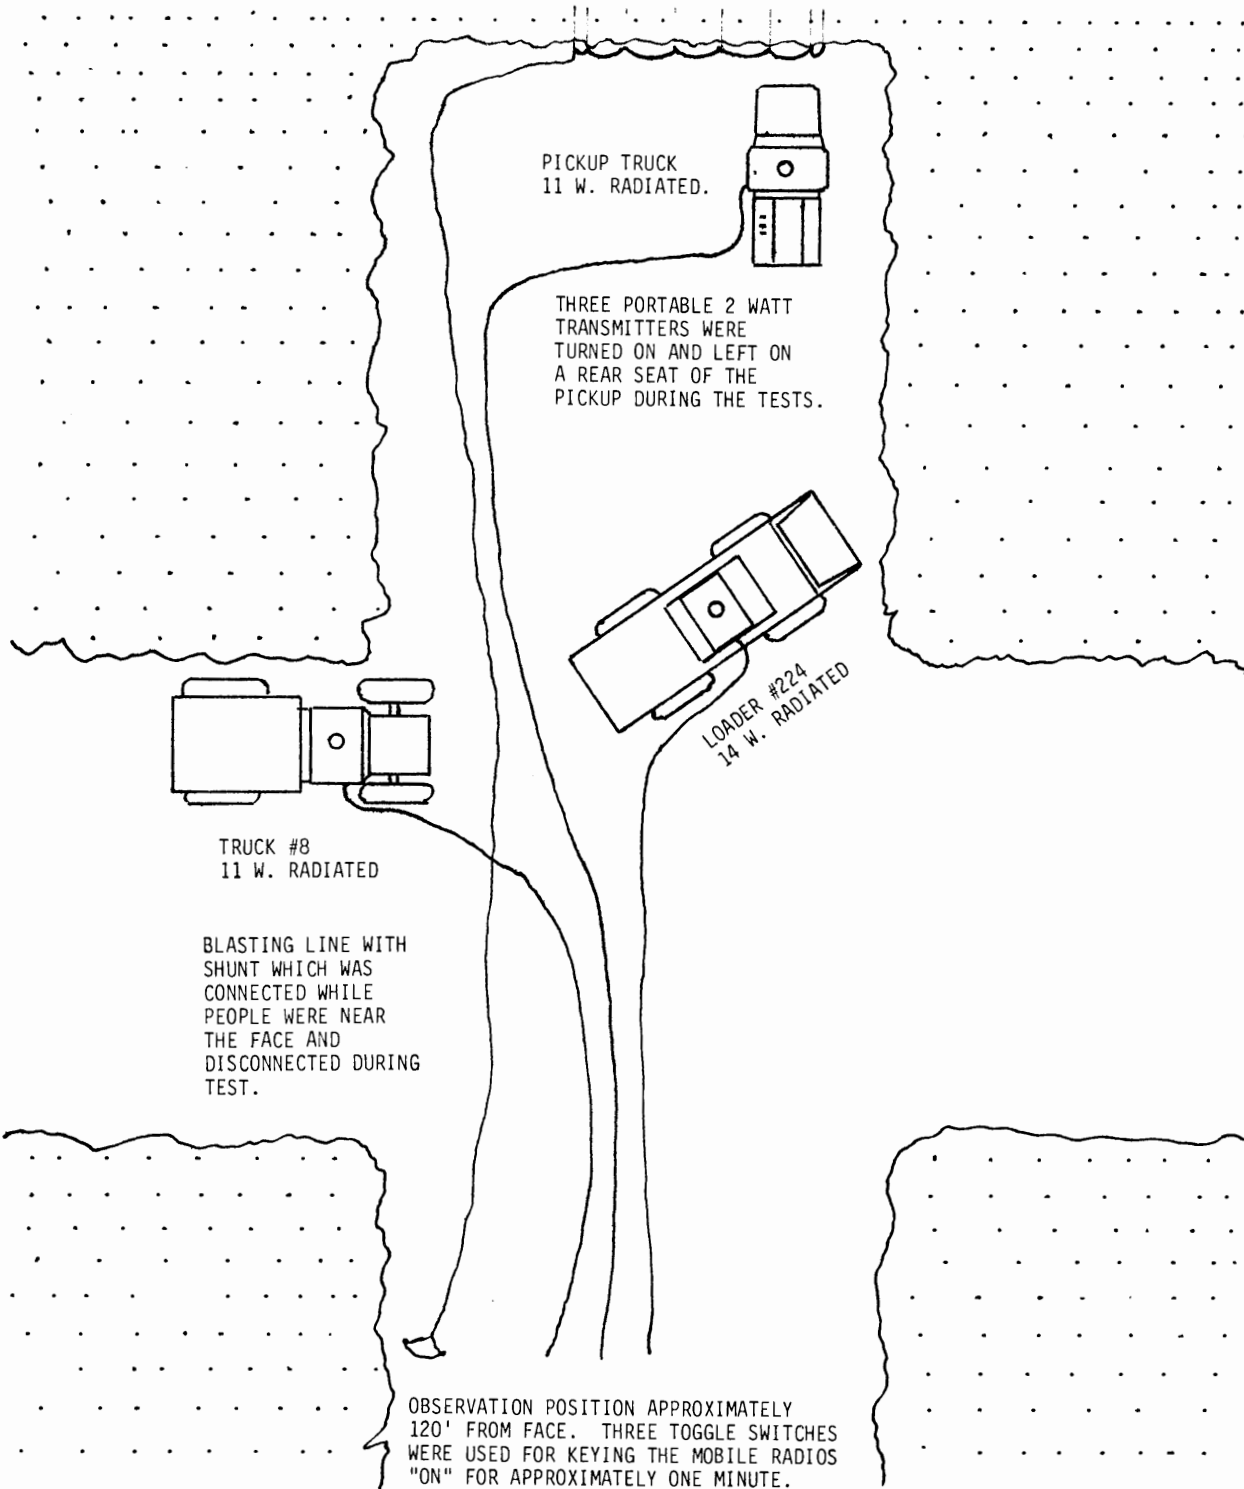
FIGURE 4.2 APPROXIMATE LOCATIONS OF VEHICLES EQUIPPED WITH MOBILE UHF RADIOS WHICH WERE PARKED ADJACENT TO THE DRILLED FACE LOADED WITH 48 BLASTING CAPS IN THE BLACK RIVER MINE, AUGUST 22, 1979.

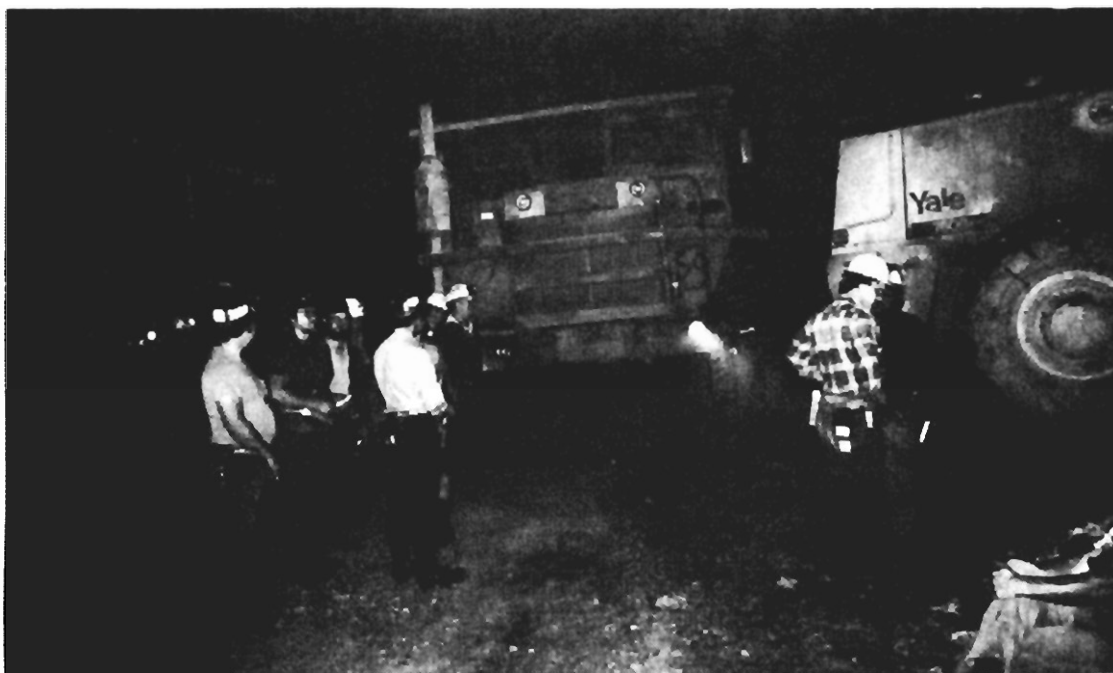
FIGURE 4.3. THE RADIO EQUIPPED VEHICLES WERE PARKED ADJACENT TO THE DRILLED ROCK FACE THAT HAD BEEN LOADED WITH ELECTRICAL BLASTING CAPS.

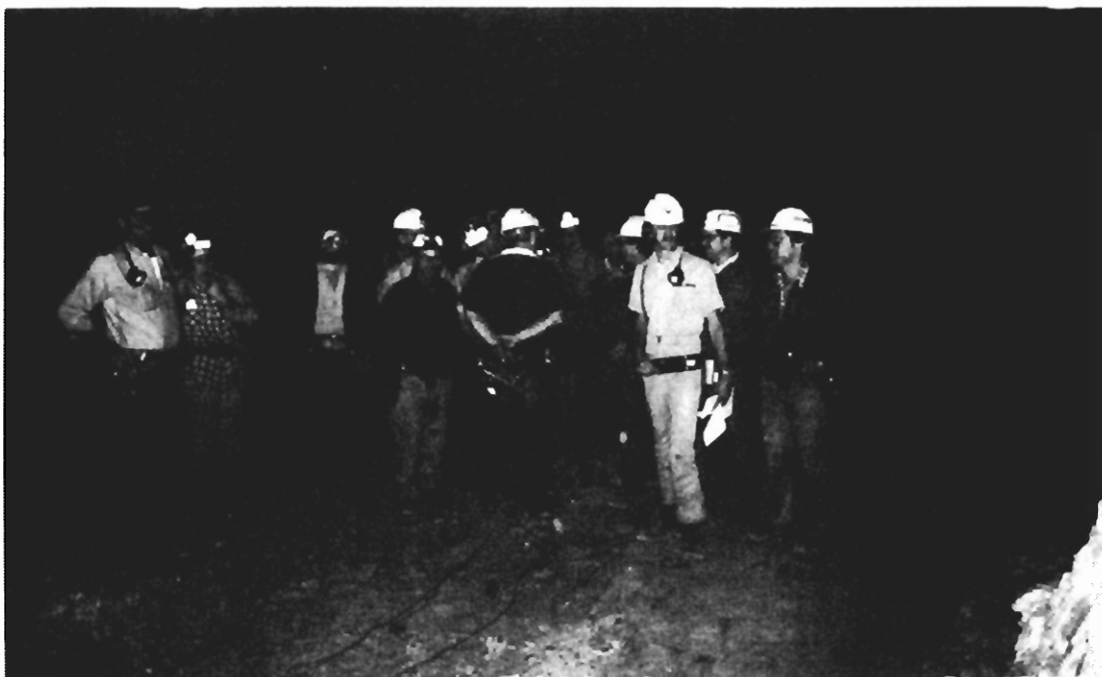
FIGURE 4.4. THE OBSERVERS OF THE TESTS WERE APPROXIMATELY 120' FROM THE FACE THAT WAS LOADED WITH BLASTING CAPS. THE LEADS FOR KEYING THE THREE MOBILE TRANSMITTERS AND FOR SHUNTING THE FIRING LINE CAN BE SEEN ON THE FLOOR.

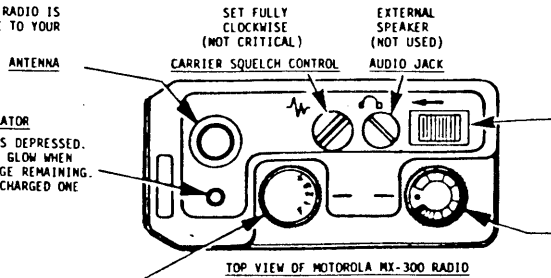
TOP VIEW OF MOTOROLA MX-300 RADIO

GLOWS WHEN PRESS-TO-TALK SWITCH IS DEPRESSED. THE LIGHT WILL BE DIM OR WILL NOT GLOW WHEN THE BATTERY HAS LESS THAN 5% CHARGE REMAINING. REPLACE THE BATTERY WITH A FULLY CHARGED ONE IF THE LIGHT IS DIM.
