Pillar and Roof Span Design in Stone Mines

ABSTRACT: Underground stone mines in the United States use the room and pillar method of mining in relatively flat laying deposits. Roof and rib falls account for 15% of all lost time incidents. This paper presents the result of a study to improve pillar and roof span design methods so that unexpected ground instabilities will be reduced. A pillar design equation and related design guidelines are presented based on the observation of pillar performance at 34 different underground operations. A roof span design procedure is also proposed that systematically addresses the main issues related to roof instability. The guidelines are based on the observation of actual pillar and roof span performance in stone mines in the Eastern and Midwestern United States and therefore only apply to stone mine design within these regions.

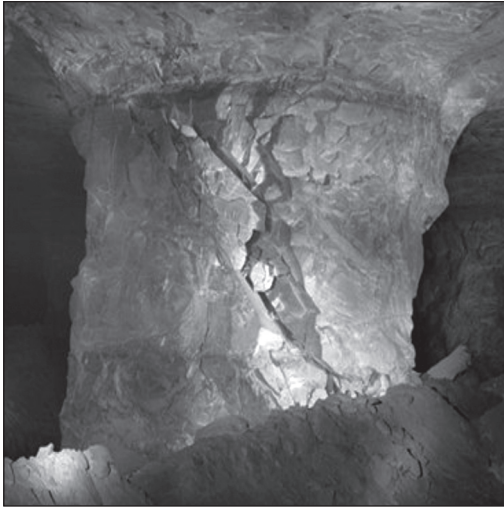
Figure 1. Partially benched pillar that failed along two angular discontinuities. Width-to-height ratio is 0.58 based on full benching height and average pillar stress is about 4% of the UCS.

- Large angular discontinuities that typically extend from roof-to-floor in a pillar. Sliding can occur along these discontinuities which can significantly weaken these slender pillars (Esterhuizen, 2006). Of the 18 unstable pillars observed, seven were affected by these large angular discontinuities. Figure 1 shows a pillar that is weakened by two angular discontinuities that contributed to failure of the pillar at a relatively low pillar stress.
- Weak bands within pillars that can extrude resulting in progressive spalling of the pillar ribs (Esterhuizen and Ellenberger, 2007). Figure 2 shows a pillar that has been severely compromised by this mechanism of failure. It

appears that moisture on the weak beds was a contributing factor in this failure. Other pillars in the immediate surrounding area were unaffected, while a number of other pillars at this mine appeared to have been affected in the same manner.

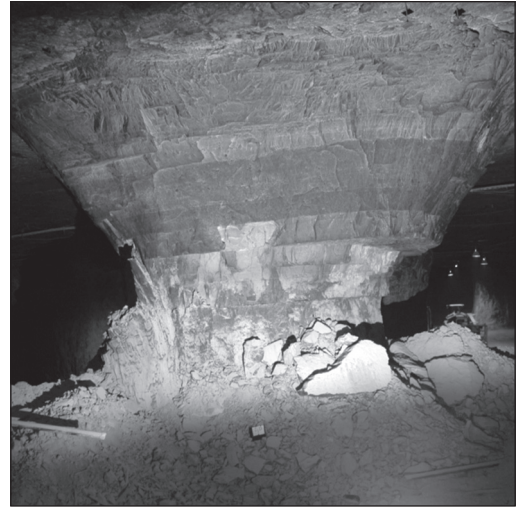
Figure 2. Pillar that had an original width to height ratio of 1.7 failed by progressive spalling. Thin weak beds are thought to have contributed to the failure. Average pillar stress is about 11% of the UCS.

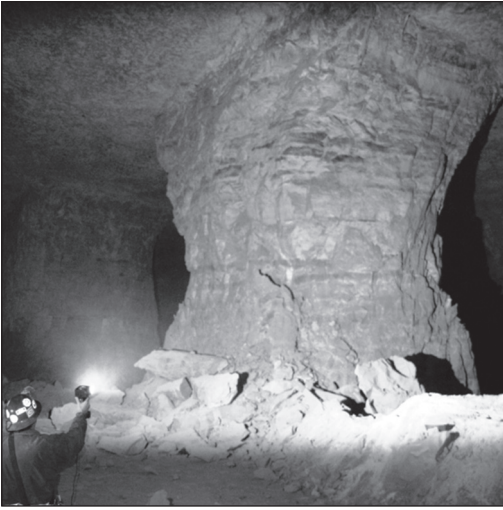
Figure 3. Partially benched pillar failing under elevated stresses at the edge of bench mining. Typical hourglass formation indicating over-loaded pillar.
