Bureau of Mines Report of Investigations/1984

# Use of a Sodium Silicate Gel Grout for Plugging Horizontal Methane-Drainage Holes

By David C. Oyler

**Report of Investigations 8843**

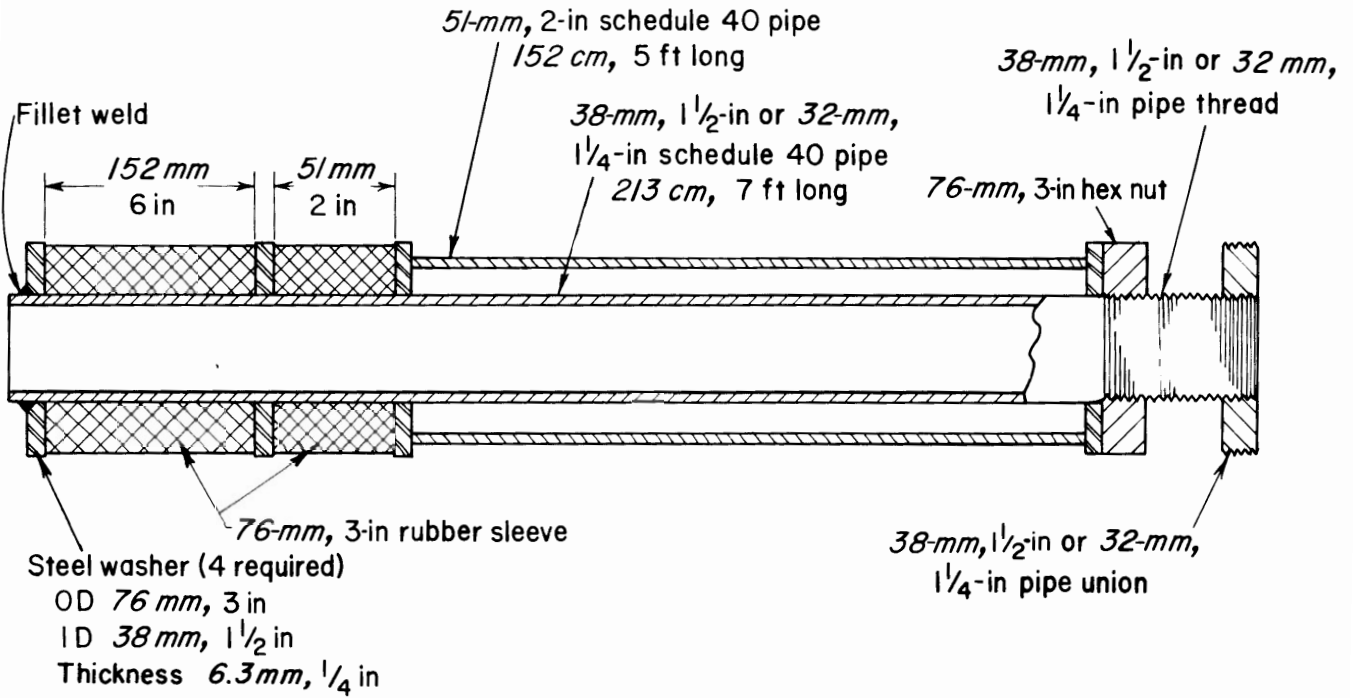
FIGURE 4. - Bureau-designed compression packer used to seal horizontal holes.

(1.25-in) ID pipe of the packers (fig. 4) in the 76-mm (3-in) holes would not allow the passage of the coupling of any pipe larger than 12.7 mm (0.5 in).

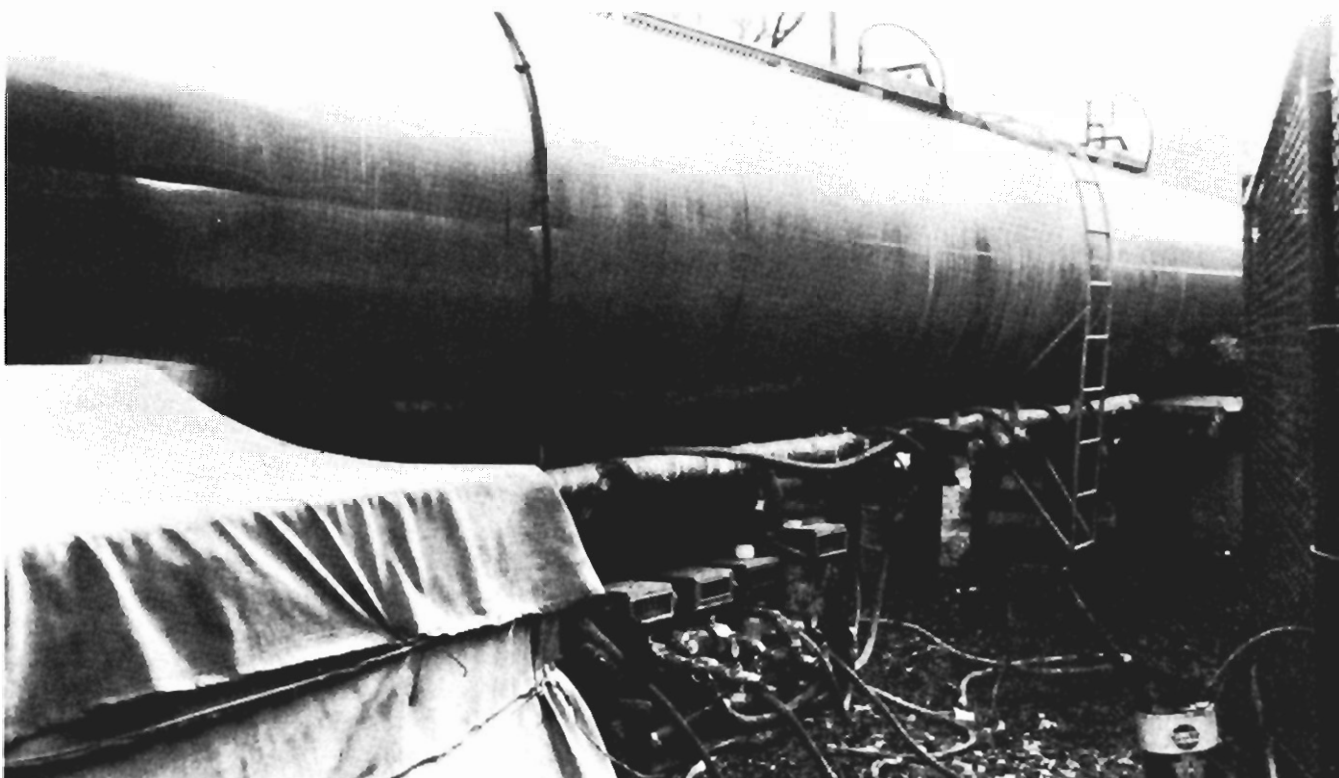
FIGURE 10. - Three-compartment tank truck at multipurpose borehole site.

The actual grouting operation was begun on November 13, 1980. First Hayward Baker's tank truck (fig. 10) was filled with a mixture of water and diatomaceous earth. This material could not be mixed more than 4 to 6 hr in advance of its use, or the diatomaceous earth would settle out in the tank, where it could not be remixed. Frozen hoses prevented the work of mixing from being completed until nearly noon, so only enough material was mixed to grout two holes.

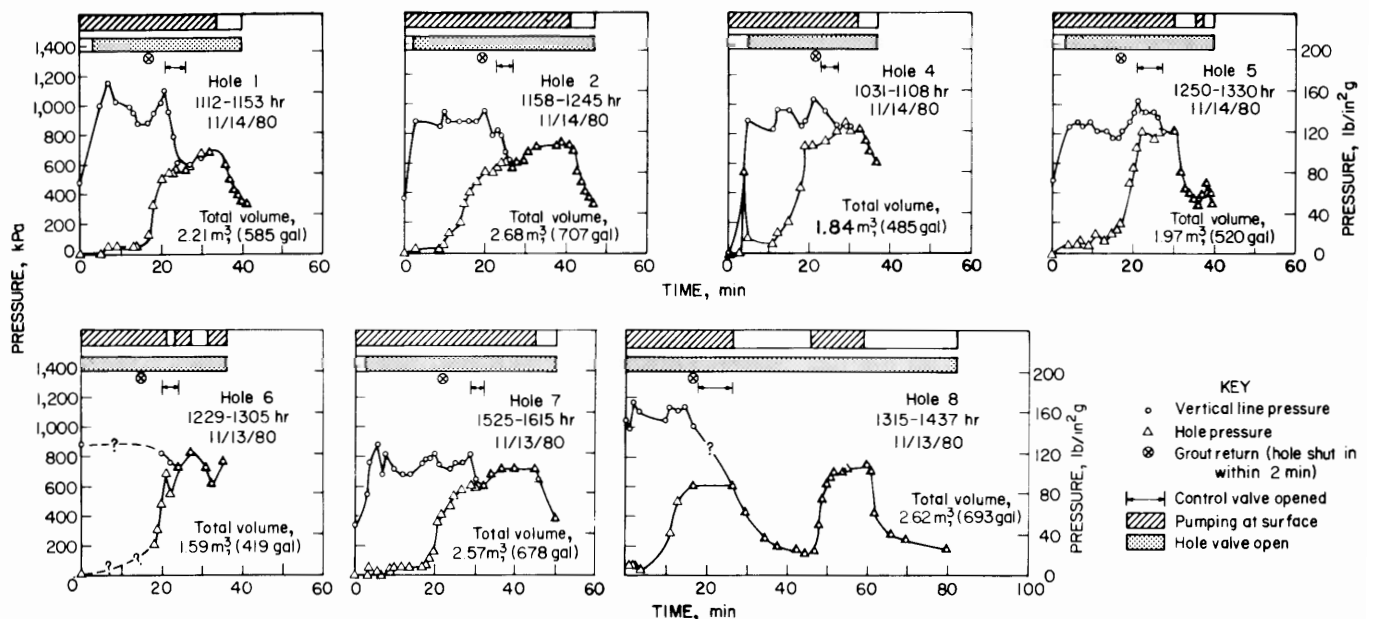
FIGURE 12. - Pressure curves and grouting records of horizontal holes. Activity times are expressed on the basis of a 24-hr clock.

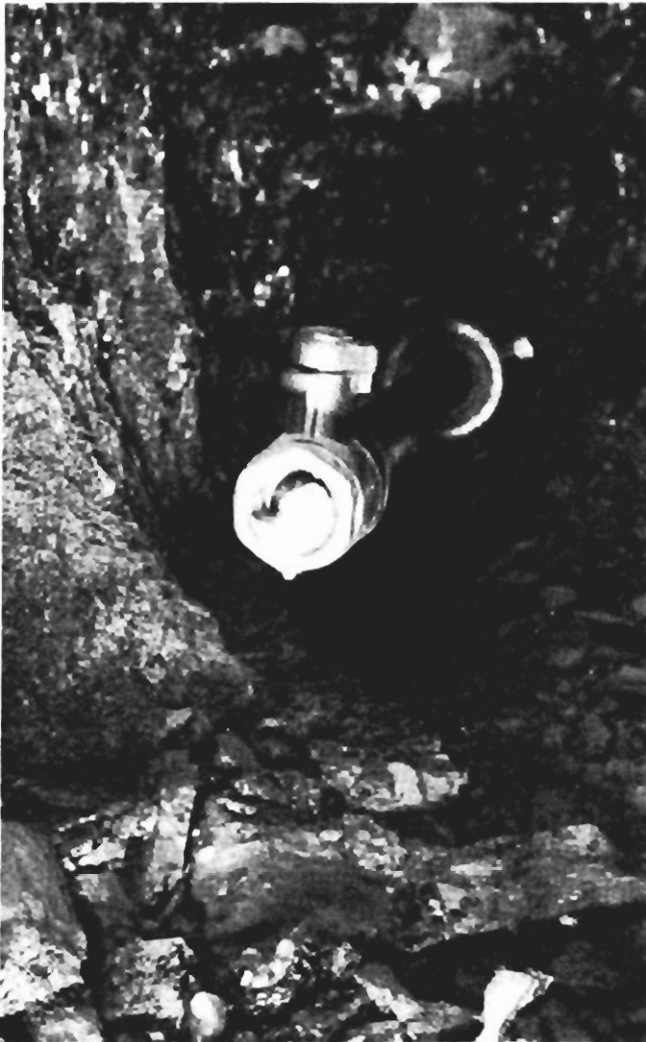
FIGURE 13. - Hole 2 five days after being grouted, location A (fig. 8). Note wet grout in the valve.

On November 19, shortly after the holes were grouted, a trip was made to the Federal No. 2 Mine to inspect hole 2 where it had been mined through in April 1980 (fig. 8, location A). A packer had been inserted to seal the hole just before the grouting operation was begun. When the valve on this packer was opened, the hole was found to have some pressure in it and some wet grout was forced out of the hole (fig. 13). With the valve shut, pressures of 41 kPa (6 lb/in<sup>2</sup>g) built up in

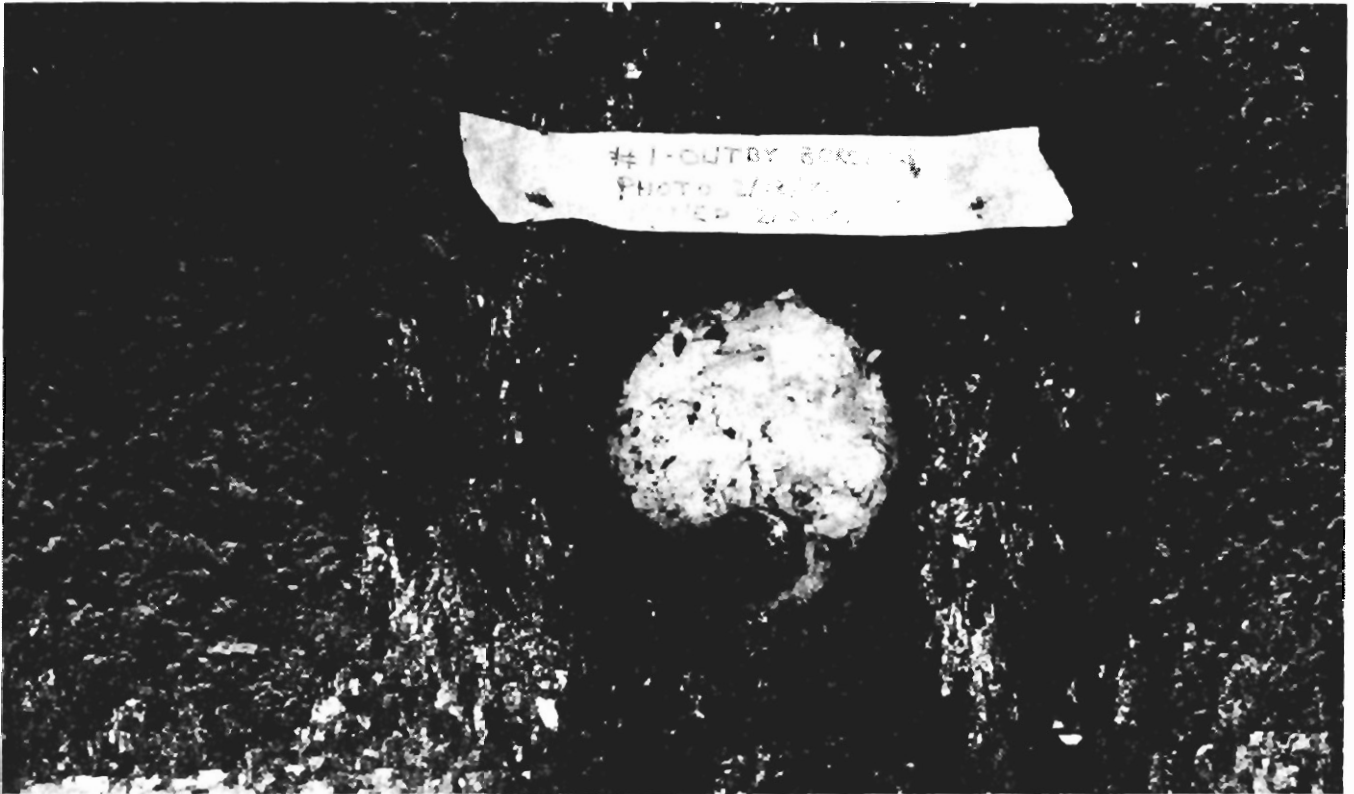
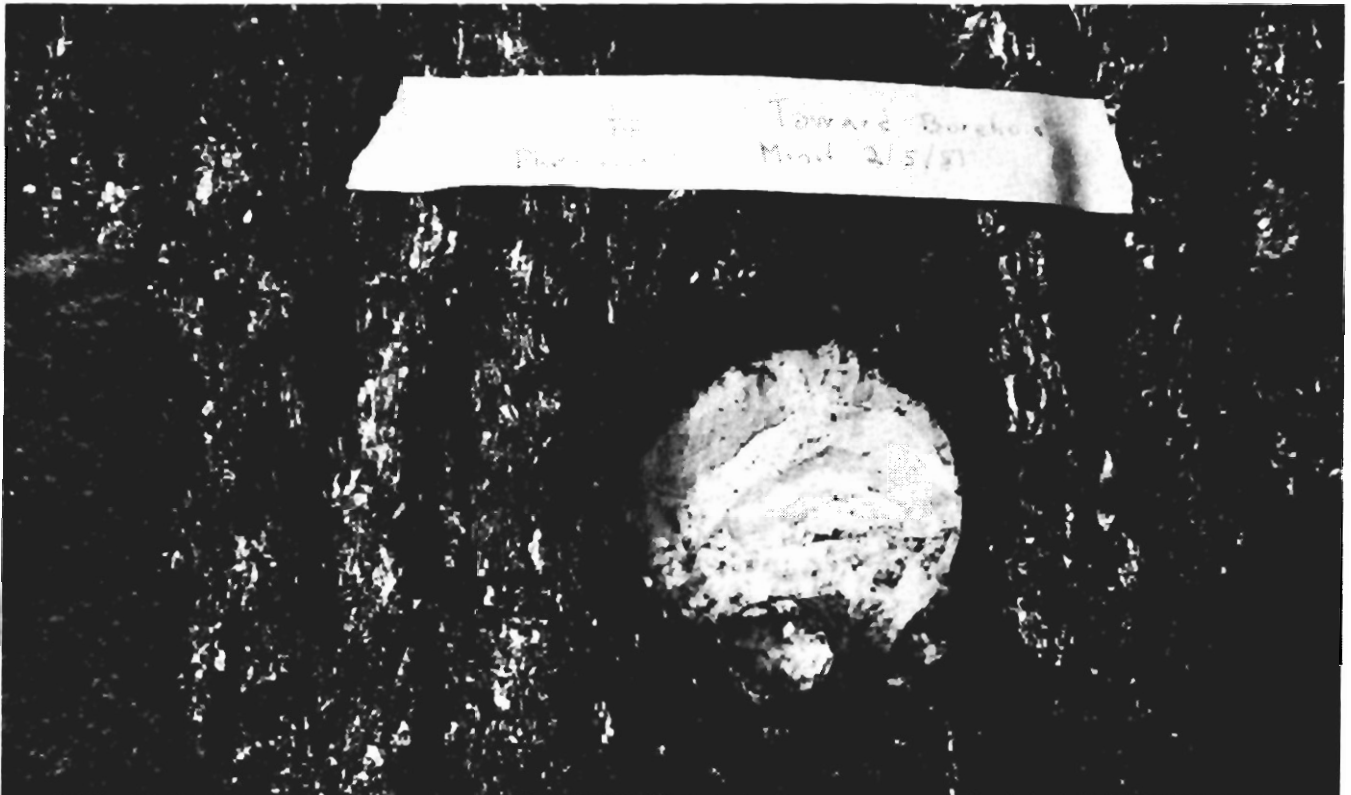
Figures 14 and 15 are photographs of hole 1, taken on February 18, 1981, looking respectively away from and toward the shaft (fig. 8, locations B and C). The grout appeared to be in good condition, and no void spaces were noted in the hole. The condition of hole 2 in the locations where it was inspected was similar. At location G (fig. 8) grout was also observed in the fracture system of the coalbed about 0.6 m (2 ft) from hole 1. Figure 16 is a photograph of the

FIGURE 14. - Hole 1, view away from the borehole at location B (fig. 8).

FIGURE 15. - Hole 1, view toward the borehole at location C (fig. 8).

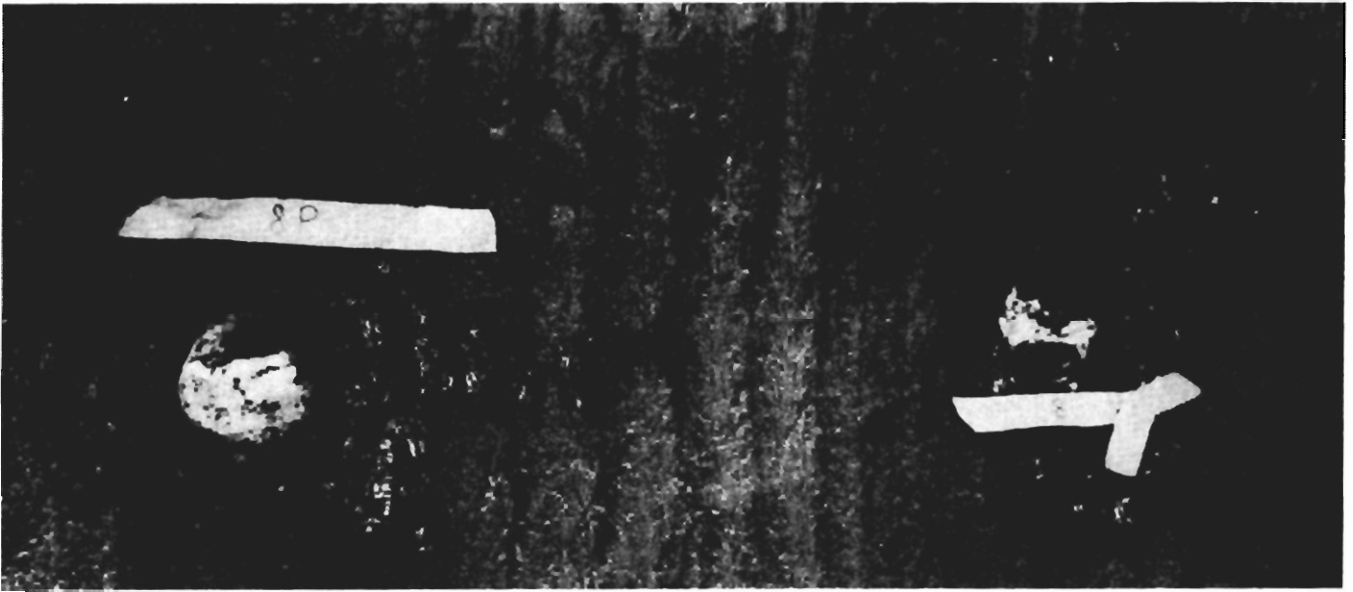
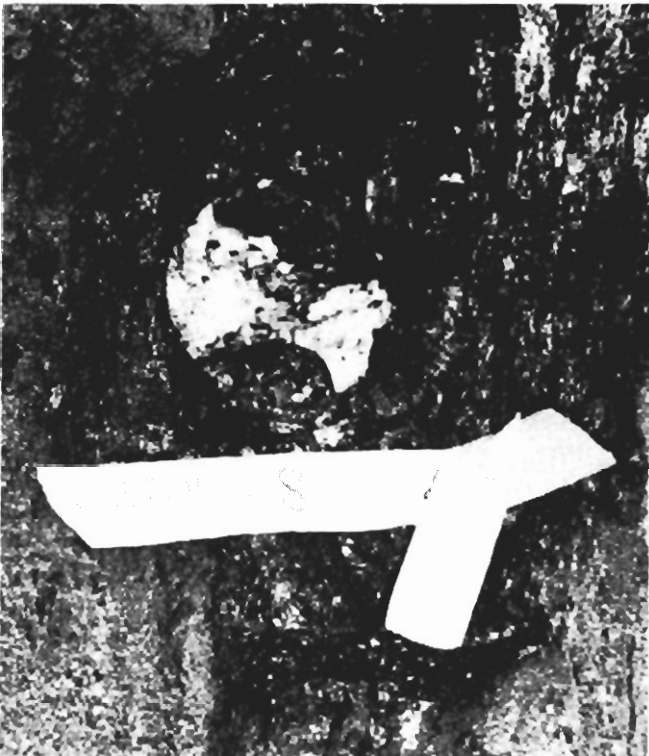
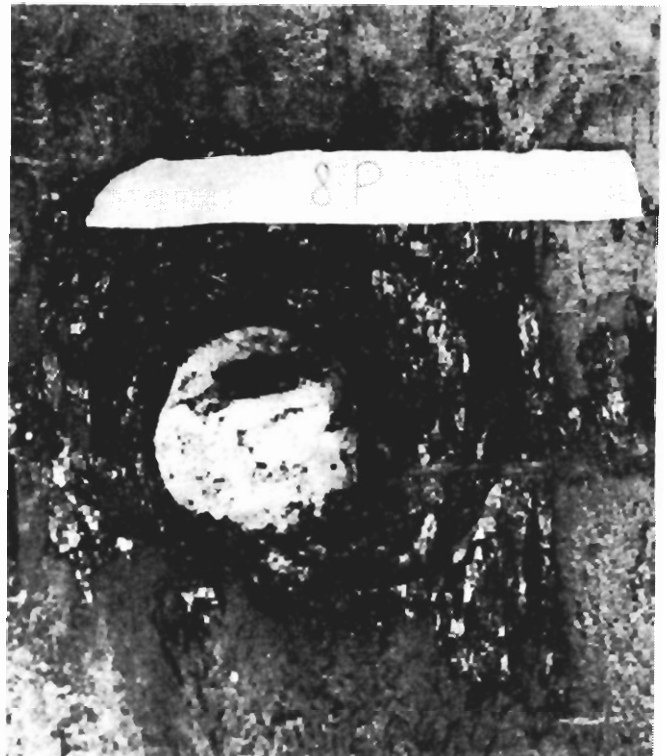
Figures 17, 18, and 19 do not clearly show that holes 8 and 8P were filled with grout. The photographs do show at least a thin film of grout adhering to the entire circumference of both holes, which indicates that both were originally filled. Part of the void spaces in the holes were caused by crushing of the dry, brittle grout by a pick used to clean rock dust from the hole for photography. Crushing of the grout in the upper portions of the holes probably indicates that the grout in that part of the hole was low in density, possibly the last grout to solidify. However, on the outby rib the grout in holes 8 and 8P was solid, and no gas flow was observed.

FIGURE 17. - Holes 8 and 8P, location H (fig. 8), holes about 50-cm (20-in) apart.

FIGURE 18. - Hole 8, same location as figure 17.

FIGURE 19. - Hole 8P, same location as figure 17.

Holes 7, 8, and 8P were mined through between February 18 and 24. They were inspected and photographed on March 3, 1981. (The shaft itself was mined into on February 25, 1981.) Holes 8 and 8P are shown together in figure 17 (location H), which was taken looking toward the shaft, and separately in closeups in figures 18 and 19. The holes are approximately 50 cm (20 in) apart at that point. They had started out roughly 23 cm (9 in) apart, and both holes had voids in the grout in the upper part of the hole when the photographs were taken. However, when the outby rib was observed (location J) there appeared to be little or no void space in the grout there. There was also a film of water flowing from the outby sides of the holes, but no water flow from the inby sides. Hole 7 was inspected at location K (fig. 8), and the condition there was found to be similar to that of holes 8 and 8P.
