Seasonal Lawn Mower Operator Crushed and Dies After Lawn Mower Rolls Over on a 30 Degree Slope

CASE SUMMARY

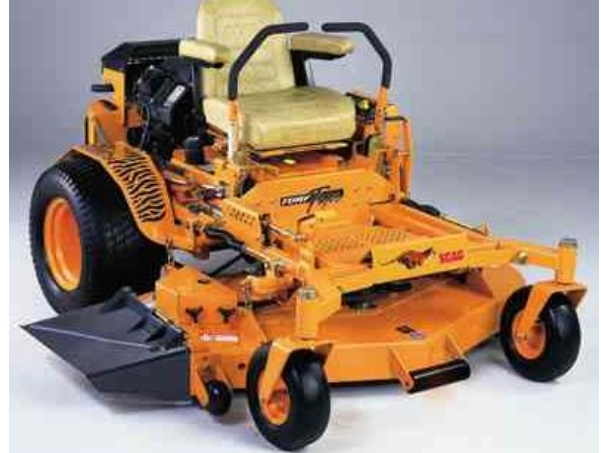
The equipment operated at the job site was a 2004 Scag brand Turf Tiger zero-turn mower, a model that weighs approximately 1,800 pounds (figure 3). The mower had a zero-turn radius and was capable of traveling at 12 mph. It was purchased without a roll over protection system, but it was equipped with a seat belt.

According to a representative for the employer, the user manual stated that the rollover bar was optional. The owner's manual clearly stated that while the rollover bar was optional, it should be used if the mower was to be operated on slopes or inclines to ensure operator safety.¹

Figure 3. Stock photo of a Scag brand Turf Tiger zero-turn riding lawn mower without ROPS installed.

Recommendation No. 2: To prevent rollover injuries, riding lawn mowers should be equipped with roll-over protective structures (ROPS) and seat belts.

Equipping a mower with a ROPS and utilization of seat belts has shown to be effective in preventing serious injury and death due to overturns. This particular riding lawn mower model was available for purchase with a ROPS. It is strongly advised that riding lawn mowers be equipped with factory installed ROPS.
