**REPORT#: 15MI064**

## Owner of Farm Land Pinned Under Tractor While Clearing Fence Line

## Michigan Fatality Assessment and Control Evaluation (FACE) Program

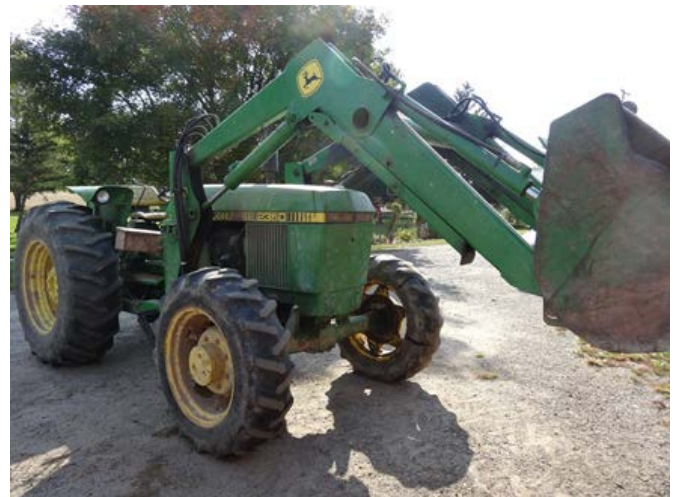
While backing up his tractor (See Figure 1), the tractor became stuck and elevated slightly, most likely from a tree. The front wheels of the tractor were on the ground, but the back wheels were not on the ground and it appears that the tractor could not gain traction to move in either direction. The decedent climbed off the tractor and walked back to his house approximately one quarter of a mile away to pick up a screwdriver and Bushman bow saw (similar to a hack saw). A family member took him back to the field with his tools; the family member waited in his vehicle, parked near the field. After returning to the tractor, the decedent went under the tractor with his body near the left rear tractor wheel. The tractor was in gear and PTO was running. Using the bushman’s saw he sawed the tree/brush that had contributed to the tractor to becoming stuck. After the tree was sawn through, the tractor fell to the ground. Because the tractor was running and still in gear, it moved forward pinning the decedent under the left rear tractor wheel. At some point, it appears his face and clothing contacted the rotating PTO.

Figure 1. Tractor involved in incident

***Recommendation #1: Tractor operators should always utilize proper tractor shut-off procedures prior to exiting the tractor seat.***

***Recommendation #2: When working under an elevated piece of equipment, always provide a secondary means of support. If wheels are in contact with the ground, block/chock these wheels to prevent equipment movement.***

***Recommendation #3: When working under equipment, if wheels are in contact with the ground, block/chock these wheels to prevent equipment movement.***

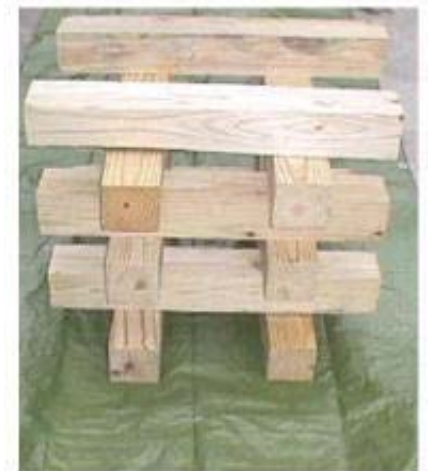
Cribbing should be used when the equipment must be supported at a height greater than blocking can provide. Cribbing involves placing timber in tiers that run in alternate directions. To place cribbing, raise the load and without placing yourself under the elevated load, place the cribbing under the load. (See Figure 2). Then lower the load onto the cribbing. If using a jack to raise the load, make sure the jack is on a firm foundation (use blocking timbers as required), raise the load to the maximum height the jack can safely lift to, place cribbing, then lower the load.

Figure 2. Example of  
cribbing
