## Career Fire Fighter Falls from Aerial Ladder While Carrying Roof Kit During Training—California

### Executive Summary

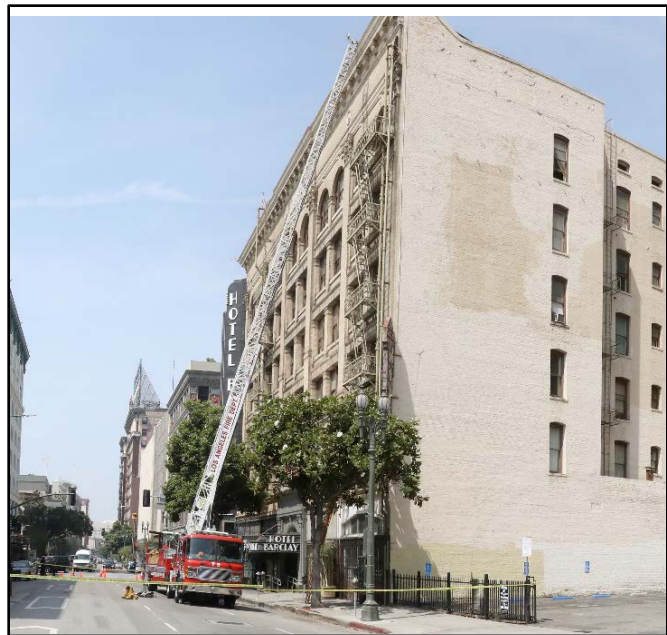
**Training site**  
*(Courtesy of the Fire Department.)*

The apparatus operator properly positioned the aerial ladder in front of the hotel and raised the aerial ladder at a 73-degree angle, and extended the 100-foot ladder to 86 feet, which placed the tip of the ladder near the roof line. The engine companies pulled hoselines and entered the hotel to ascend to the fourth floor. The truck company was to ascend the aerial ladder, enter the hotel through the roof bulkhead door, and descend to the fourth floor. The fire fighter who was first to ascend (the top member) grabbed the roof kit cradling it on his left shoulder, and stepped onto the pedestal. The top member began to ascend, and as soon as the tiller member saw the top member reach the top of the bed section of the aerial ladder, the tiller member began to ascend. The tiller member entered the inner mid-section of the aerial ladder and noticed the top member had stopped approximately 60 feet up the aerial ladder, to adjust the roof kit on his shoulder. Then the tiller member noticed that the apparatus operator was starting to ascend behind him. The tiller member heard a yell and looked up to see the top member falling down the left side of the ladder. The tiller member tucked in close to the ladder as the top member brushed by him and landed on the deck portion of the apparatus below. He was attended to by on-scene paramedics and transported to the local trauma center. On June 5, 2017, the fire fighter succumbed to his injuries.

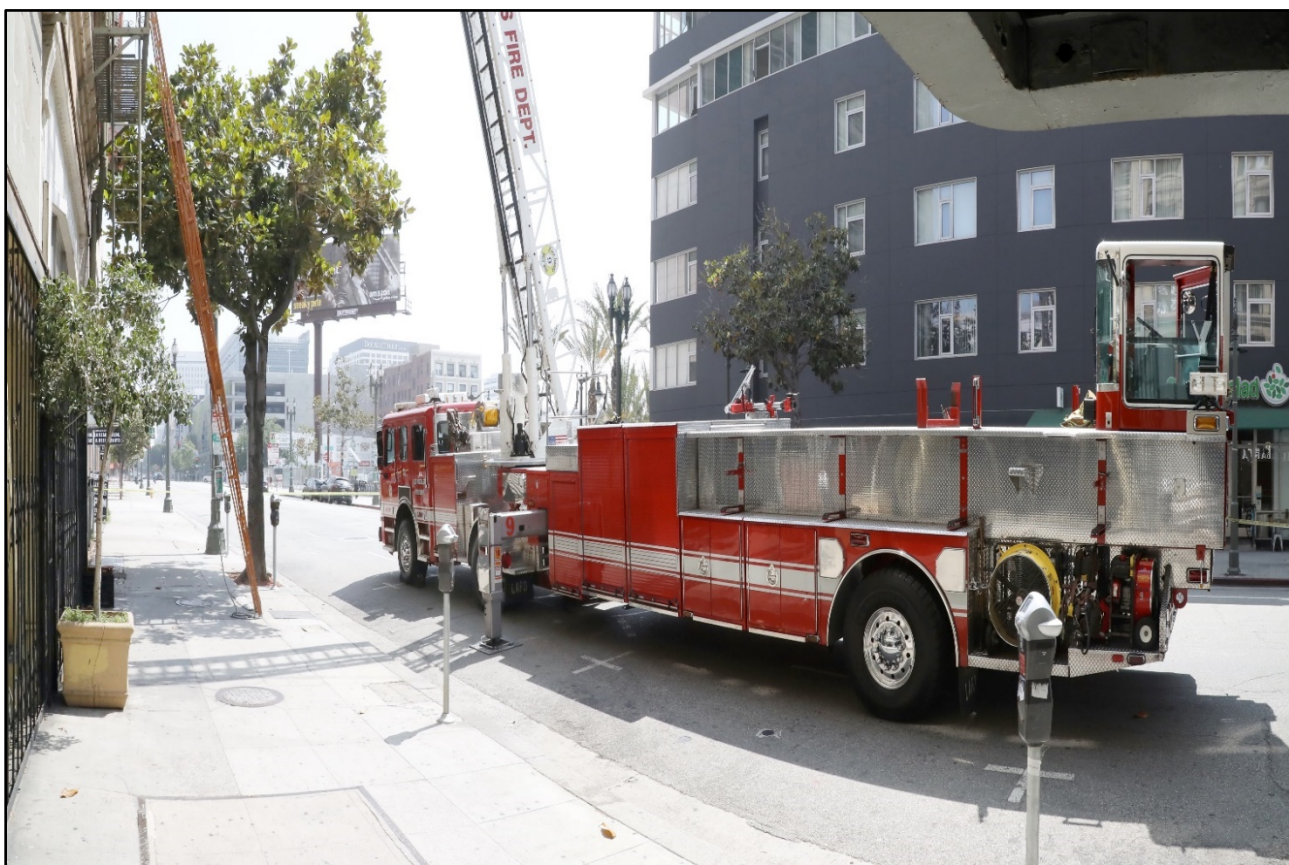
Upon arrival, the incident commander gave a size-up and crew assignments. The apparatus operator spotted the aerial ladder in front of the hotel (see Photo 1), raised the aerial ladder at a 73-degree angle (see Photo 2), and extended the 100-foot ladder to 86 feet, which placed the unsupported ladder tip near the roof line, in accordance with manufacturer guidelines (see Photo 3).

**Photo 1. Positioning of apparatus and aerial ladder.**  
*(Courtesy of the Fire Department.)*

Discussion: There are several variables that have to be considered when positioning an aerial ladder. They include proper distance between the structure or object and the aerial to achieve maximum stability, best climbing angle, and adequate extension ability. Long extensions at low angles place maximum stress on the aerial [MFRI 2010; IFSTA 2009]. Steepening the angle, even when kept within accepted standards, can make climbing and tool carrying more difficult for some persons. If the structure is on fire, the incident commander must also consider the condition of the building and the extent and location of the fire when positioning the aerial.

In this incident, the aerial ladder was parked parallel to the building with the aerial ladder extended 86 feet at a 73-degree angle and perpendicular to the street (see Photos 1, 2, and 3) which is in accordance with fire department and manufacturer guidelines. The manufacturer does not recommend an angle greater than 75 degrees. The above mentioned tactical, firefighting specific, and general human factors considerations should be incorporated into the SOGs and pre-incident plans that suit a fire department’s local situation, and training should occur often. Given the additional demands and stresses placed on firefighters during ladder climbs, fire departments should consider adopting a maximum angle of 70 degrees or less for aerial (and perhaps all) ladder operations.

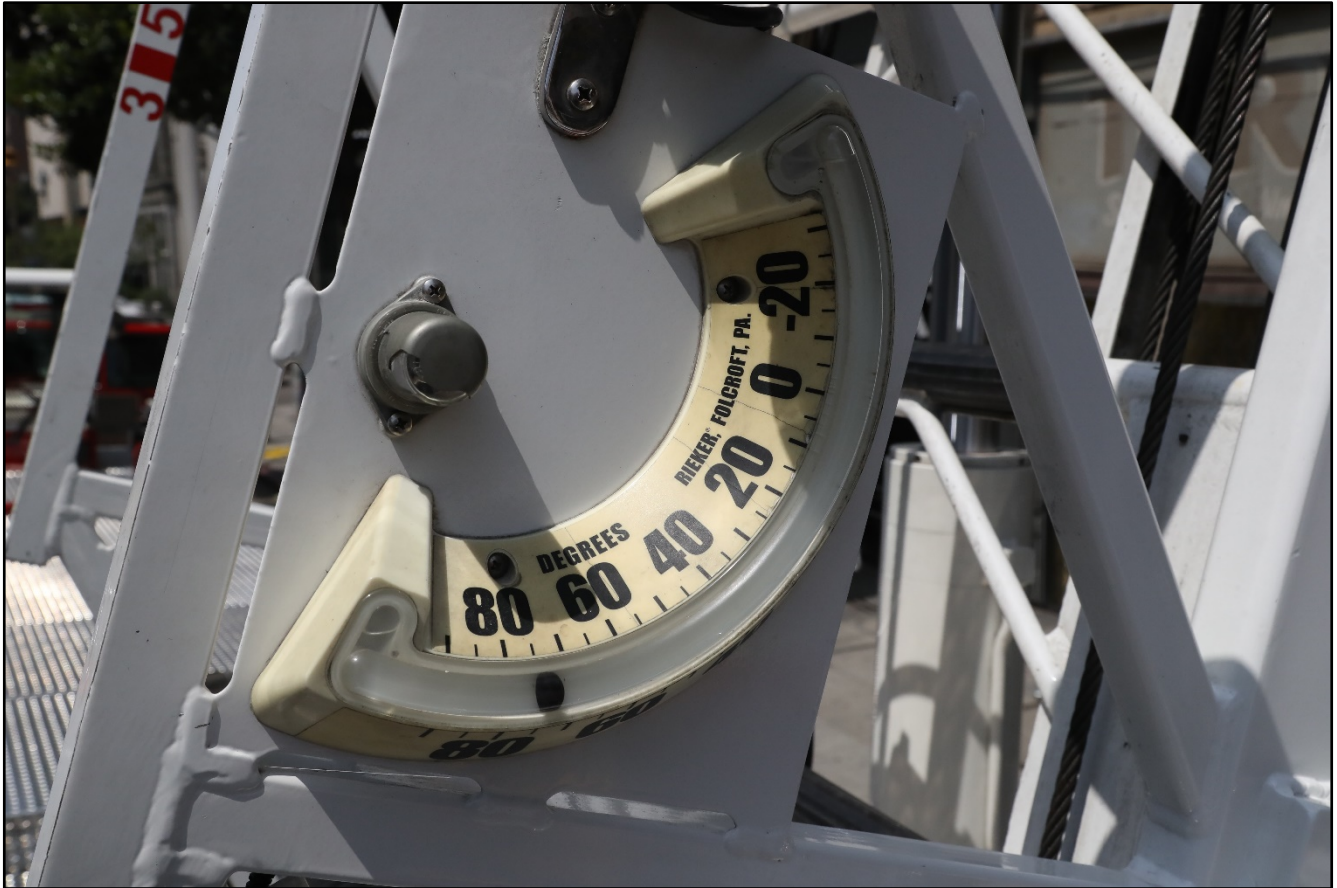
**Photo 2. Position of climbing angle indicator for aerial ladder at the time of the incident.**  
*(Courtesy of the Fire Department.)*

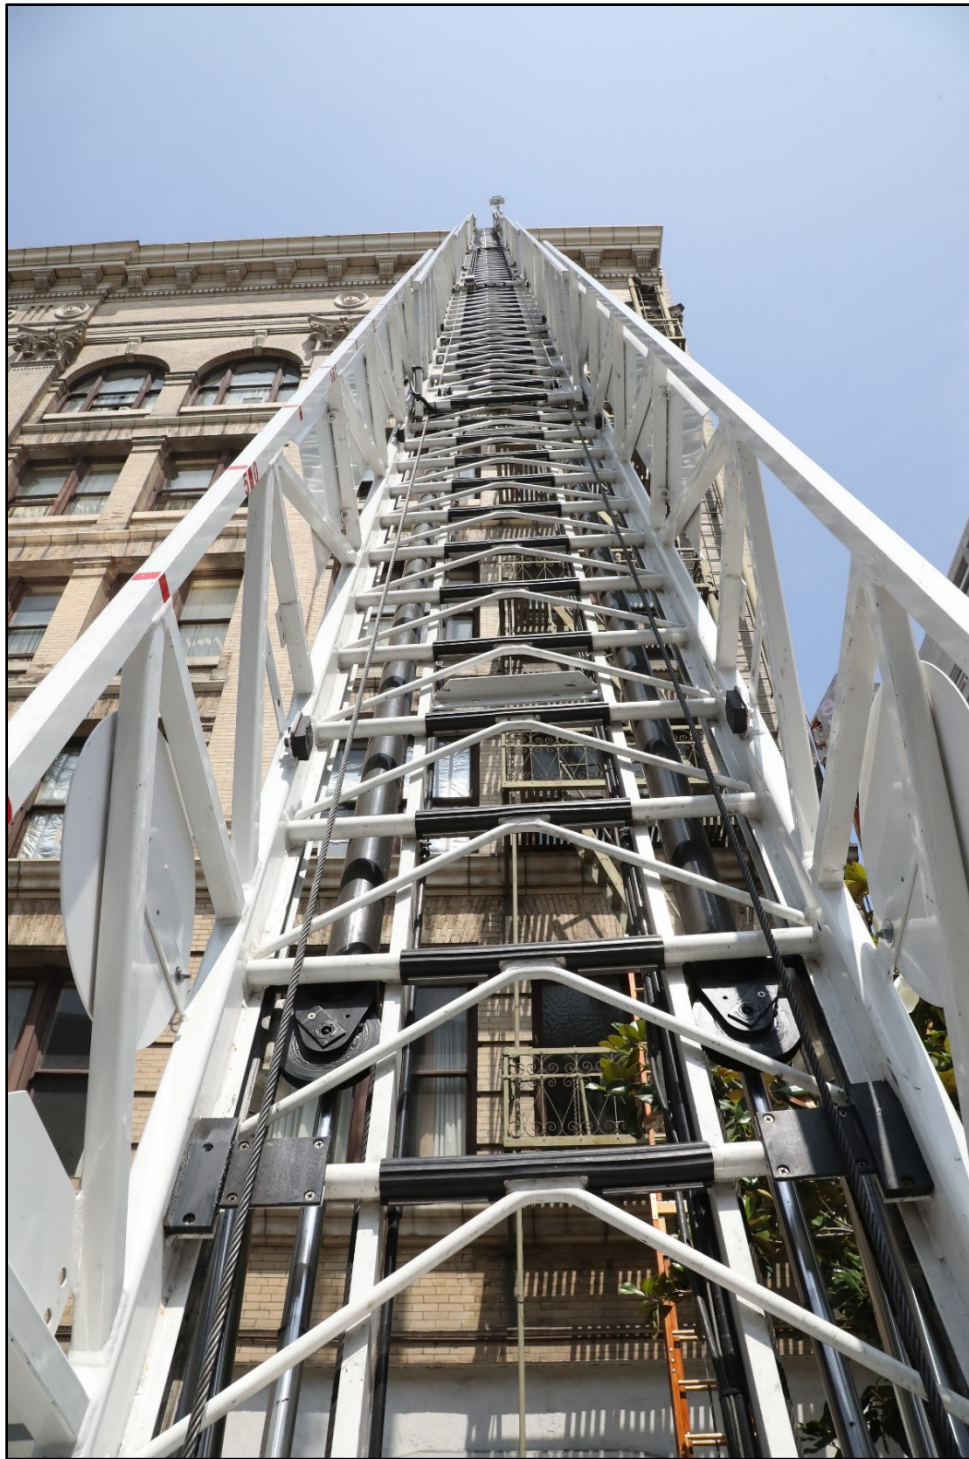
**Photo 3. View of aerial ladder from base.**  
*(Courtesy of the Fire Department.)*

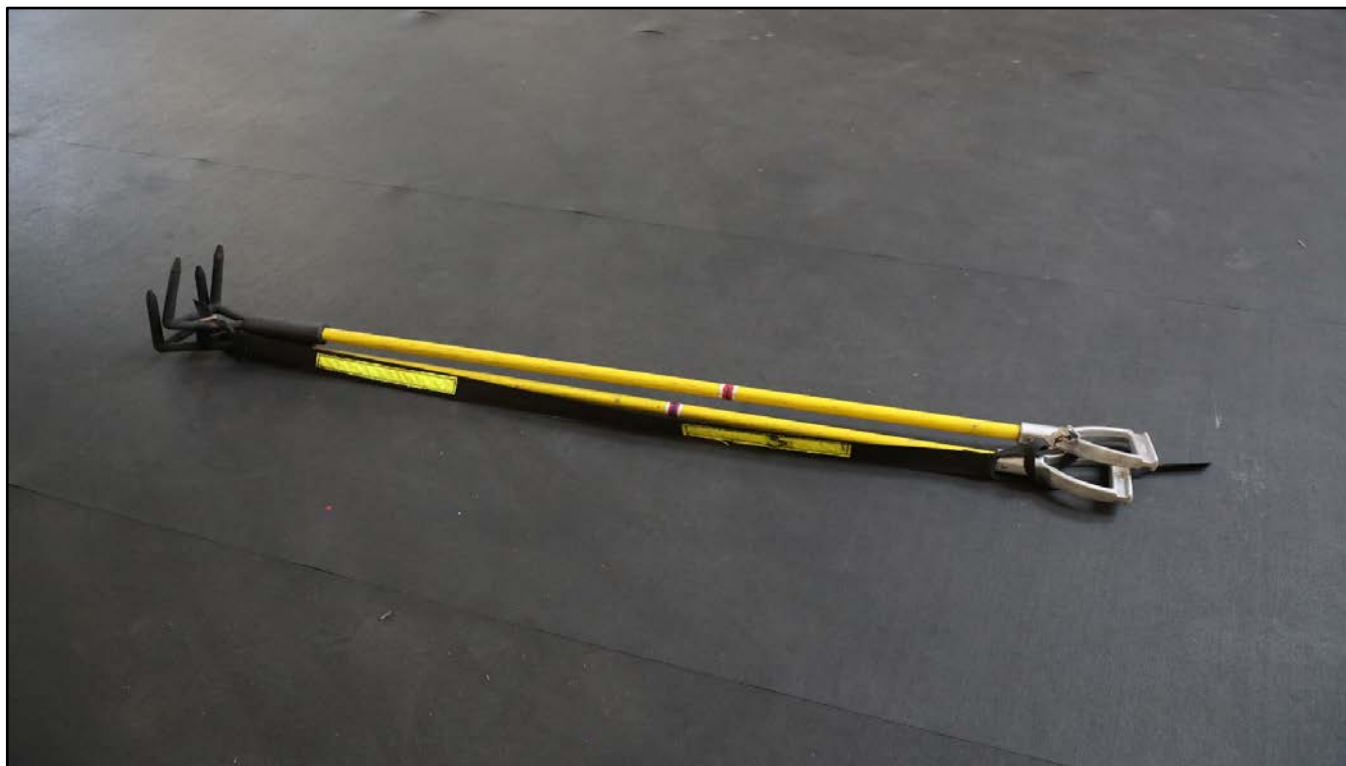
The engine companies pulled hoseline and entered the hotel to ascend to the fourth floor. The truck company was to ascend the aerial ladder, enter the hotel through the roof bulkhead door, and descend to the fourth floor. The fire fighter who was first to ascend (the top member) grabbed a roof kit (see Photo 4), which was two six-foot rubbish hooks strapped together, (totaling 20 pounds), and cantilevered them over his left shoulder with the D-handles facing to the rear. *Note: The roof kit is supposed to be carried over the shoulder using the webbed strap. It is unknown why the fire fighter did not utilize the strap. After the incident, it was noted that part of the strap was missing but it is not known if this occurred prior to or during the incident.*

**Photo 4. Example of a roof kit similar to the one carried by the fire fighter. A roof kit consists of two six-foot rubbish hooks and a webbed carrying strap weighing a total of 20 pounds.**

**Recommendation #1:** *Fire departments should ensure that carrying methods of equipment/tools are safe and secure.*

In this incident, the fire fighter was carrying two six-foot rubbish hooks strapped together with a web sling and weighing 20 pounds cantilevered over one shoulder and not utilizing the web sling to support

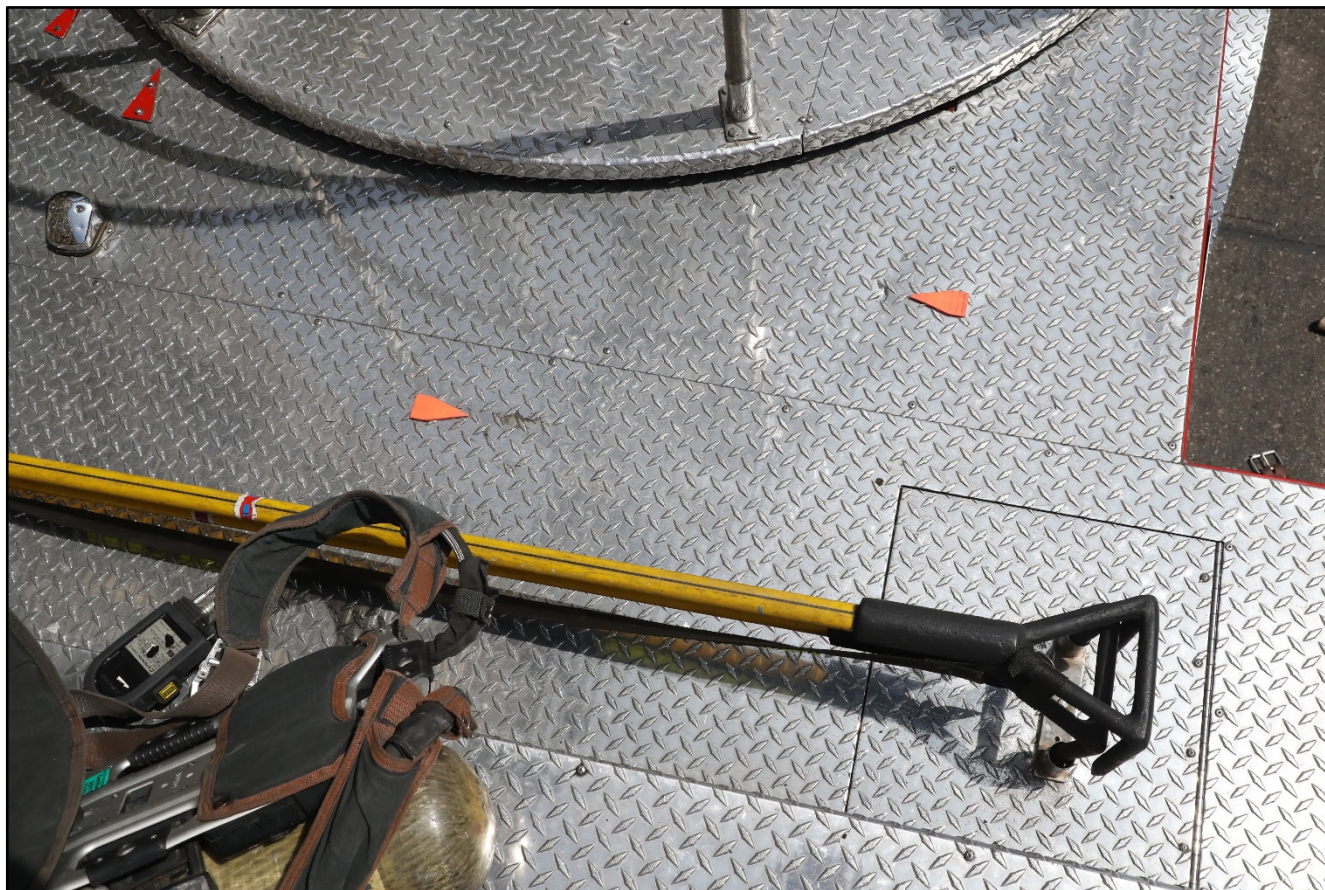
and the apparatus operator. The station captain, who was the training organizer and an observer, heard yelling and saw the fire fighter fall the last 15 feet and immediately looked for available paramedics. The fire fighter landed on the deck portion of the apparatus below, just to the left of the turntable (see Photo 5). The incident commander was in the command vehicle and heard a crash and noticed a helmet on the street. The incident commander radioed that the exercise was completed and ran over to the truck and saw the apparatus operator attending to the fallen fire fighter.

**Photo 5. General area where the fire fighter landed.**  
*(Courtesy of the Fire Department.)*

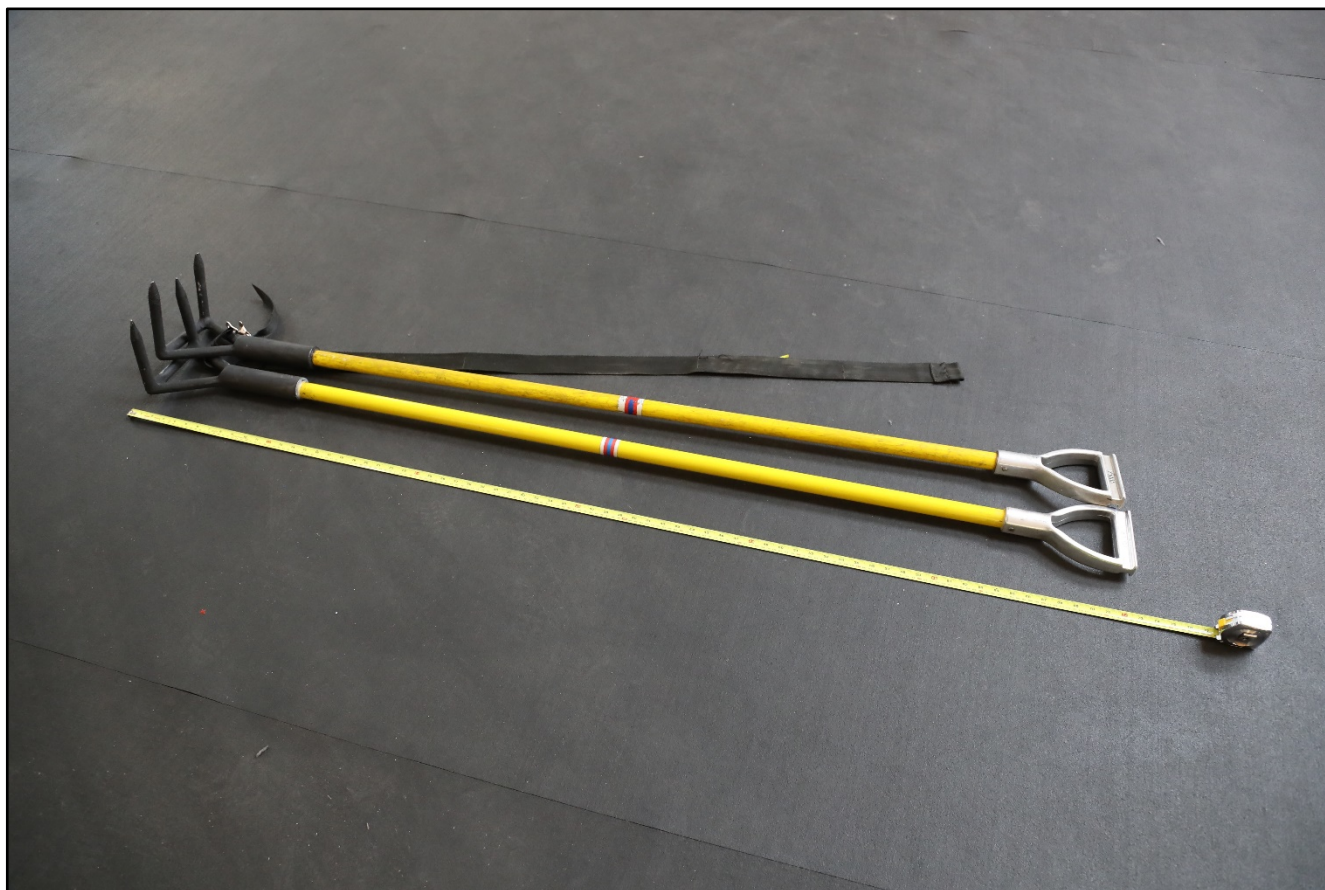
the load. It is unknown why the fire fighter did not utilize the web sling as taught in the training academy. The tiller member had noticed that the fire fighter had stopped to adjust the roof kit on his shoulder prior to his fall. After the incident, the rubbish hooks were found missing the cinch strap for the D handles as part of the web sling (see Photo 6).

**Photo 6. Roof kit (two 6-foot rubbish hooks weighing 20 pounds) carried by the fire fighter. Note the cinch strap for the D handles is missing.**  
*(Courtesy of the Fire Department.)*

This fire department trains using the above mentioned reference but a specific fire department standard operating guideline (SOG) should be generated to address specific methods for securing and carrying each type of equipment or tool. Another source for training and proficiency guidelines is NFPA 1410, *Standard on Training for Initial Emergency Scene Operations*, Section 9.3.1, which details recommended performance criteria for truck company personnel and the use of ropes, knots, and hitches for the hoisting of tools and appliances [NFPA 2015a].

If customized packs or slings are used, a thorough evaluation should be conducted to determine their effectiveness and safety. Another option is mounting some tools near the tip of the aerial or ladder provided the apparatus manufacturer endorses the method of attachment and the effects of the tool's dimensional properties on the aerial ladder stability.
