Firefighter-EMT Dies After Falling from the Roof of a Five-Story Commercial and Residential Condominium Complex -Colorado

Executive Summary

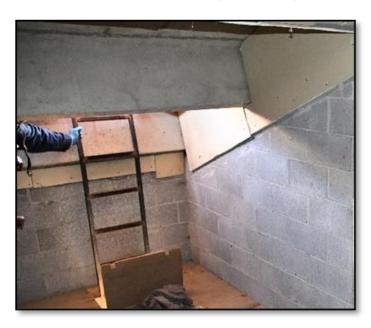
Photo 3. Photograph in the building's attic. The photo shows a fixed black metal ladder extending from the scuttle-hole on the ceiling of the fourth-floor to the roof access hatch.

Access to the residential unit's roof required climbing through two narrow openings. The first was a scuttle-hole located near the elevator in the fourth-floor hallway. The scuttle-hole opened into the building's attic where the second opening (the roof access hatch) exited on the north side of the roof (see Photo 3). The roof access hatch was constructed of metal and located above the scuttle-hole. A metal ladder, affixed to the interior side of the building's north wall, extended from the attic to the roof access hatch (see Photo 3).

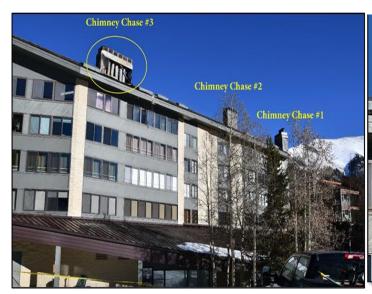
Photo 4 and 5. Left photo shows three of the building's four chimney chases. The fire occurred in the circled 3rd chase. The right photo is a close-up of chimney chase #3 with the fire damage. The 3rd chase contained eight flues from the units below.

entered the third chimney chase located on the roof between units 406 and 408. The third chimney chase measured 13.5-feet east-to-west, 3.25-feet north-to-south, and 8.5-feet in height.

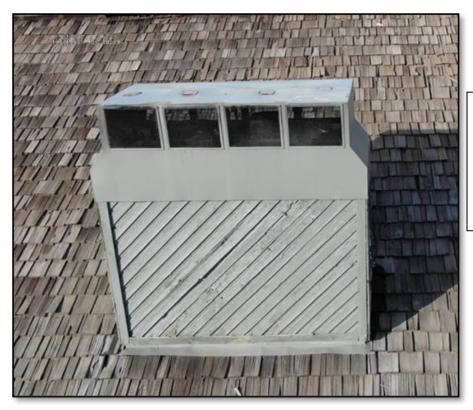
Photo 6. Chimney chase number 2. (Photo courtesy of the fire department's origin and cause report.)

Sheet metal was installed horizontally above the wood framing of the chimney chases (see Photo 6). The individual flues contained metal roof jacks that were affixed to the sheet metal. There was metal screening that surrounded the area above the sheet metal, where the flues terminated. There were no observed spark arrestors at the end of the flues. There was a metal cap that sat atop of the metal screening, above all the flues.

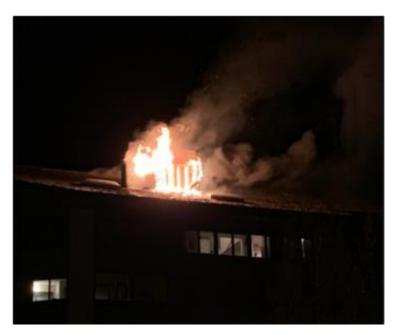
Photo 7. Chimney chase fire on the roof as seen from Side Charlie/Delta corner.
