LINE OF DUTY DEATH REPORT

REPORT F2020-11 • May 2024

Firefighter Killed by the Collapse of the Porch Roof at a Residential Structure Fire-Pennsylvania

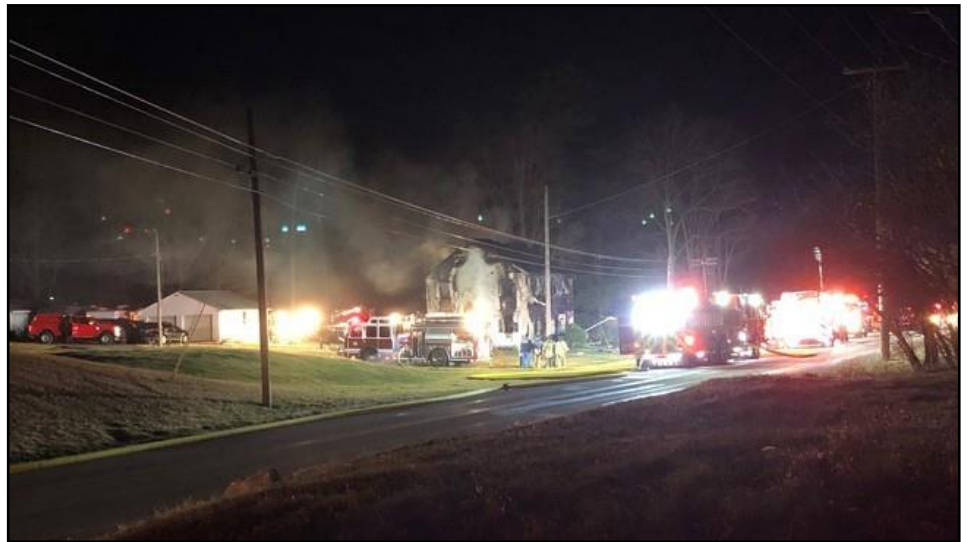
A firefighter from E336 was killed when the front porch roof collapsed on him while operating at this residential structure fire. Engine 336 is parked on Side Bravo and Command is located at the Side Bravo/Side Charlie corner in the red vehicle.

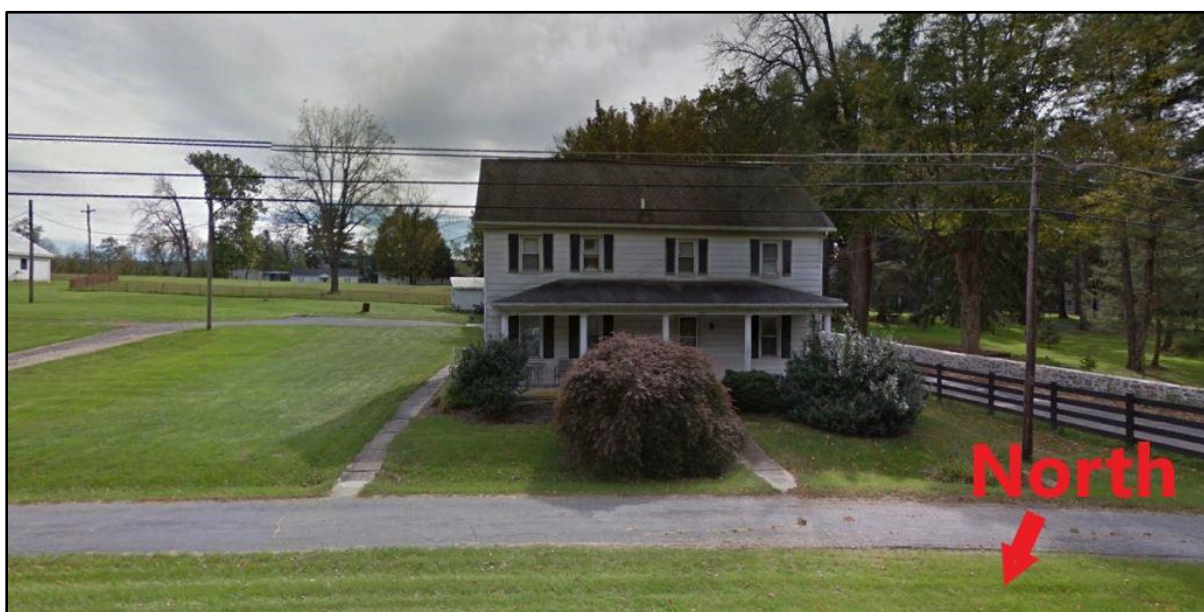
**Photo 1. Residential structure from Side Alpha. The house was balloon frame, built on a slab and termed a farmhouse.
(Photo from Google Maps)**

The structure was a 2½-story wood frame residential farmhouse. The year the structure was built was not determined. The house was constructed of heavy timber and balloon-framed ordinary construction with brick-and-mortar exterior. The house was built on a concrete slab. The dimensions of the house were approximately 40 feet wide by 25 feet in length. There was an addition on Side Bravo. The structure was approximately 2000 – 2500 square feet (**See Photo 1 and Photo 2**). The columns or pillars supporting the front porch roof were powdered aluminum. There were entrances to the house on Side Alpha and Side Charlie.

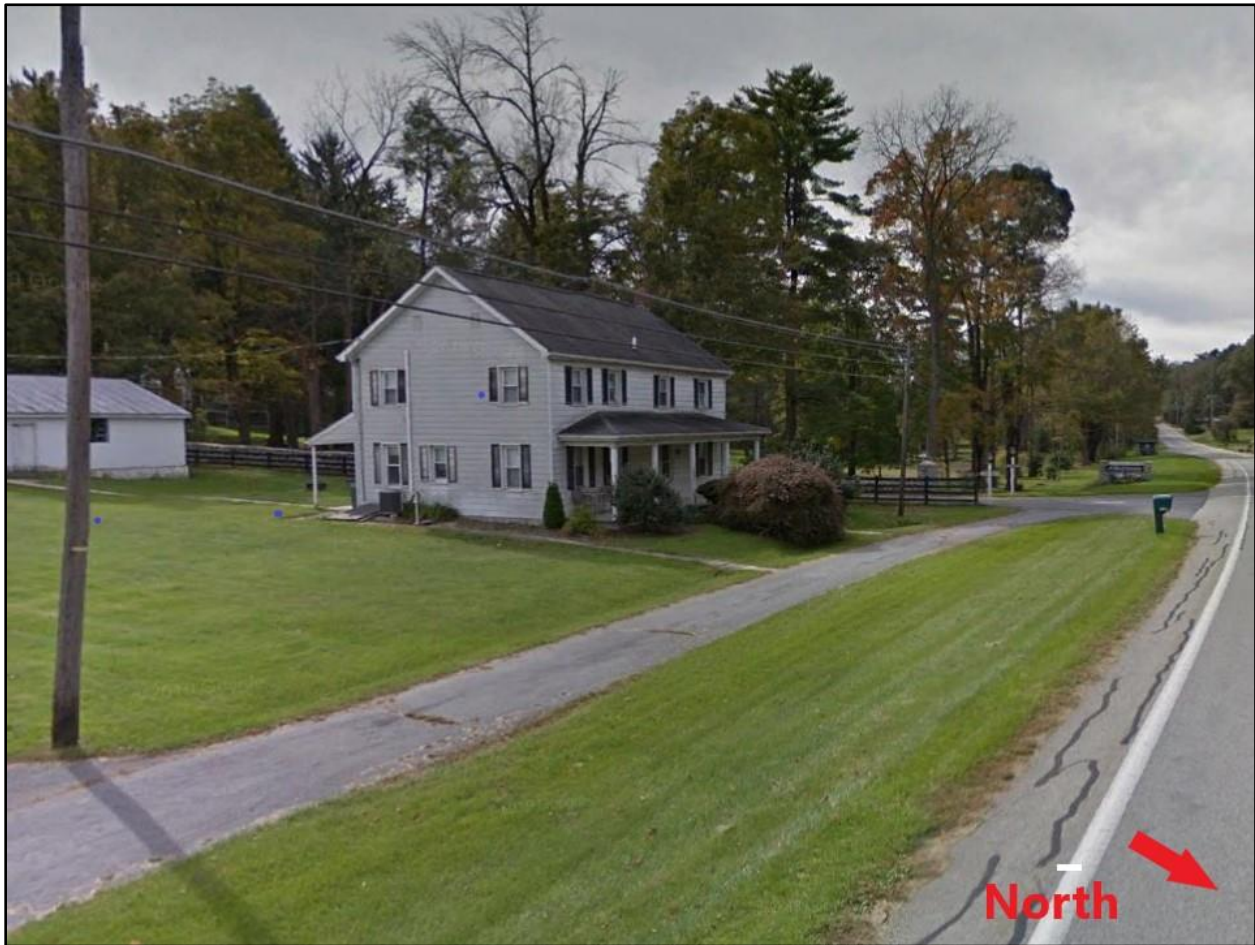
**Photo 2. Sides Alpha and Side Bravo of the house. The service line on Side Bravo burned through during the fire.
(Photo from Google Maps)**
