# LINE OF DUTY DEATH REPORT

REPORT F2022-04 • January 2025

## ***Career Firefighter Killed in a Structural Collapse While Conducting Fire Attack and Search in a Derelict Single-Family Residence – Missouri***

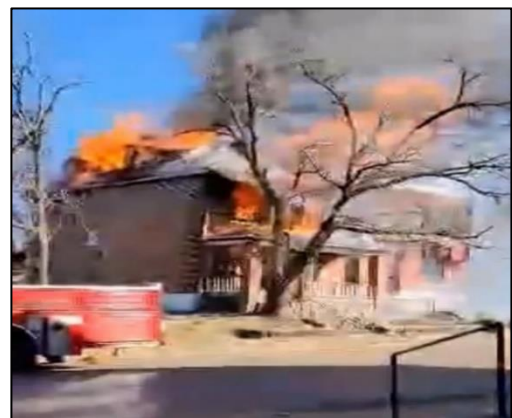
**Photo 1. Conditions on the arrival of Truck 13 showing post flashover fire conditions throughout the second and third floors. (Courtesy of FD)**

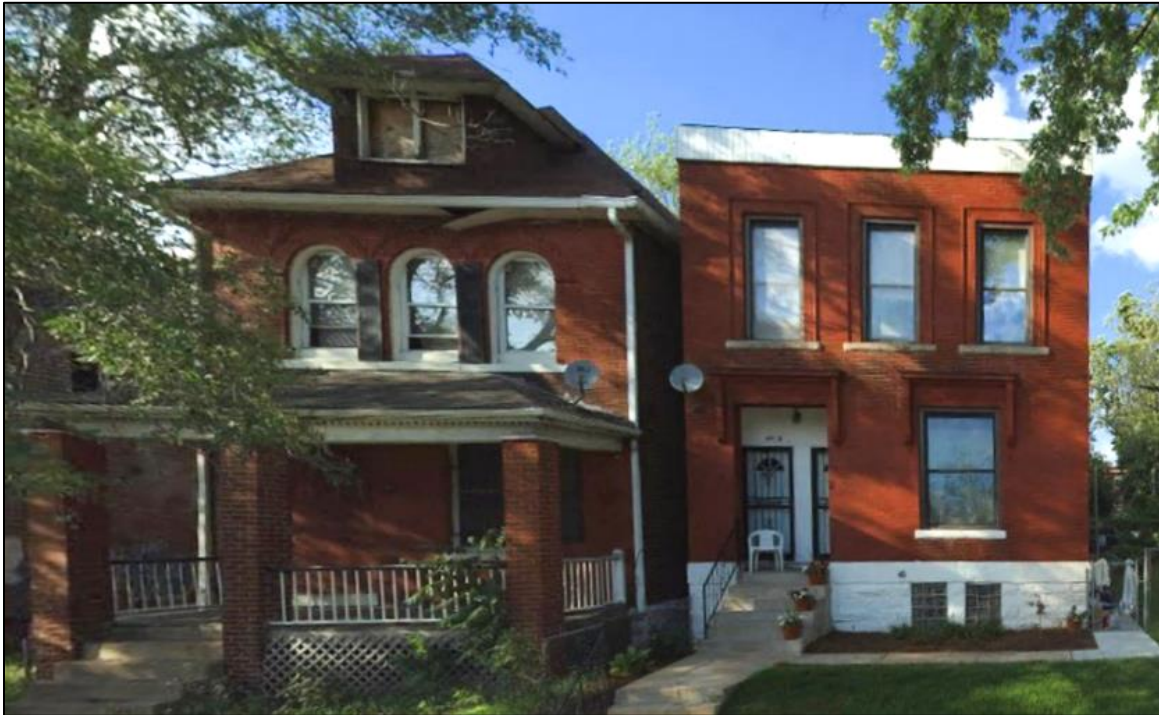
**Photo 2. Fire building on the left, and the Side Delta exposure on the right, showing pre-fire conditions. Note indications of the fire building being a derelict structure with deteriorated conditions. (Photo from Google Earth)**

The structure involved in this incident was a derelict 2½ -story single-family residence (see photos 2-5 and diagrams 1-2). It was built in 1895 and was constructed of Type III Ordinary Construction. It consisted of a basement, first floor, second floor, and third floor/half story with all 4 levels accessed via interior stairs. The structure had been abandoned for several years during which time it had sustained significant damage from vandalism and exposure to the elements. It had also sustained damage from a previous fire. The structure had been identified by the local authority having jurisdiction as being abandoned and the utilities to it had been disconnected. There were numerous

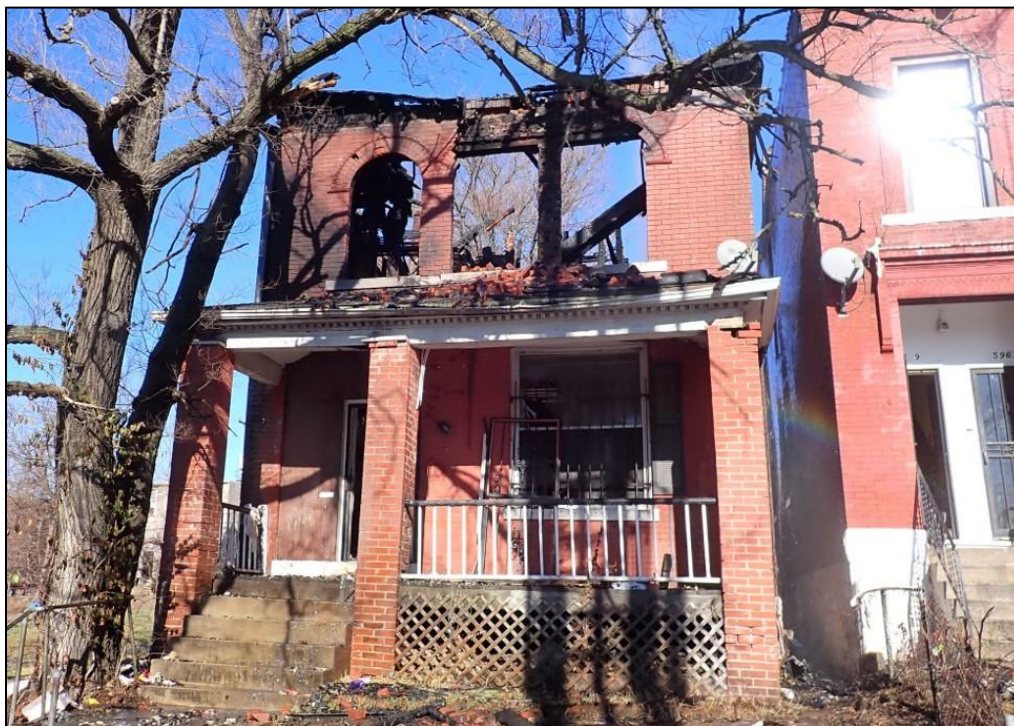
**Photo 3. Side Alpha post fire conditions. (Courtesy of FD)**

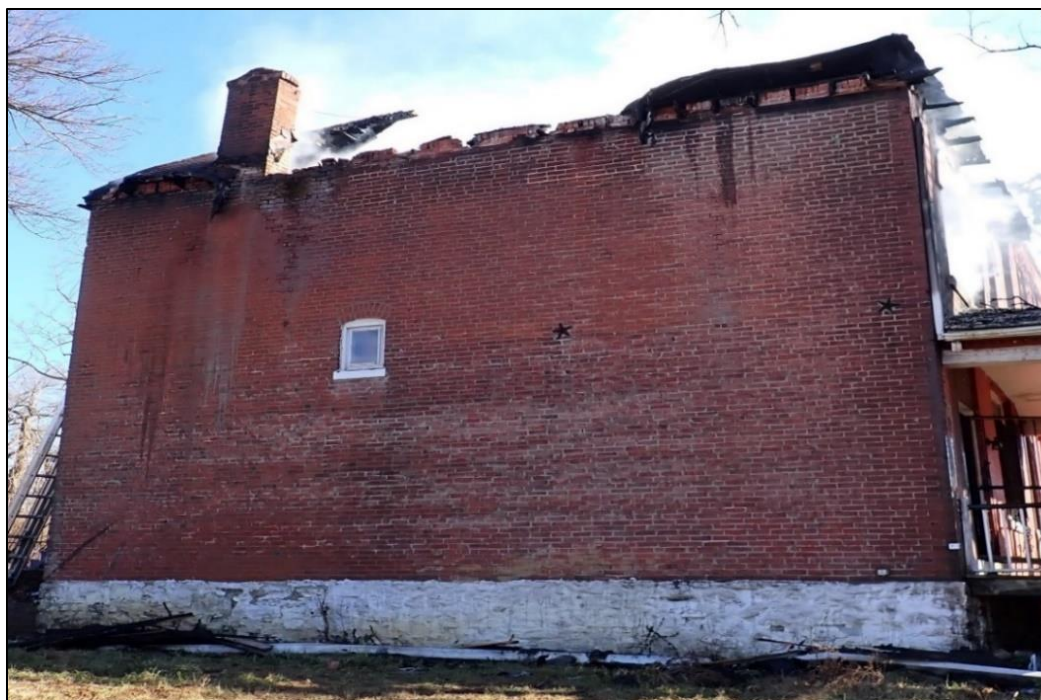
**Photo 4. Side Bravo post fire conditions. (Courtesy of FD)**

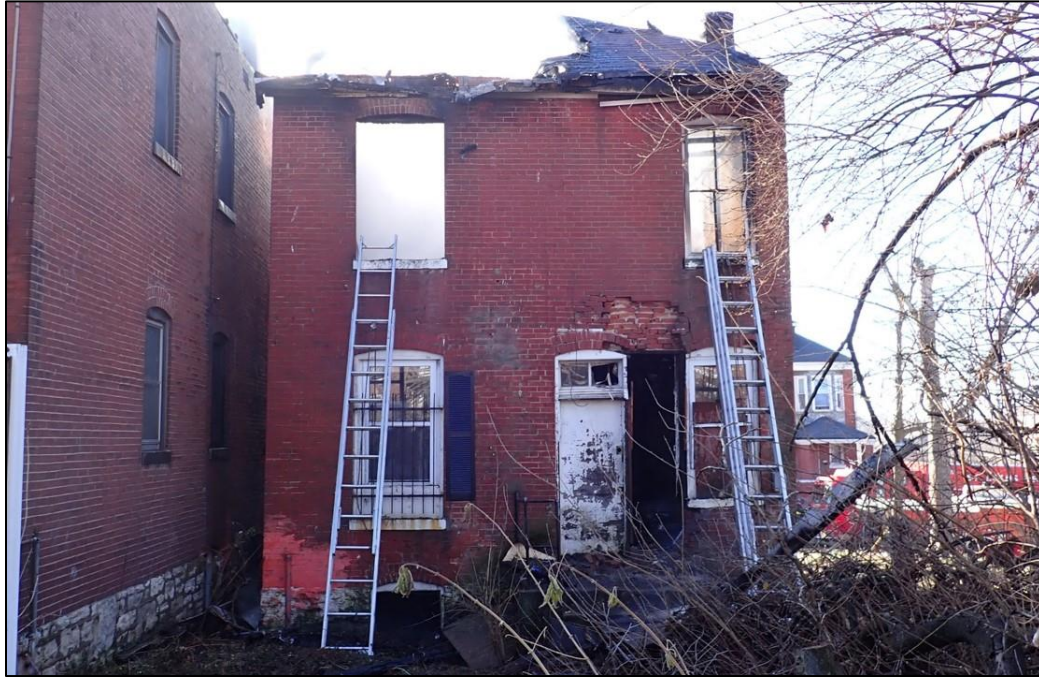
**Photo 5. Side Charlie post fire conditions showing the missing wall section on the 1<sup>st</sup> floor and the basement window used to access the basement by a member of RS-2. (Courtesy of FD)**

openings to the outside environment with windows being broken out and a section of the exterior wall missing on the 1st floor Side Charlie (see photo 5). The front door of the structure had been covered over with a piece of plywood.

At approximately 12:00, two members of RS-2 entered and conducted a search of the basement. One member entered the first floor of the structure from Side Charlie, worked his way through the collapsed debris, and accessed the interior basement stairs located along Side Bravo (see diagram 1). The other Rescue Squad member worked with a firefighter from H&L-5 to remove security bars from basement window located on Side Charlie. Once the security bars were removed, he entered the basement via that exterior window. Both members searched the basement, finding that it was empty with no fire conditions. They also found no indications of the missing firefighter T-13B.

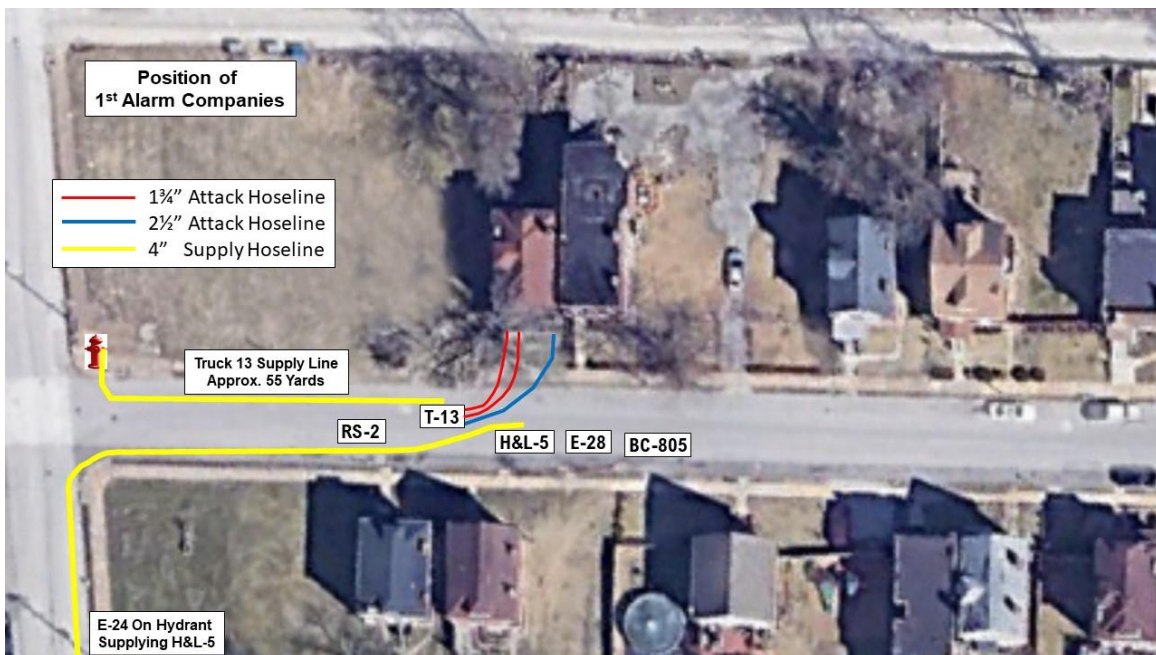
**Diagram 3. Position of 1<sup>st</sup> Alarm Units. (Image from Google Earth, additional content NIOSH)**

At approximately 11:50, H&L-5, E-28, and E-24 arrived on the scene, with H&L-5 and E-28 positioning in front of the structure, and E-24 laying a supply line from H&L-5 out to a secondary water supply (See diagram 3). Each apparatus was fully staffed with 4 personnel.

At approximately 11:54, Battalion Chief 805 (BC-805) arrived on the scene and positioned in front of the structure (see diagram 3). While enroute he had observed heavy black smoke to the west, with no change in color indicating that no water had been placed on the fire. He heard the radio exchange between the captains of E-24 and E-28 about apparatus roles and E-28A reporting defensive operations. As BC-805 approached the scene, he heard Fire Alarm announce, "T-13B you have an open mic, T-13B you have an open mic." He estimated that it was approximately four minutes from dispatch to the open mic broadcast. He stated that before he arrived on the scene it was announced on the radio that a firefighter had been trapped.

The RS-2 driver placed the apparatus close to the scene for ease of access to tools and equipment (see diagram 3). Upon arrival the rescue squad split into multiple groups and entered different parts of the structure to conduct searches for the missing firefighter.

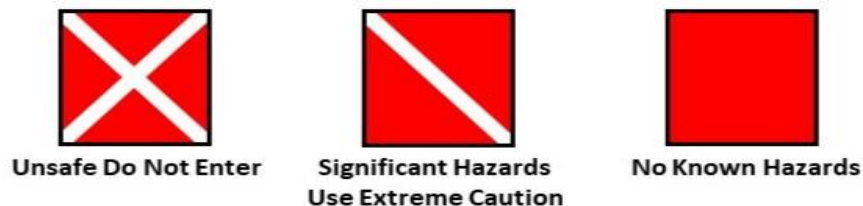
Image 8. IAAI/USFA high-risk building marking system (*Courtesy of USFA*)

The IAAI / USFA Abandoned Building Project, utilizes a simple system consisting of a box with a diagonal line to indicate the condition of the building.

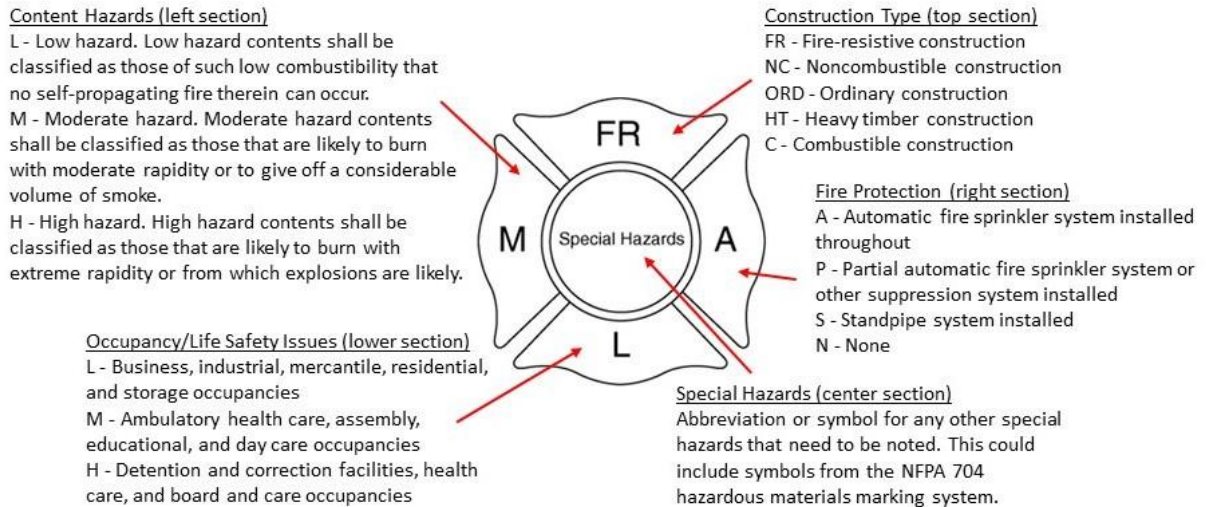
Image 9. IFC/NFPA high-risk building marking system (*Courtesy of NFPA*)

The 2021 International Fire Code (IFC) Appendix J Building Information Sign (International Fire Code, 2020) and the NFPA 1 Fire Code, Annex C - Fire Fighter Safety Building Marking System (Zevotek, 2022) utilize a more detailed marking system based on a Maltese Cross that includes those outlined in Image 9.
