# PPE CASE

## Personal Protective Equipment Conformity Assessment Studies and Evaluations

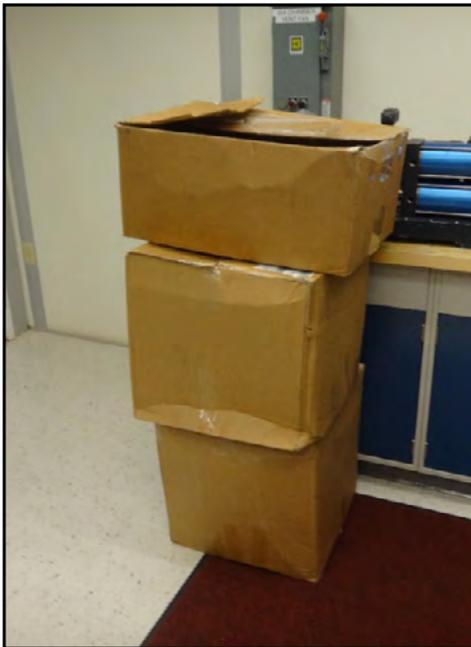
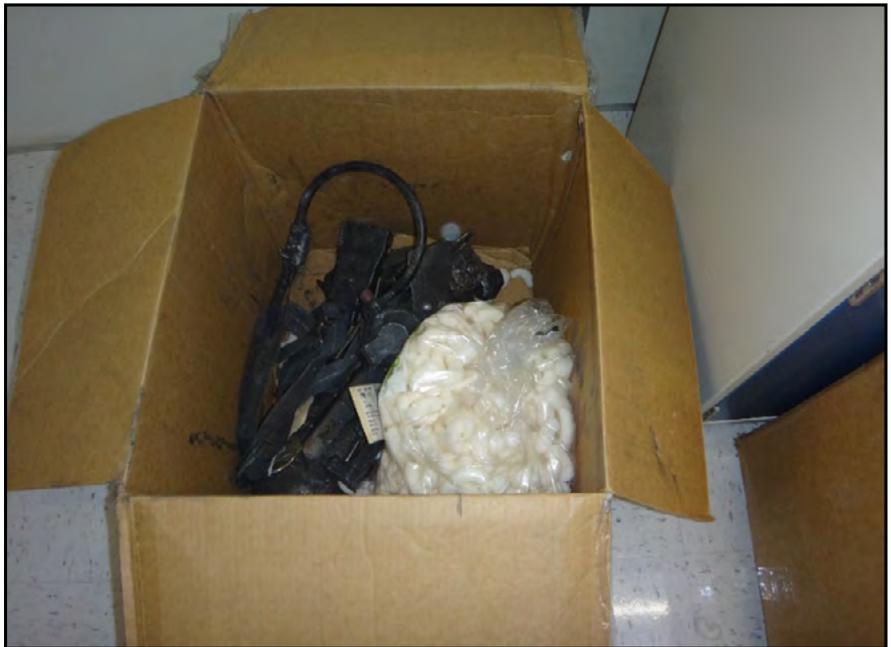
**Figure 1: SCBAs as received**
