# AN EVALUATION OF MICROSEISMIC ACTIVITY ASSOCIATED WITH MAJOR ROOF FALLS IN A LIMESTONE MINE: A CASE STUDY

**J. Ellenberger,** NIOSH, Pittsburgh, PA
**T. Bajpayee,** NIOSH, Pittsburgh, PA

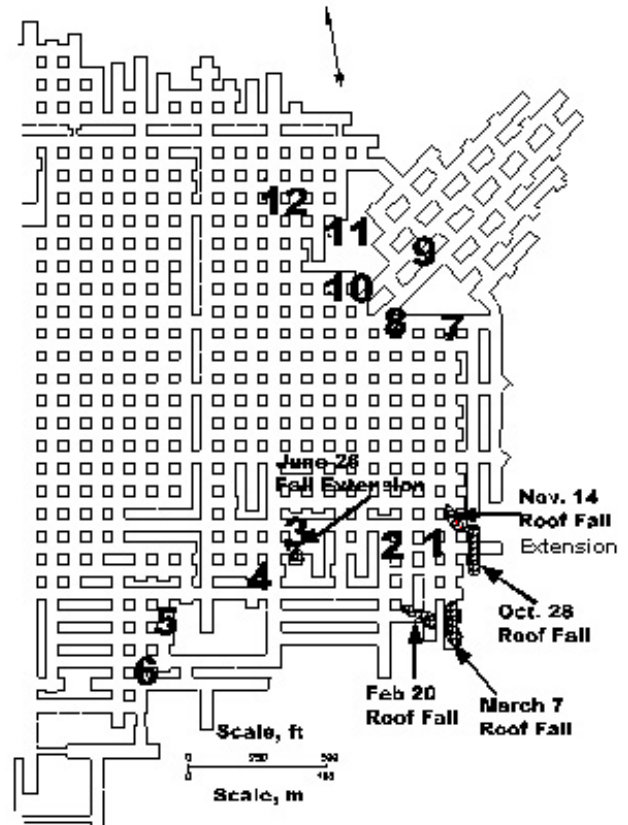
The locations and dates of the three major roof falls and the extension of two major falls that occurred during this study period are shown in figure 2. It should be noted that all three major falls occurred in an area approximately 300 feet (90 m) wide in an E-W direction by 500 feet (150m) in the N-S direction. The February 20 fall was approximately 130 feet (40 m) long and trended NW-SE. The March 7 fall was approximately 150 feet (45 m) long, trending N-S. The June 26 fall was the extension of a previous fall, and was the only roof fall outside of the 300 foot (90m) by 500 foot (150m area). The October 28 fall was approximately 170 feet (50 m) long in a N-S direction, and the major fall of November 14 extended the October fall approximately 110 feet (35 m) in a NW-SE direction.

**Figure 2.** Mine map showing the locations of geophones, three major roof falls, two roof fall extensions and dates.

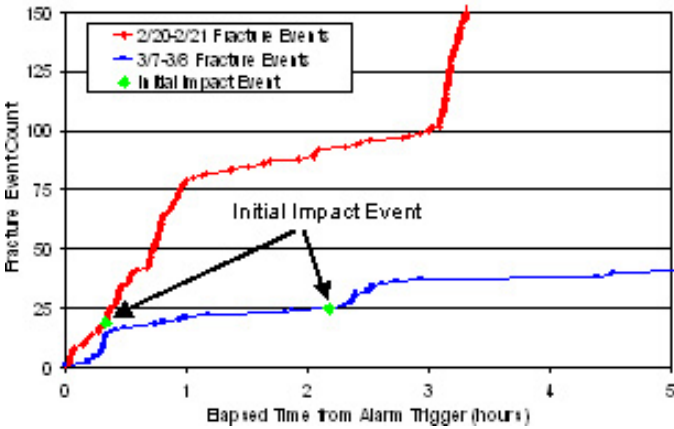
The first category of elevated fracture activity includes roof falls that may be anticipated before the major fall occurs. Two of the four falls that occurred in group #2 were detected by microseismic activity before the initiation of the roof fall. Elevated fracture activity following the alarm trigger rate of five fracture events in the ten minute time period is shown in figure 5 for these two roof falls. The initial roof fall impact event associated with each fall is also shown on the graph. The elapsed time from the initial alarm trigger (the fifth fracture event)

determines the warning time associated with the initial roof fall episode. For these two falls, the warning time was 22 minutes for the February 20-21 fall and 2 hours and 11 minutes for the March 7-8 fall.

**Figure 5.** Event count plot of two major roof falls with recorded initial impacts.

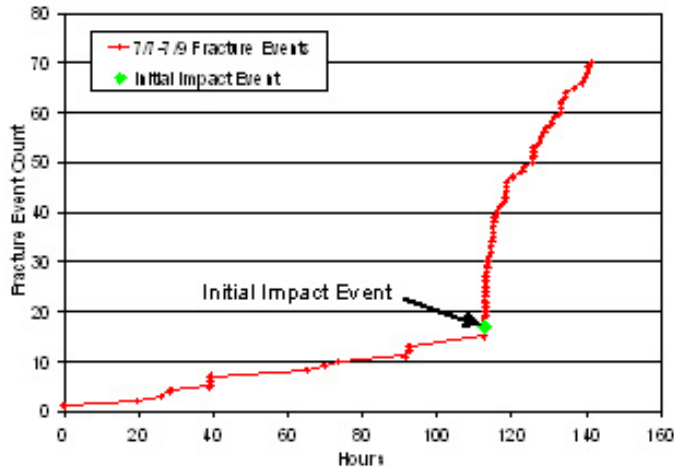
The second category of elevated activity can be classified as roof falls that are not immediately preceded by elevated microseismic activity (roof falls with no microseismic warning). In this category earlier fracture events may have deformed and weakened the roof, reducing the number of fracture events necessary to weaken the roof to failure. Roof falls that occur in this category might also be related to geologic structures or discontinuities that have significantly weakened the roof before mining (Iannacchione et al., 2001). These falls are associated with a high level of fracture activity after the fall develops. The microseismic data has value to the operator in locating the fall area, especially if it occurs in remote areas. The cumulative event count plot for the fall shown in Figure 6 shows an example of a roof fall that occurred on July 7-9, which was not preceded by elevated microseismic activity. The plot shows typical background activity for over 100 hours preceding the fall, followed by a similar trend to that of the forecasted major falls in the previous category. However, the initial roof fall impact event is the third event as the activity elevates. A total of 55 fracture events were identified in the elevated activity period.

**Figure 6.** Cumulative fracture event plot of a roof fall with virtually no warning. Note the abrupt change from background to elevated activity.

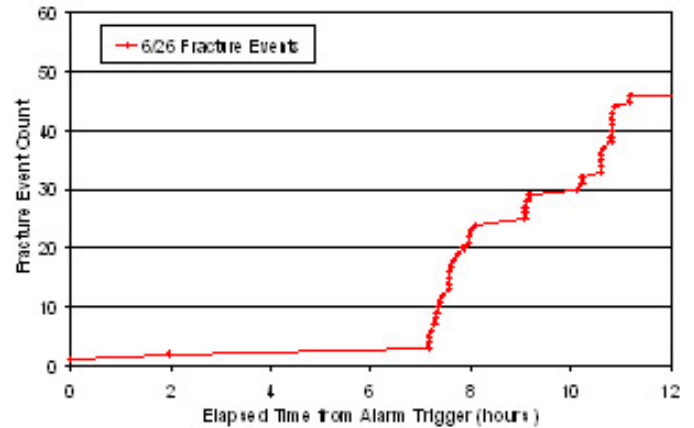
The third category of elevated fracture activity is one where a roof fall is identified by on-site observation, but the microseismic records did not include a roof fall impact event. Figure 7 shows the cumulative event count of fracture events recorded on June 26, and it is very similar to the plots seen in association with roof falls in figures 5 and 6. Nearly 50 fracture events were recorded between 7 and 11 hours on the plot. The review of the seismic records showed that the events were readily identified as being nearest geophones 3 or 4. A roof fall

that was observed to have extended to a greater depth on June 26 is also near geophones 3 and 4. Since the material that fell from the roof to extend the fall probably fell on existing rubble, it is reasonable to assume the impact events were masked from the microseismic system to record the event.

**Figure 7.** Cumulative fracture event activity with no identified roof fall impact.

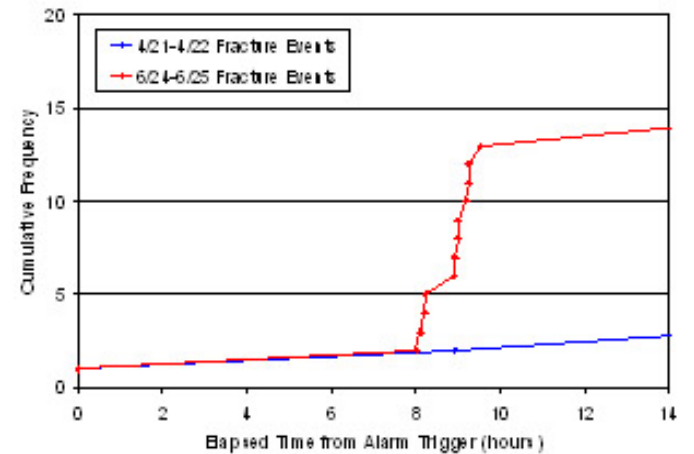
The fourth category, elevated fracture activity that results in no roof fall, may best be classified as false alarms. In these situations, fracture events occur, and the frequency may reach that of an alarm, but the roof reaches equilibrium without having a failure. Figure 8 shows two elevated cumulative event count periods that were not associated with significant roof damage. These plots include a small number of fracture events following the 5 events in 10 minutes that classified them as triggered alarms, while the roof falls of February 20-21 and October 28-29 included 507 and 244 events, respectively. It should be noted that the elevated activity seen on June 24-25 preceded the fall extension that occurred on June 26 (category two). These episodes of elevated activity do represent the development of fractures and the continued weakening of the roof, and may contribute to those falls described earlier that occur with little or no warning.

**Figure 8.** Cumulative fracture count of two elevated activity periods with no identified impact events.
