Multiple Seam Mining Interactions:
Case Histories From the Harris No. 1 Mine

Frank E. Chase, Research Geologist
NIOSH-Pittsburgh Research Laboratory
Pittsburgh, PA

ABSTRACT

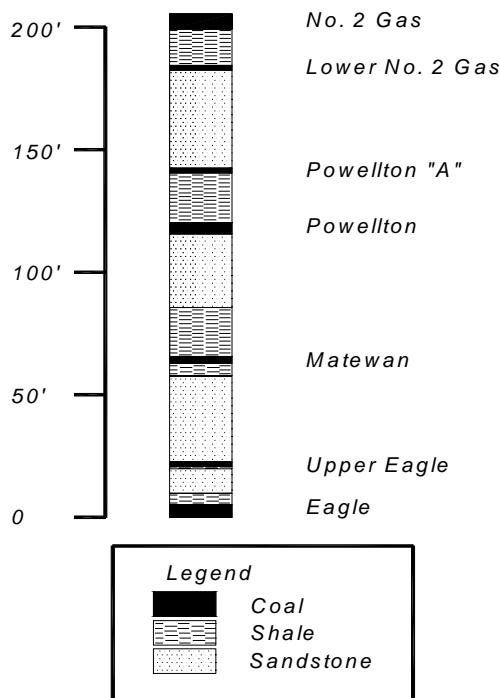
Figure 2. Generalized interburden stratigraphy.

Figure 2 is a generalized stratigraphic column of the interburden between the No. 2 Gas and Eagle Coalbeds. It should also be noted that the major sandstone and shale units shown in figure 2 vary in thickness. For example, in a few of the core holes the upper two sandstone units merge into a 100 ft thick unit. The same can be said for the lower two sandstone units. These rock unit thickness variations suggest ancient stream channel activity. Usually, the interburden contains 6 distinct rock units; however, the actual number varies from 4 to 7. In general, the interburden is rather competent, with the percentage of sandstone, sandy shale, and limestone ranging from 59 to 80 percent. The coalbeds between the Eagle and No. 2 Gas shown in figure 2 have not been mined above Harris.

Another factor identified in determining the magnitude of the interaction is the immediate roof rock competency (4). The shale unit shown in figure 2 directly above the Eagle Coalbed varies in thickness from 0 to 10 ft. In areas of Harris, this shale unit can either be laminated, sandy, or nonexistent (replaced by a sandstone scour). These fluctuations explain the range in Coal Mine Roof Rating (5) values from 44 to 71. These values indicate that the immediate roof rock is moderately strong to strong.

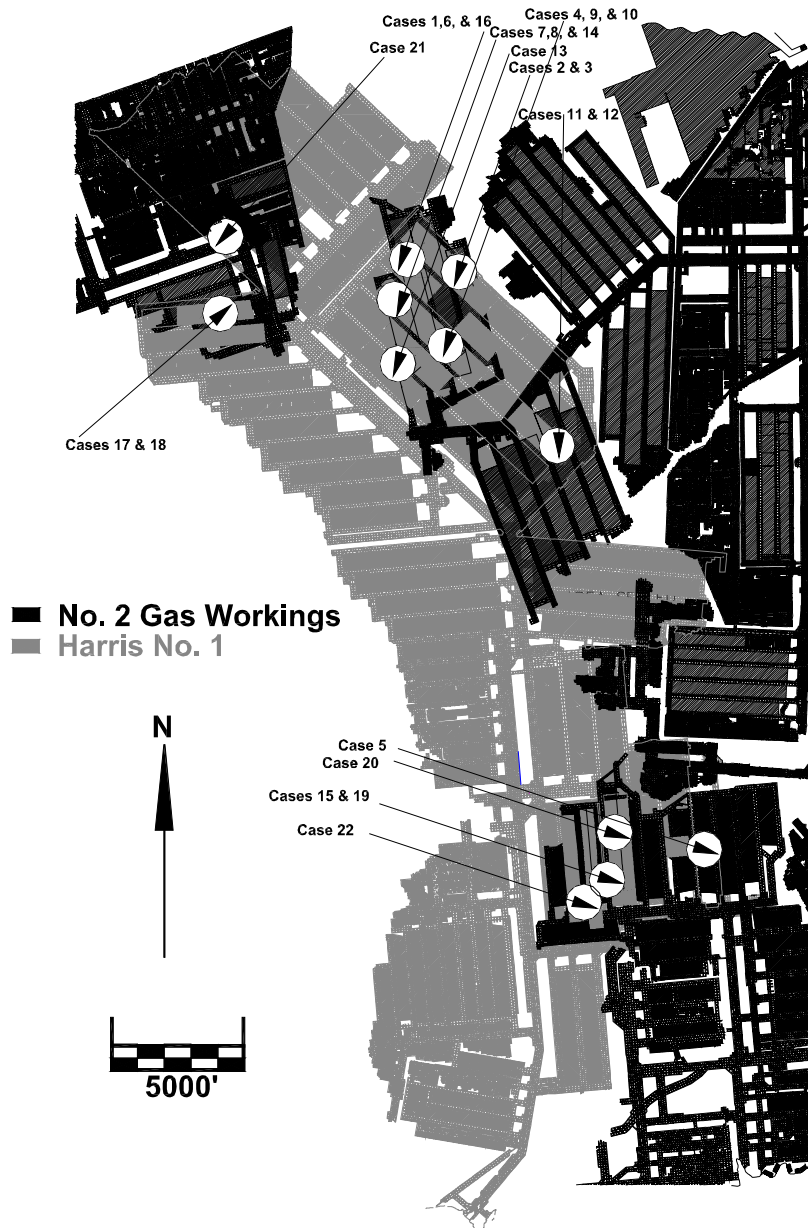
Figure 3. No. 2 Gas workings superimposed on Harris No. 1 Mine.

A detailed examination of both the No. 2 Gas and Harris No. 1 workings (figure 3) revealed 22 case histories where multiple seam interactions happened or might have been anticipated. In each case history, gateroads were driven and panels were extracted under various upper seam structures, and the outcomes are listed in the Appendix. Overburden depth, interburden thickness and composition, and additional consequential mining parameters, which are thought to determine whether or not interactions will occur (1-3) are also listed in the Appendix. Prior to the analyses, the data base was separated into two categories, gate entry workings (17 cases) or longwall face stability (5 cases) because of the major differences between the two. A rating system from 1 to 6 (see the Appendix for details) was developed to numerically

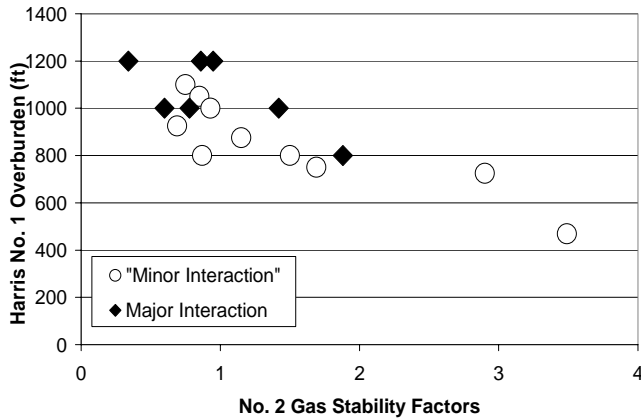
Figure 5. Relationship between degree of interaction and the No. 2 Gas ALPS stability factors and Harris No. 1 overburden.

A series of XY scatter plots were generated in order to examine the various mining and geologic parameters for correlations. Figure 4 indicates that 6 out of 7 of the major interaction gateroad workings cases occurred when Harris' depth of cover was 1,000 ft or greater and the Analysis of Longwall Pillar Stability Factor (ALPS) was 1.5 or less. Further, figure 5 points out that 5 out of 7 of the major interaction cases occurred when the No. 2 Gas ALPS

SF was less than 1.0 and the depth of cover was 1,000 ft or more in Harris. Finally, figure 6 illustrates a weak correlation between problematic cases and a No. 2 Gas overburden/interburden ratio of 3.9 or greater. As for the five longwall face stability cases, the only parallels that could be drawn were that the depth of cover was primarily 1,000 ft or greater, and the immediate roof rock was enerally relatively weak. Upper seam pillar design did not appear to be an issue; however, both it and the findings mentioned in this section warrant additional examination and discussion.

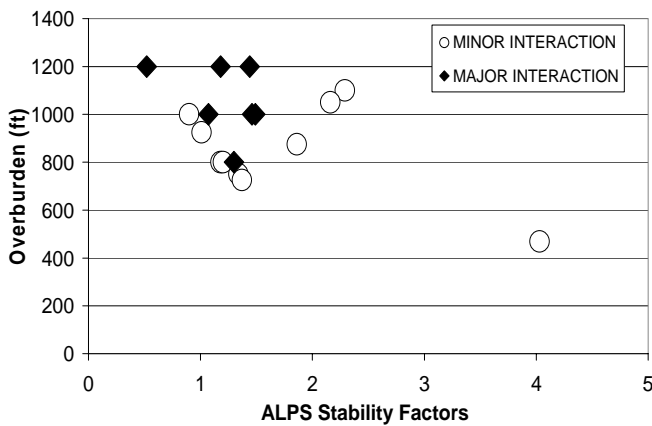
Figure 4. Relationship between degree of interaction and the Harris No. 1 ALPS stability factors and overburden.

As stated in the case history analyses section, 6 out of the 7 major interactions occurred when the Harris depth of cover was 1,000 ft or greater and when the ALPS SF was less than 1.50 (figure 4). The cover relationship is noteworthy, in that, most operators maintain that there is a correspondence between multiple seam interaction difficulties and overburden. Typically, operators state that troubles generally begin occurring at roughly 800 ft of cover. Essentially, it takes a certain amount of cover load to cause downward load transfer problems. One possible explanation for the higher cover value at Harris may be interburden competency. It is conceivable that the three sandstone units which comprise 59 to 80 percent of the interburden are bridging, and therefore dampening the downward load transfer. As for the Harris ALPS SF's, figure 4 suggests that the probability of a major interaction occurring decrease as the stability factor increases. The same can be said for the No. 2 Gas ALPS SF's. As shown in figure 5, 5 out of 7, or 71 pct of the major interaction cases occurred when the No. 2 Gas ALPS SF was less than 1.0 and the depth of cover was 1,000 ft or more in Harris. Based on the above mentioned findings, a certain amount of concern and supplemental support are probably warranted when dealing with deep cover and lower upper and lower seam ALPS SF's. Like the old longwall adage goes, "it is better to be safe than be shut down." (It should be noted that multiple seam stress transfer values were not taken into account when determining the ALPS SF's listed in the Appendix or shown on the figures.)

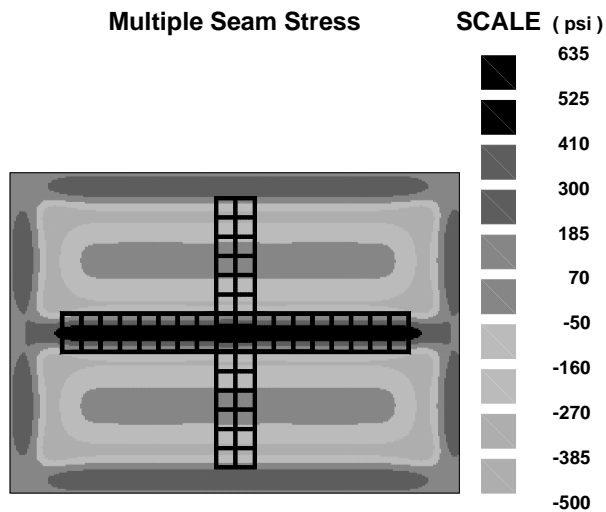
Figure 8. LaModel output for 60 ft wide No. 2 Gas pillars.

LaModel, a displacement-discontinuity boundary element program was used to evaluate the hypothesis described above. The models were run using standard default parameters and yield zones. Figure 8 displays the basic layout of the two mine designs which were modeled. In the Harris design case, a three entry longwall gate entry development section (oriented from top to bottom on figure 8) was driven on 120 ft entry and crosscut centers in a 6 ft high reserve. The pillars had an ALPS SF of 3.07 and the depth of cover was 1,200 ft. A three entry isolated gateroad system (oriented from left to right on figure 8) was then situated 200 ft above Harris. The crosscut center spacing in the No. 2 Gas remained constant at 140 ft. The entry centers were varied from 30 to 180 ft in 10 ft increments for each LaModel run and the mining height was 6 ft. As illustrated in figure 8, the No. 2 Gas and Harris workings are situated perpendicular to one another so that four pillars were stacked in the center of the LaModel grid. Figure 8 also displays the LaModel analysis results for a No. 2 Gas gateroad system with 60 ft wide pillars. Figure 8 clearly shows that the multiple seam stress transfer magnitudes in Harris are the highest beneath the isolated gateroads. Conversely, the de-stressing effects of the overlying gob are also evident in figure 8.

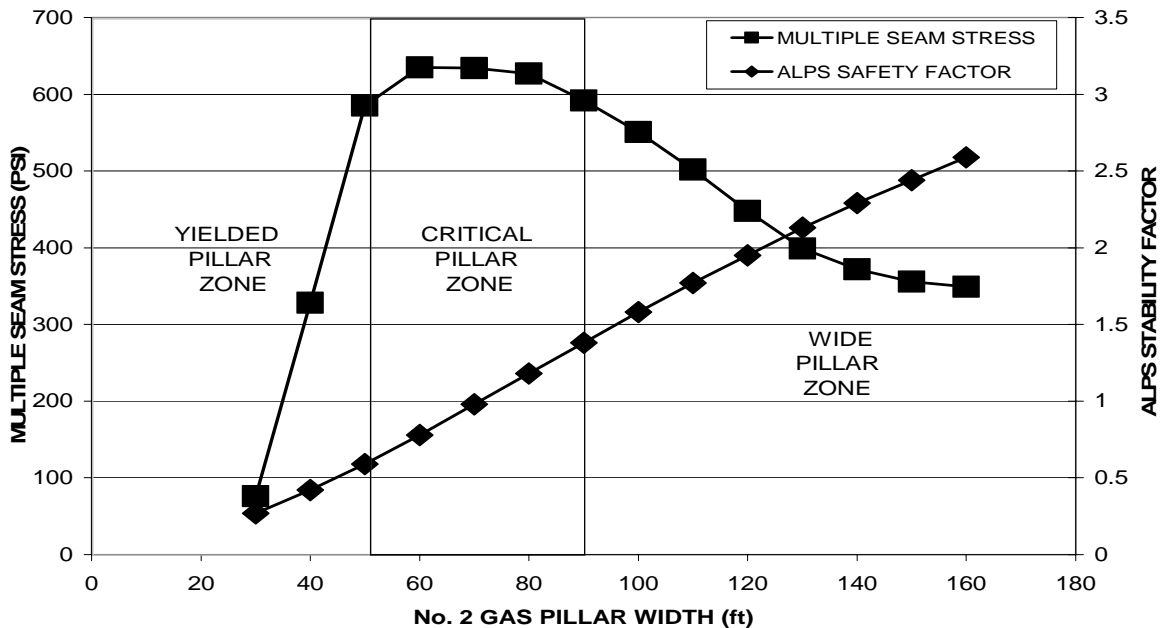
Figure 9. Peak multiple seam stress transfer values and the ALPS SF's for modeled pillar widths.

Figure 9 displays the peak multiple seam stress transfer value and the ALPS SF for each pillar width modeled. Figure 9 illustrates the wide range in multiple seam peak stress transfer values which are dependent on the width of the pillar. When analyzing figure 9, the multiple seam stress transfer curve appears to have three distinct regions that correspond to the three upper seam load distributions shown in figure 7. The peak or "critical" multiple seam stress transfer values occur when the chain pillars in the upper seam are in the 50 to 90 ft range. The models indicated that the cores of these pillars were all heavily loaded. On the left side of the critical pillar region, the models showed that the stresses in the cores of smaller, upper seam pillars were much lower than for the critical pillars. The smaller the pillar, the lower the peak stress, and the less the multiple seam stress experienced in the lower seam. On the right side of the critical pillar region, as the upper seam pillars get wider, they distribute their load more evenly. The result is a steady

decreasing trend in downward stress transfer as the pillar width is increased up to around 130 ft. Once the pillar reaches a certain width, there is essentially no interaction between the two high-stress zones at the ribs and the peak stress transfer levels out at approximately 350 psi.
