# **Semi-Truck Team Driver Pinned and Killed while Adjusting Tandems**

**Incident Number: 14KY064**

**Kentucky Fatality Assessment and Control Evaluation (FACE) Program**  
**Incident Number: 14KY064**  
**Release Date: September 2, 2015**  
**Subject: Semi Truck Team Driver Pinned and Killed while Adjusting Tandems**

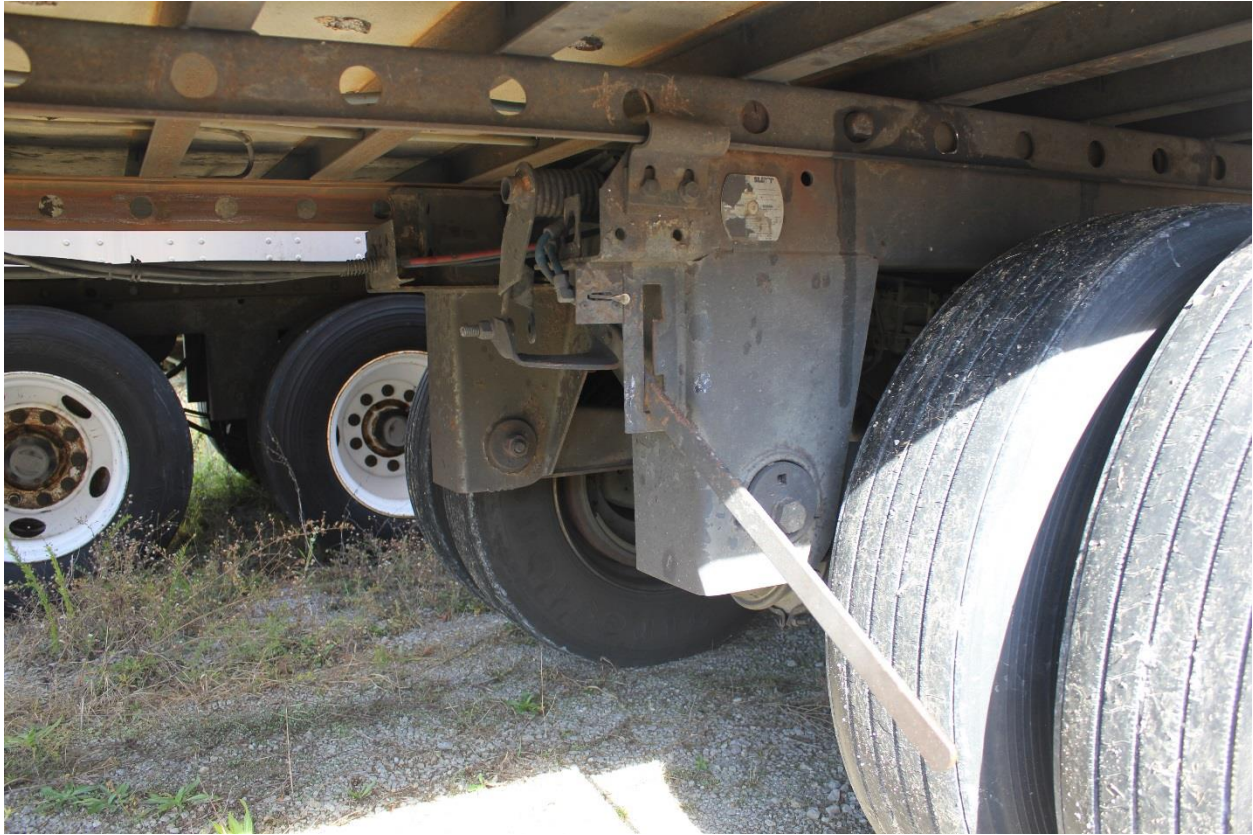
Photo courtesy of KY OSH

On October 30, 2014, at approximately 7:00 am, a semi-truck driver and fellow team driver parked in a chain restaurant parking lot to make their delivery, unloaded their product, and were adjusting the tandems on the trailer. The team driver placed himself near the tandems while the semi-truck driver climbed into the truck cab to rock the truck so that the tandems would slide into place. The team driver was found with his head pinned between the tire and the bottom of the trailer.

driver sprayed WD-40 onto the pins then struck them with a hammer in an attempt to loosen the rust that caused the pins to stick. When the pins were loose, he actuated a manual release lever near the front of the tandem and instructed the semi-truck driver to rock the truck back and forth to release the tandems (see photos #1 & #3).

**Recommendation No. 1: Employers should consider providing extension rods to manually adjust tandems that will allow workers to remain clear of moving or shifting tandems.**<sup>1</sup>

**Recommendation No. 2: Tandem adjustments should be performed by the semi-truck driver.**

Employers should consider the implementation of a best practice where only the semi-truck driver adjusts the tandems. This prevents miscommunication between two drivers and eliminates placing one of the drivers in a hazardous situation.

**Recommendation No. 3: Drivers should consider using a tandem stopper tool.**<sup>3</sup>
